## LUMBERYARD at PAINT CREEK

### PROGRESS REPORT

#### PHASE 2 – CONCEPT

For the Period 4/15/25 – 5/15/2025

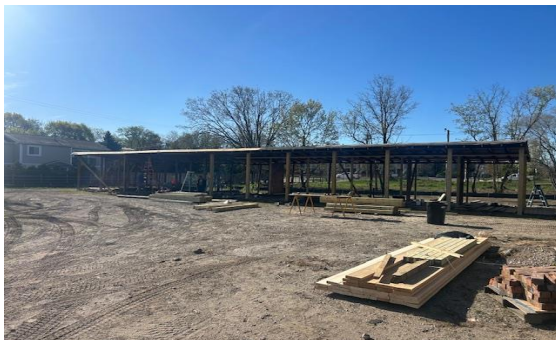
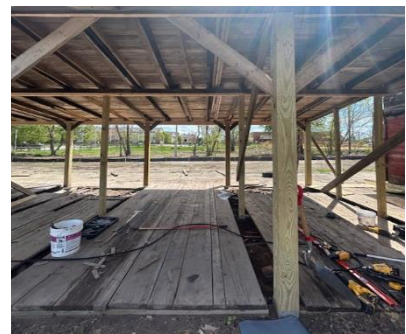
***The Market Shed:*** This structure was originally a lumber rack, and is being transformed into a multi-stall market/vendor pavilion. We have kept the original cedar plank roofing, but added strength through upgraded post, cross support, and headers. Adding new sheeting and a new metal roof.

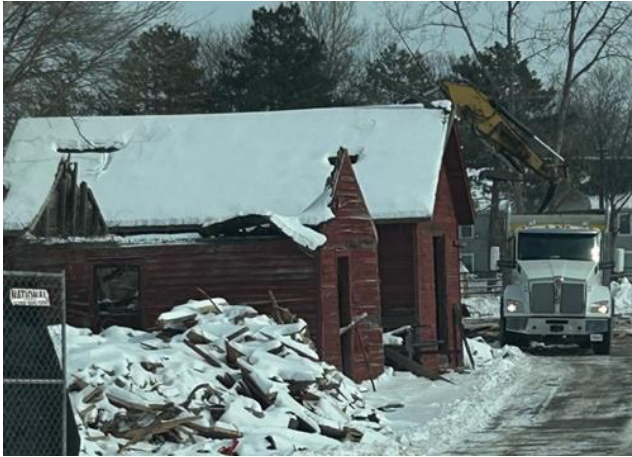
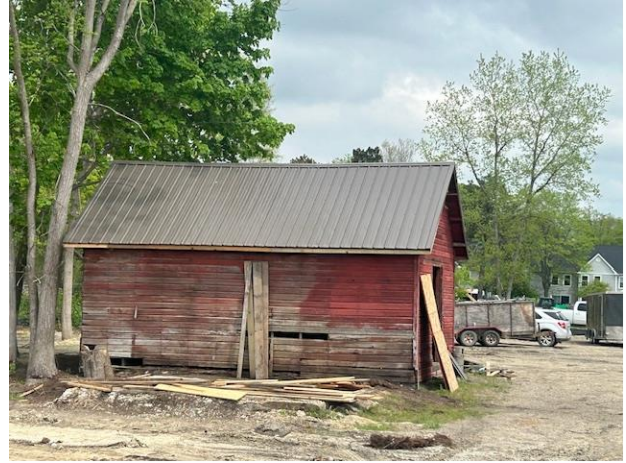
**Coal Shed:** this shed was one of two used by the original railroad and coal operations on site. They were built in 1917. One was not savable, but its foundation is now usable as an approach for the restoration and use of the other. The interior roof materials has been patched to reflect its original character, new sheeting, and internal header support form material found in the barn. A new roof.

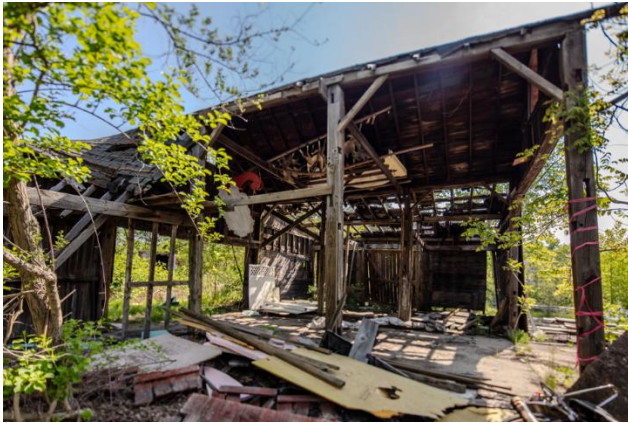
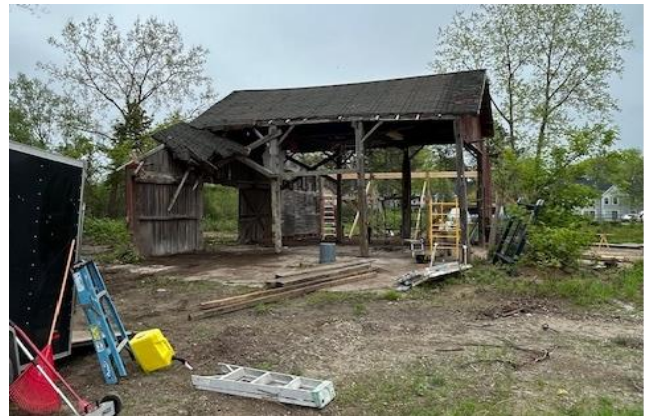
**Supply Shed:** This 1917 structure was originally a supply shed and is now transforming into the centerpiece of a trailhead for the Paint Creek Trail. The debris is being carefully removed. The main posts are being reinforced, the beams doubled, and the north and south walls repaired for strength. We are keeping the old façade on both the interior and exterior of those walls.

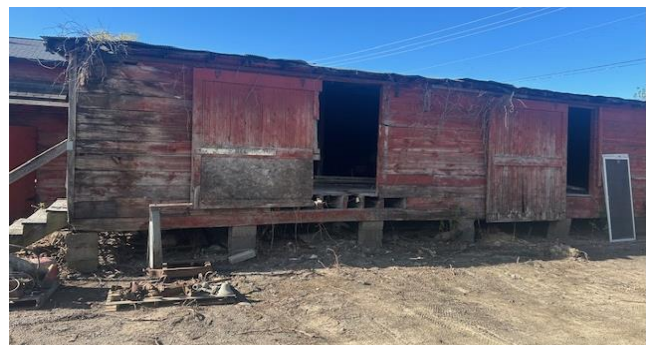
**Main Barn:** This main structure is next. A standing seam metal roof is the goal, but it requires repairing the foundation/footings on the north side of the annex, and bracing the large truss system.

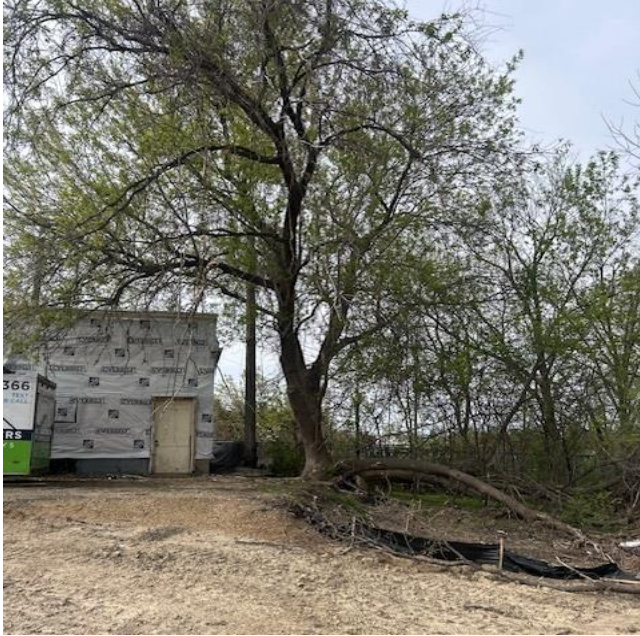
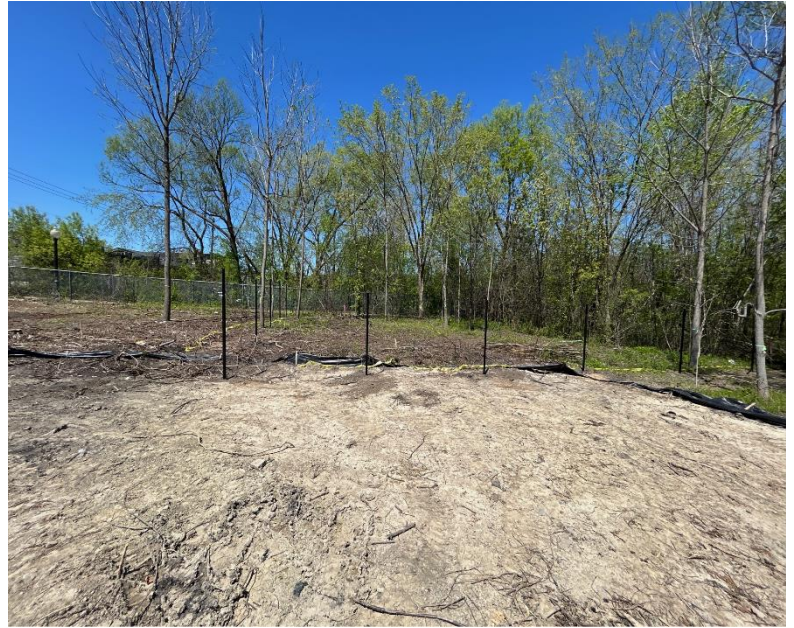
We have proceeded with clearing the Waltman Lot. Fencing is being restored around the MDOT spillway area for security and safety.

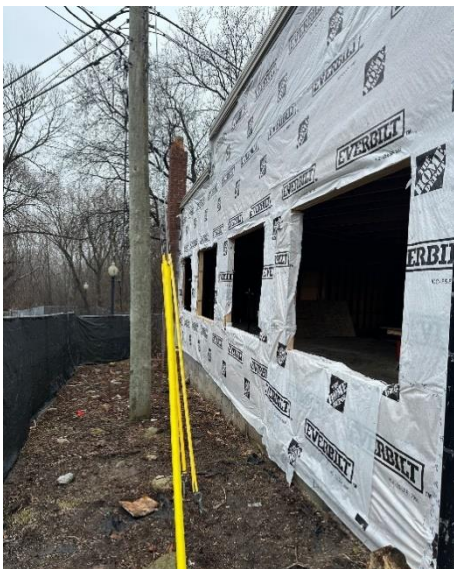
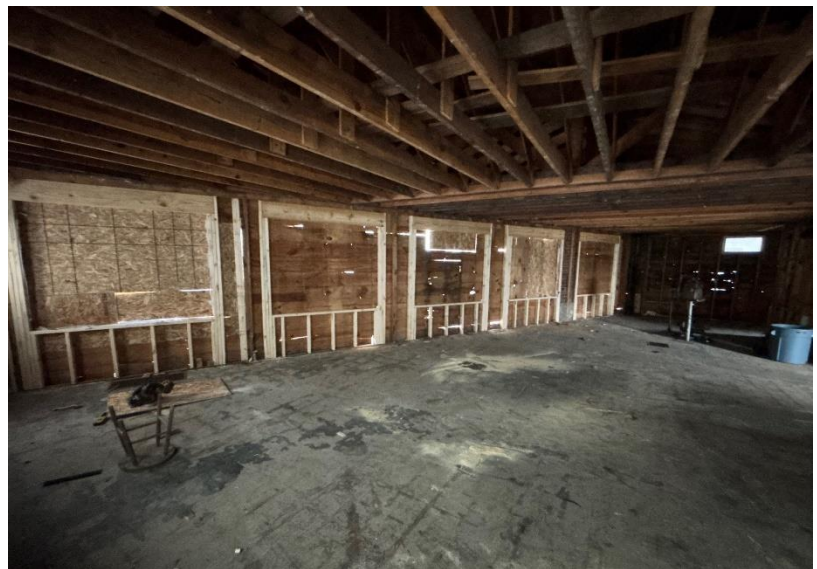
The window package was delivered incorrectly. This is on hold until the remaining windows arrive in May. The window package will be finished in May. Starrs Roofing of Lake Orion will be starting on a new rolled roof in May.
