## LUMBERYARD at PAINT CREEK

### PROGRESS REPORT

### Report to the Board

For the Period 3/15/25 – 4/15/2025

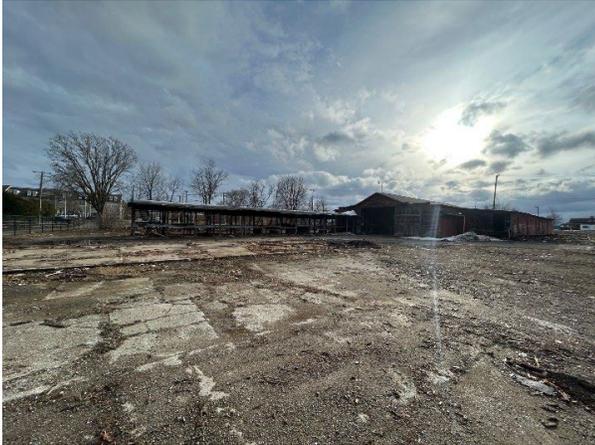
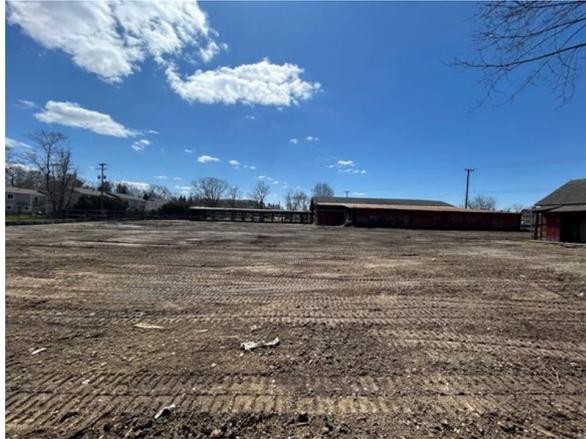
with applicable state and federal rules. All hazardous materials identified as part of demolition were properly removed and disposed of according to the required manifests.

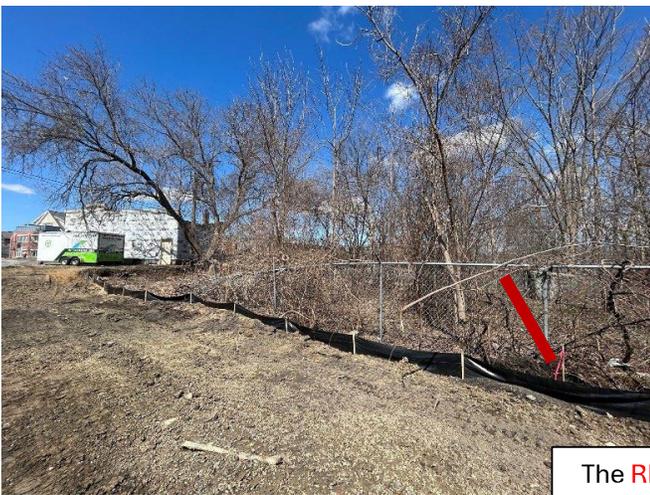
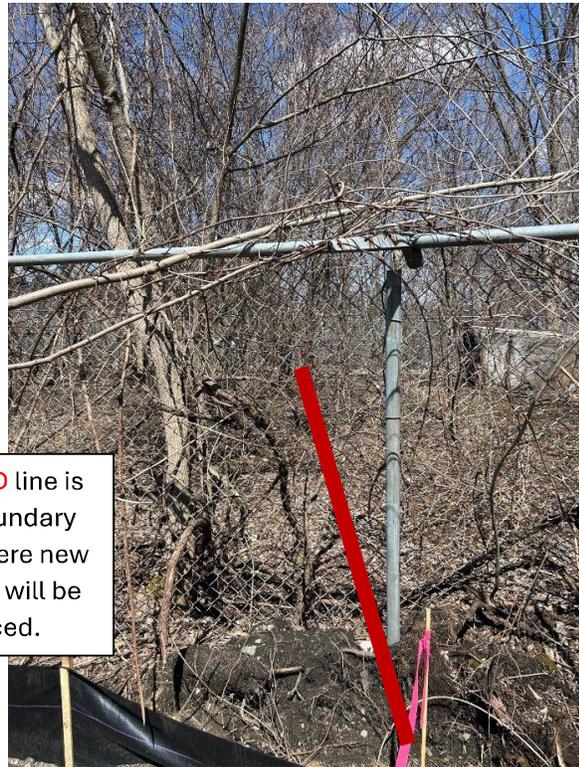
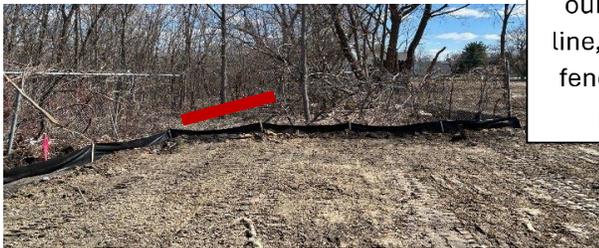
The survey revealed that our Northern Boundary lies within the existing fenced area of the MDOT spillway. There is a gate covering the public sanitary easement, and extending from the gate westward, the staking revealed the actual location of our boundary. This staked line will be re-fenced with a matching black chain-link. The area must be fenced for both safety and regulatory reasons, and the area will connect to the existing fencing along the south side of the bypass bike lane between our property and the Oat Soda building.

The **RED** line is our boundary line, where new fencing will be placed.

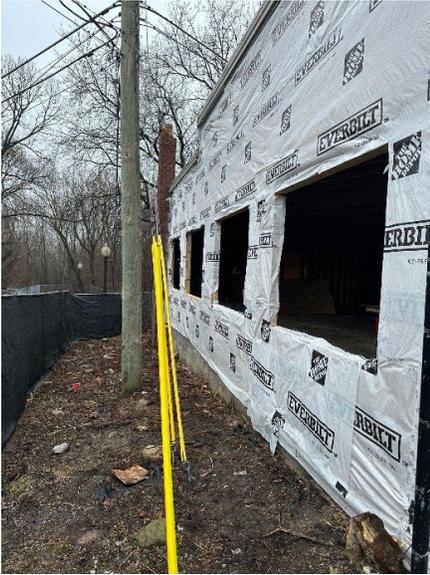
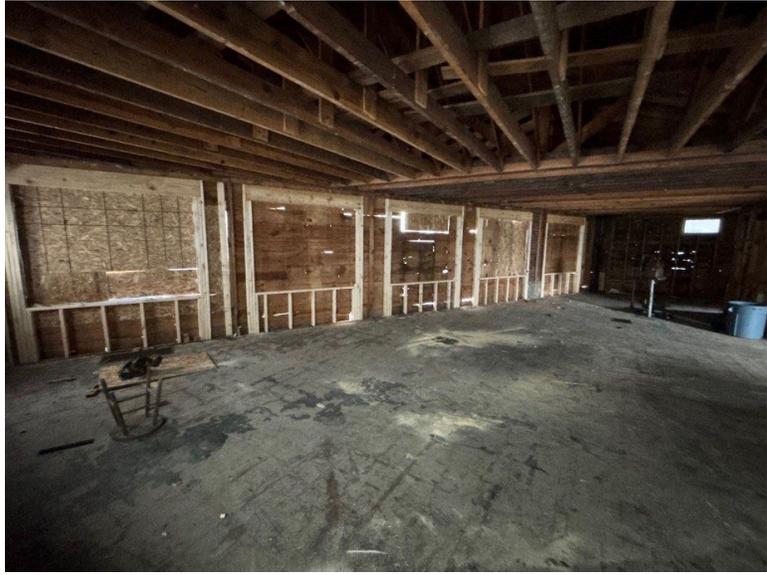
The original office was stripped of salvageable materials and prepped for rehabilitation in January. The building is now being prepped for further repairs and the replacement of windows and siding. At the April meeting, the board will receive and consider ratifying an agreement for the repair of structural elements and installation of windows, such windows in the style of the original windows of the era that the building was constructed (1917). **No permit, no architect, no engineer - who is the responsible party for structural modifications?**

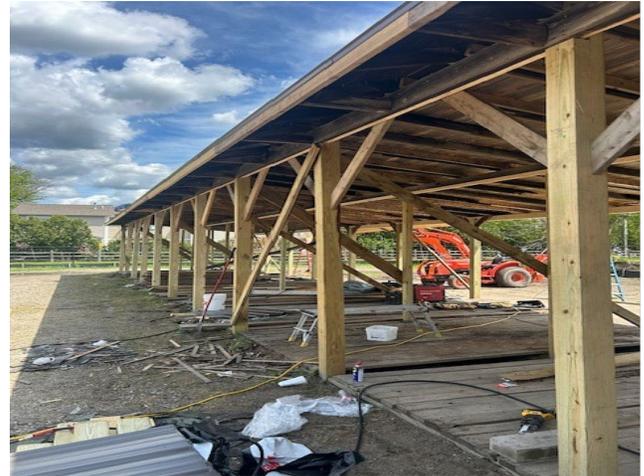
**All new framing and bracing**

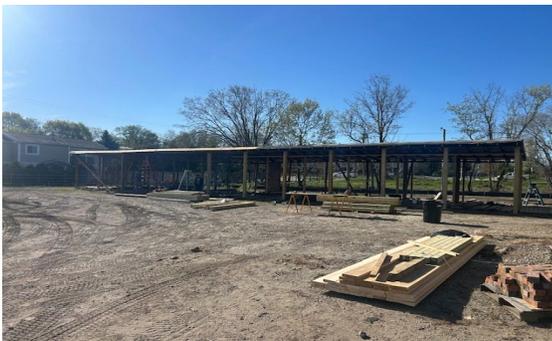
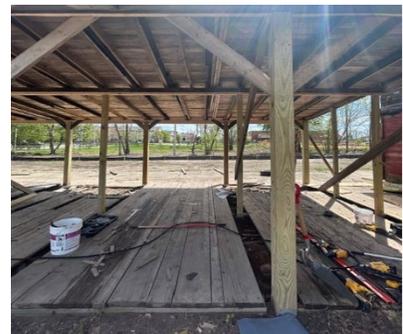
**The Market Shed:** This structure was originally a lumber rack, and is being transformed into a multi-stall market/vendor pavilion. We have kept the original cedar plank roofing, but added strength through upgraded post, cross support, and headers. Adding new sheeting and a new metal roof. **change of use requiring code compliance**

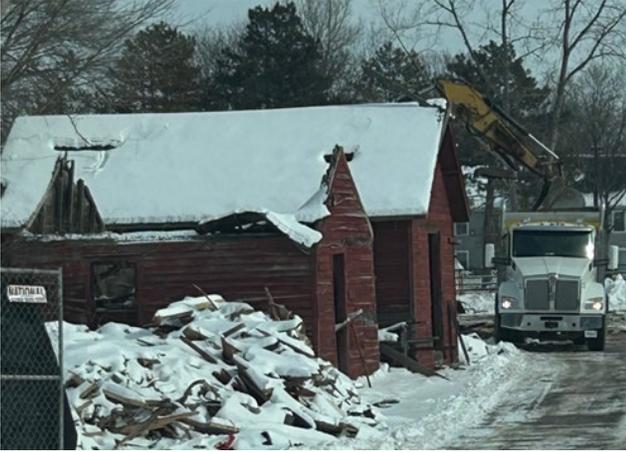
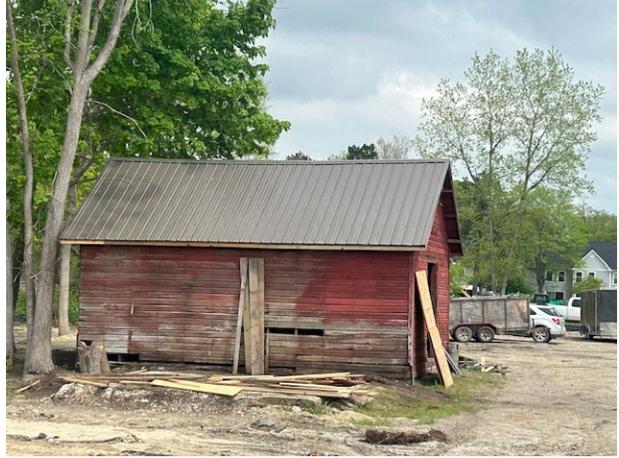
**Cool Shed:** this shed was one of two used by the original railroad and coal operations on site. They were built in 1917. One was not savable, but its foundation is now usable as an approach for the restoration and use of the other. The interior roof materials has been patched to reflect its original character, new sheeting, and internal header support form material found in the barn. A new roof.

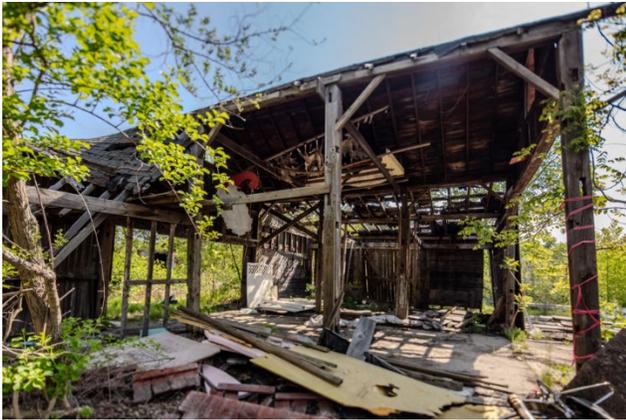
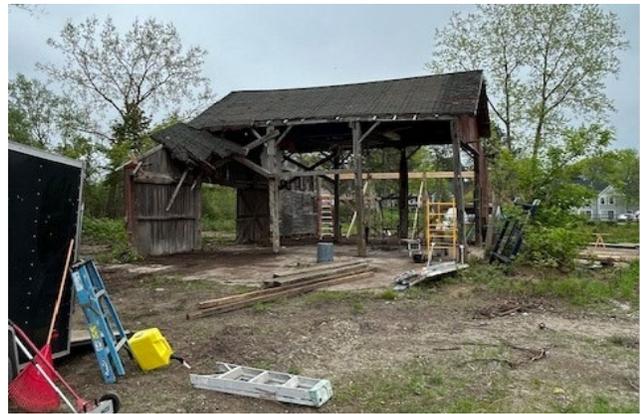
**Supply Shed:** This 1917 structure was originally a supply shed and is now transforming into the centerpiece of a trailhead for the Paint Creek Trail. The debris is being carefully removed. The main posts are being reinforced, the beams doubled, and the north and south walls repaired for strength. We are keeping the old façade on both the interior and exterior of those walls.

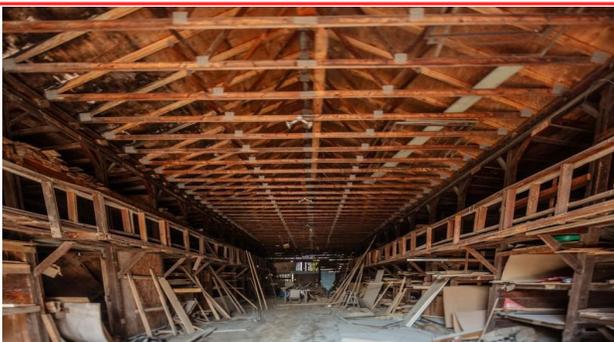
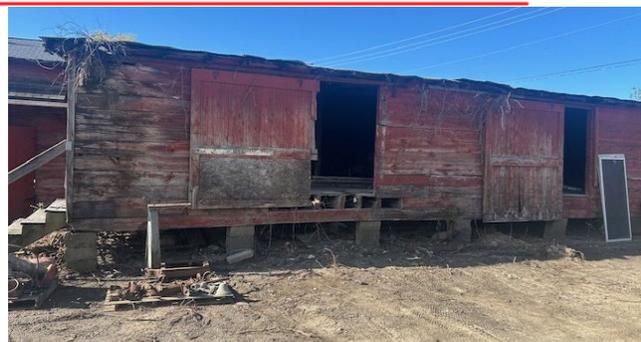
**Main Barn:** This main structure is next. A standing seam metal roof is the goal, but it requires repairing the foundation/footings on the north side of the annex, and bracing the large truss system.

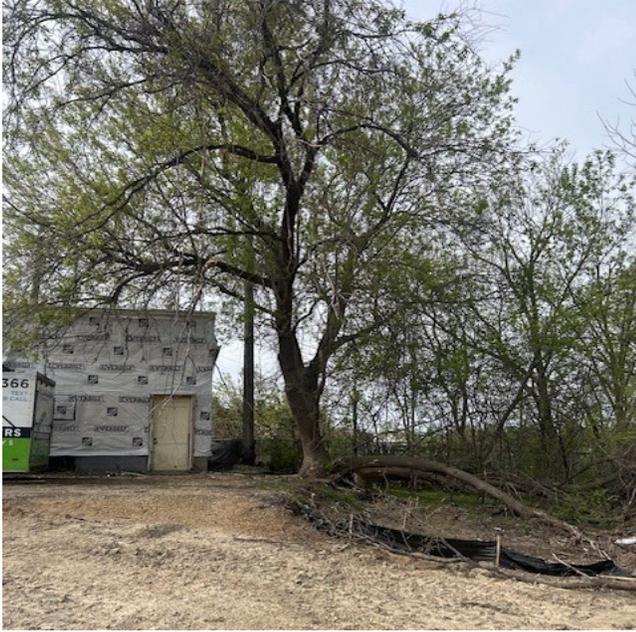
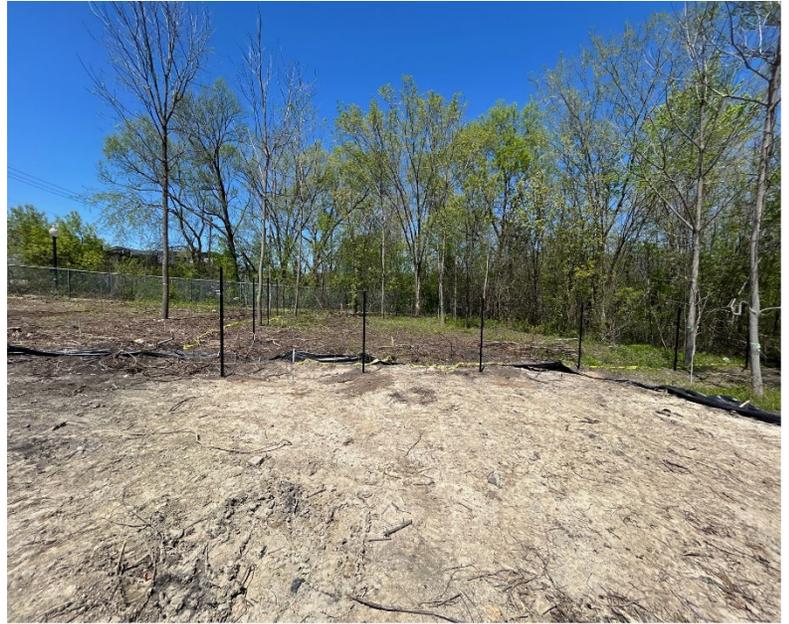
We have proceeded with clearing the Waltman Lot. Fencing is being restored around the MDOT spillway area for security and safety.

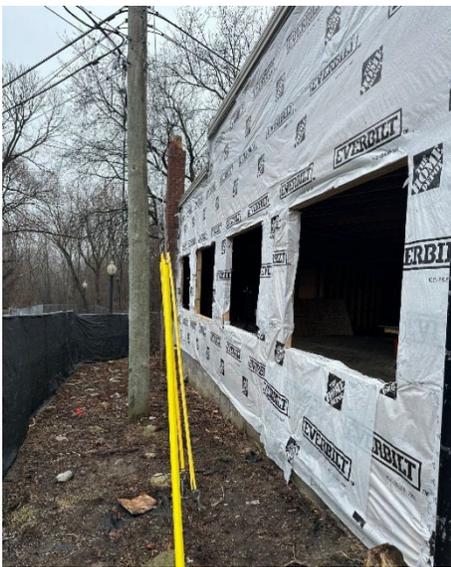
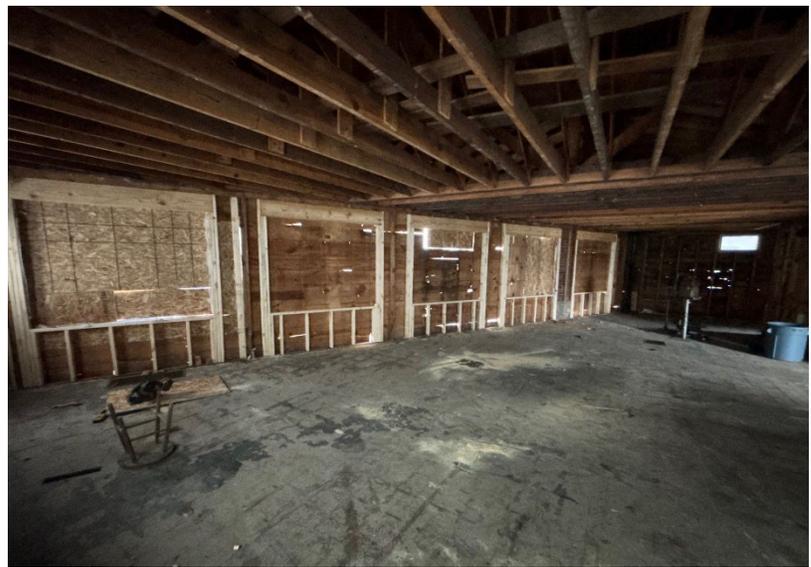
The window package was delivered incorrectly. This is on hold until the remaining windows arrive in May. The window package will be finished in May. Starrs Roofing of Lake Orion will be starting on a new rolled roof in May.

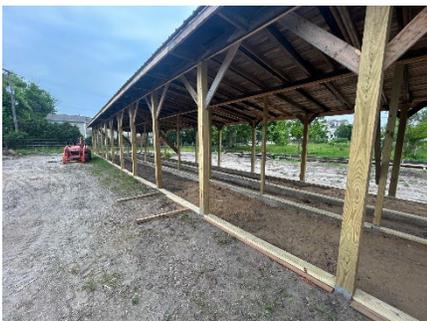
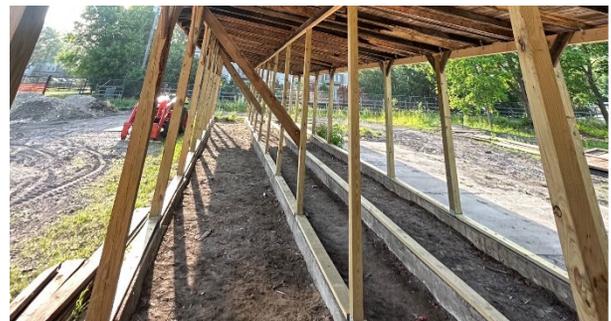
**The Market Shed:** This structure was repaired to make it solid and safe for public use as a market pavilion, and a new metal roof was installed. The contractor is now moving forward with preparing the existing footings and deck to replace the severely rotted decking where vendors and public will traverse. It was originally intended to re-place the historic 2” planking with salvage, but based on estimates as to how much salvaged material we have left, the decision was made to save that historic material for inside the main barn. We will use new wood intended to grey quickly to the aesthetic.

The DDA Board approved contract with Mickey’s Construction for the repair of the four public space buildings is continuing. There are several change orders on the June 17, 2025 DDA Board agenda (those can be followed through the agenda) **Minimum 100 p.s.f. live load if public walkway-no such information provided in FOIA response and what was provided is inadequate.**

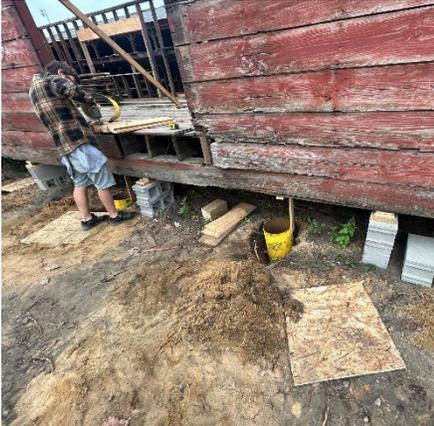
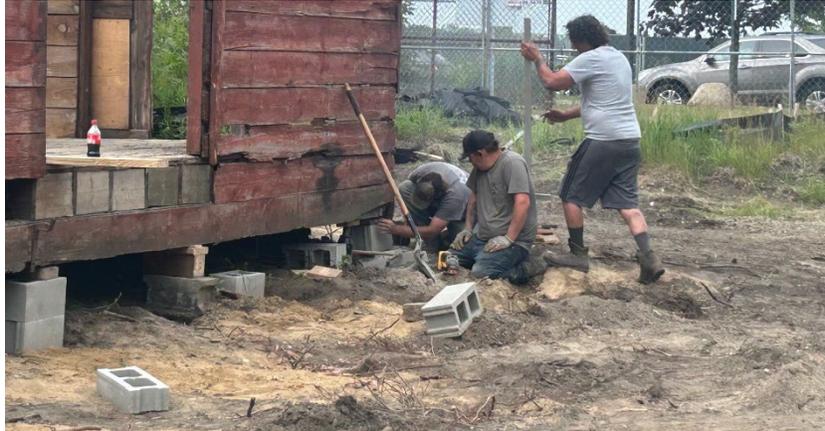
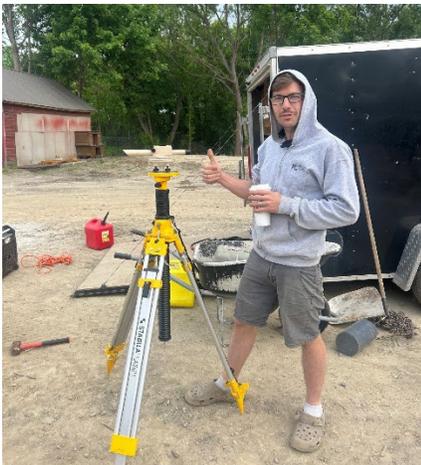
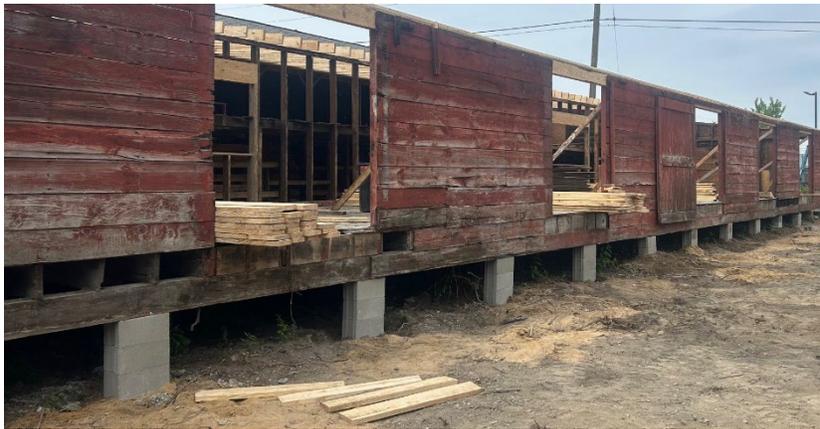
**Footing Repair** – To support the repair of a new roof, the joist and beam calculations for structural repairs, and support, the pillar footings on the north face the barn needed to be redone and new footings poured in certain places. The holes and type of repair was reviewed with officials and upon inspection the load calculations and supports were approved and updated. **no such informaton provided in FOIA response**

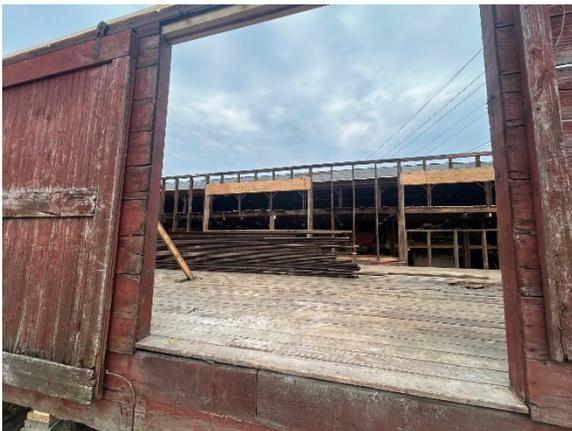
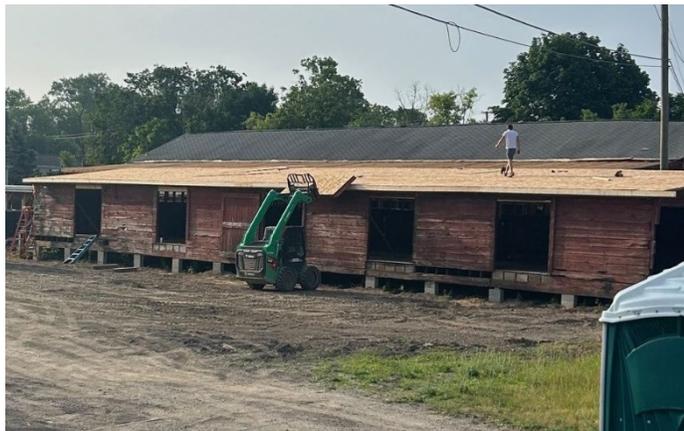
**Re-Roofing:** Structural work and bracing the large truss system in preparation for a new roof

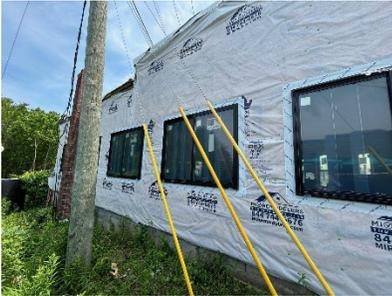
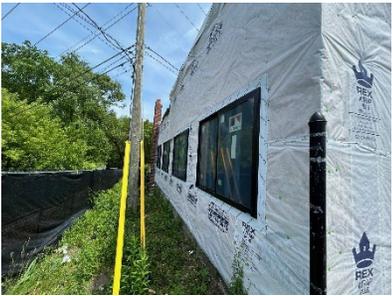
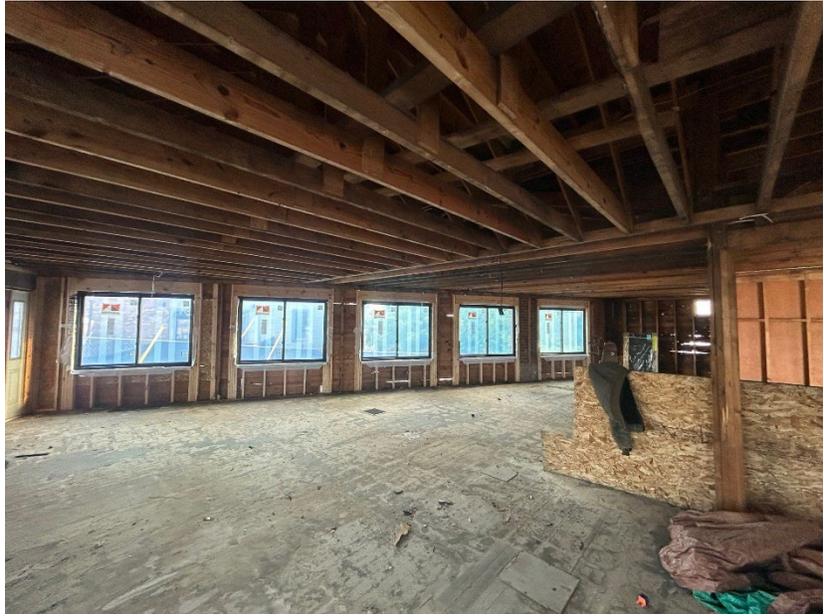
Windows: The re-ordered window package was delivered and the main windows facing the Paint Creek and Downtown have been installed.

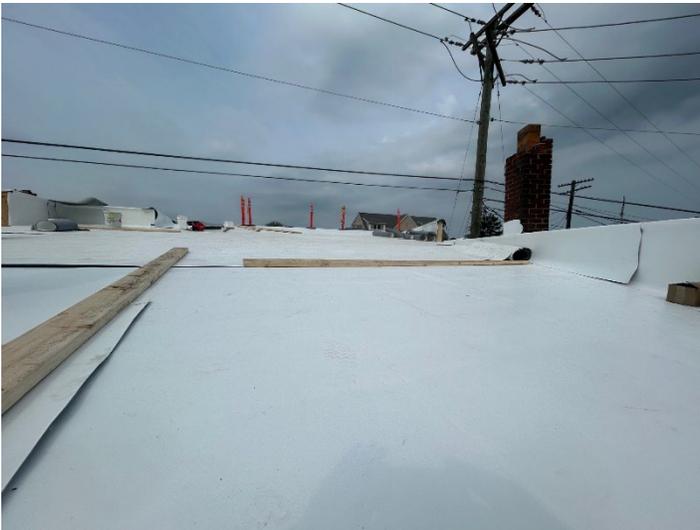
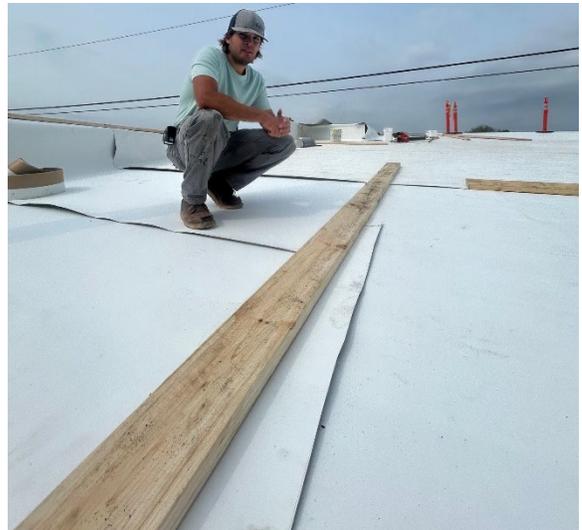
Roof: Five layers of rolled and glued roofing were removed. A new code compliant (R30) roof has been installed by Starrs Roofing.

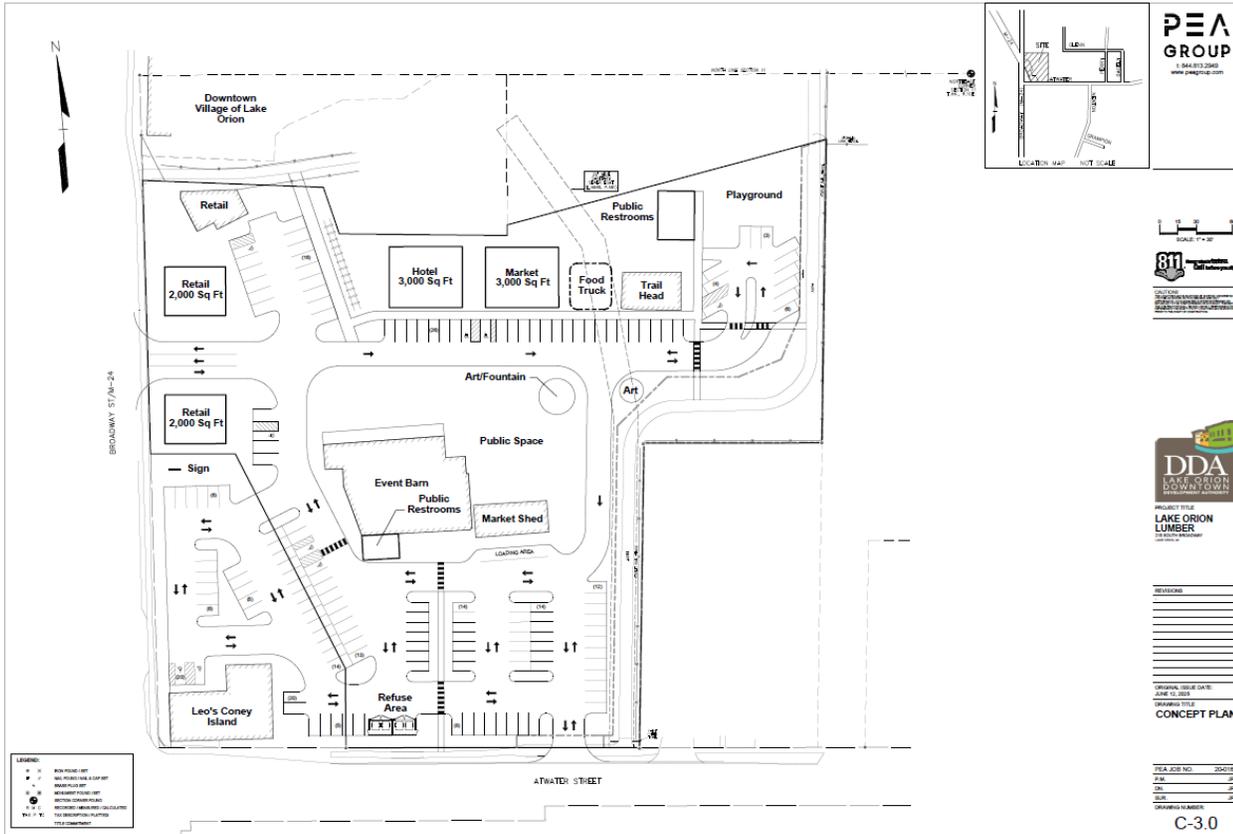
**SJTE PLAN:** The topographical survey has been completed and is pending drawings. The site plan has been started, and the following is the initial rough draft. The project is targeting the August 2025 Planning commission meeting. Engineering is already underway, and will be completed following the planning approval.

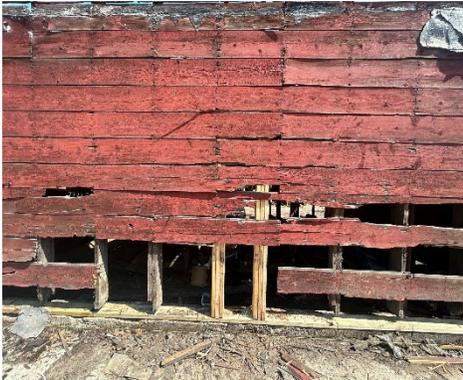
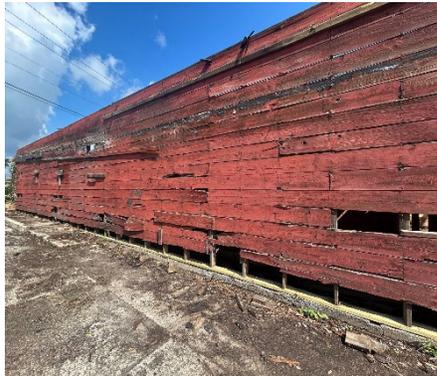
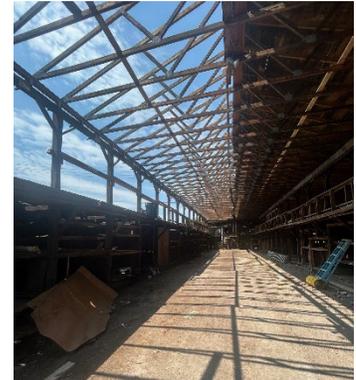
- The main barn is now principally empty of debris. We filled seven (7) more 30 yard dumpsters, and likely could fill one final load to complete the debris removal.
- The north facing roof has been re-paired and re-structured with new joist and truss work. It is sheeted and ready for metal roofing. The north wall was repaired to handle the new load, and the interior wall between the annex and the main room has been repaired with beam and bracing as recommended by the building official.
- Footing repairs are ongoing and there are new 42" poured footing supports on multiple corner and post locations. This is identical to what was decided for the north annex wall.
- The base plate on the south wall is replaced, and splicing against original material is being used to re-build the framing of the interior walls to allow for the use of original material on the exterior siding.

- The south roof, outside of the balloon truss system is being rebuilt in the same fashion as the north. Expect a material change order for the additional lumber, which was anticipated.
- There are three garage door openings being framed as part of the south wall repairs, this allows for the rationing of exterior/salvage siding material and enhances the structural integrity of the wall to accept the standing seam roof. All re-framing is being done as repair work er historic code.

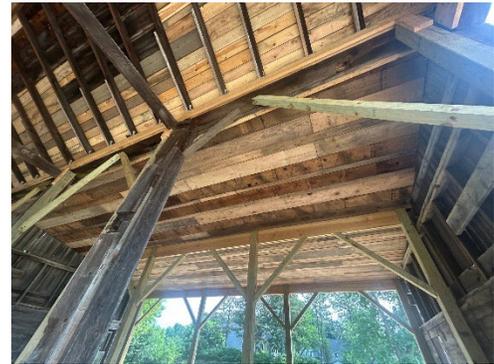
Materials Salvaged throughout the site are being re-applied as appropriate to the historic preservation and the design plan of the public space grant from Oakland County. In the case of the Supply Shed, which will be the trail head main feature, salvaged 1" wood was patched as the ceiling and support for the final repairs of the structure.

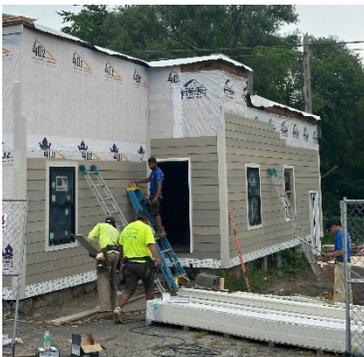
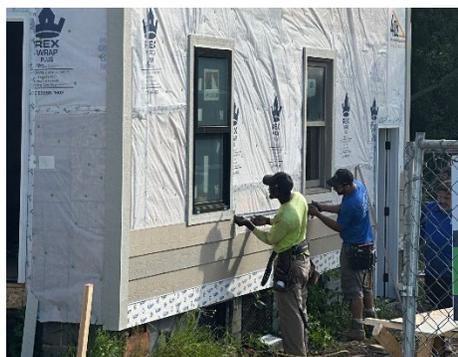
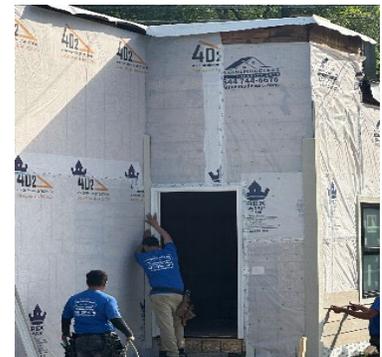
The roofing repairs are completed and awaiting the siding installation to finish the coping and cap. Primed siding was chosen to expedite getting the exterior repairs done. Siding is going on as this report is being written.
