Site Plan Application

Project: Cayuga Data Campus

By: TeraWulf Inc.

EXECUTIVE SUMMARY – SITE PLAN REVIEW APPLICATION

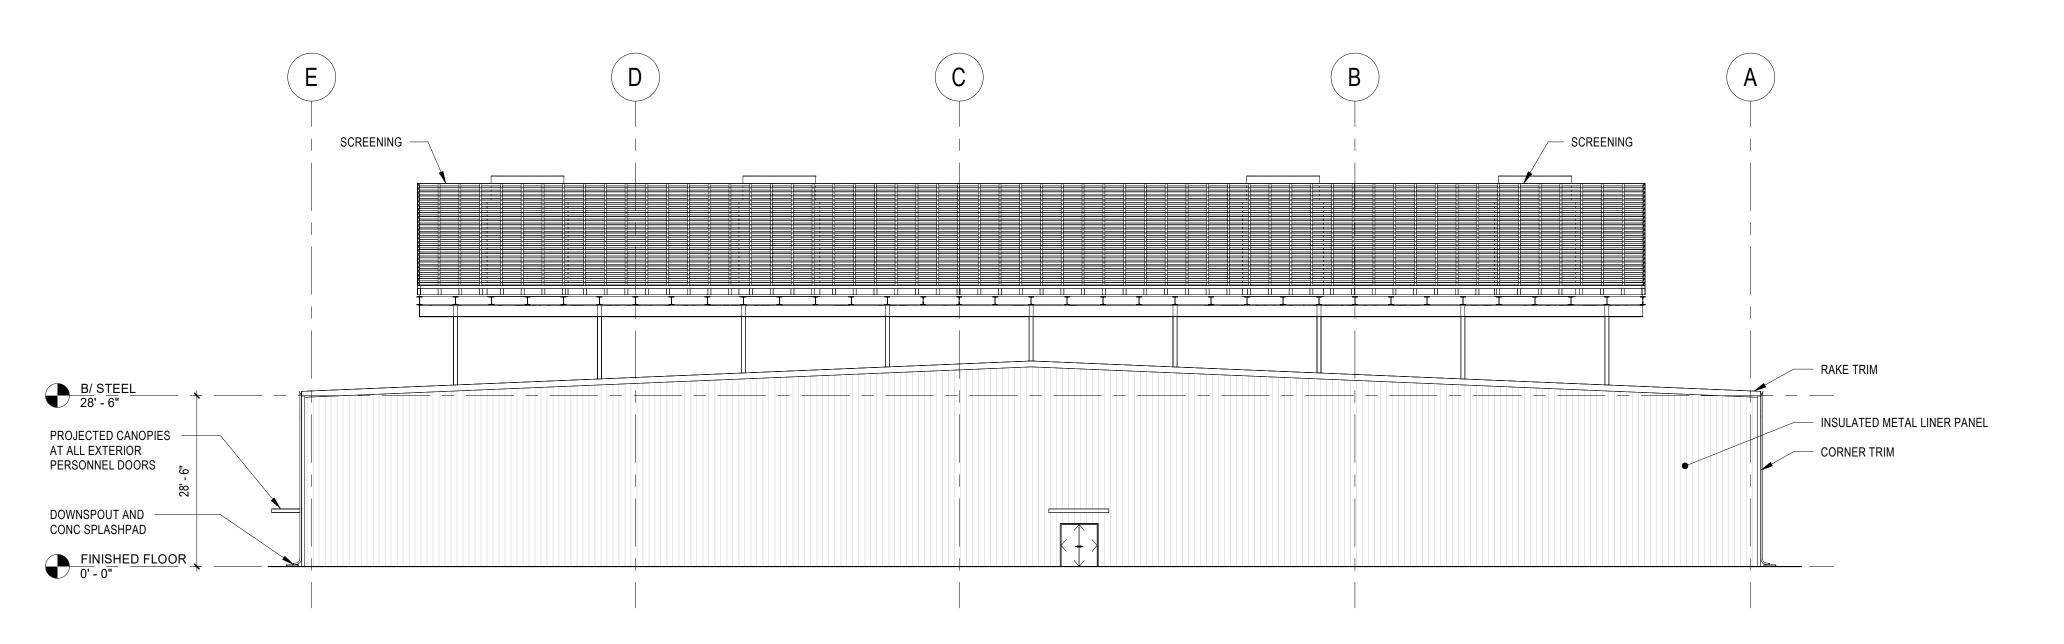
EAST ELEVATIONSCALE: 1/16" = 1'-0" 16' 8' 0

1. WALL ORIENTATION / DIRECTION IS BASED ON PLAN NORTH, REFER TO PLANS FOR FURTHER INFORMATION.

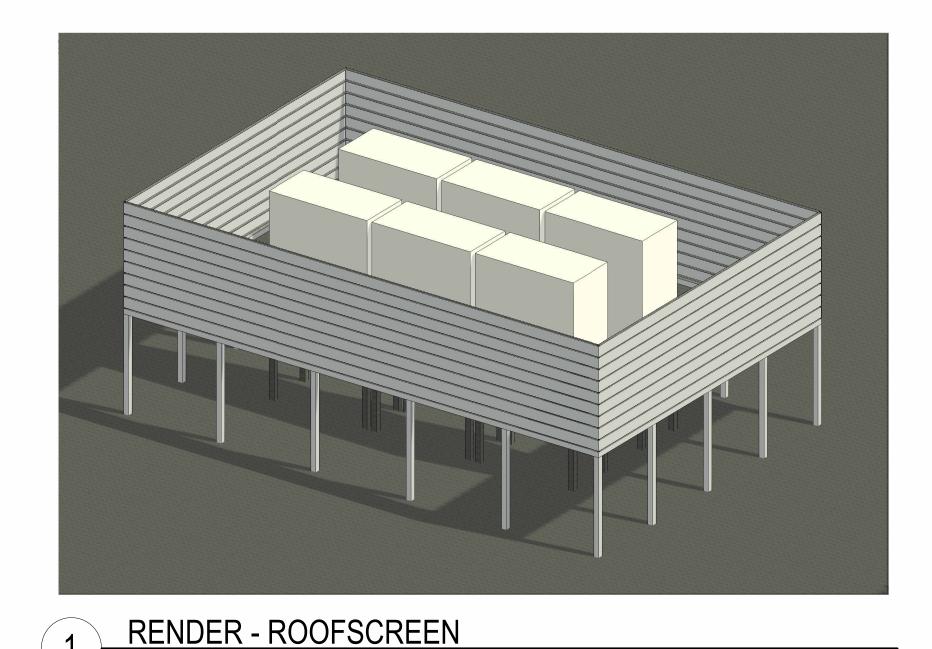
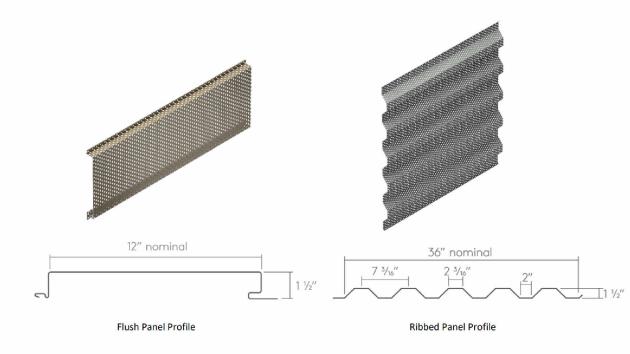
PRODUCT OVERVIEW:

- ADDS ELEMENTS OF TEXTURE AND DEPTH.
- PERFORATED PANELS SIMILAR TO 7.2 RIB AND FLUSH PANELS OFFERED BY ROOFSCREEN.
- THE 40% OPEN AREA PATTERN IS COMPRISED OF 1/8" HOLES @ 3/16" STAGGER.
- OTHER PATTERS AND PROFILES AVAILABLE UPON REQUEST.
- MATERIAL: .40 ALUMINUM STANDARD (OTHER GAUGES AVAILABLE UPON REQUEST).
- LENGTH: UP TO 30'.
- ATTACHMENT: EXPOSED FASTENERS.
- FINISH: PVDF (70% POLYVINLIDENE).
- COLORS: SEE COLOR CHART.
- WARRANTY: 20 YEARS.
- INSTALLATION: ORIENTED VERTICALLY OR HORIZONTALLY.

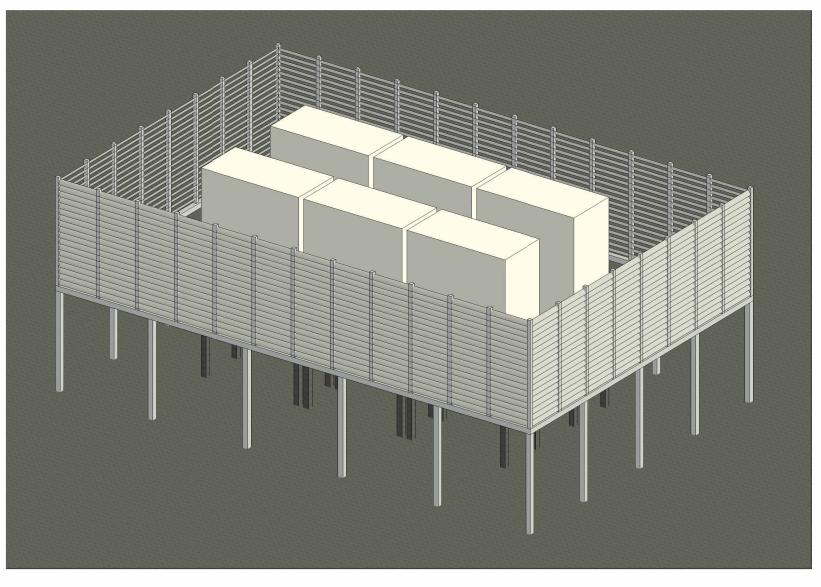
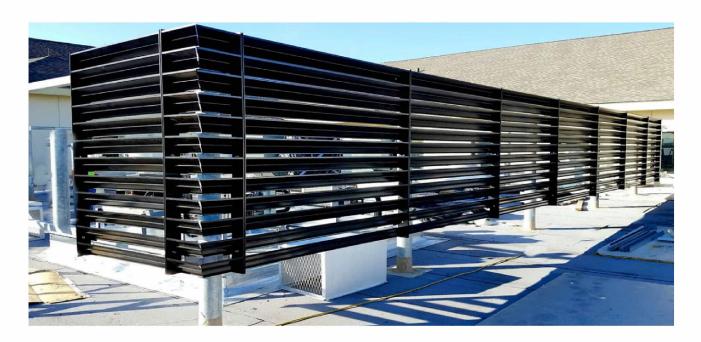
2 RENDER - SHARCHS SCALE:

PRODUCT OVERVIEW:

- OUTRIGGERS: 4" x .25" ALUMINUM FLATBAR (6063-T6 RECTANGULAR PROFILE BLOCKED NOSING
- INFILL: AIR FOIL
 6" x 1" x .080"
 EXTRUDED ALUMINUM (6063-T6)
- FINISH: ARCHITECTURAL POWDER COAT (RAL COLORS)
 (ANODIZED AND KYNAR FINISHES AVAILABLE)
- SITE SPECIFIC ENGINEERING: AVAILABLE UPON REQUEST
- ALL MATERIALS AND WORKMANSHIP ARE WARRANTED FOR A PERIOD OF ONE YEAR FROM THE DATE OF COMPLETION.
- LENGTH: 72" MAX BETWEEN SUPPORTS
- MAINTENANCE: NONE REQUIRED

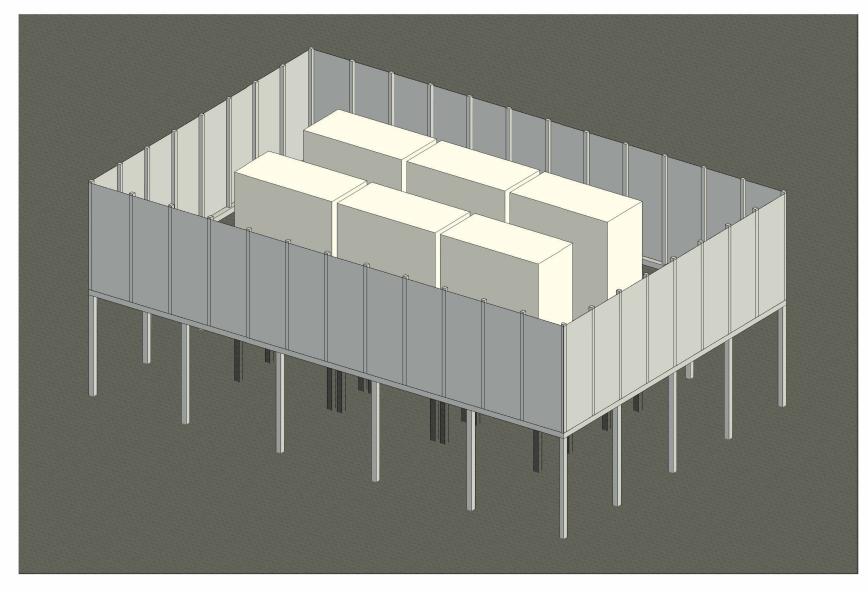
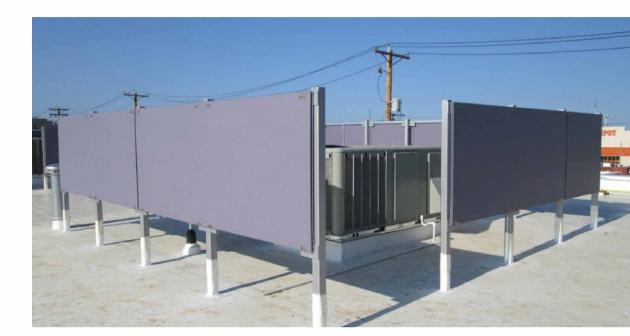
3 RENDER - LAWRENCE FABRIC AND METAL STRUCTURES SCALE:

PRODUCT OVERVIEW:

- METAL OPTIONS: SOLID. CORRUGATED. PERFORATED.
- FABRIC OPTIONS: SOLID MESH FABRIC. MESH FABRIC.
- DURABLE MATERIALS INCLUDING STEEL, ALUMINUM, COPPER PAIRED WITH HIGH QUALITY COATINGS TO WITHSTAND HEAT, WIND AND CLIMATE FLUCTUATIONS.
- LONG TERM DURABILTY AND MINIMAL MAINTENANCE.
- IMPROVED AIRFLOW AND WIND RESISTANCE
- INCREASED NOISE REDUCTION.
- COMPLEMENT ARCHITECTURAL FACADE.
- LONG TERM WARRANTIES AND PROTECTION.

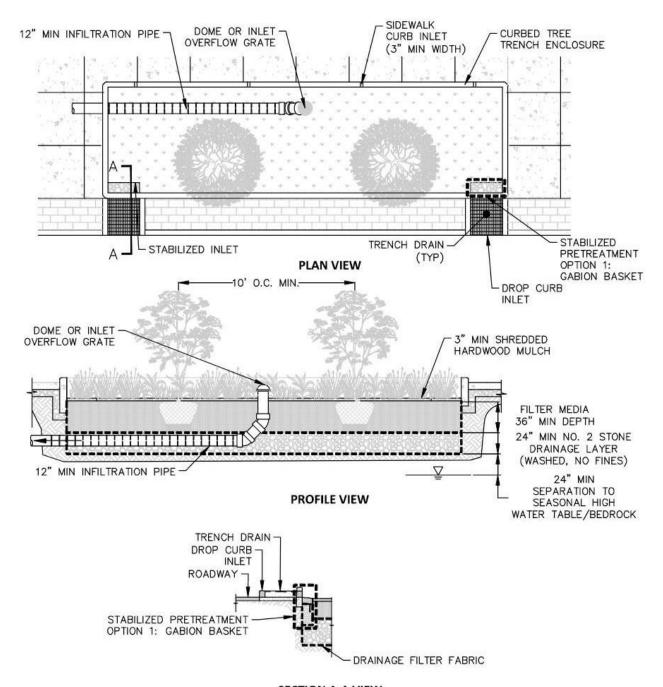
APPENDIX D
NYSDEC STORMWATER DESIGN MANUAL
TREE TRENCH STANDARD DETAIL WITH GABION BASKET PRETREATMENT

SECTION A-A VIEW
Figure 5.38 Tree Trench Surface Flow (RR-3)

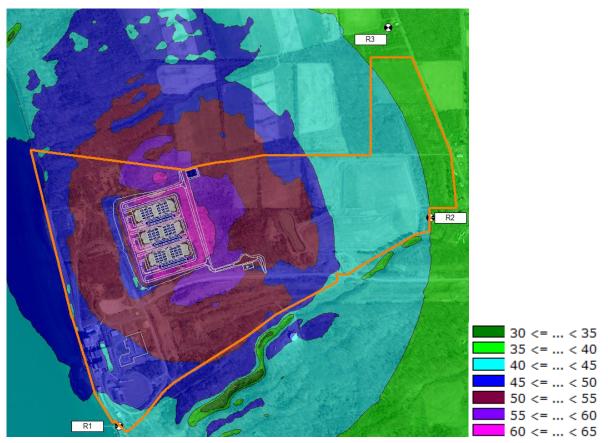
Figure 1. Predicted Sound Pressure Level Contours and Receptor Locations for Project Site

¹ For example: if the ambient is above 37 DBA at Receptor R1 then no noise abatement is needed for regulatory compliance and if the ambient is 37 DBA or below at Receptor R1 then noise abatement is needed for regulatory compliance.

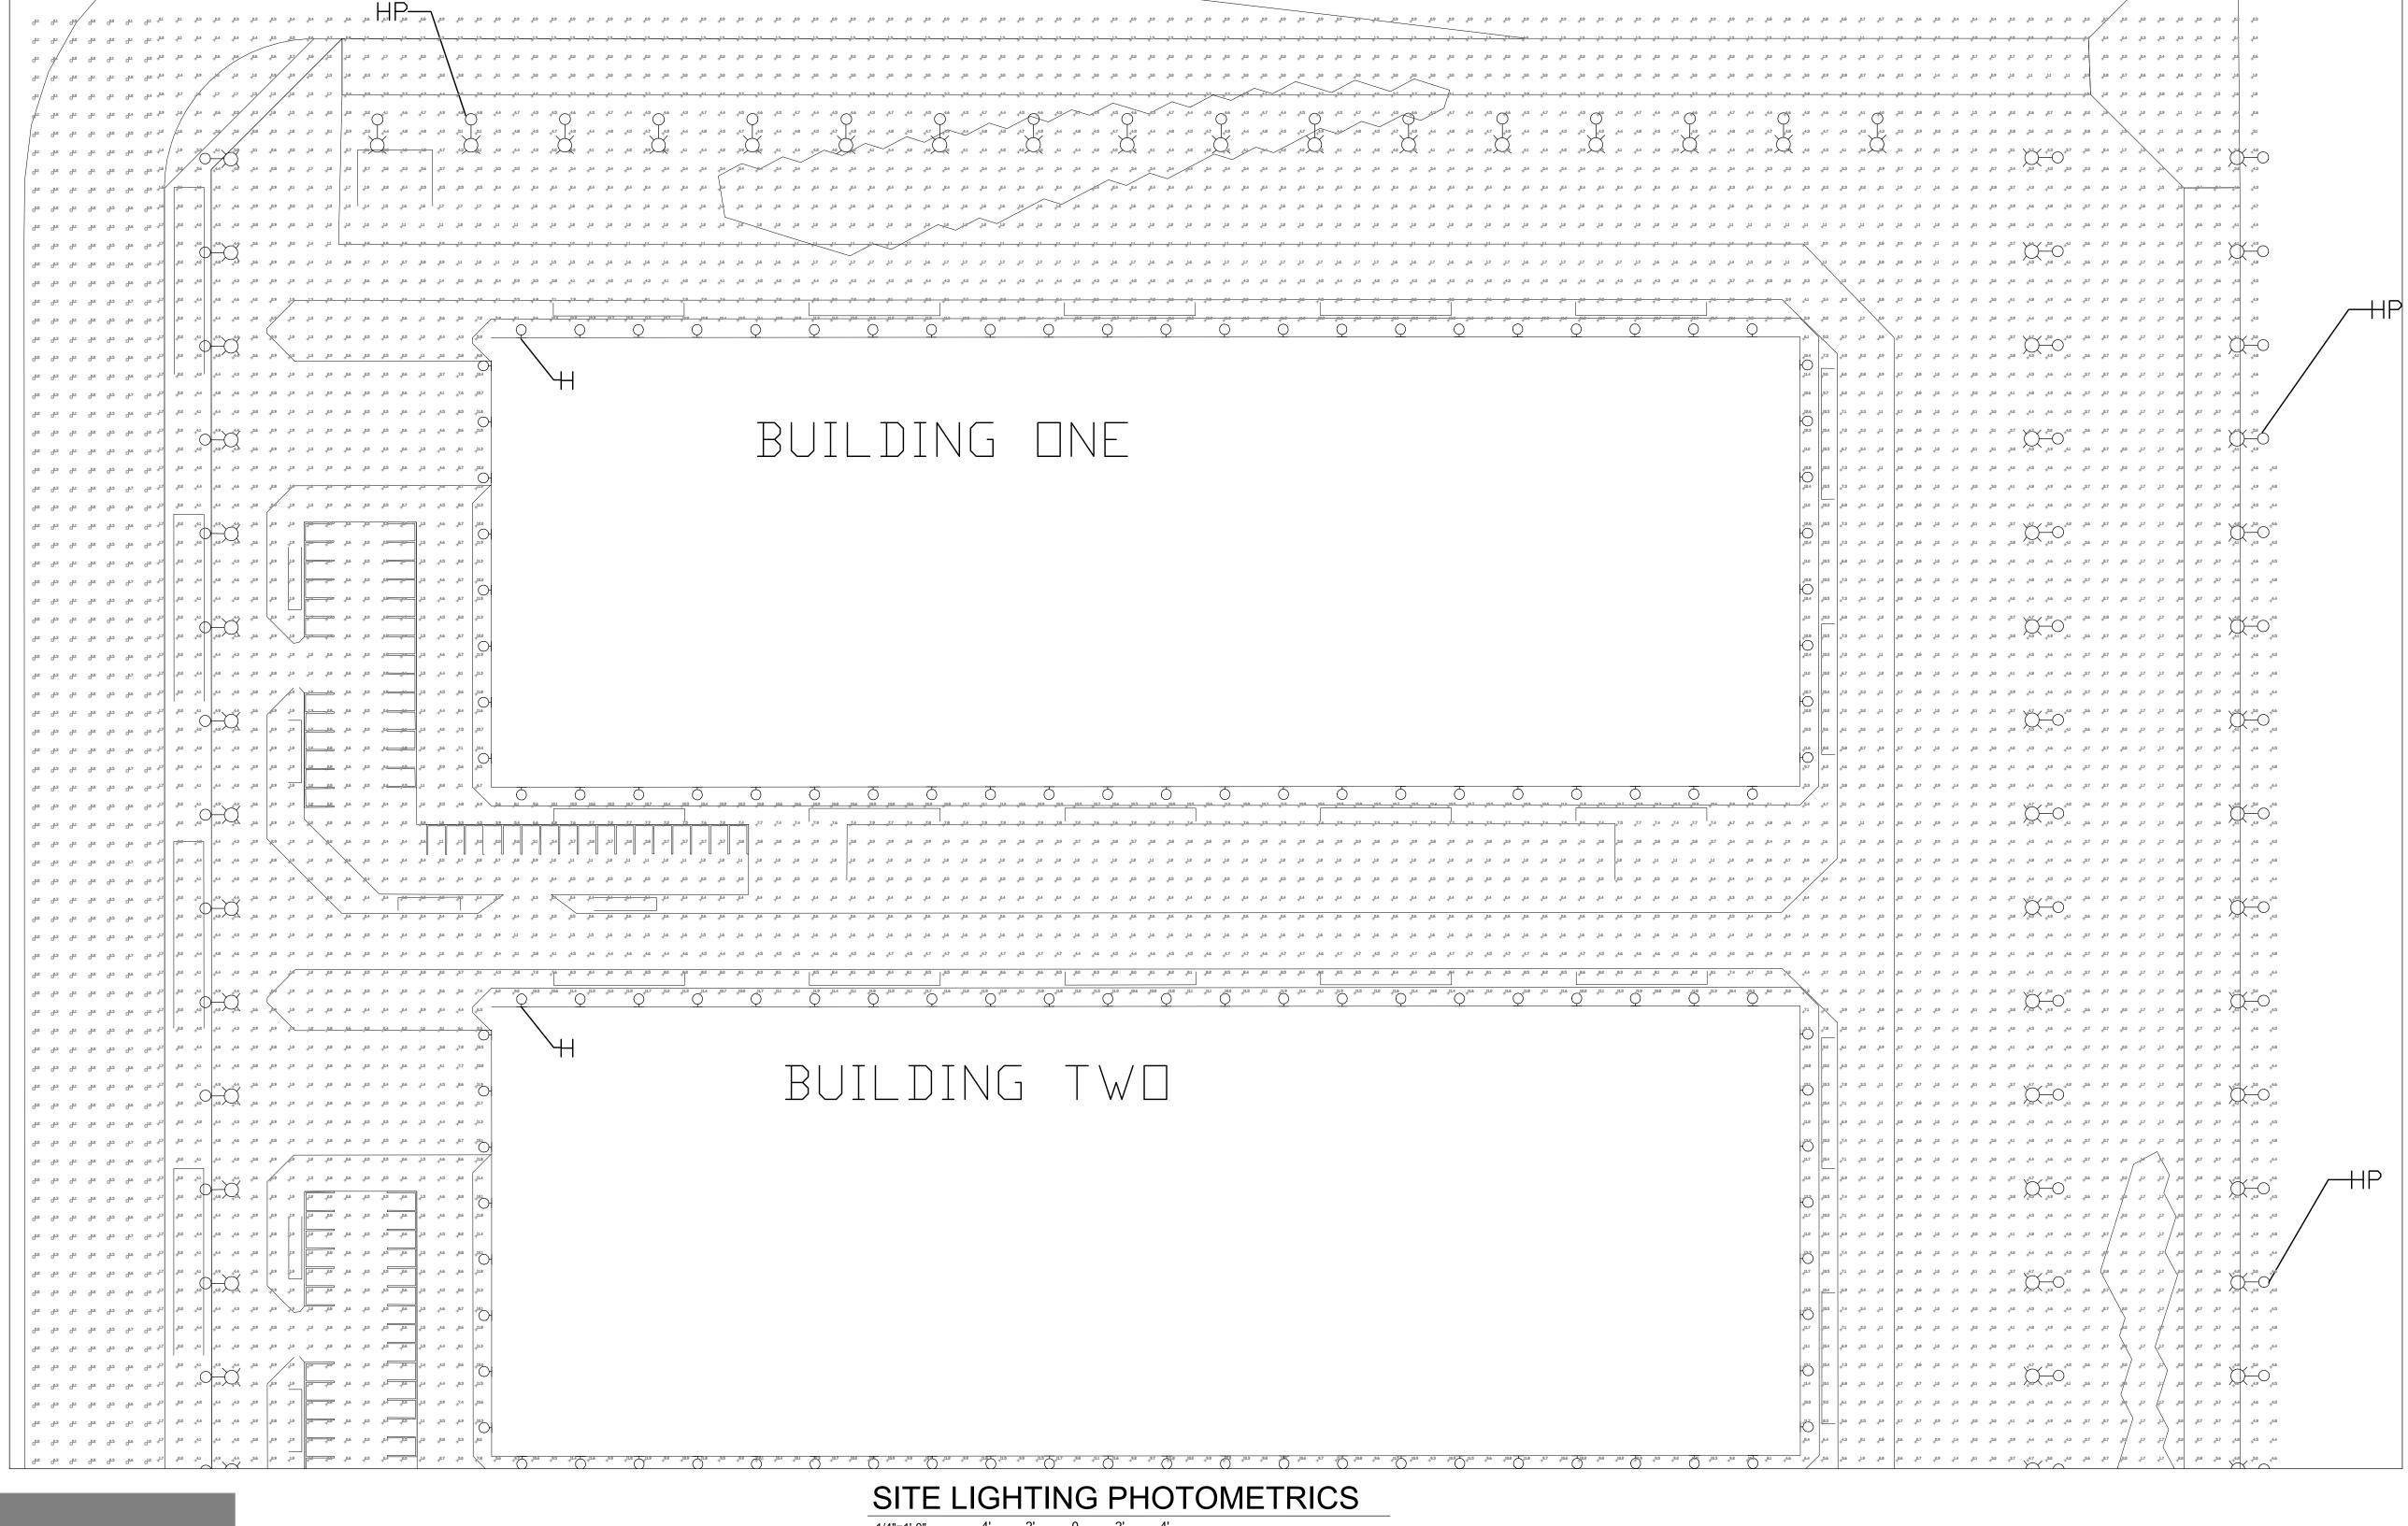
2. THE RECOMMENDED AVERAGE LIGHTING LEVEL FOR BUILDING EXTERIORS AND PEDESTRIAN WALKWAYS AND PATHWAYS IS 1-5 FOOT-CANDLES PER IESNA.

- 3. THE RECOMMENDED AVERAGE LIGHTING LEVEL FOR ROADWAYS AND STREETS IS 1-2 FOOT-CANDLES PER IESNA.
- 4. A DARK SKY COMPLIANT FIXTURE IS DESIGNED TO REDUCE LIGHT POLLUTION BY DIRECTING LIGHT DOWNWARD AND MINIMIZING GLARE. IT MUST BE FULLY SHIELDED, EMIT NO LIGHT ABOVE THE HORIZONTAL PLANE, AND USE A COLOR TEMPERATURE OF 3000K OR LOWER.

Statistics		
Description	Symbol	Avg
Building One Exterior	+	4.3 fc
Building Three Exterior	+	4.3 fc
Building Two Exterior	+	4.4 fc
Exterior Perimeter Road	+	3.0 fc
Guard Shed Exterior	+	3.1 fc
Parking Building One	+	1.2 fc
Parking Building Three	+	1.3 fc
Parking Building Two	+	1.2 fc
Past Tree Line		0.4 fc
Site Overall	+	3.6 fc

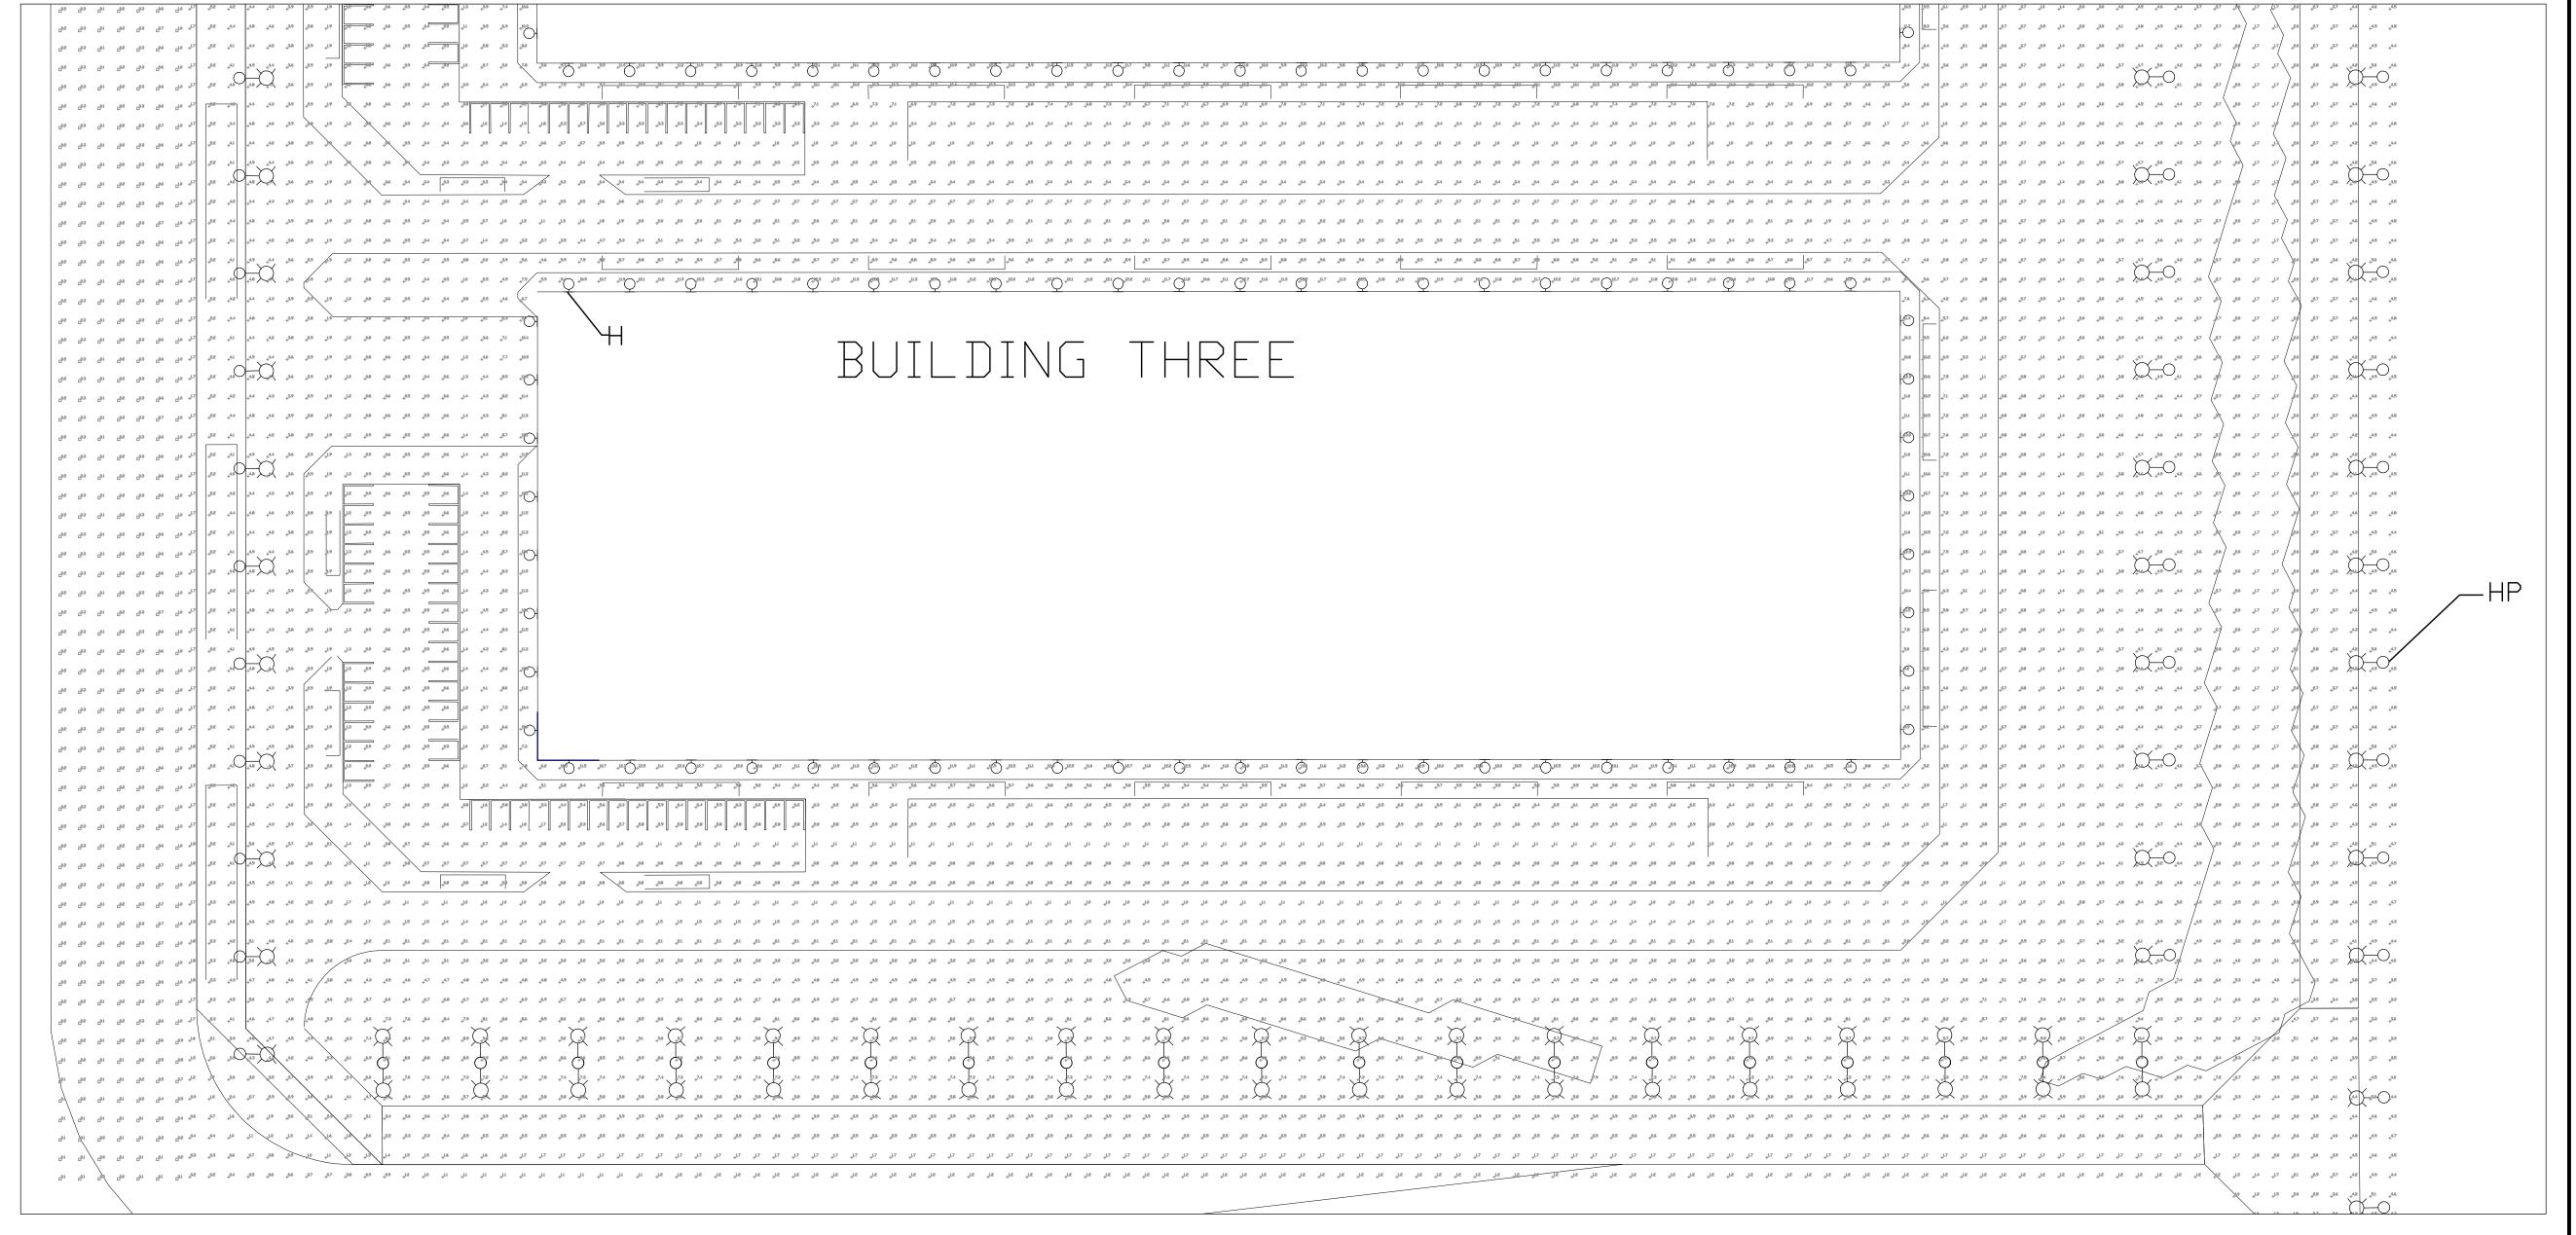
SITE LIGHTING PHOTOMETRICS 1/4"=1'-0" 4' 2' 0 2' 4'

- THE RECOMMENDED AVERAGE LIGHTING LEVEL FOR UNCOVERED PARKING LOTS IS 1 FOOT-CANDLES (FC), AND CAN RANGE FROM 0.5-2 FC PER IESNA.
- THE RECOMMENDED AVERAGE LIGHTING LEVEL FOR BUILDING EXTERIORS AND PEDESTRIAN WALKWAYS AND PATHWAYS IS 1-5 FOOT-CANDLES PER IESNA.
- 3. THE RECOMMENDED AVERAGE LIGHTING LEVEL FOR ROADWAYS AND STREETS IS 1-2 FOOT-CANDLES PER IESNA.
- A DARK SKY COMPLIANT FIXTURE IS DESIGNED TO REDUCE LIGHT POLLUTION BY DIRECTING LIGHT DOWNWARD AND MINIMIZING GLARE. IT MUST BE FULLY SHIELDED, EMIT NO LIGHT ABOVE THE HORIZONTAL PLANE, AND USE A COLOR TEMPERATURE OF 3000K OR LOWER.

Statistics		
Description	Symbol	Avg
Building One Exterior	+	4.3 fc
Building Three Exterior	+	4.3 fc
Building Two Exterior	+	4.4 fc
Exterior Perimeter Road	+	3.0 fc
Guard Shed Exterior	+	3.1 fc
Parking Building One	+	1.2 fc
Parking Building Three	+	1.3 fc
Parking Building Two	+	1.2 fc
Past Tree Line		0.4 fc
Site Overall	+	3.6 fc

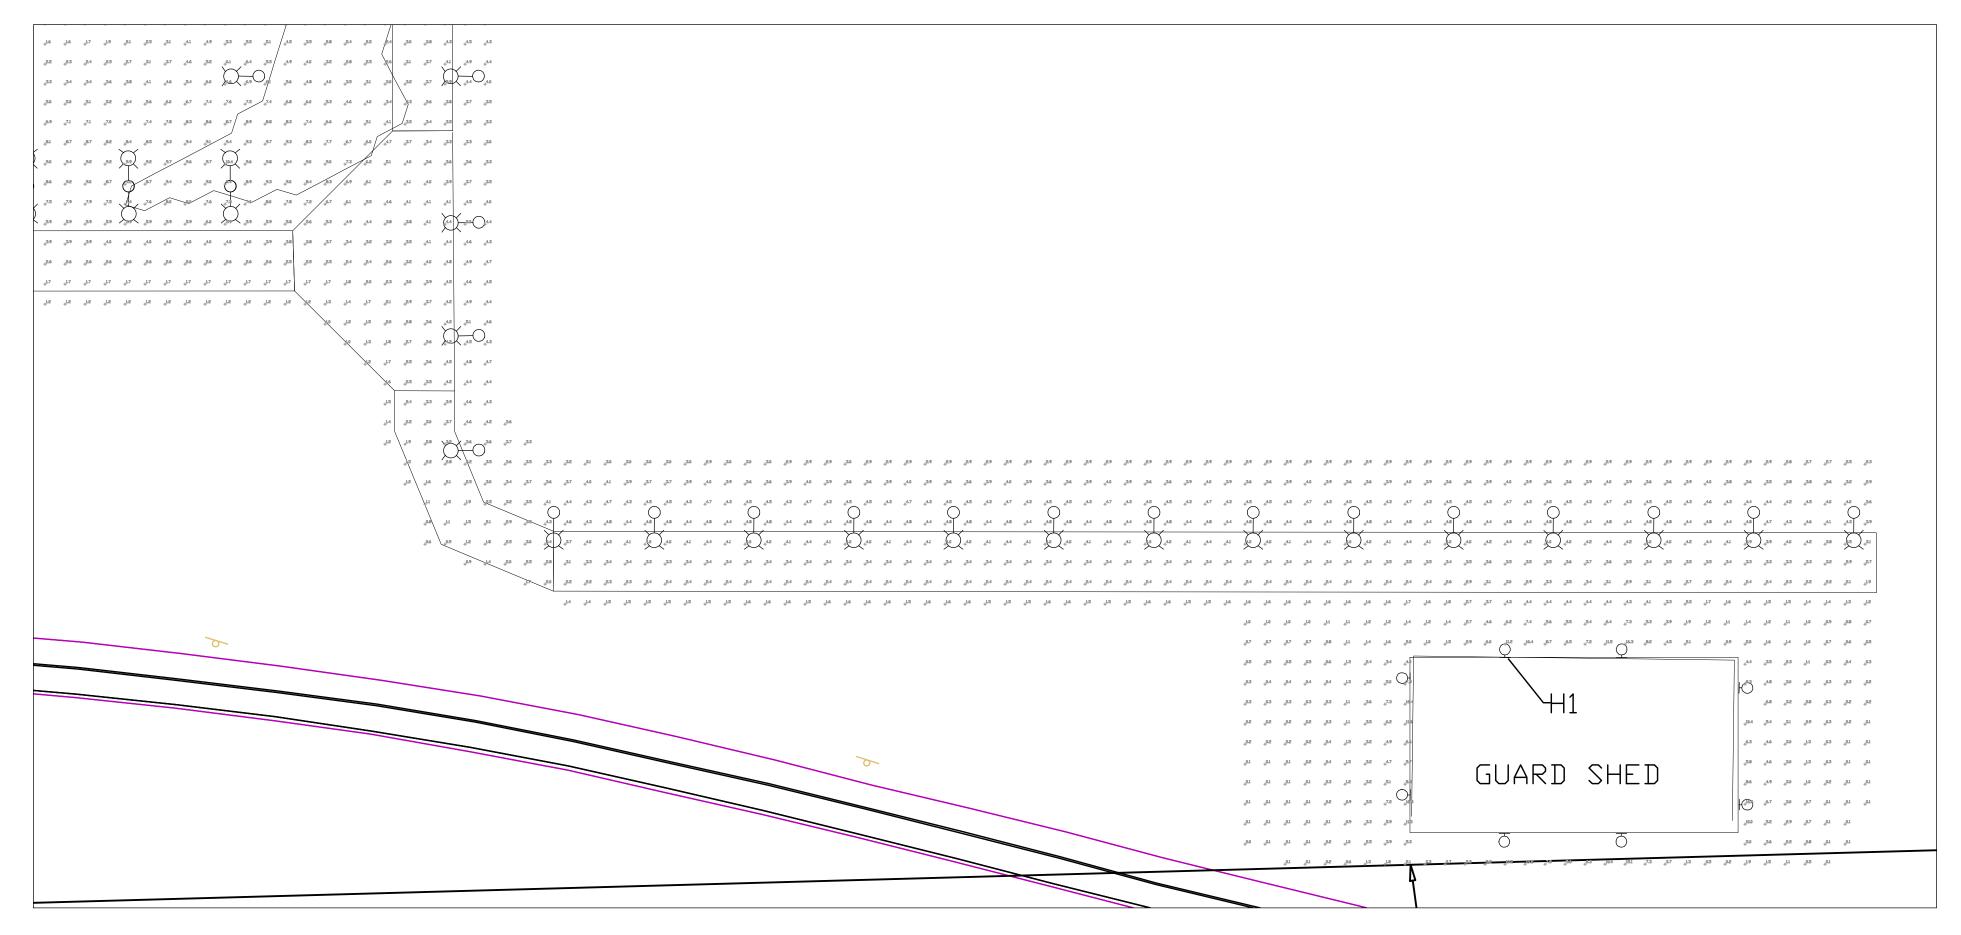
SITE LIGHTING PHOTOMETRICS 1/4"=1'-0" 4' 2' 0 2' 4'

- THE RECOMMENDED AVERAGE LIGHTING LEVEL FOR UNCOVERED PARKING LOTS IS 1 FOOT-CANDLES (FC), AND CAN RANGE FROM 0.5-2 FC PER IESNA.
- THE RECOMMENDED AVERAGE LIGHTING LEVEL FOR BUILDING EXTERIORS AND PEDESTRIAN WALKWAYS AND PATHWAYS IS 1-5 FOOT-CANDLES PER IESNA.
- THE RECOMMENDED AVERAGE LIGHTING LEVEL FOR ROADWAYS AND STREETS IS 1-2 FOOT-CANDLES PER IESNA.
- . A DARK SKY COMPLIANT FIXTURE IS DESIGNED TO REDUCE LIGHT POLLUTION BY DIRECTING LIGHT DOWNWARD AND MINIMIZING GLARE. IT MUST BE FULLY SHIELDED, EMIT NO LIGHT ABOVE THE HORIZONTAL PLANE, AND USE A COLOR TEMPERATURE OF 3000K OR LOWER.

Statistics		
Description	Symbol	Avg
Building One Exterior	+	4.3 fc
Building Three Exterior	+	4.3 fc
Building Two Exterior	+	4.4 fc
Exterior Perimeter Road	+	3.0 fc
Guard Shed Exterior	+	3.1 fc
Parking Building One	+	1.2 fc
Parking Building Three	+	1.3 fc
Parking Building Two	+	1.2 fc
Past Tree Line		0.4 fc
Site Overall	+	3.6 fc
