Site Plan Application

Town of Lansing, NY

Application #: SITE-25-9

By: Cayuga Operating Company, LLC
228 Cayuga Dr., Lansing NY 14882

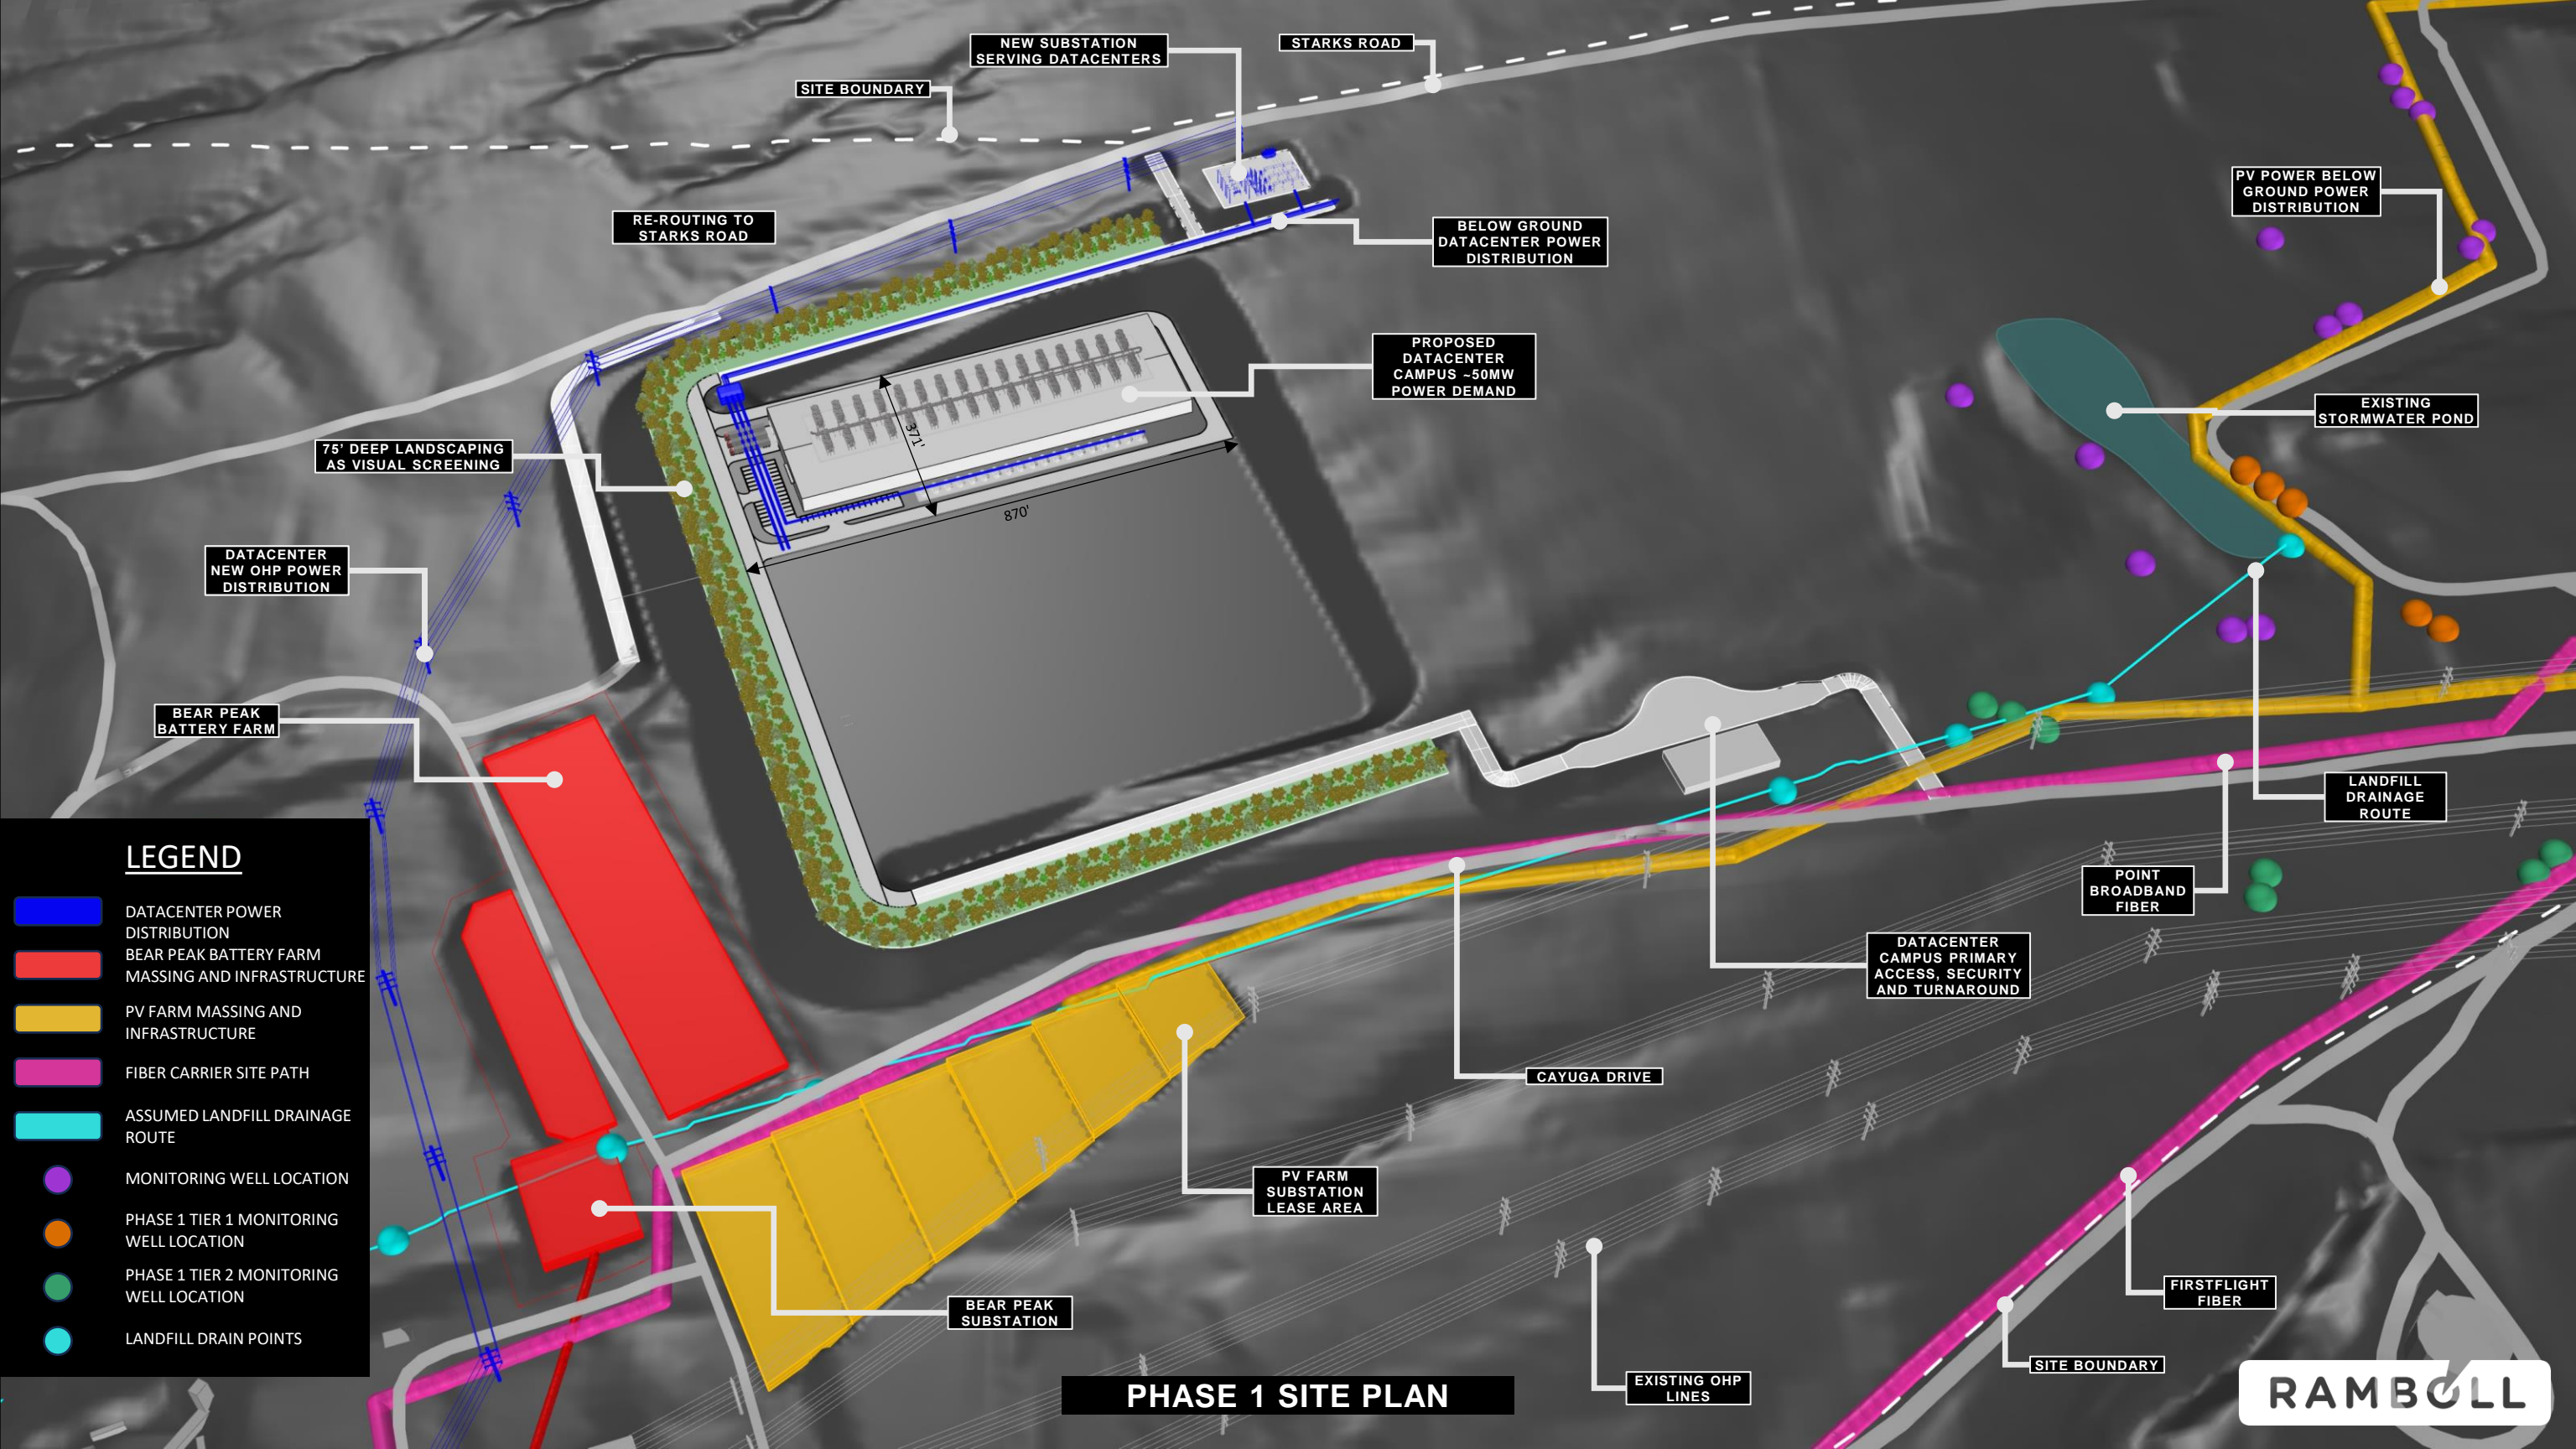
PHASE 1 SITE PLAN

This image highlights the first datacenter building to be constructed, located at the northernmost point of the lower terrace. By constructing this initial building in the northern position, future buildings on the terrace can be developed progressively, moving away from the substation and switchgear yards, thus minimizing disruption to critical infrastructure.

Regrading for the entire lower terrace will be completed during this phase, which will facilitate campus circulation and the operation of the first building while the remaining two buildings are under construction. This strategic approach ensures efficiency and smooth operational workflow, setting the stage for subsequent developments on the lower terrace.

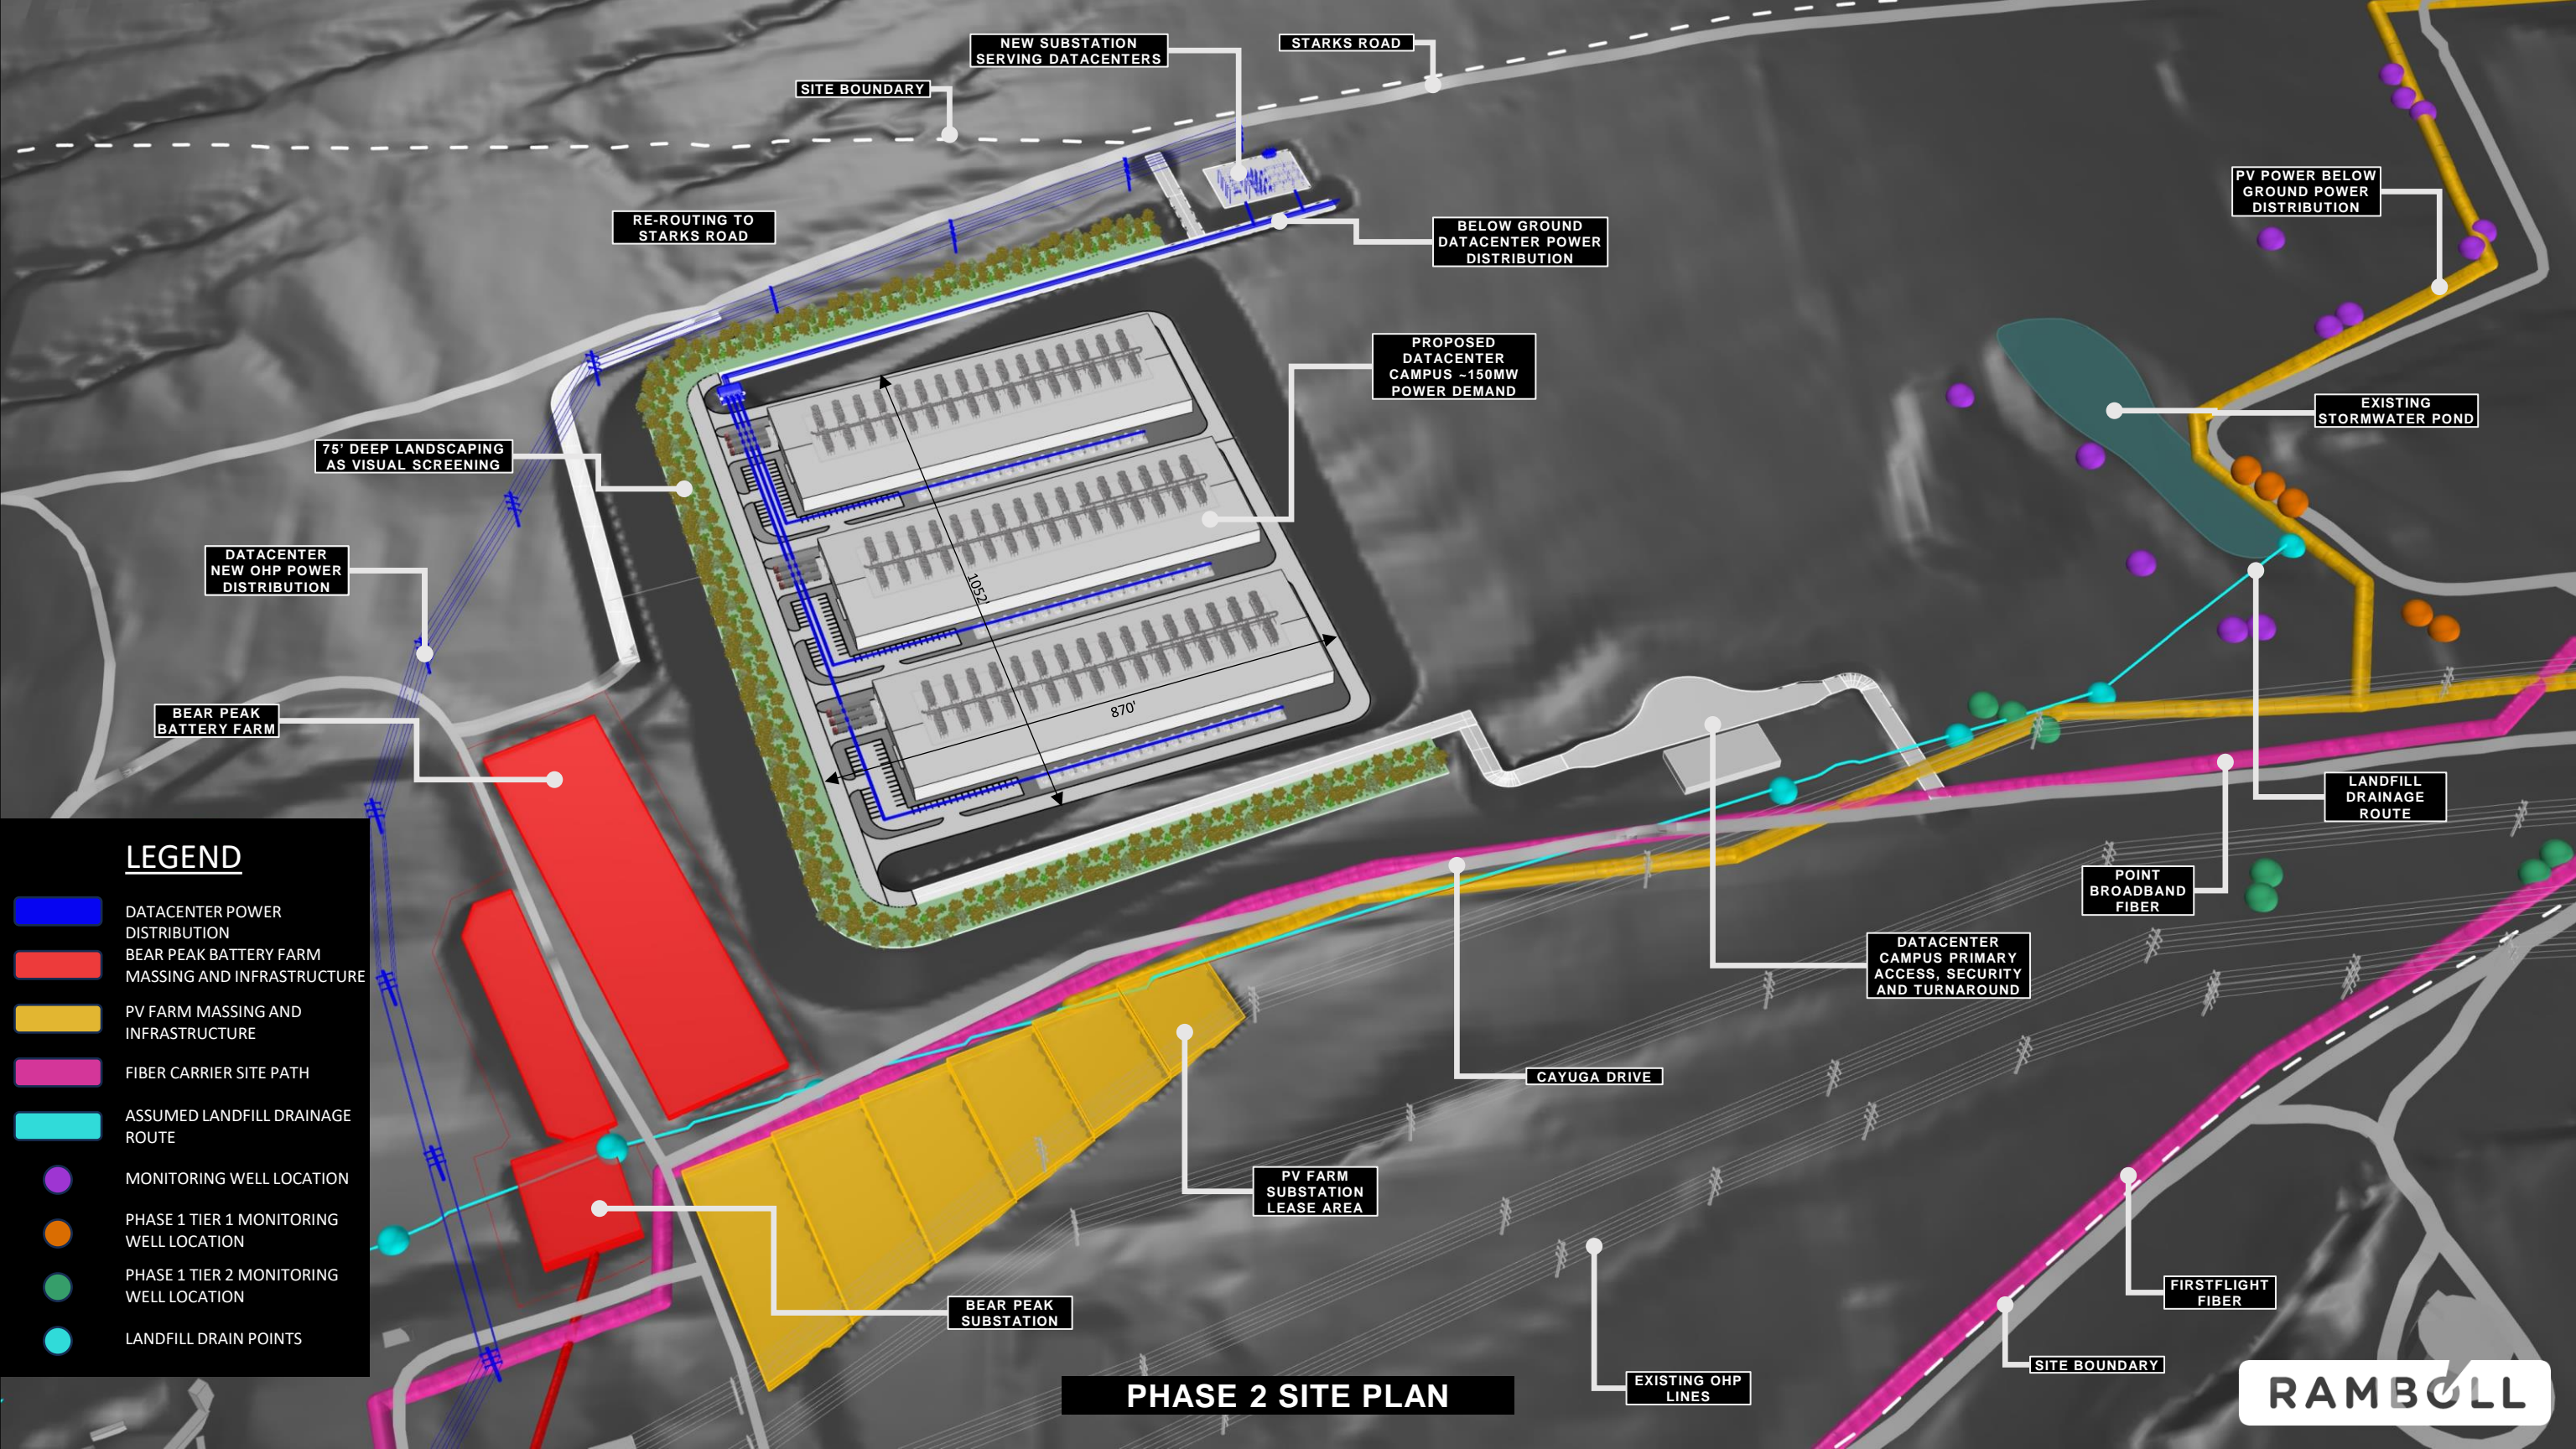
PHASE 2 SITE PLAN

This zoomed-in view of the datacenter campus provides a detailed general arrangement of the three datahall buildings. The infrastructure for both overhead and below-grade power distribution is depicted in blue, demonstrating the comprehensive integration of essential facilities. To ensure visual screening and enhance aesthetics, a 75-foot wide vegetation buffer encircles the campus. The primary access to the datacenter site, along with security and turnaround provisions, is strategically located to the south, off Cayuga Drive.

The masterplan includes preliminary regrading efforts that work harmoniously with the existing sloped topography. This ensures an efficient and functional layout while accommodating the natural land contours. Starks Road is carefully rerouted around the northwest corner of the campus to provide ample space for the buildings, roads, and other critical features. Coordination will be essential during subsequent design stages as the regrading at the southwest of the campus slightly overlaps with the proposed regrading extents of the Bear Peak Battery farm.

Power Demand for the datacenter campus is approximately 150MW.

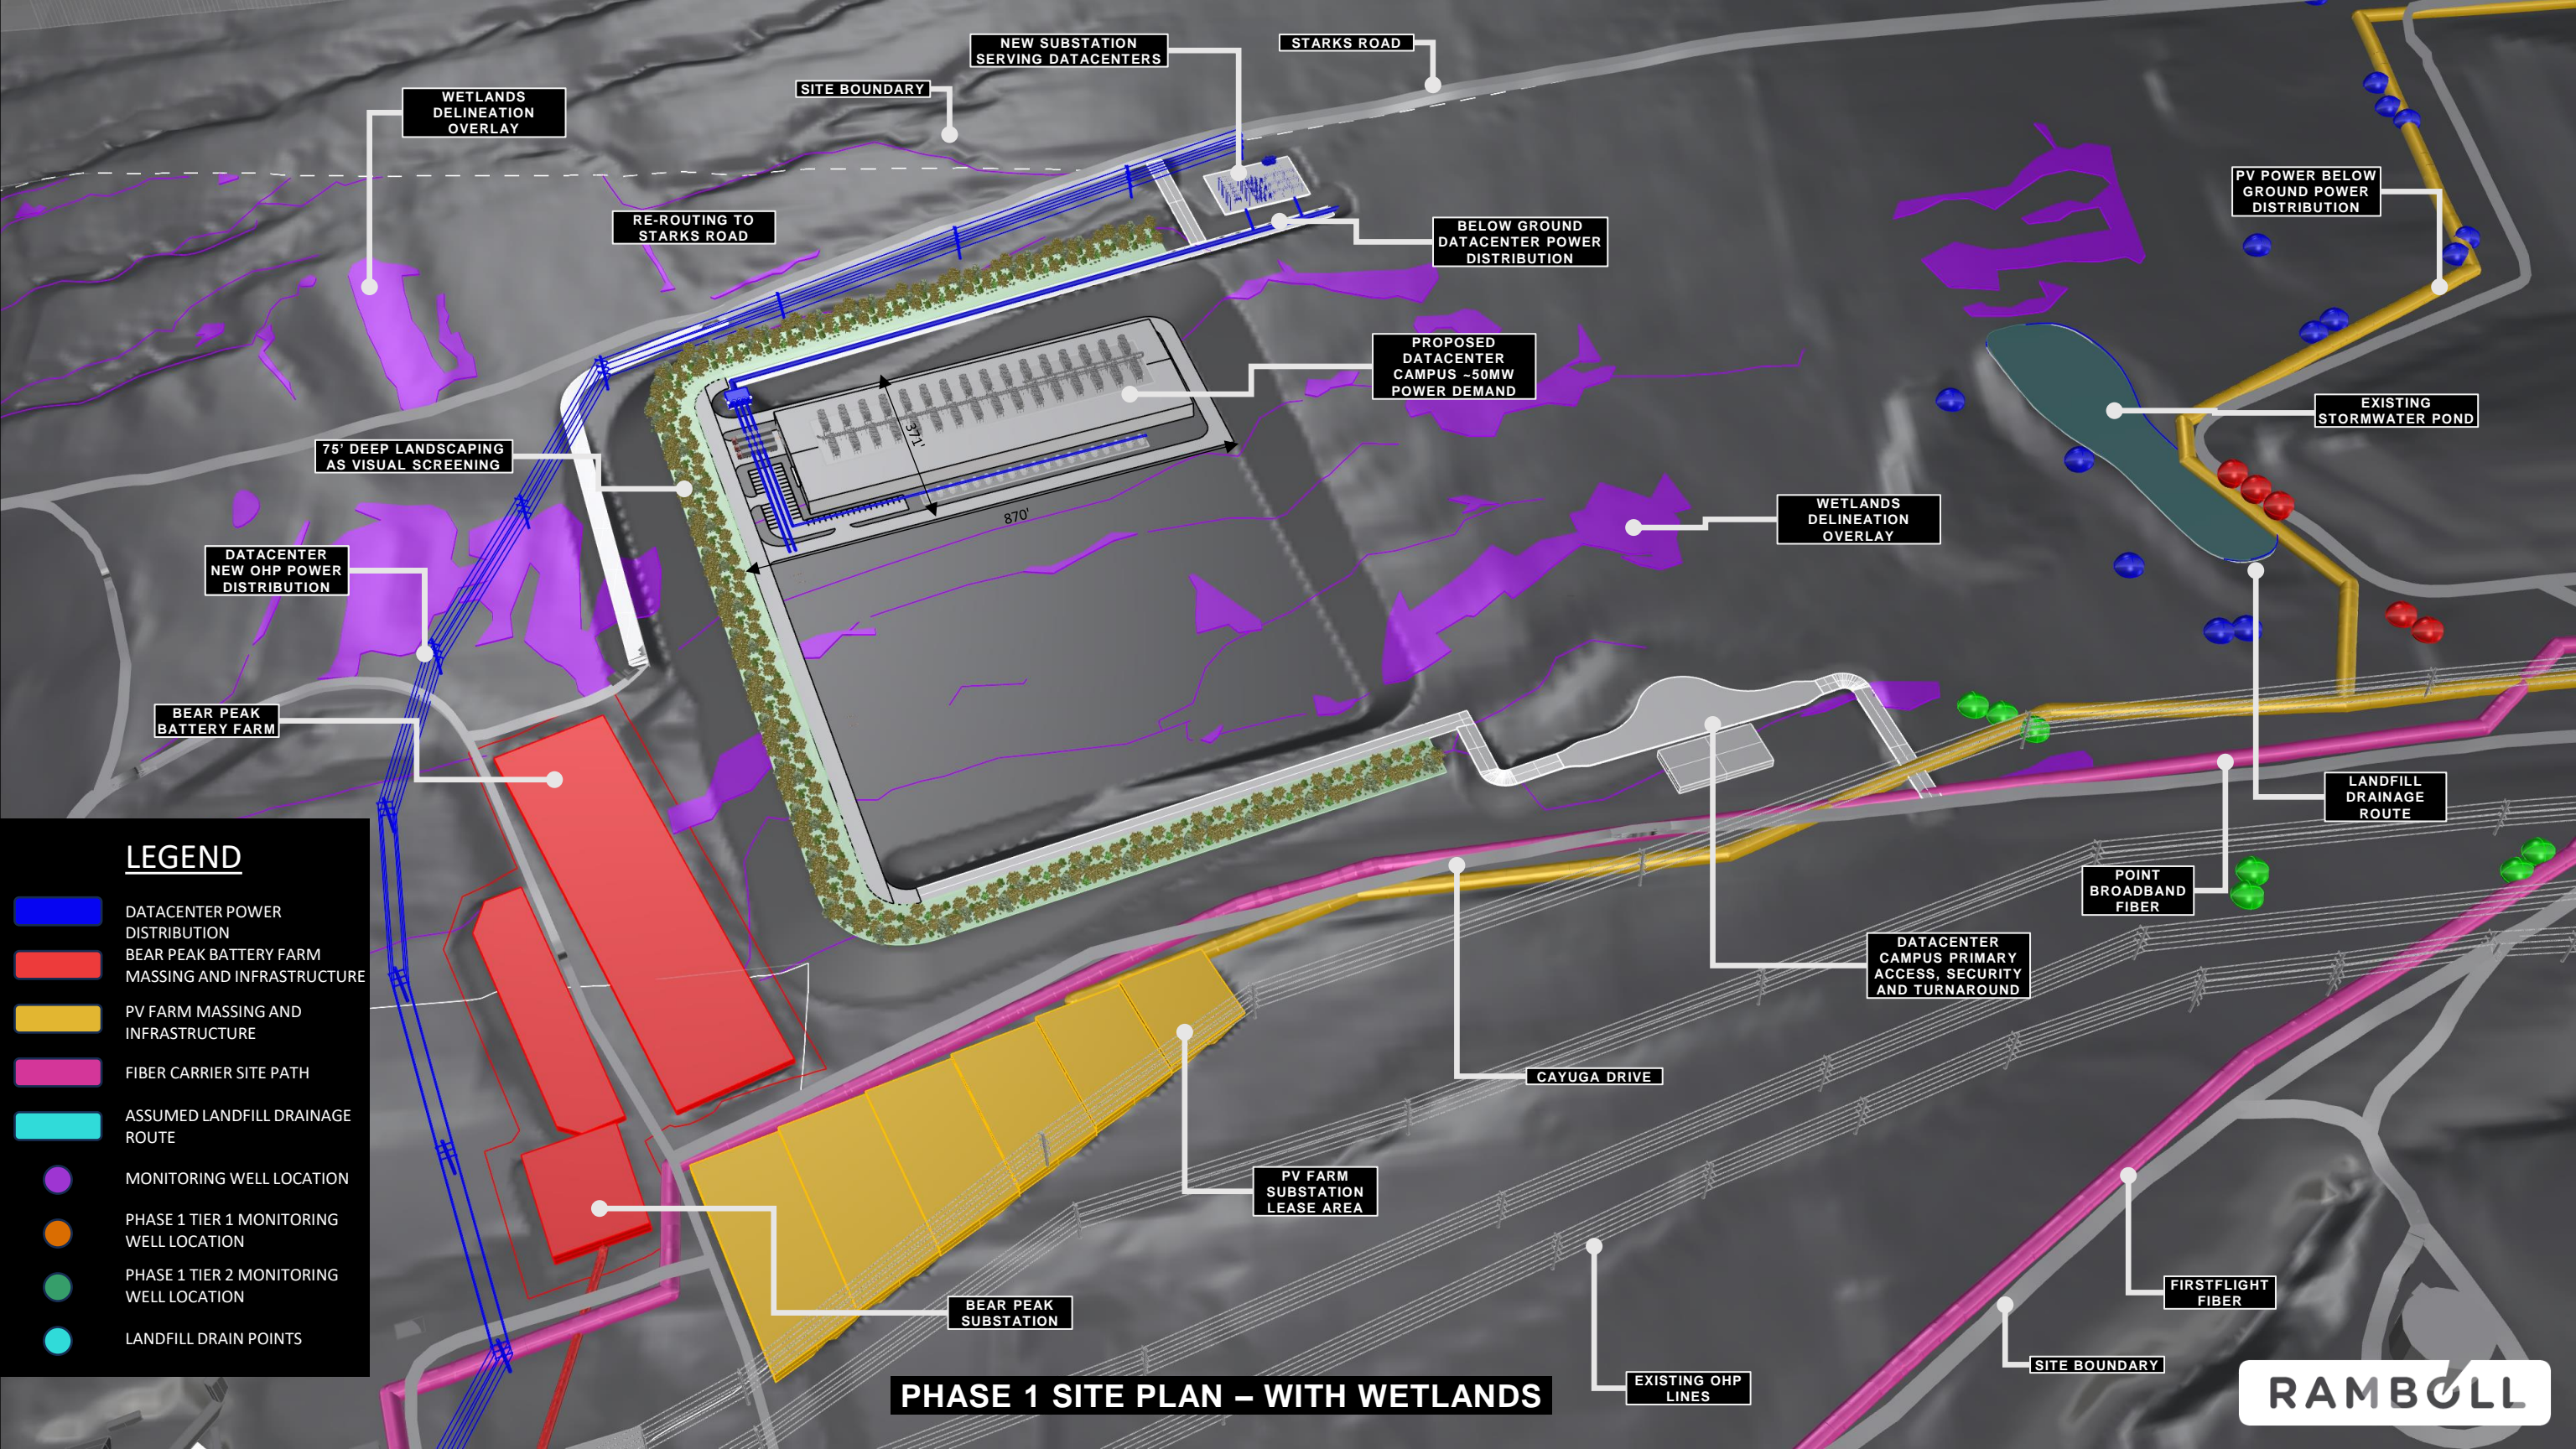
PHASE 1 WITH WETLANDS

Regrading for the entire lower terrace will be completed during this phase, which will facilitate campus circulation and the operation of the first building while the remaining two buildings are under construction. This strategic approach ensures efficiency and smooth operational workflow, setting the stage for subsequent developments on the lower terrace.

The wetlands delineation is integrated into this masterplan, highlighting the wetlands affected by the new construction. All necessary agencies will be involved for the wetland mitigation process.

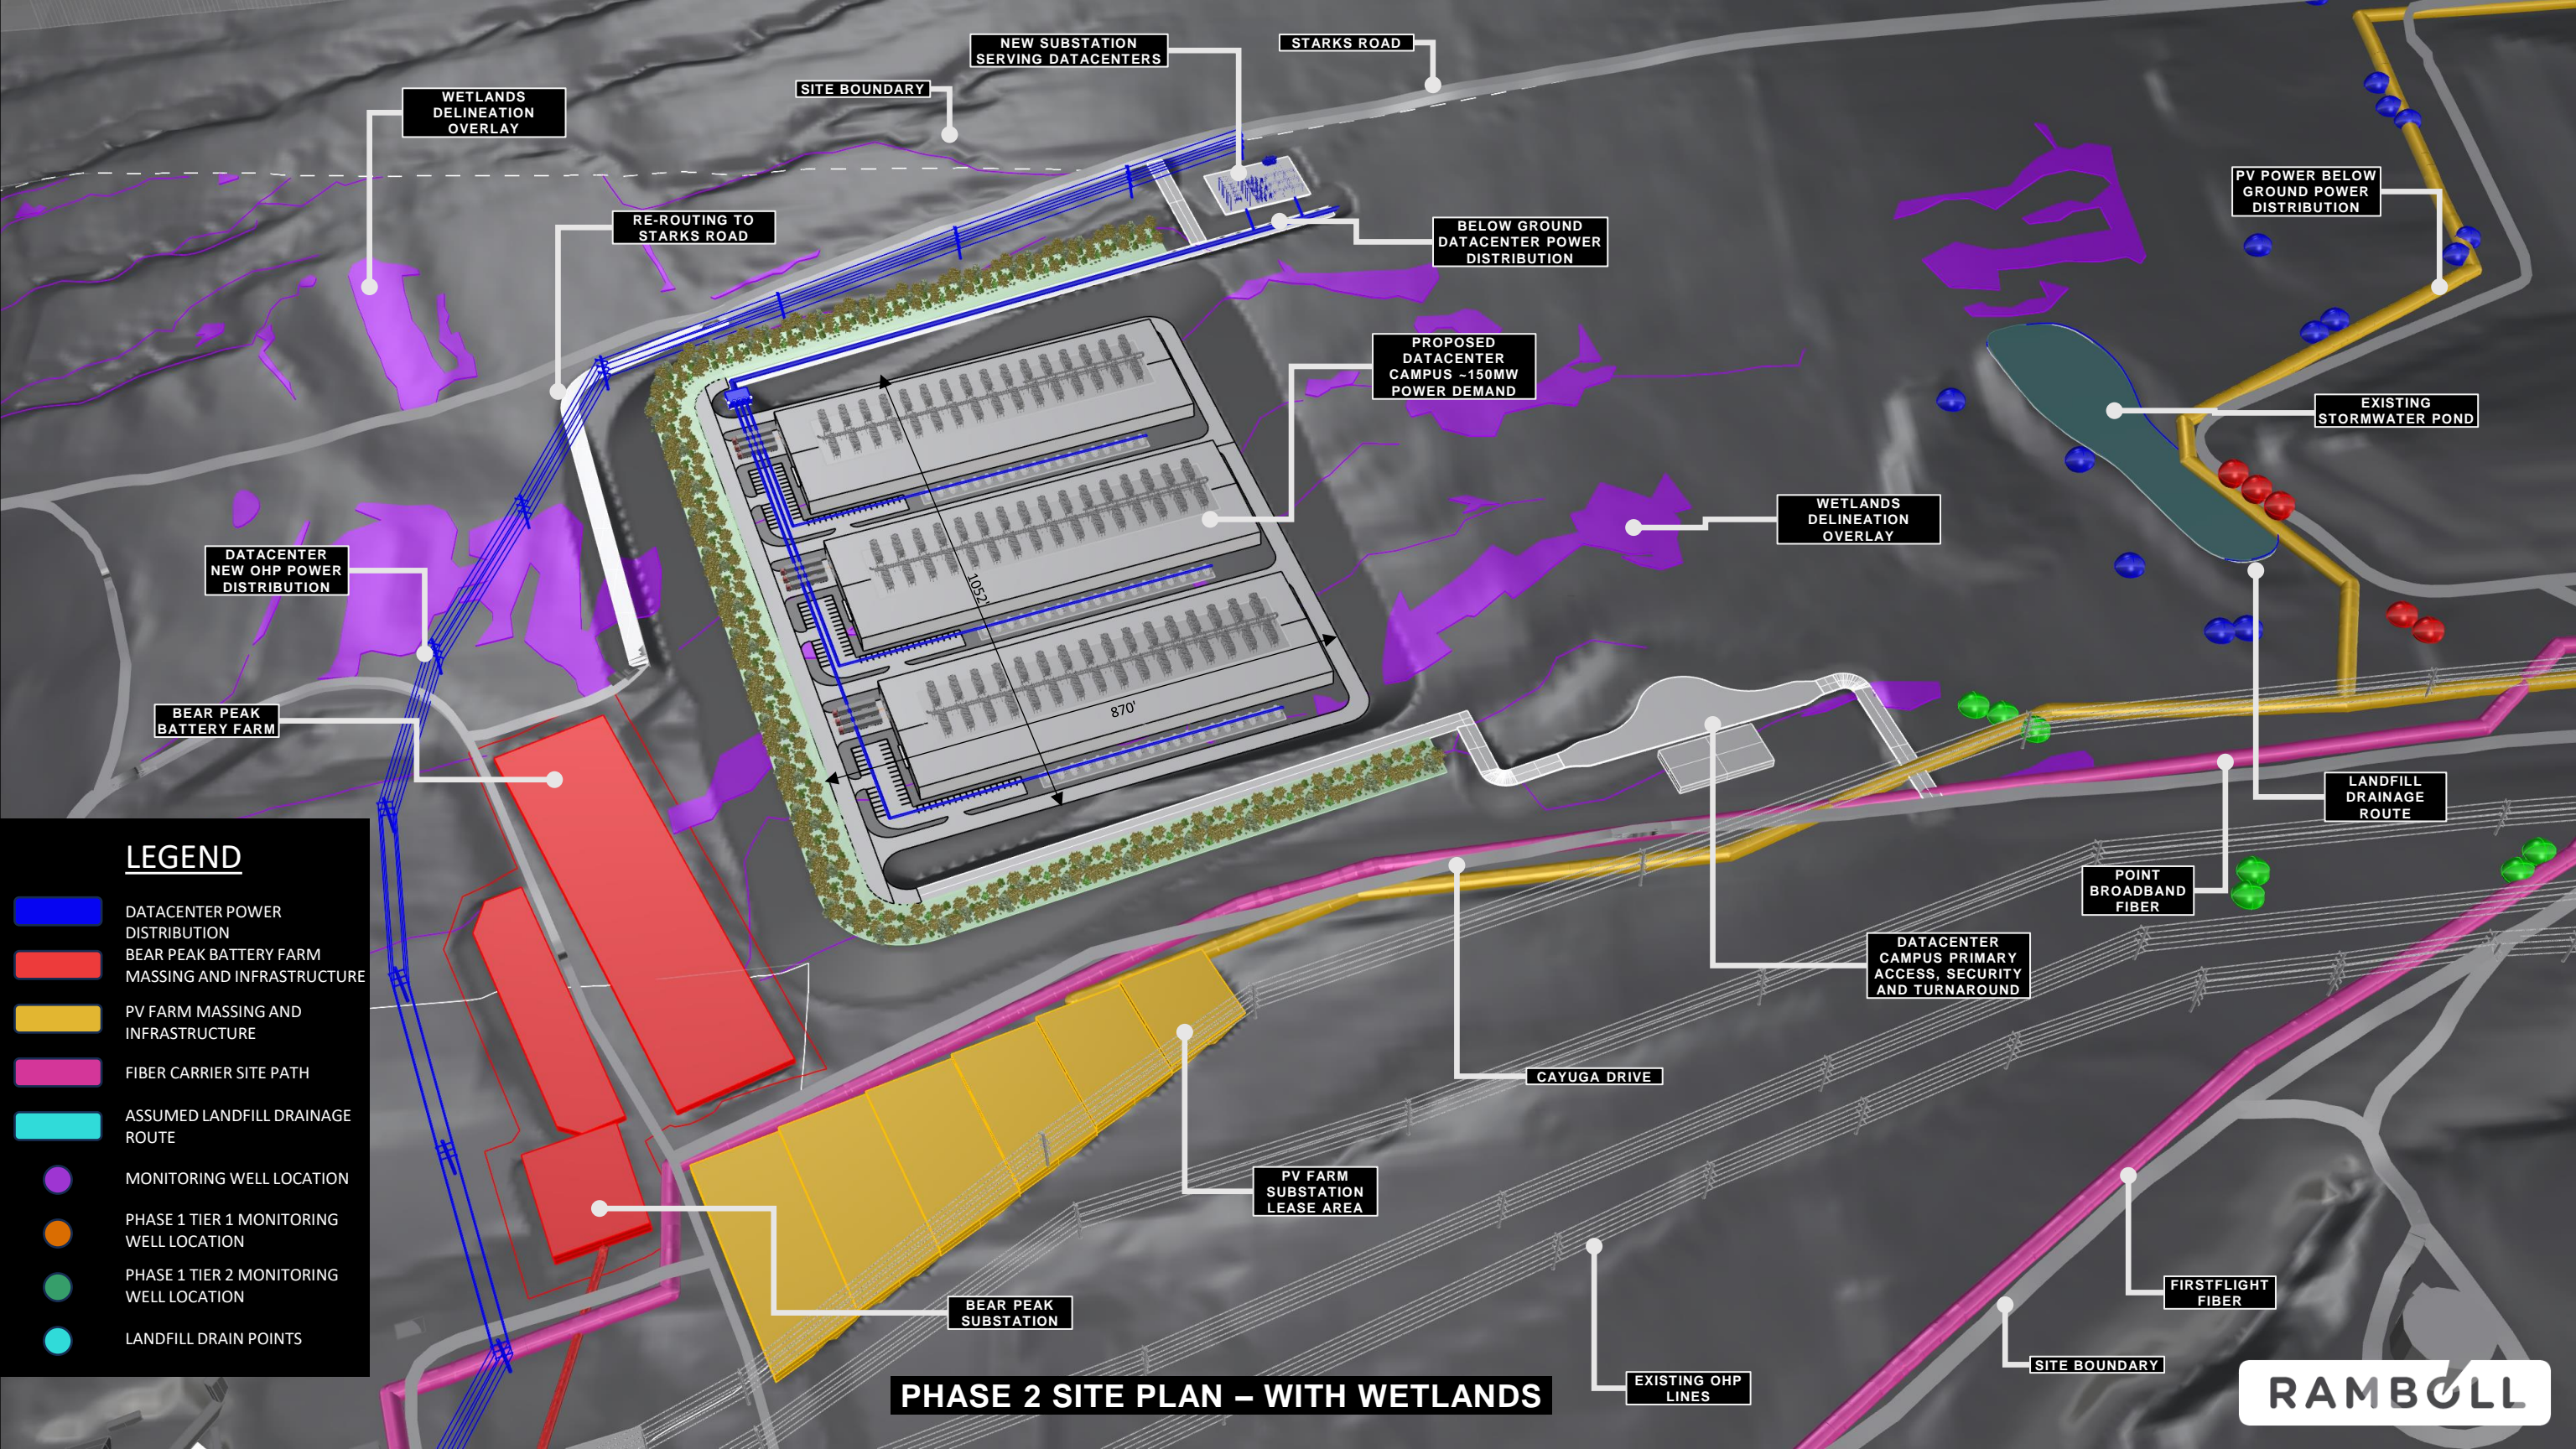
PHASE 2 WITH WETLANDS

The masterplan includes preliminary regrading efforts that work harmoniously with the existing sloped topography. This ensures an efficient and functional layout while accommodating the natural land contours. Starks Road is carefully rerouted around the northwest corner of the campus to provide ample space for the buildings, roads, and other critical features. Coordination will be essential during subsequent design stages as the regrading at the southwest of the campus slightly overlaps with the proposed regrading extents of the Bear Peak Battery farm.

The wetlands delineation is integrated into this masterplan, highlighting the wetlands affected by the new construction. All necessary agencies will be involved for the wetland mitigation process. Power Demand for the datacenter campus is approximately 150MW.

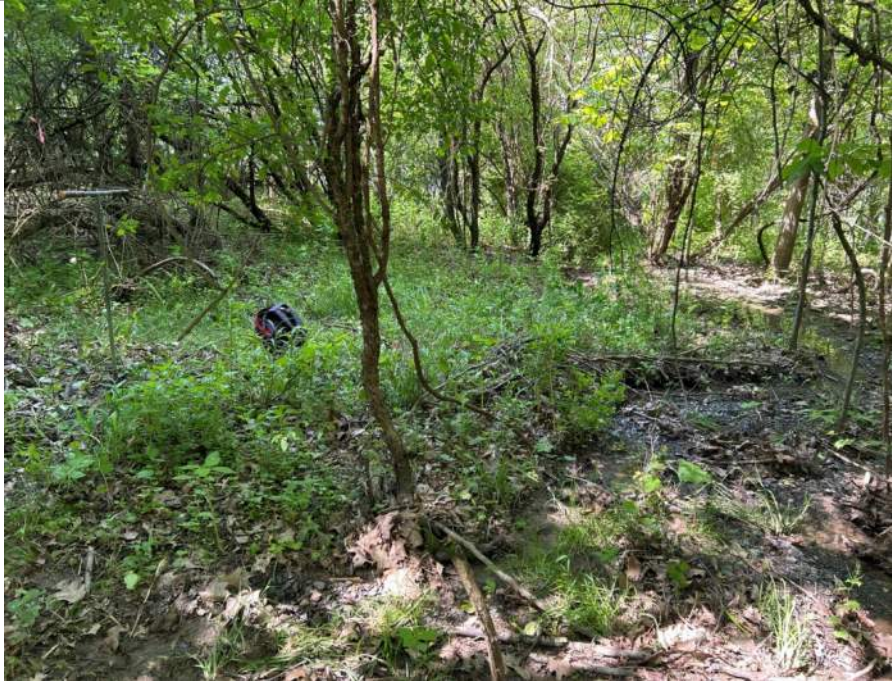
118Client Name: Cayuga Concept Engineering		Site Location: Tompkins County, Lansing, NY	Project No. 1940113922-001
Photo No. 1	Date: 6/4/2025

Description CCE-SB-01			
Client Name: Cayuga Concept Engineering		Site Location: Tompkins County, Lansing, NY	Project No. 1940113922-001
Photo No. 2	Date: 6/4/2025

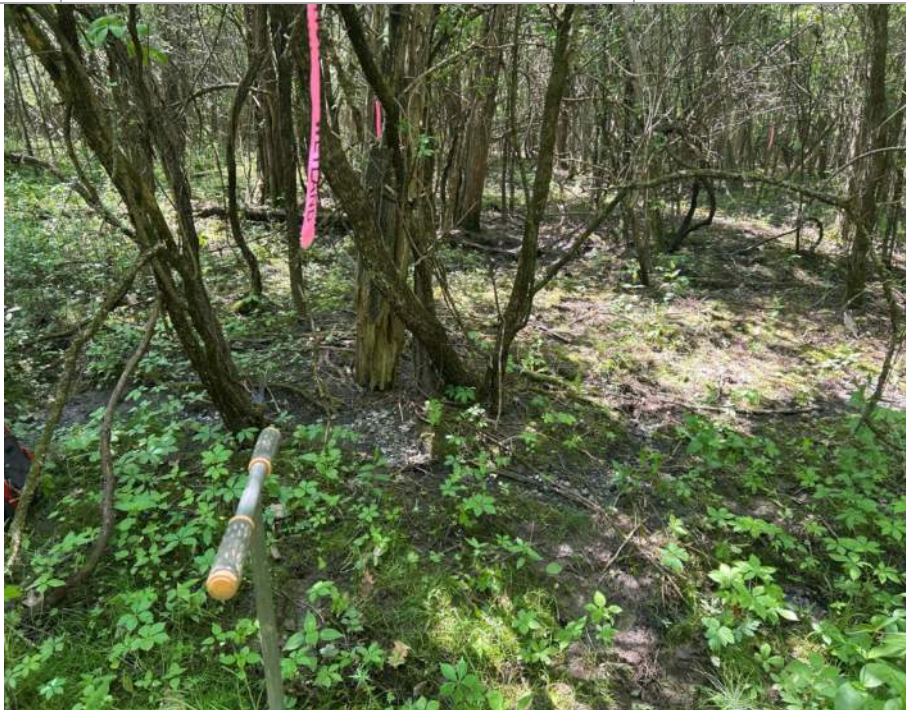
Description CCE-SB-02

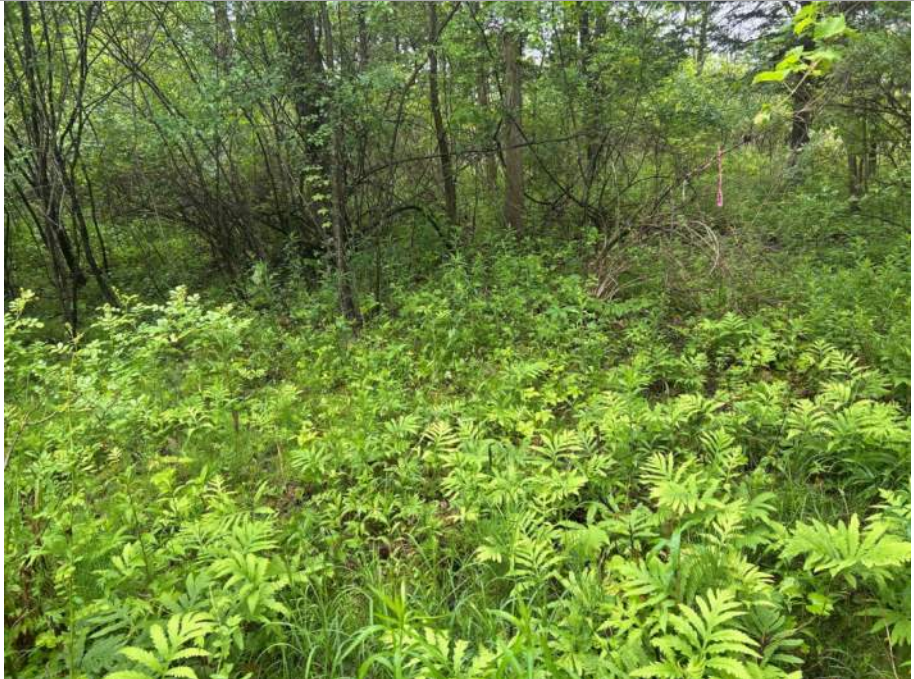
Client Name: Cayuga Concept Engineering		Site Location: Tompkins County, Lansing, NY	Project No. 1940113922-001
Photo No. 13	Date: 6/6/2025

Description CCE-SB-13

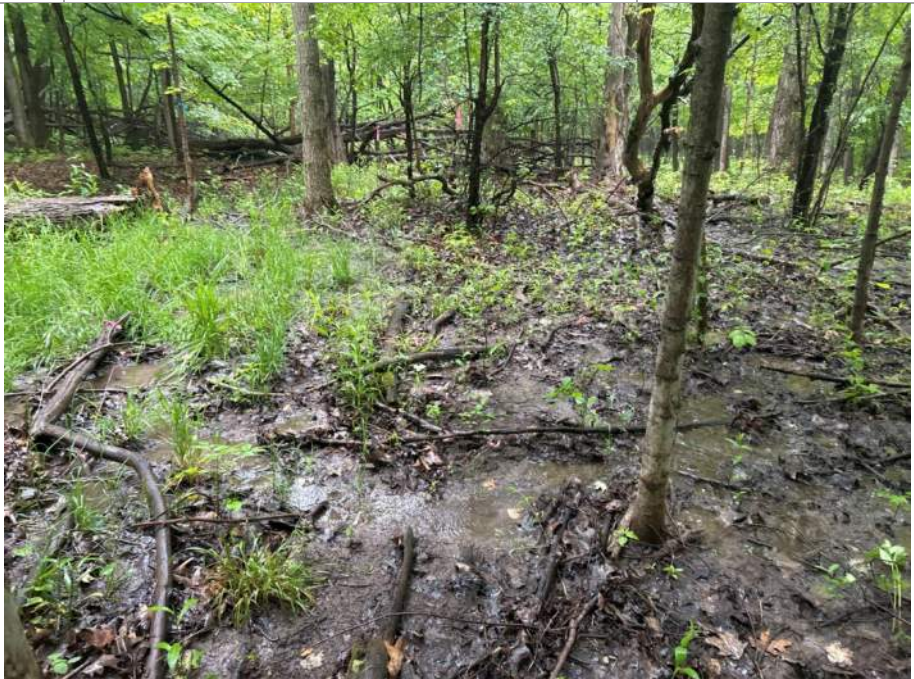
Client Name: Cayuga Concept Engineering		Site Location: Tompkins County, Lansing, NY	Project No. 1940113922-001
Photo No. 14	Date: 6/6/2025

Description CCE-SB-14

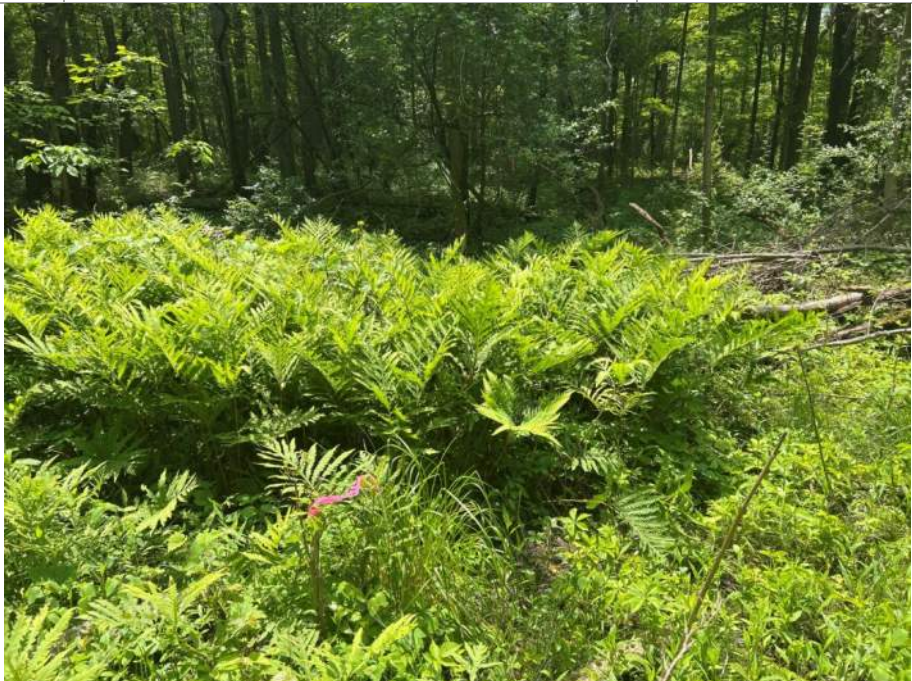
Client Name: Cayuga Concept Engineering		Site Location: Tompkins County, Lansing, NY	Project No. 1940113922-001
Photo No. 19	Date: 6/9/2025

Description CCE-SB-19			
Client Name: Cayuga Concept Engineering		Site Location: Tompkins County, Lansing, NY	Project No. 1940113922-001
Photo No. 20	Date: 6/9/2025

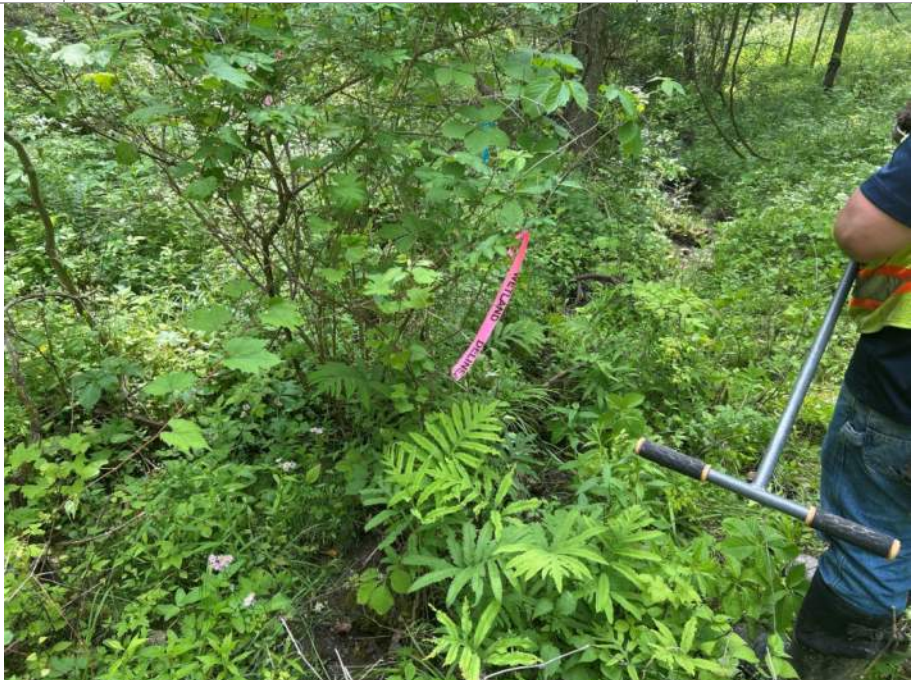
Description CCE-SB-20

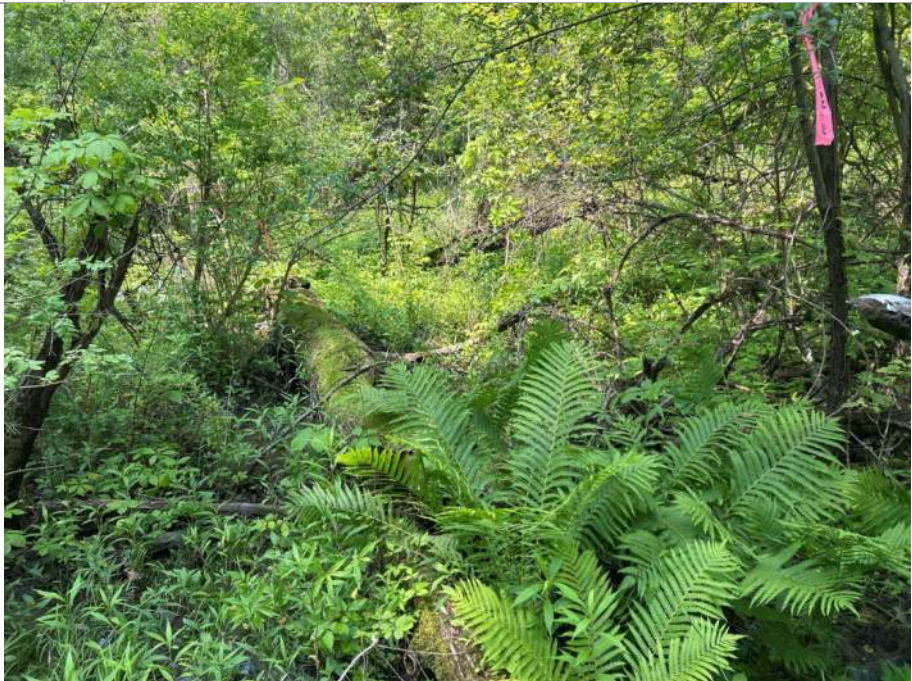
Client Name: Cayuga Concept Engineering		Site Location: Tompkins County, Lansing, NY	Project No. 1940113922-001
Photo No. 23	Date: 6/11/2025

Description CCE-SB-23

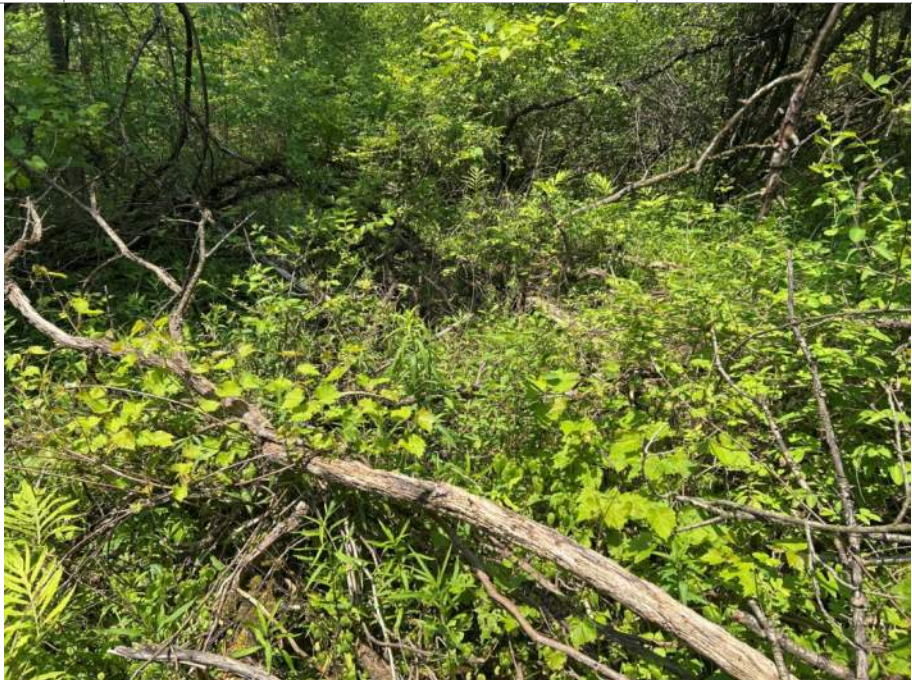
Client Name: Cayuga Concept Engineering		Site Location: Tompkins County, Lansing, NY	Project No. 1940113922-001
Photo No. 24	Date: 6/11/2025

Description CCE-SB-24

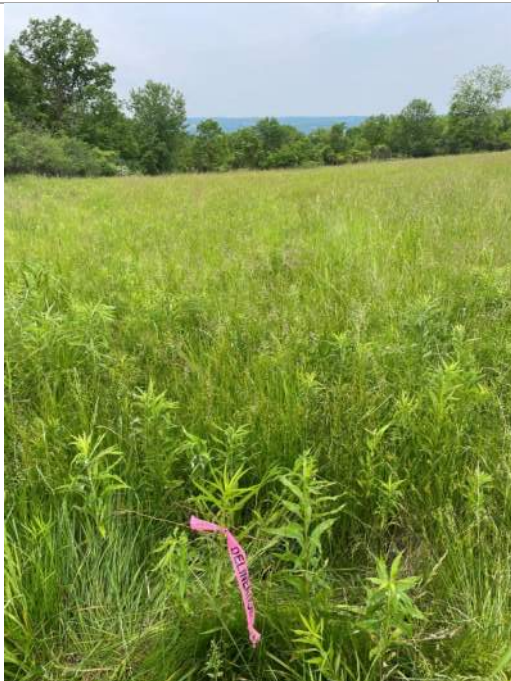
Client Name: Cayuga Concept Engineering		Site Location: Tompkins County, Lansing, NY	Project No. 1940113922-001
Photo No. 27	Date: 6/13/2025

Description CCE-SB-27

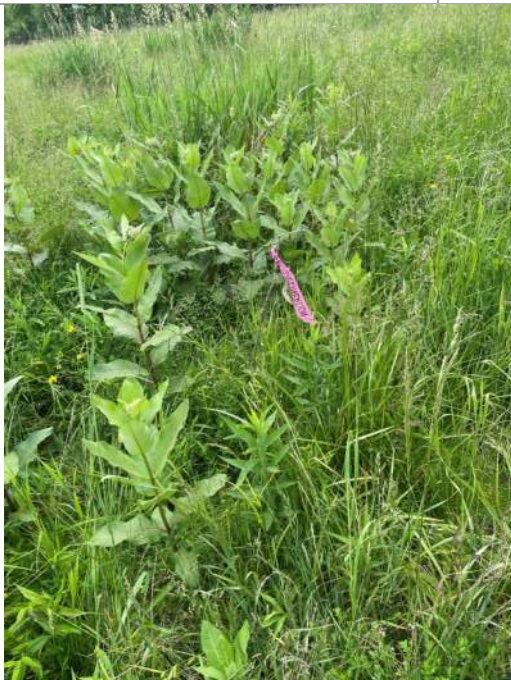
Client Name: Cayuga Concept Engineering		Site Location: Tompkins County, Lansing, NY	Project No. 1940113922-001
Photo No. 28	Date: 6/13/2025

Description CCE-SB-28

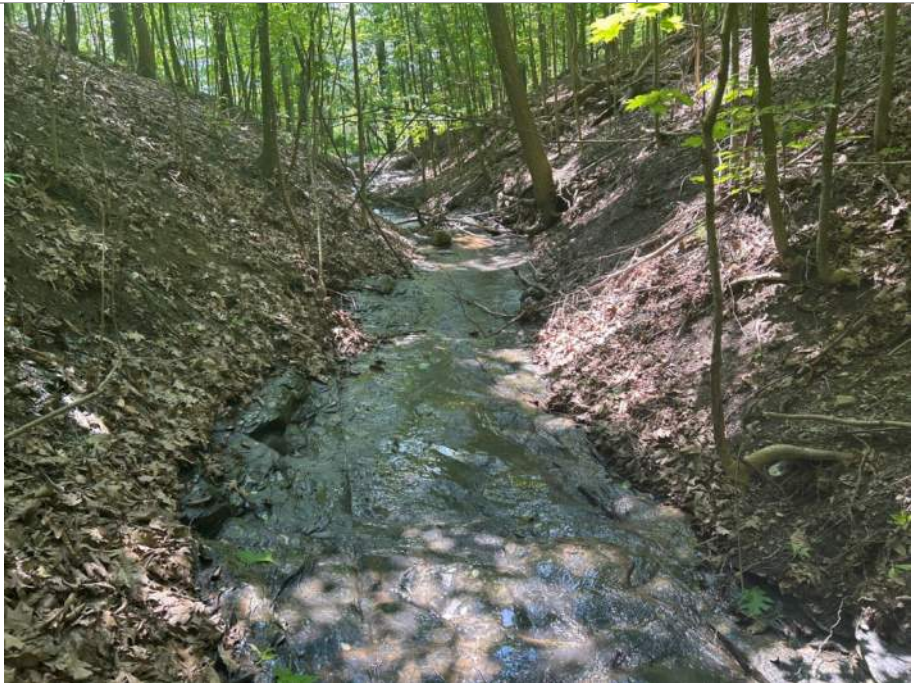
Client Name: Cayuga Concept Engineering		Site Location: Tompkins County, Lansing, NY	Project No. 1940113922-001
Photo No. 37	Date: 6/4/2025

Description CCE-IS2

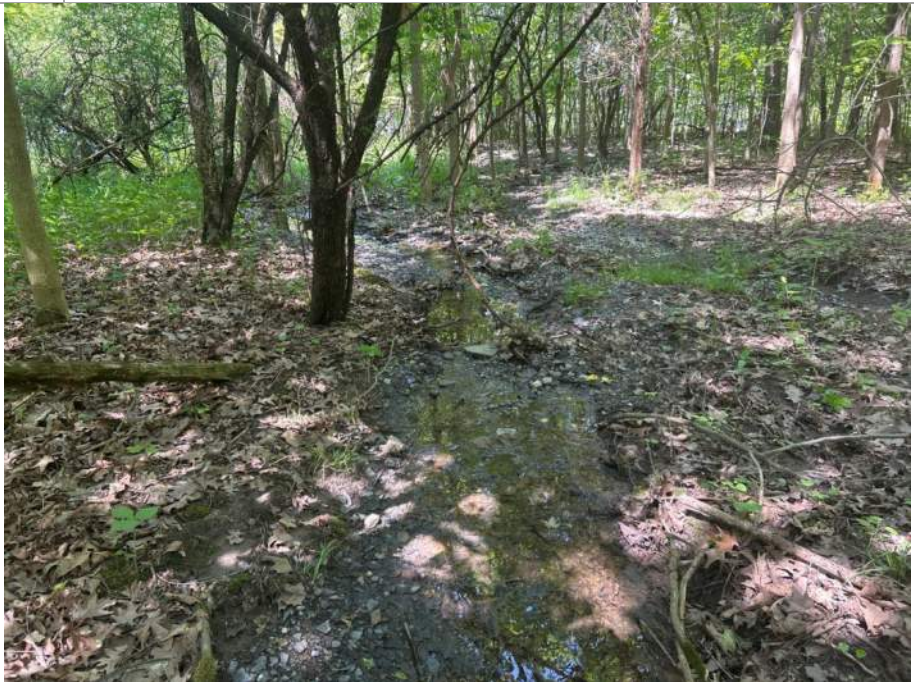
Client Name: Cayuga Concept Engineering		Site Location: Tompkins County, Lansing, NY	Project No. 1940113922-001
Photo No. 38	Date: 6/4/2025

Description CCE-EP1
