Site Plan Application

Town of Lansing, NY

Application #: SITE-25-9

By: Cayuga Operating Company, LLC
228 Cayuga Dr., Lansing NY 14882

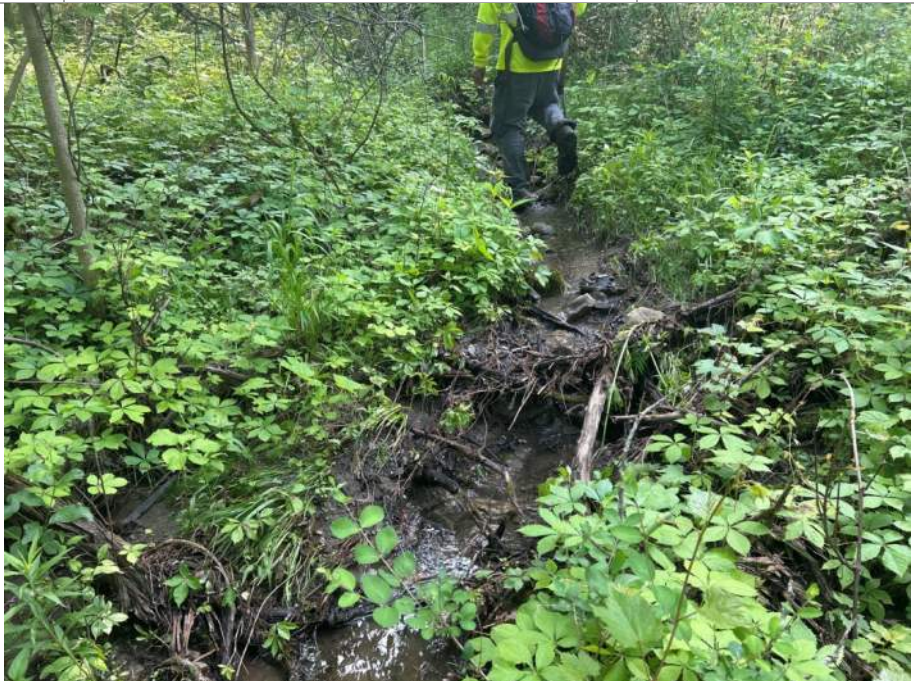
Client Name: Cayuga Concept Engineering		Site Location: Tompkins County, Lansing, NY	Project No. 1940113922-001
Photo No. 49	Date: 6/9/2025

Description CCE-EP13

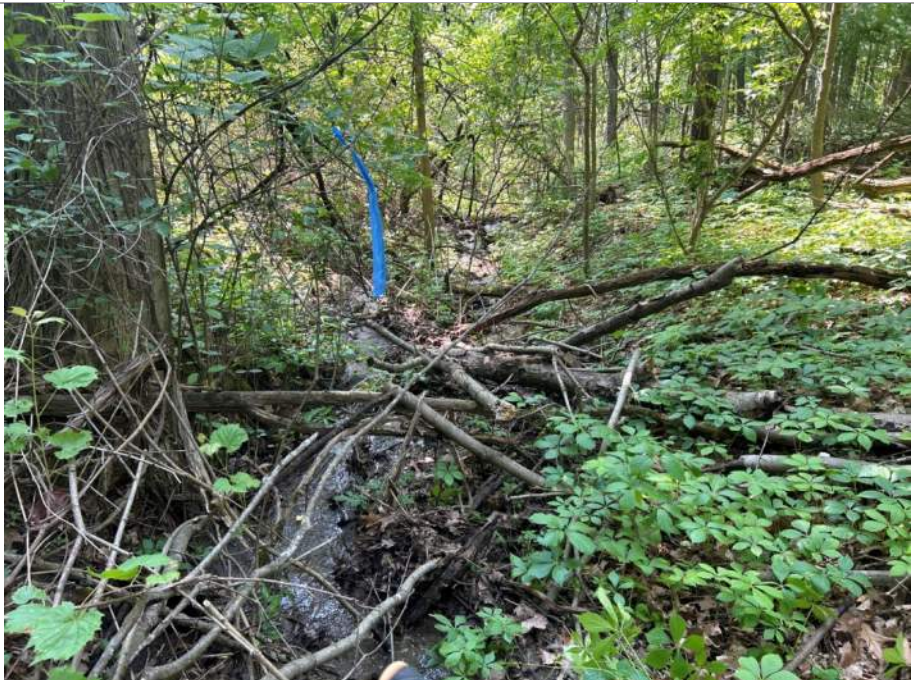
Client Name: Cayuga Concept Engineering		Site Location: Tompkins County, Lansing, NY	Project No. 1940113922-001
Photo No. 50	Date: 6/9/2025

Description CCE-EP14

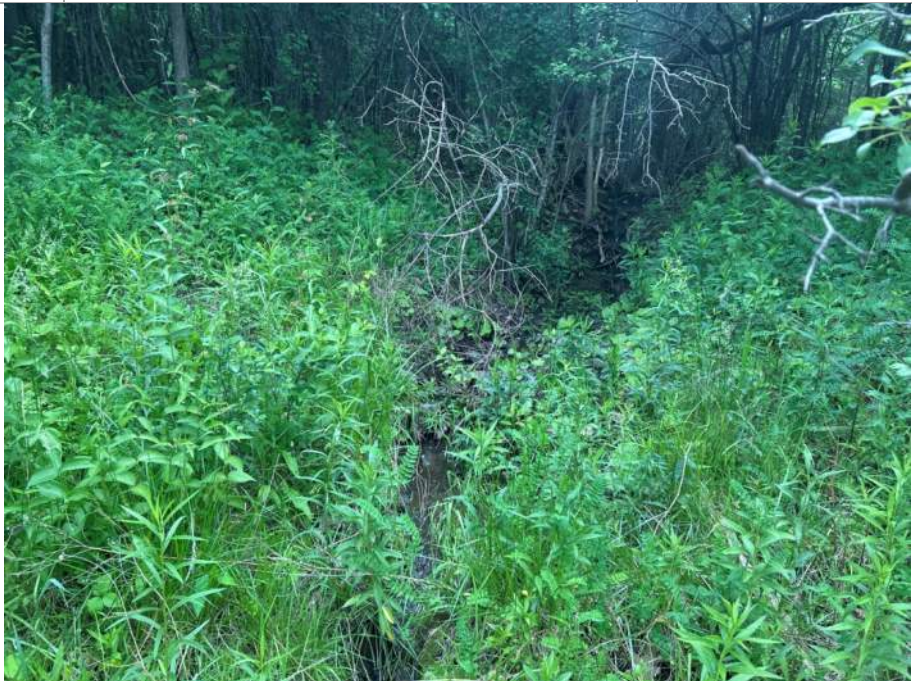
Client Name: Cayuga Concept Engineering		Site Location: Tompkins County, Lansing, NY	Project No. 1940113922-001
Photo No. 53	Date: 6/9/2025

Description CCE-EP18

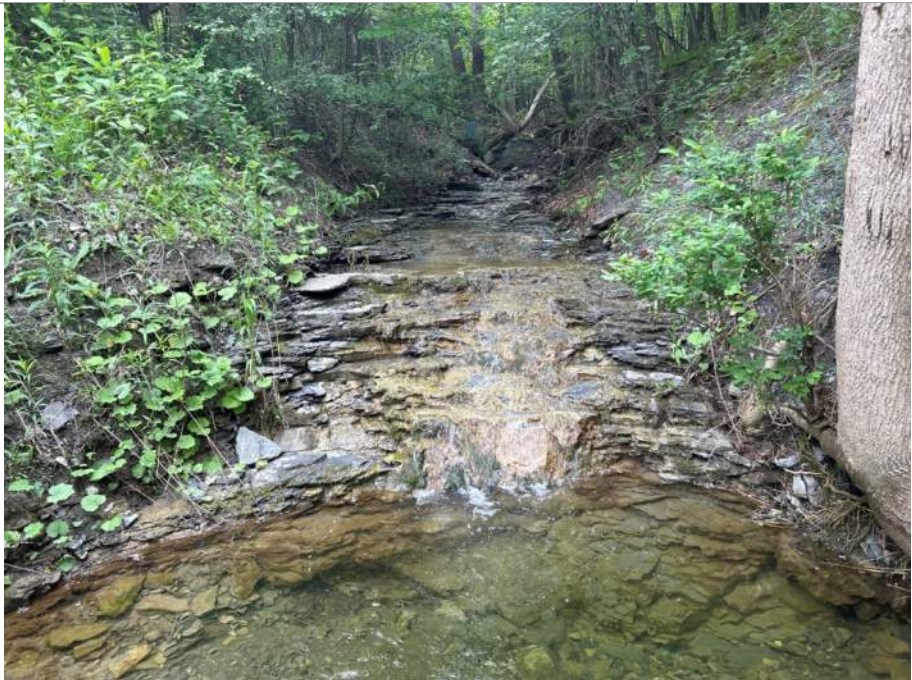
Client Name: Cayuga Concept Engineering		Site Location: Tompkins County, Lansing, NY	Project No. 1940113922-001
Photo No. 54	Date: 9/13/2024

Description CCE-IS3

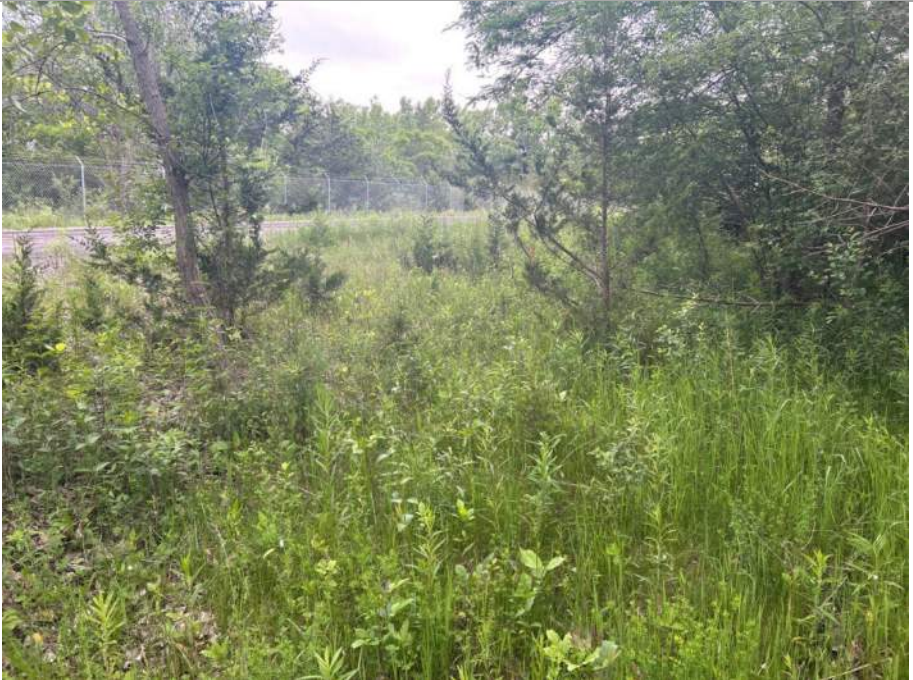
Description Ditch 7

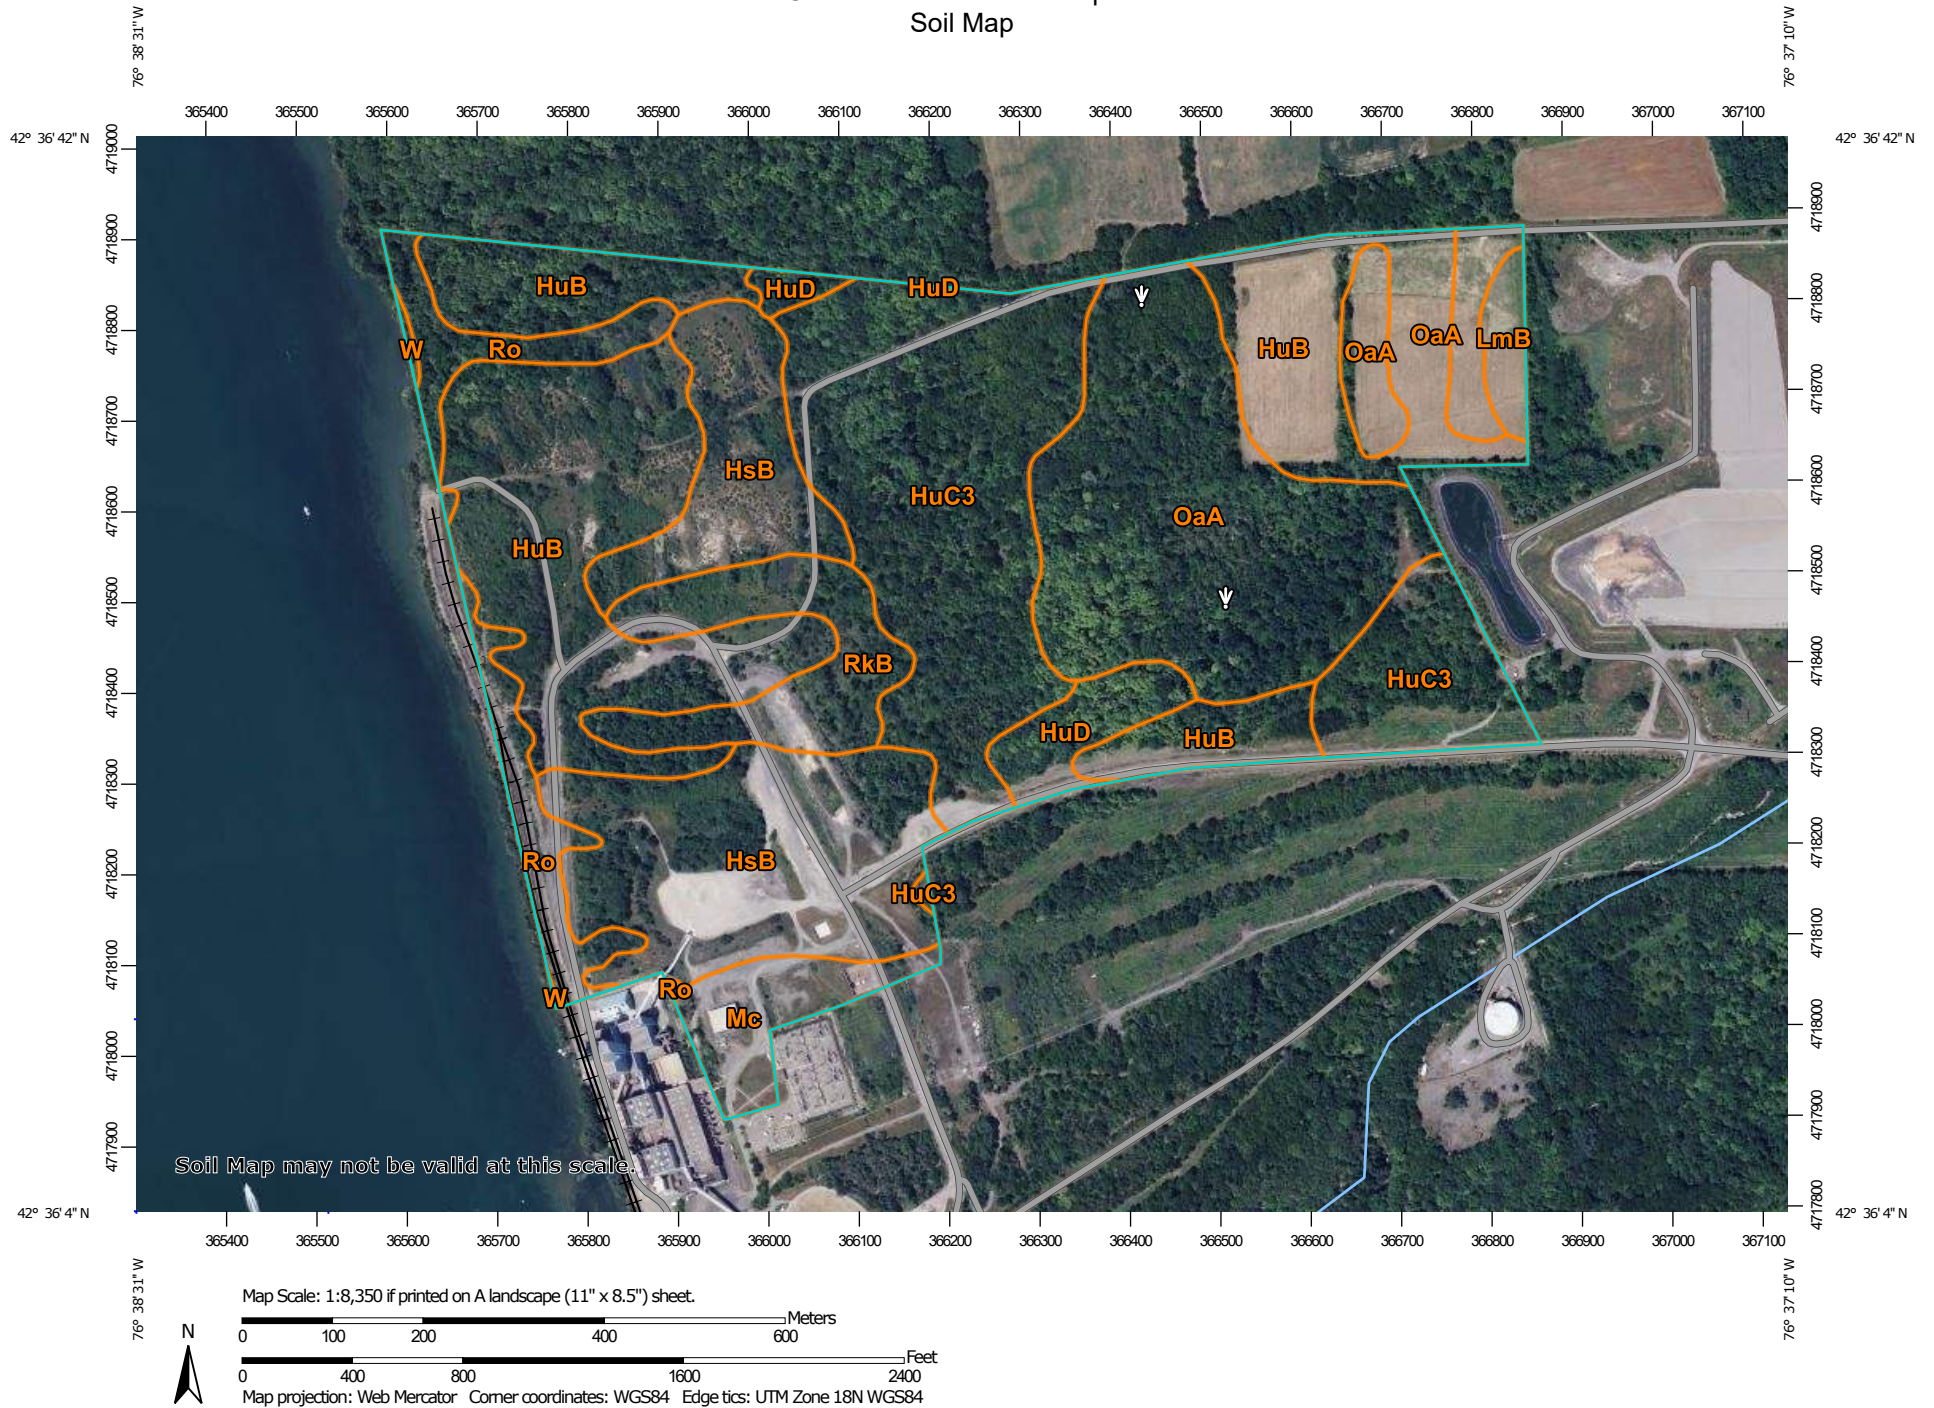
Custom Soil Resource Report Soil Map

The soil map section includes the soil map for the defined area of interest, a list of soil map units on the map and extent of each map unit, and cartographic symbols displayed on the map. Also presented are various metadata about data used to produce the map, and a description of each soil map unit.

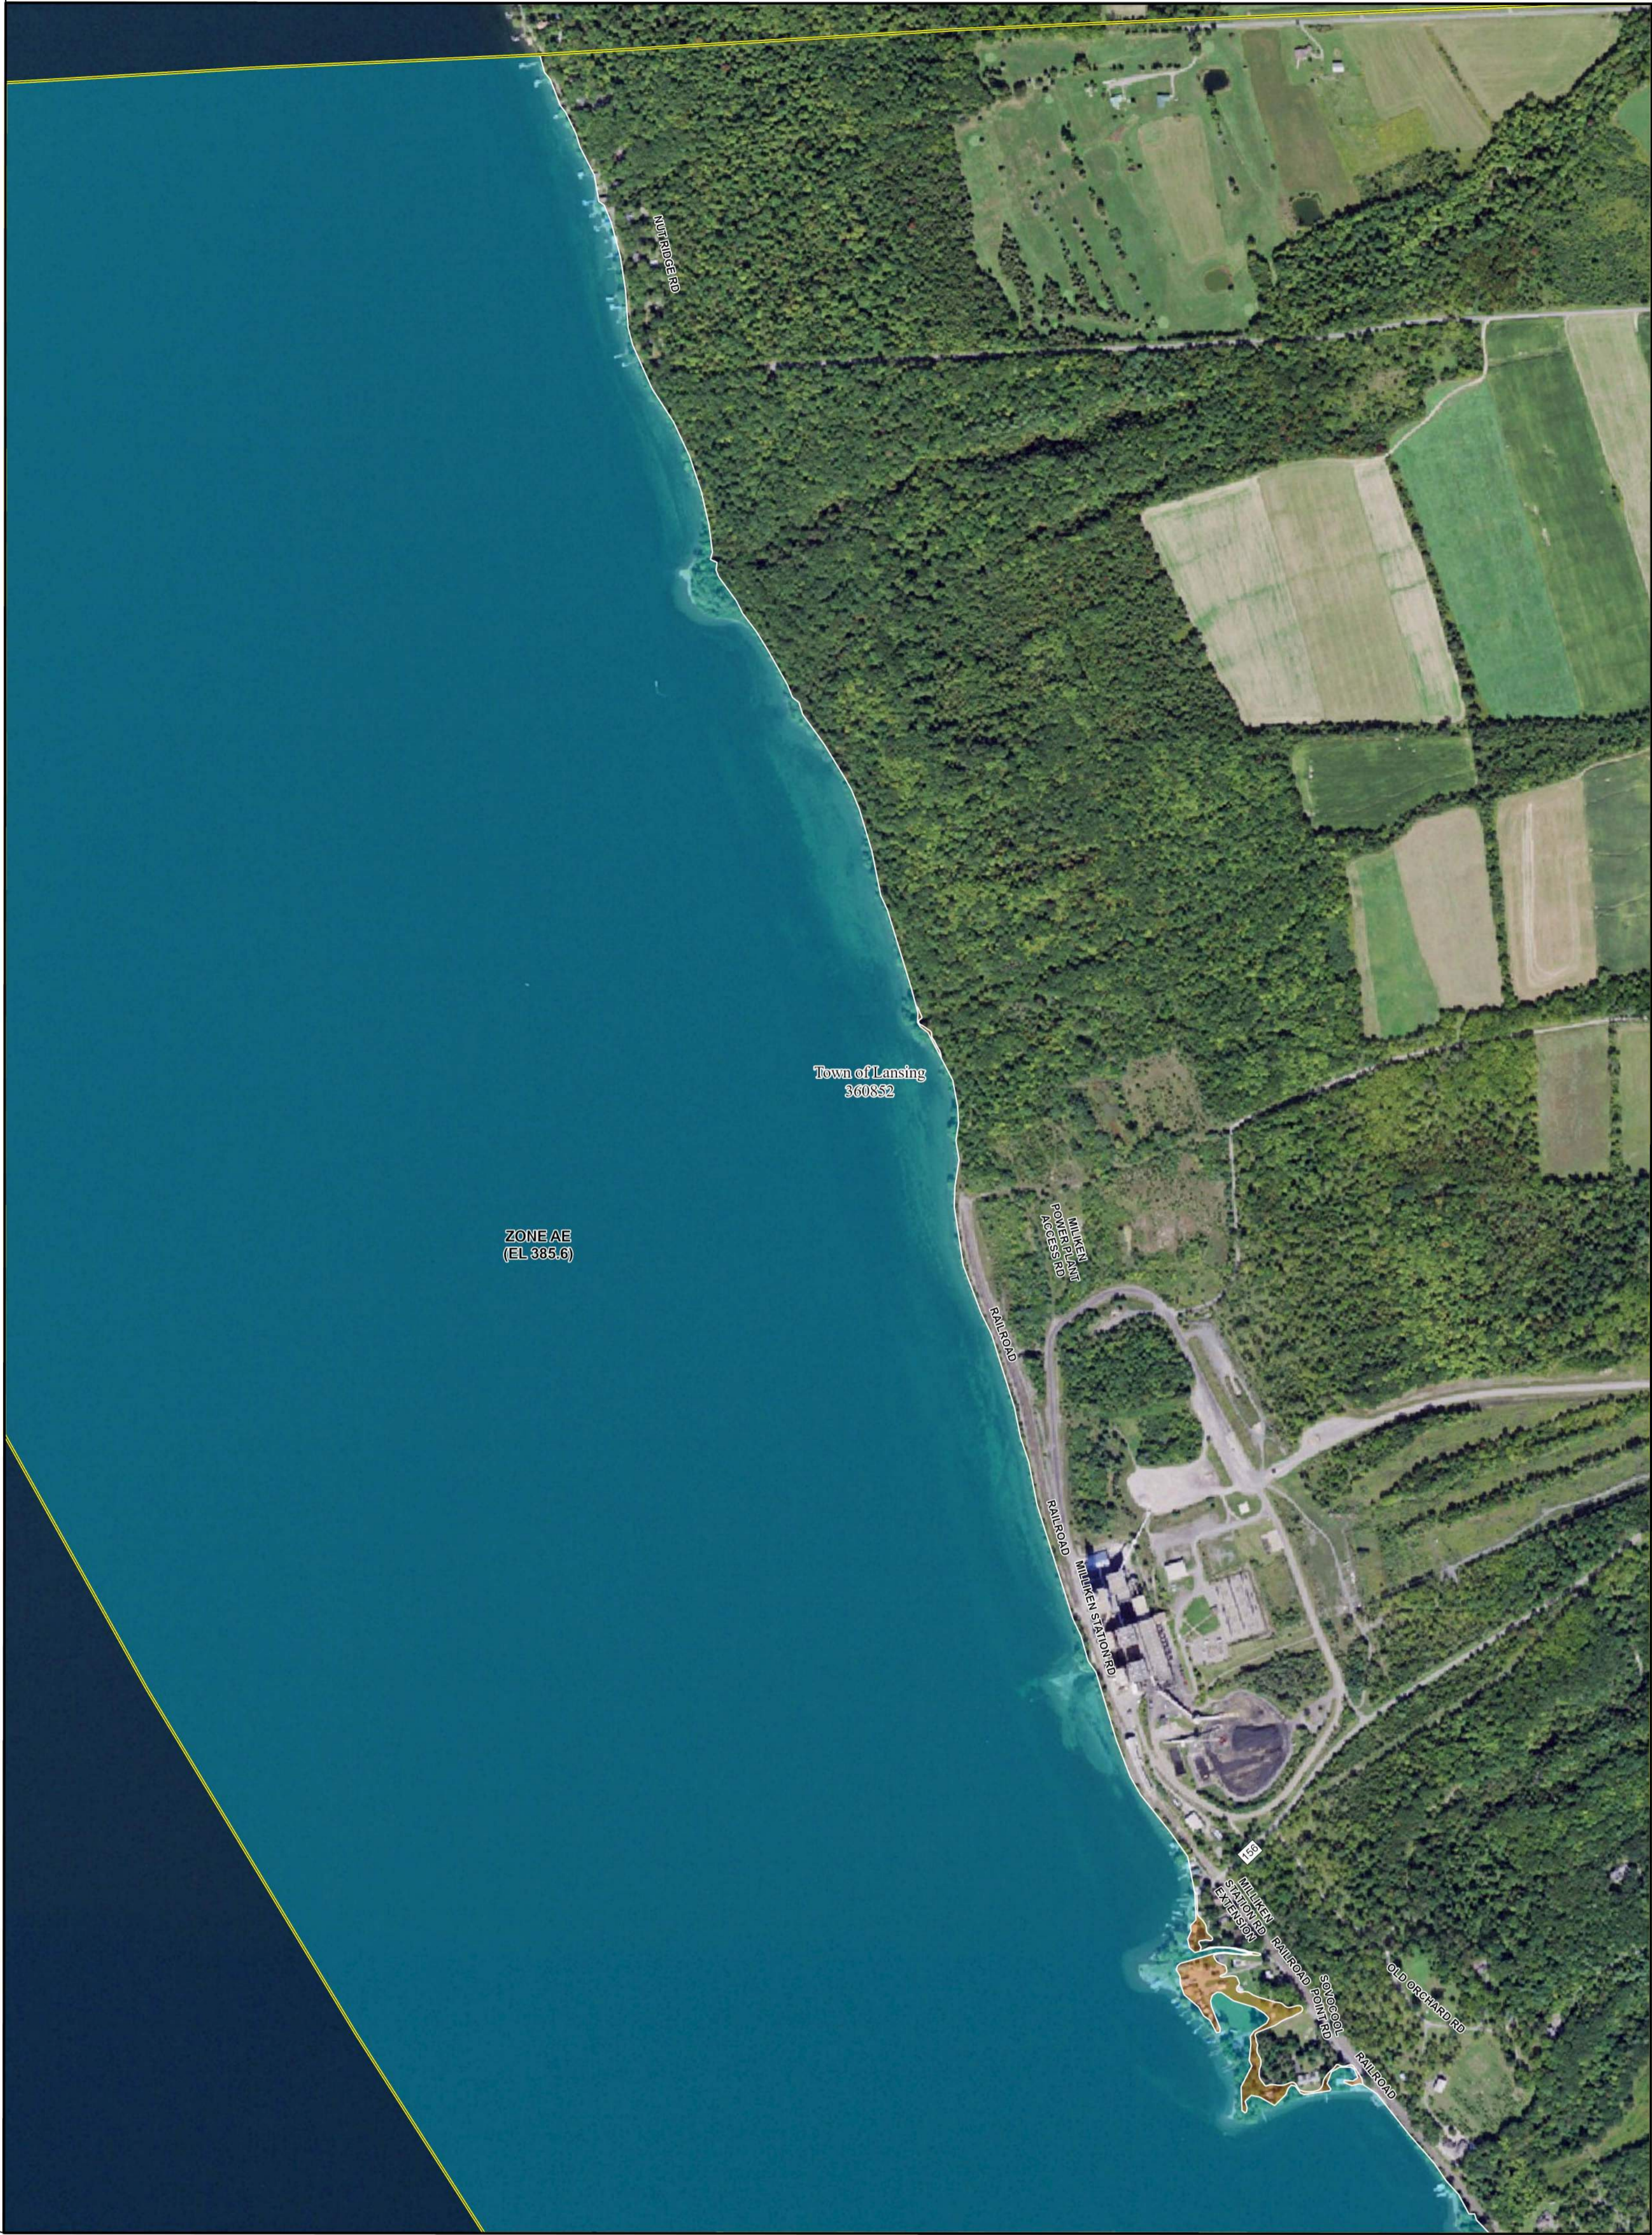
FLOOD HAZARD INFORMATION

SPECIAL FLOOD HAZARD AREAS		Without Base Flood Elevation (BFE) Zone A, V, A99
		With BFE or Depth Zone AE, AO, AH, VE, AR
OTHER AREAS OF FLOOD HAZARD		Regulatory Floodway

0.2% Annual Chance Flood Hazard, Areas of 1% annual chance flood with average depth less than one foot or with drainage areas of less than one square mile Zone X
		Future Conditions 1% Annual Chance Flood Hazard Zone X
		Area with Reduced Flood Risk due to Levee See Notes Zone X
OTHER AREAS		Area with Flood Risk due to Levee Zone D
		Area of Minimal Flood Hazard Zone X
GENERAL STRUCTURES		Area of Undetermined Flood Hazard Zone D
		Channel, Culvert, or Storm Sewer
OTHER FEATURES		Levee, Dike, or Floodwall
		Cross Sections with 1% Annual Chance
		Water Surface Elevation
		Coastal Transect
		Coastal Transect Baseline
		Profile Baseline
		Hydrographic Feature
		Base Flood Elevation Line (BFE)
		Limit of Study
		Jurisdiction Boundary

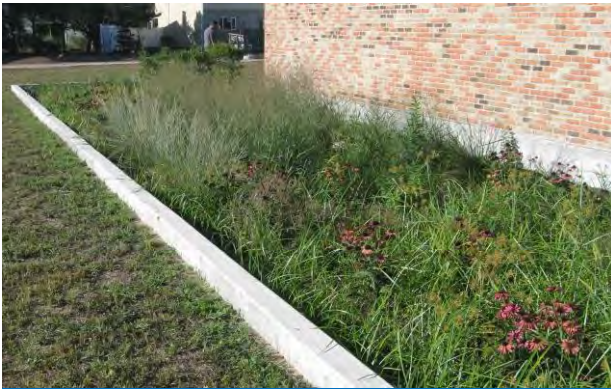
Fact Sheet: Stormwater Planters (RR-7)

Description: Passive filtration system to manage and treat small to moderate volumes of stormwater runoff from adjacent impervious surfaces. The system consists of an inflow component, a shallow ponding area over a planted soil bed, mulch layer, stone drainage layer, plantings and an overflow mechanism to convey larger rain events to the storm drain system.

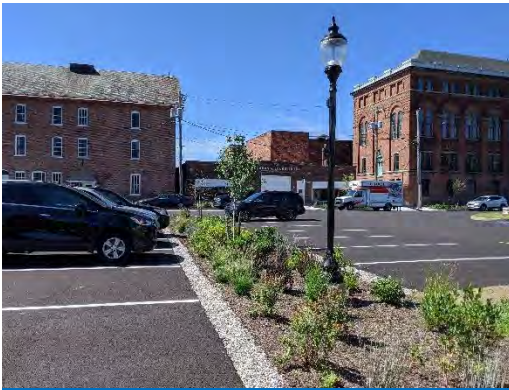
Fact Sheet: Infiltration Bioretention (F-4)

Description: Shallow stormwater controls that utilize vegetation and engineered filter media to capture, treat, and infiltrate stormwater runoff into the underlying soils.

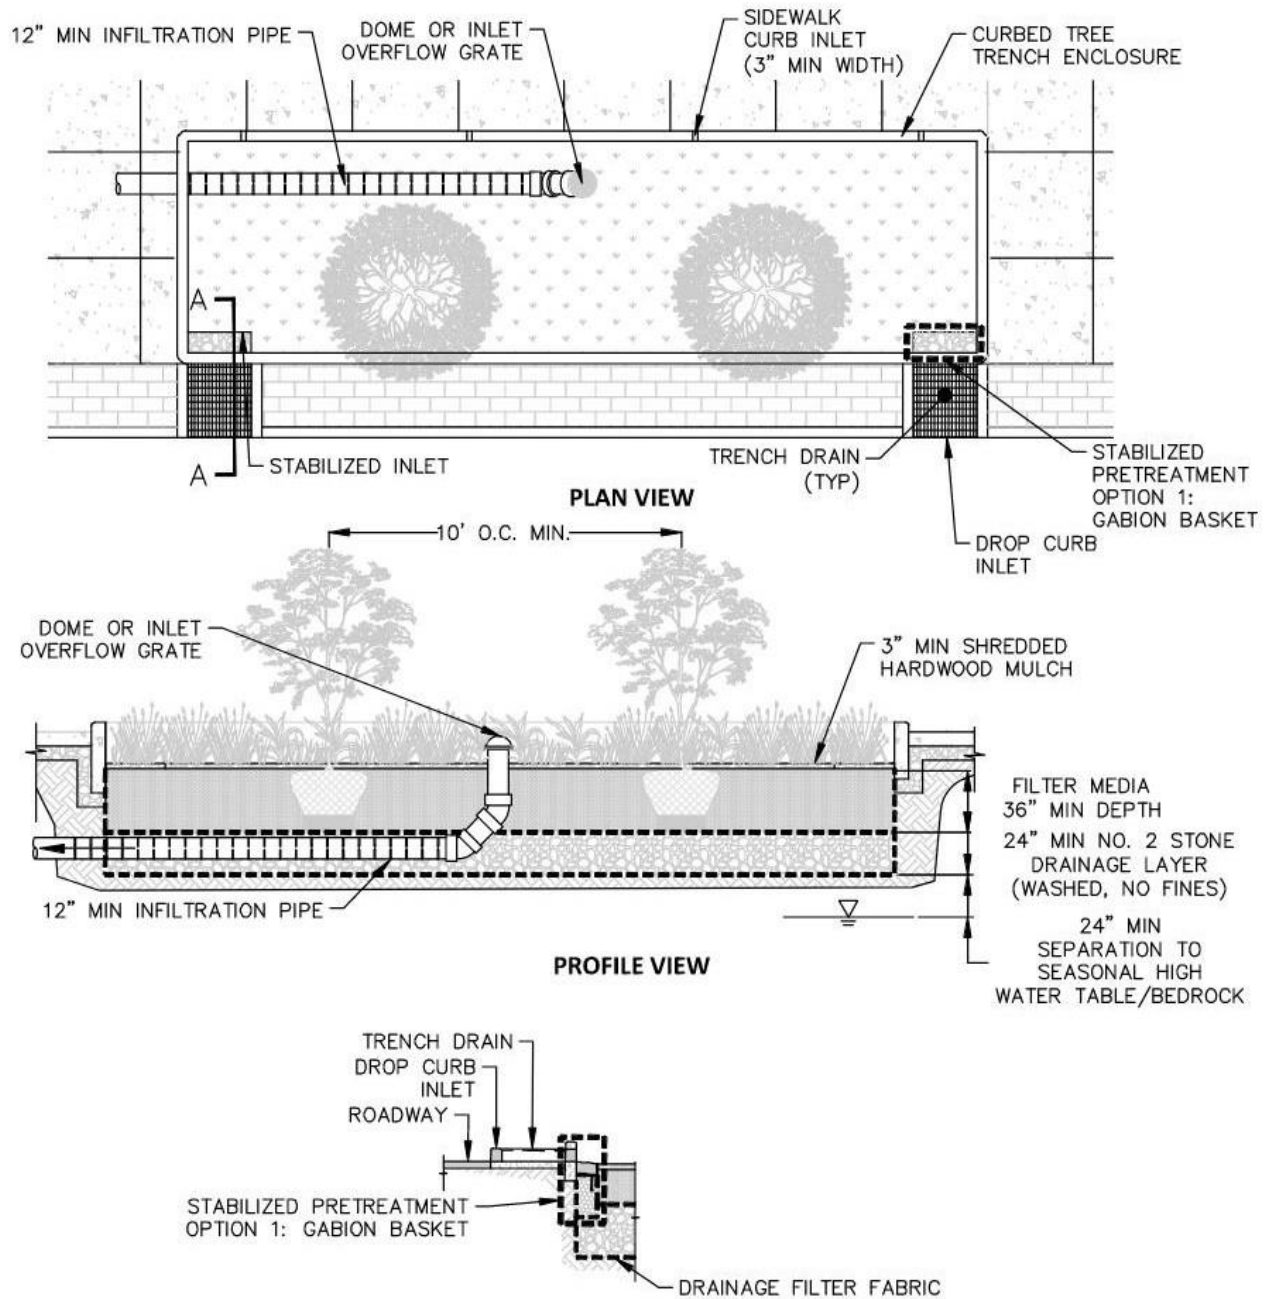
Figure 5.38 Tree Trench Surface Flow (RR-3)

APPENDIX D
NYSDEC STORMWATER DESIGN MANUAL
TREE TRENCH STANDARD DETAIL WITH GABION BASKET PRETREATMENT

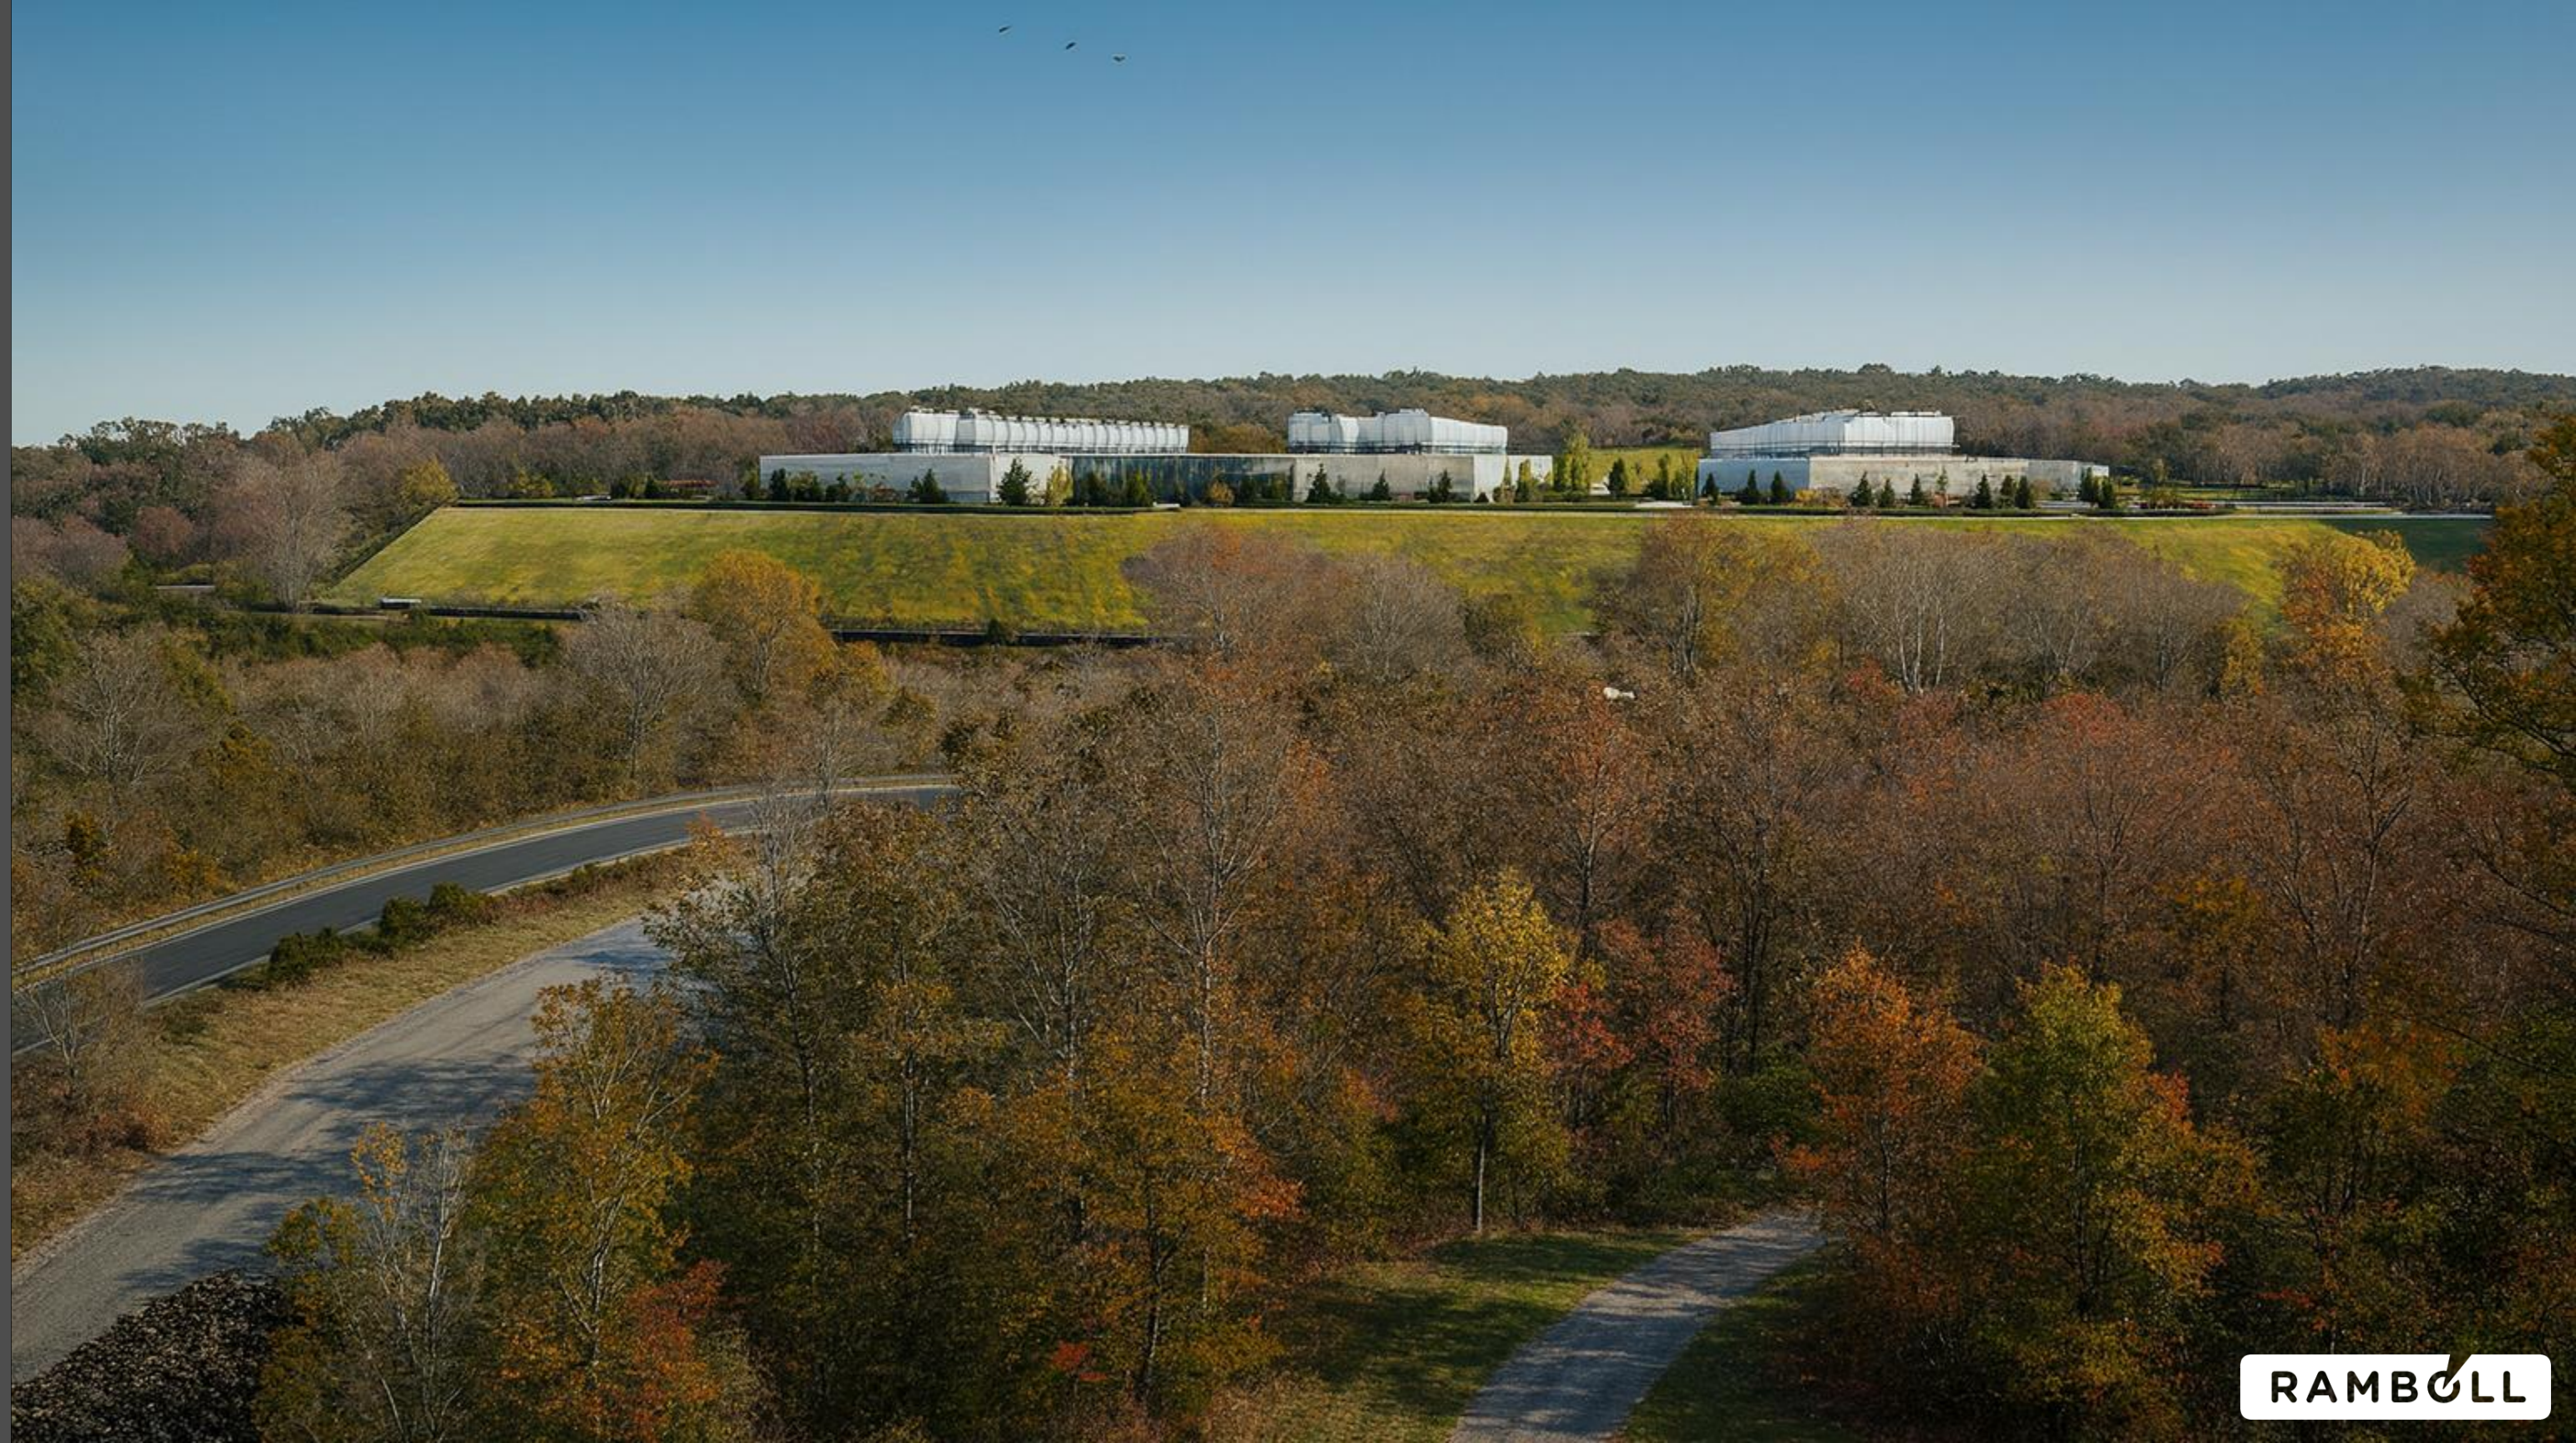
View taken from approximately 500 feet AMSL above the existing limestone pad to the north of Milliken Station.

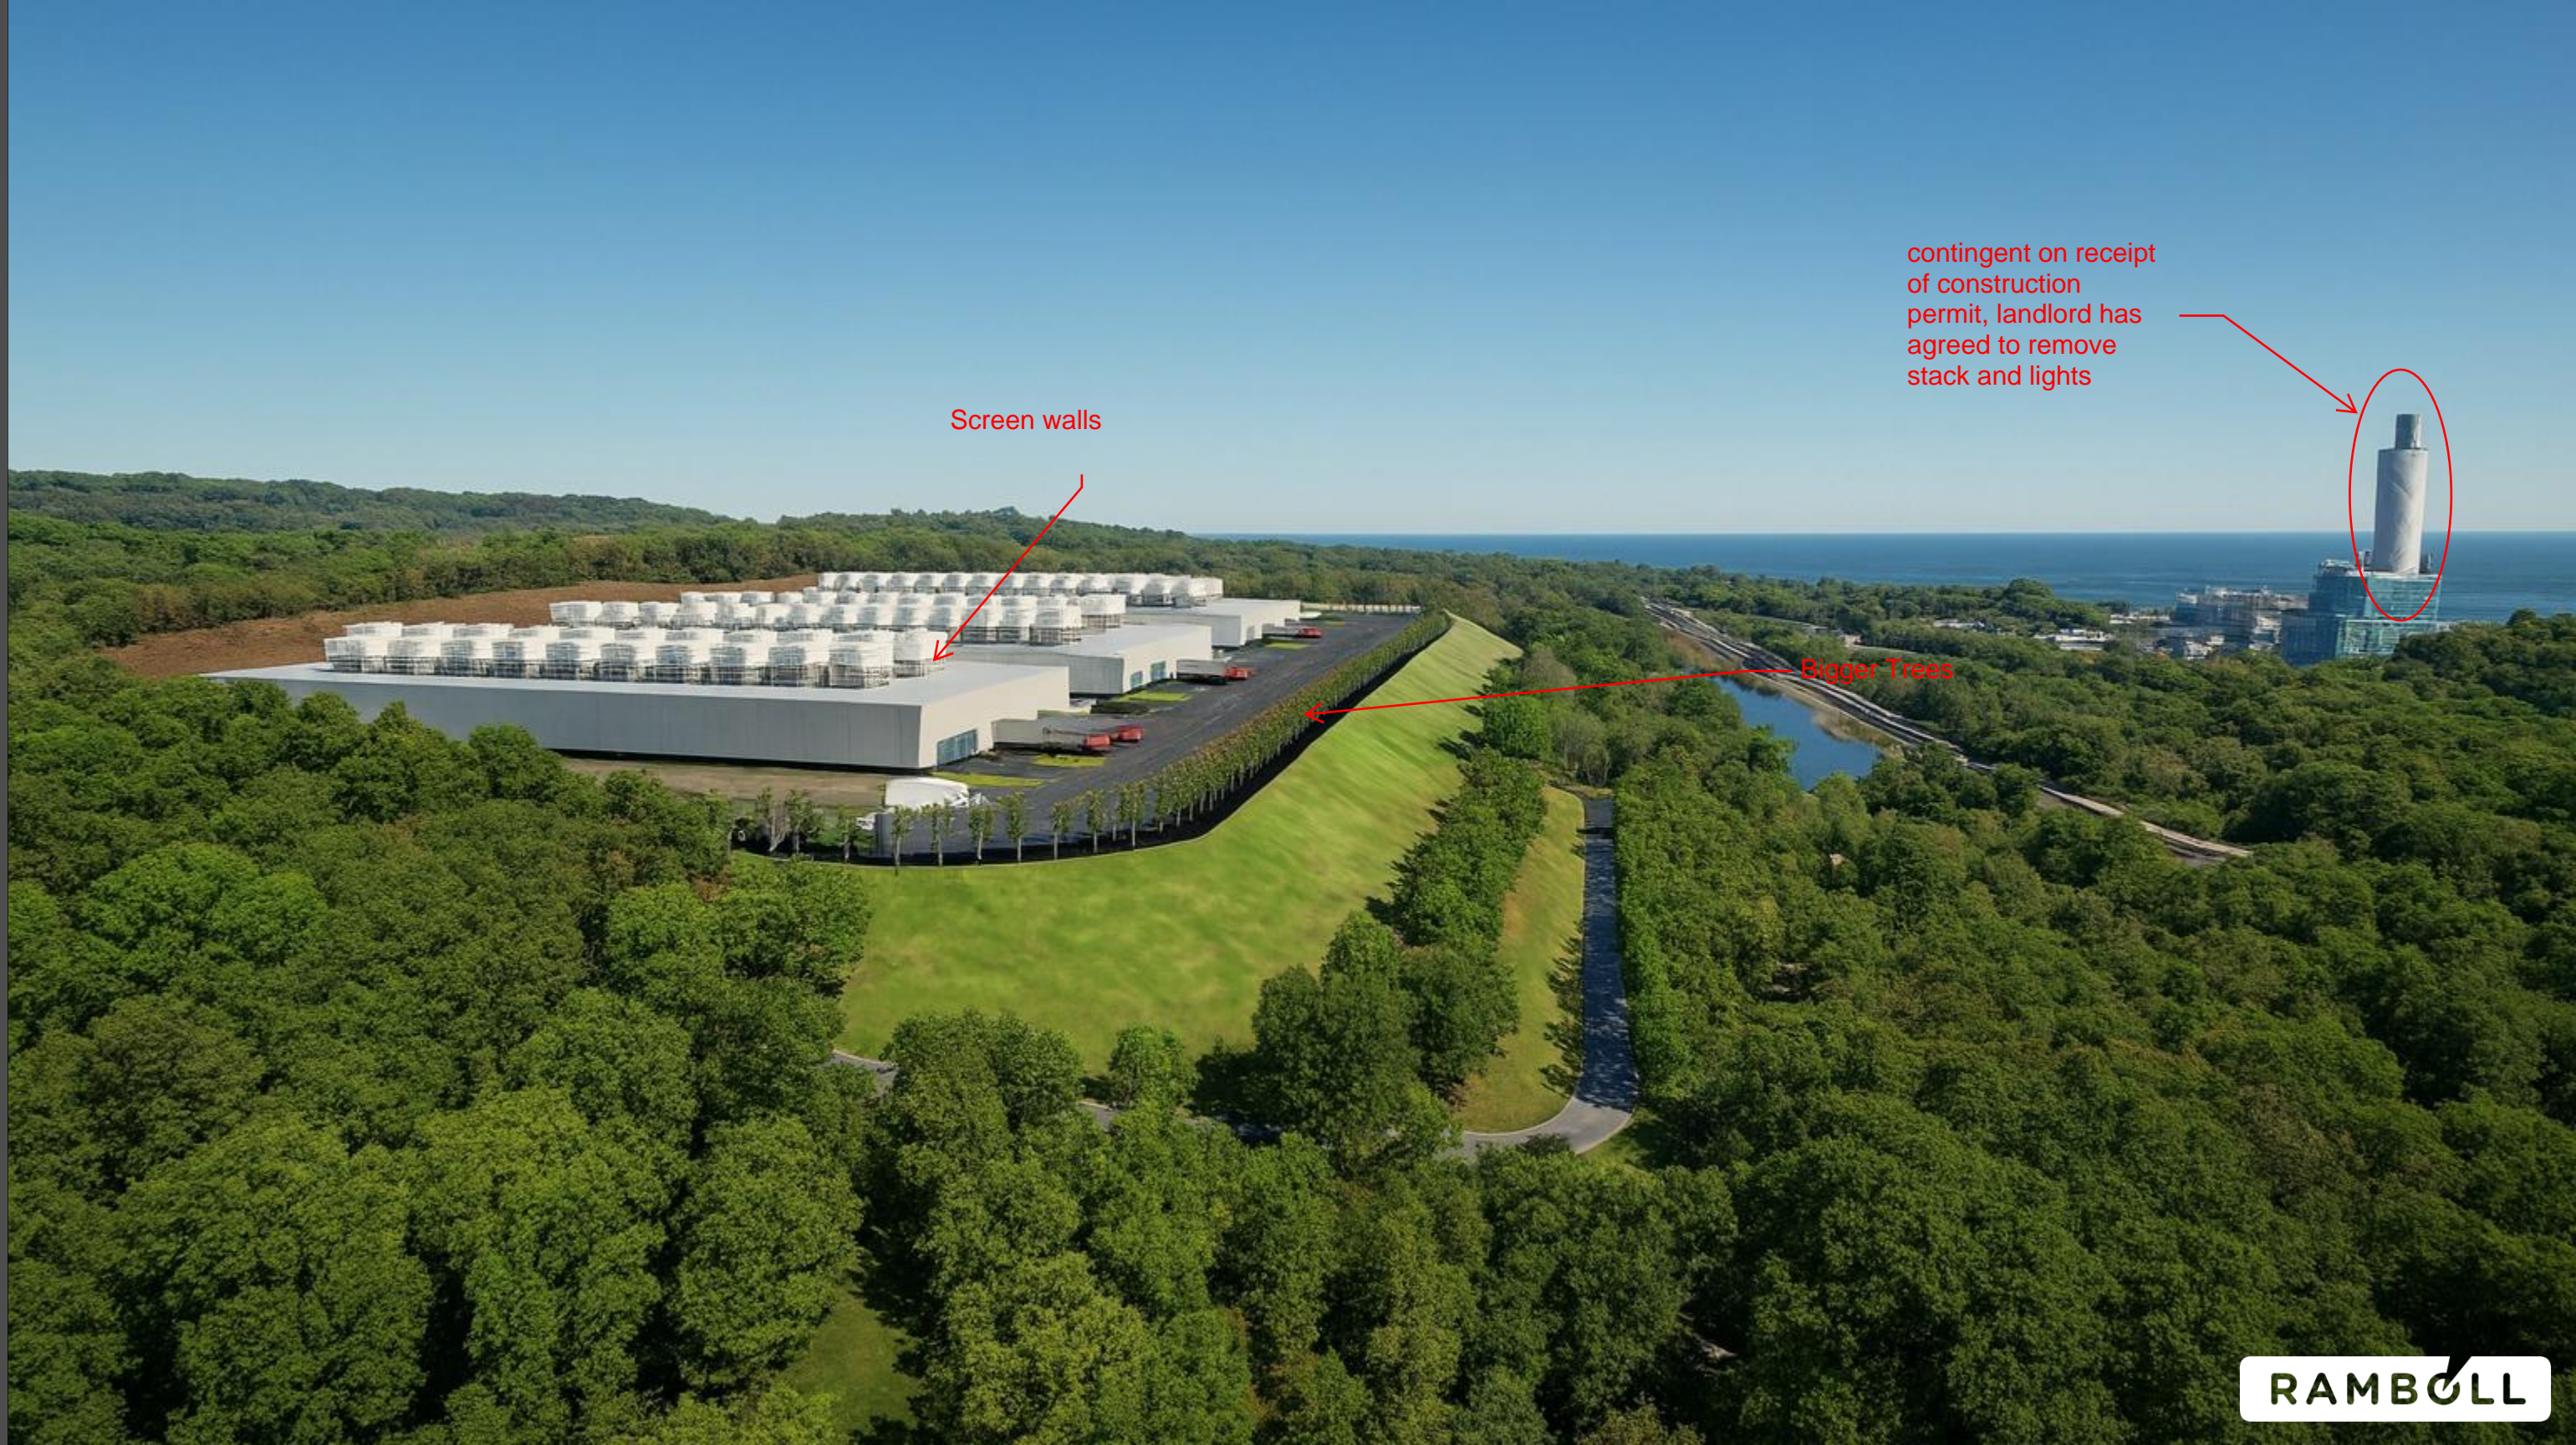
Side View of Datacenter Campus Buildings with Milliken Station in the background and Cayuga Lake beyond.
