To: Levy County Board of County Commissioners
From: Mary-Ellen L. Harper, County Manager
Date: February 4, 2025
Subject: H.A. White Gymnasium

It was brought to my attention during the heavy rains this past December that we had some significant leaking and water damage in the H.A. White Gymnasium which is located on the property of the Government Center Complex next to the Maintenance Department.

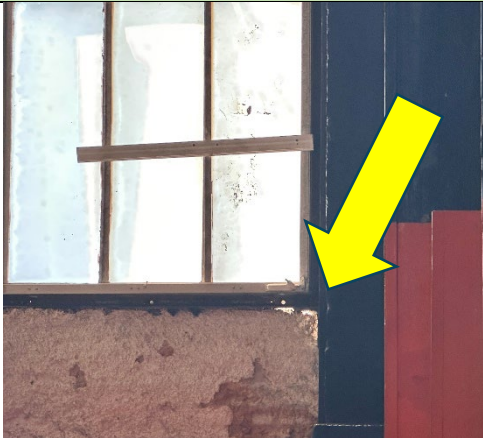
<p>The upper walls of the gymnasium are metal which has corroded. The corroded metal is deteriorating. The yellow arrow in this picture is pointing to daylight that is visible around the window where the metal has rusted away from the window creating a gap. This is happening in multiple places in the gym. If not addressed, the windows will fall out of the walls and could hurt someone.</p>

Option	Estimated Cost
<p>1. Identify funding to:</p> <ul style="list-style-type: none"> • Hire an architect to design plans to repair and renovate the building. • Hire a contractor to repair and renovate the building. 	<p>The Maintenance Director received an estimate of \$250,000 to repair the roof. The estimate to remediate the mold and then to renovate the gymnasium to current building codes are an additional \$1.15 Million.</p> <p>When considering the cost hiring an architect to design plans, the BoCC can anticipate the cost of the project to be close to \$1.4 Million.</p>
<p>2. Demolish the building.</p>	<p>If the BoCC is not interested in funding the repair and replacement of the building, consideration should be given to demolishing the building as its condition will only continue to deteriorate as a result of the water leaks.</p> <p>The BoCC should be aware that the County currently has a rented an excavator for one month to facilitate demolition and cleanup around the Government Complex. This excavator is scheduled to be on site through mid-February. As the excavator is already on site, it would be more cost-efficient to perform the demolition while the excavator is on site than it would be to re-mobilize the excavator again at a different time. The cost of renting this excavator for one month is \$6,825.</p>
