Roadways and Walkways

Lake Forest Park City Council Retreat

03.23.24

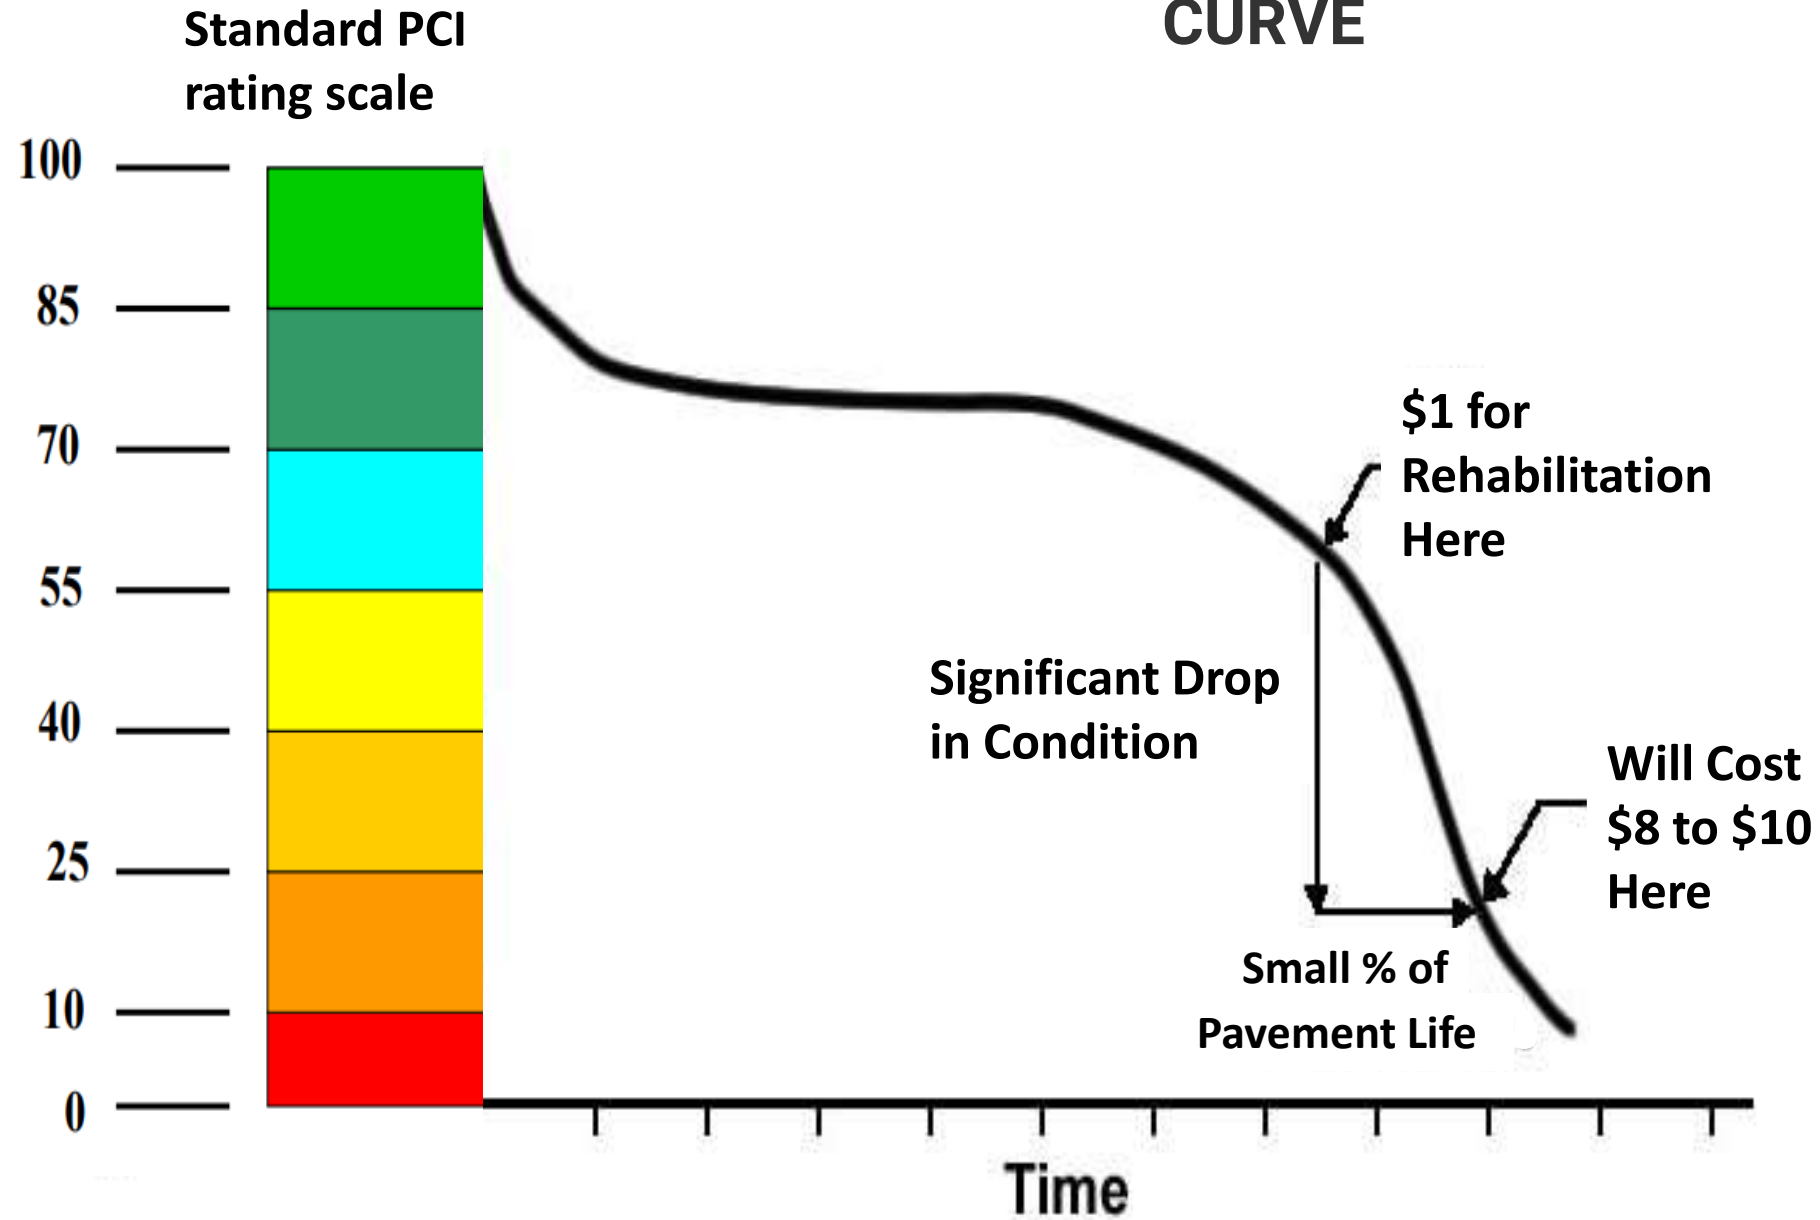
PAVEMENT DEGRADATION CURVE

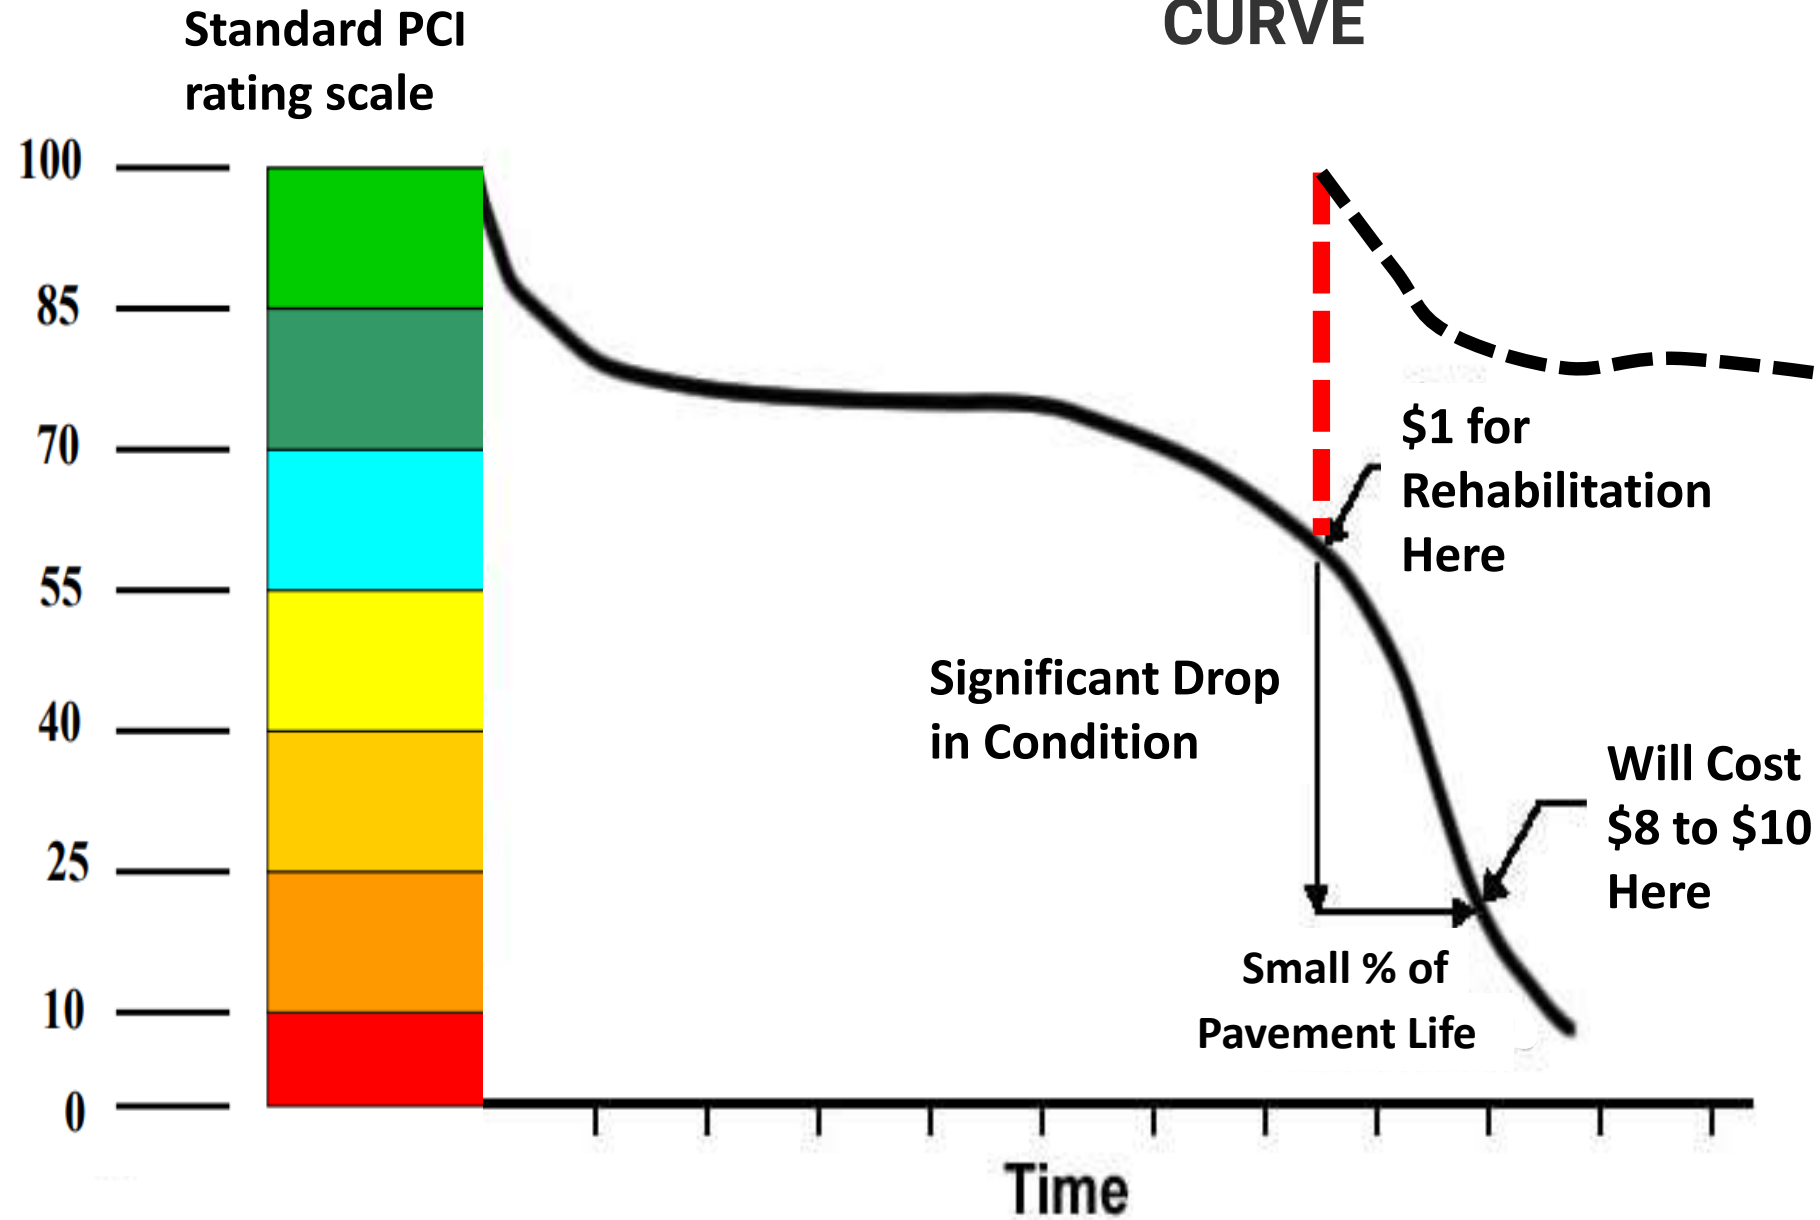
PAVEMENT DEGRADATION CURVE

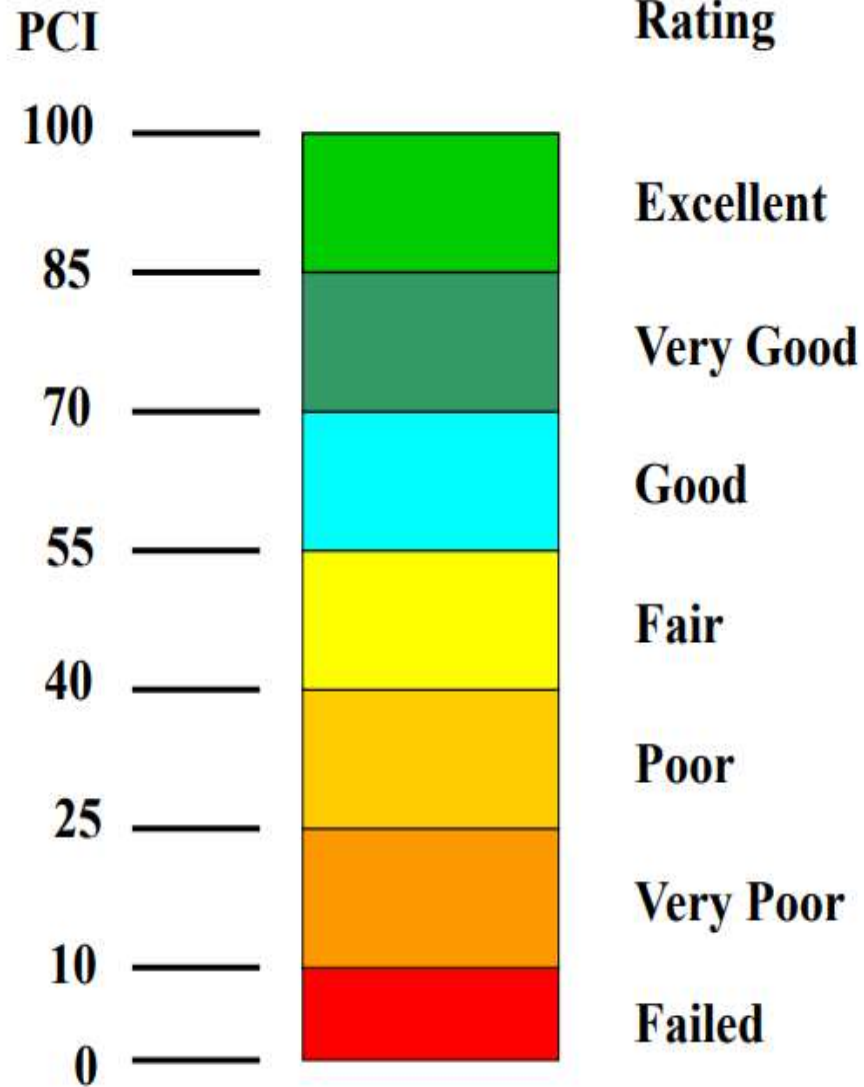
PAVEMENT CONDITION INDEX SCORES

CONDITION	RATING INDEX	DEFINITION
Excellent	86-100	Stable, no cracking, no patching, and no deformation. Very good riding qualities.
Very Good	71-85	Stable, minor cracking, generally hairline and hard to detect. Minor patching and possibly some minor deformation evident. Dry or light-colored appearance. Good riding qualities. Rutting less than ½".
Good	56-70	Generally stable, minor areas of structural weakness evident. Cracking is easier to detect, patches evident, patched but not excessively. Deformation more pronounced and easily noticed. Ride qualities are good to acceptable.
Fair	41-55	Areas of instability marked evidence of structural deficiency, large crack patterns (alligating) heavy and numerous patches, deformation very noticeable. Riding qualities range from acceptable to poor.
Poor	26-40	Pavement in extremely deteriorated condition. Numerous areas of instability. Majority of section showing structural deficiency. Ride quality is poor.

Very Poor	11-25	Pavement in extremely deteriorated condition. Extensive potholes. Numerous areas of instability. All of section showing structural deficiency. Ride quality is very poor.
Failed	0-10	Pavement structure failed. All of section showing severe structural deficiency.

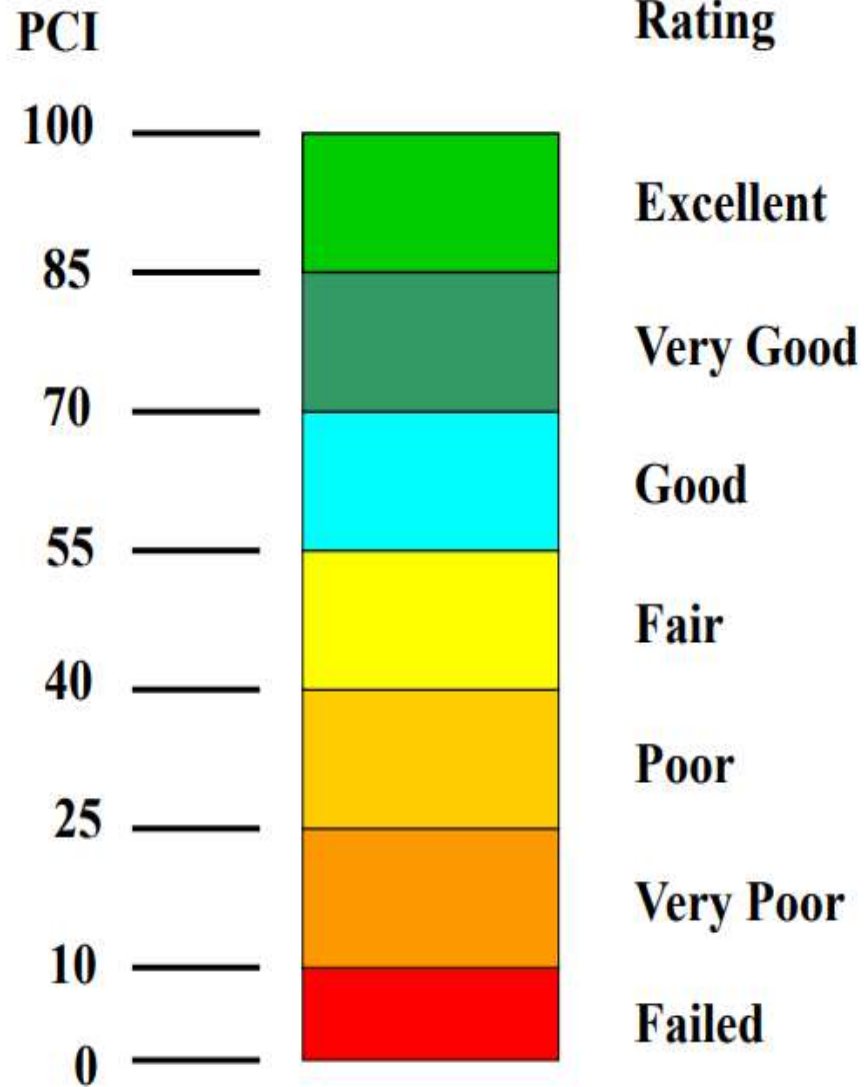
PAVEMENT CONDITION INDEX SCORES

CONDITION	RATING INDEX	DEFINITION
Excellent	86-100	Stable, no cracking, no patching, and no deformation. Very good riding qualities.
Very Good	71-85	Stable, minor cracking, generally hairline and hard to detect. Minor patching and possibly some minor deformation evident. Dry or light-colored appearance. Good riding qualities. Rutting less than ½".
Good	56-70	Generally stable, minor areas of structural weakness evident. Cracking is easier to detect, patches evident, patched but not excessively. Deformation more pronounced and easily noticed. Ride qualities are good to acceptable.
Fair	41-55	Areas of instability marked evidence of structural deficiency, large crack patterns (alligating) heavy and numerous patches, deformation very noticeable. Riding qualities range from acceptable to poor.
Poor	26-40	Pavement in extremely deteriorated condition. Numerous areas of instability. Majority of section showing structural deficiency. Ride quality is poor.

Very Poor	11-25	Pavement in extremely deteriorated condition. Extensive potholes. Numerous areas of instability. All of section showing structural deficiency. Ride quality is very poor.
Failed	0-10	Pavement structure failed. All of section showing severe structural deficiency.

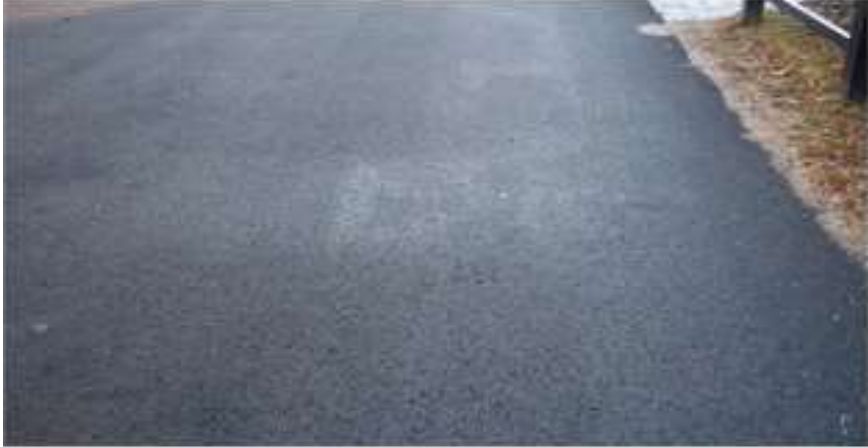
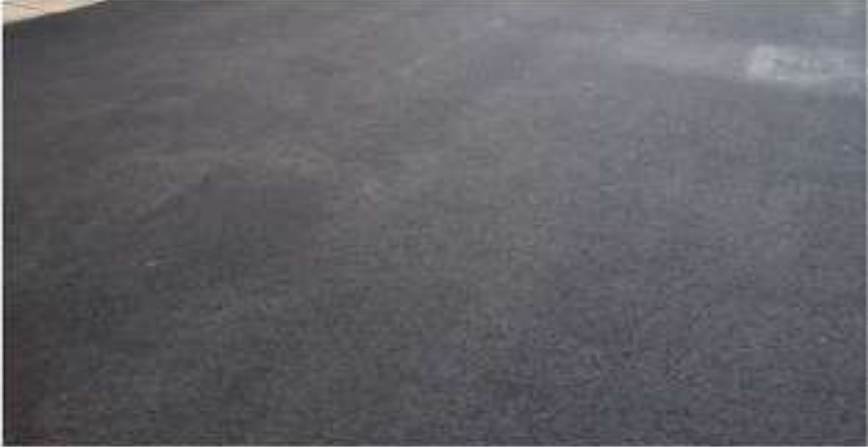
**Pavement Condition
86 – 100 (Excellent)**

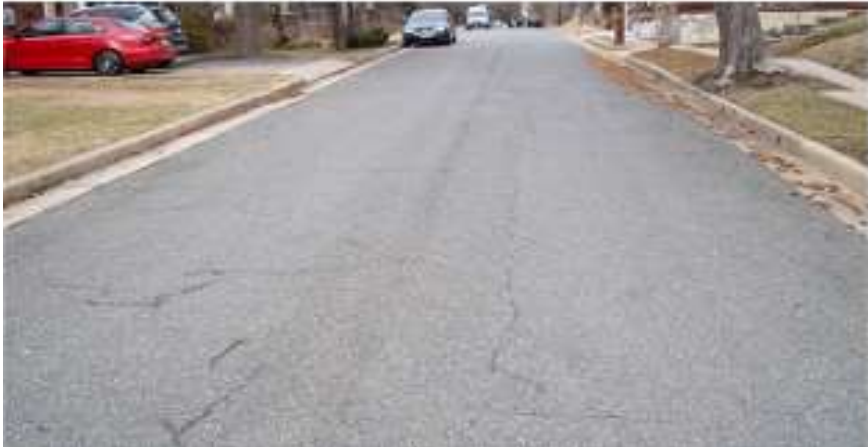
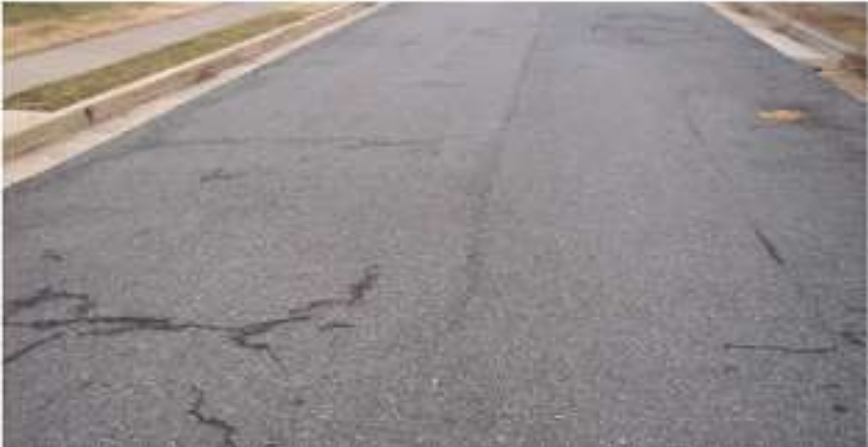
**Pavement Condition
71 – 85 (Very Good)**

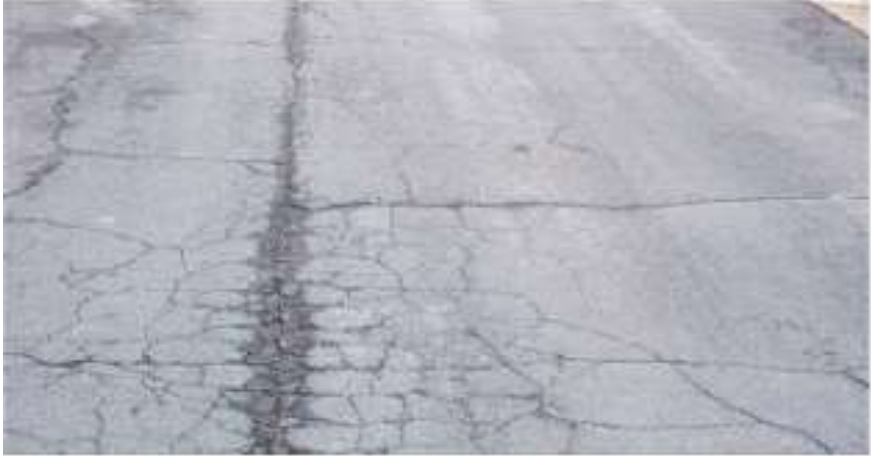
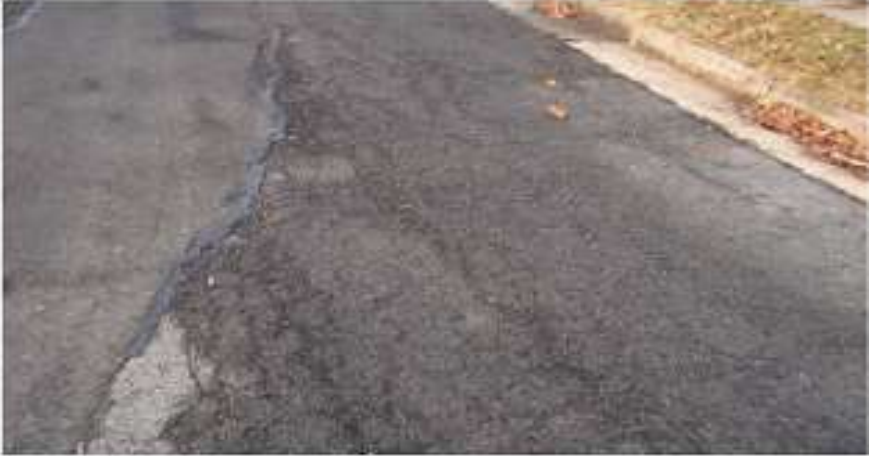
**Pavement Condition
56 – 70 (Good)**

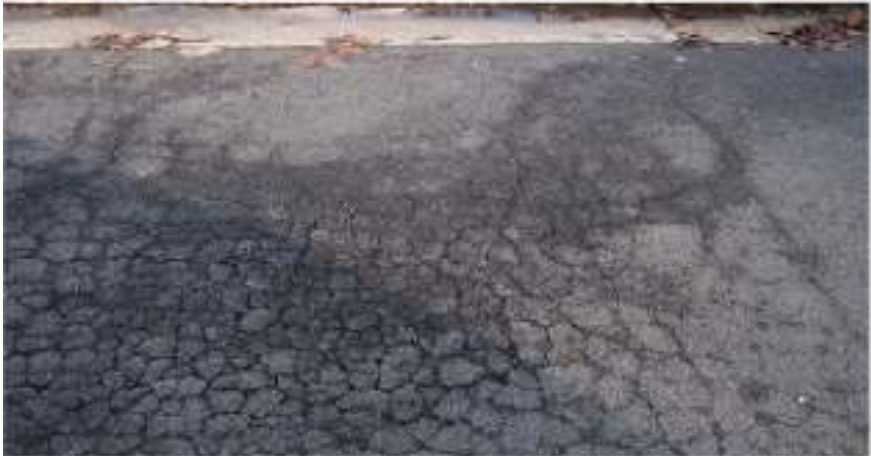
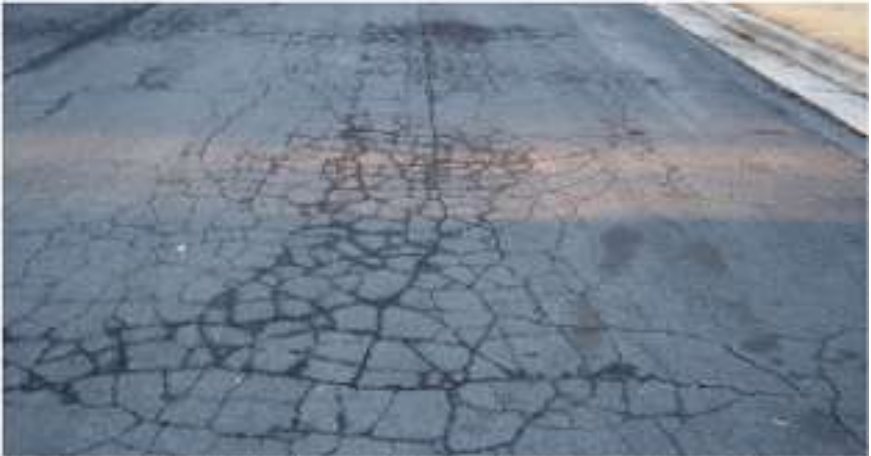
**Pavement Condition
41 – 55 (Fair)**

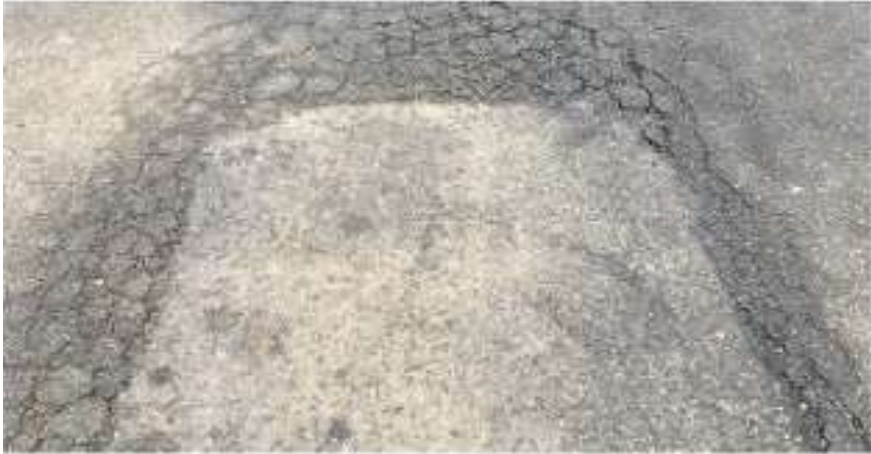
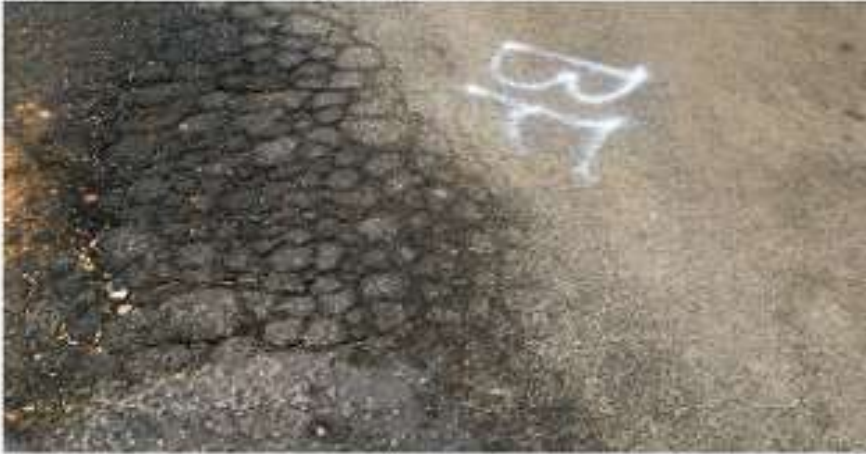
**Pavement Condition
11 – 40 (Poor/Very Poor)**

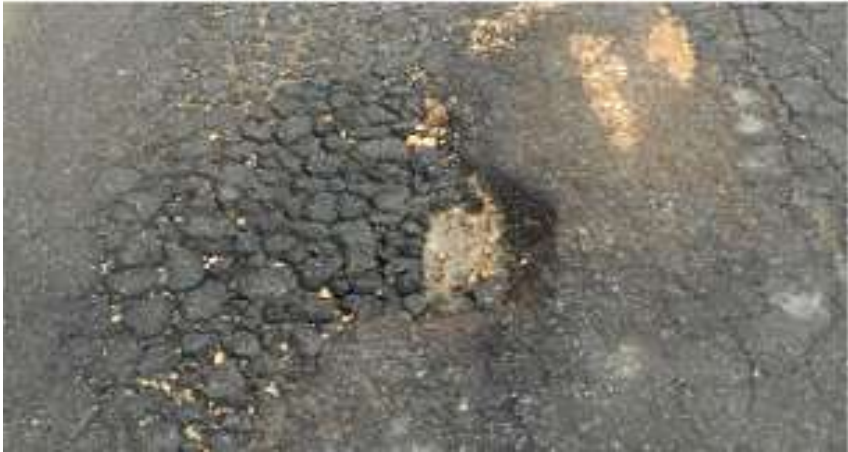
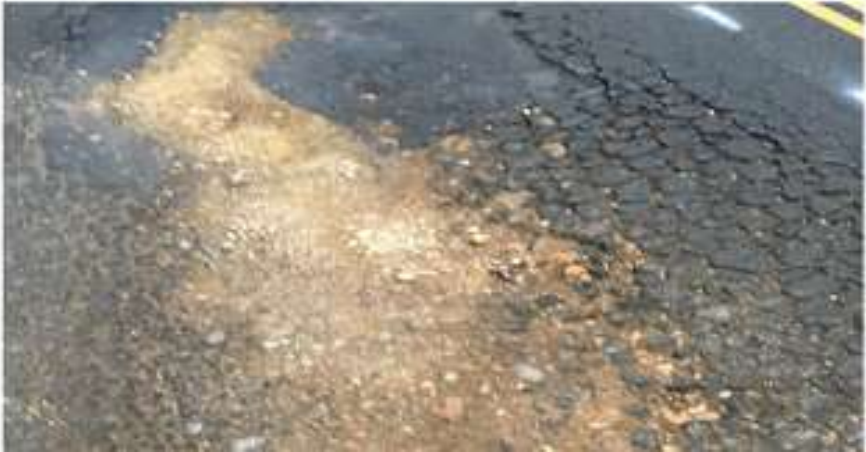
**Pavement Condition
0 – 10 (Failed)**

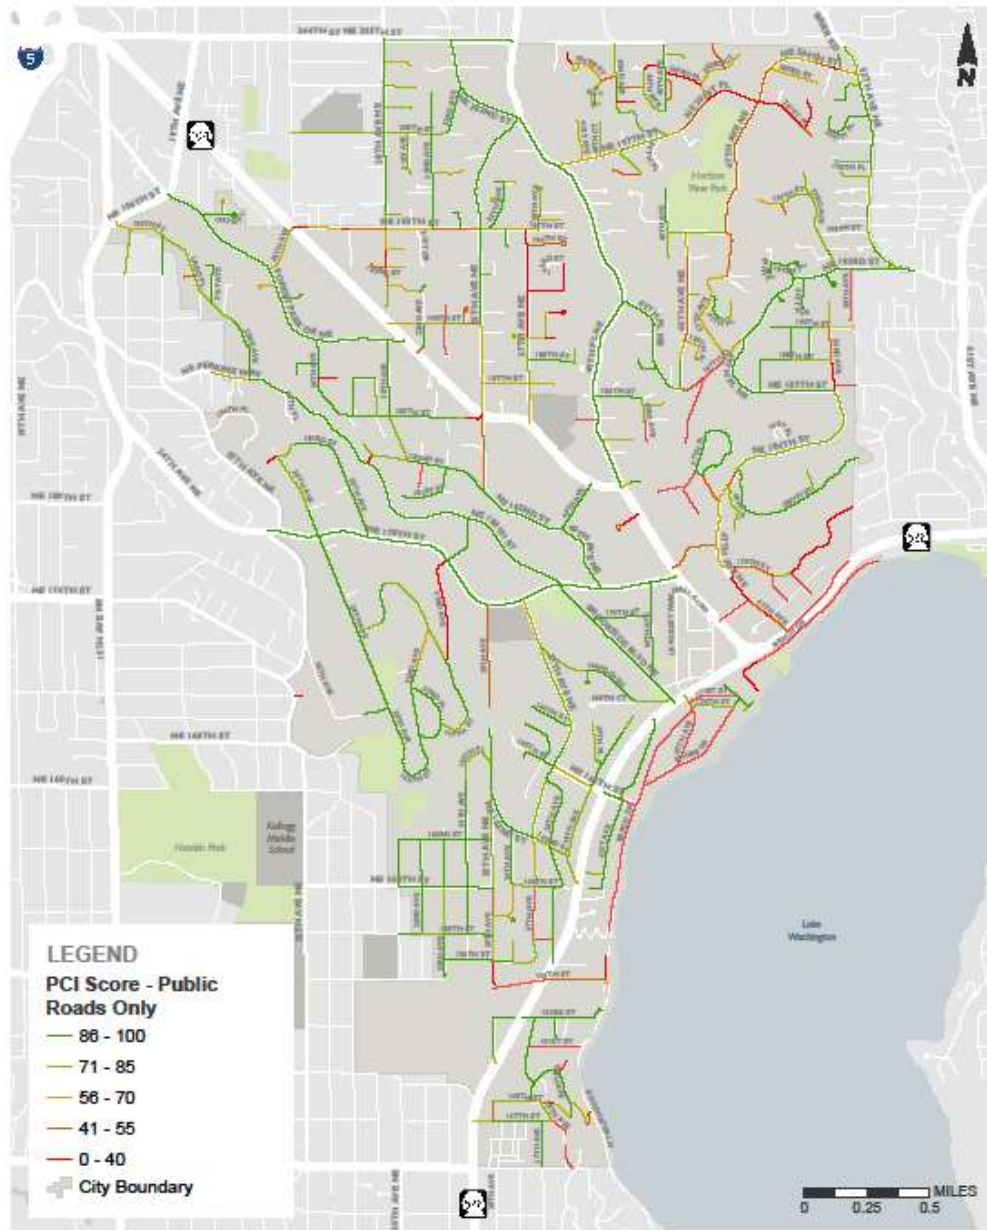
Pavement Condition Index (PCI)

National Average: +/- 70

Lake Forest Park: **80**

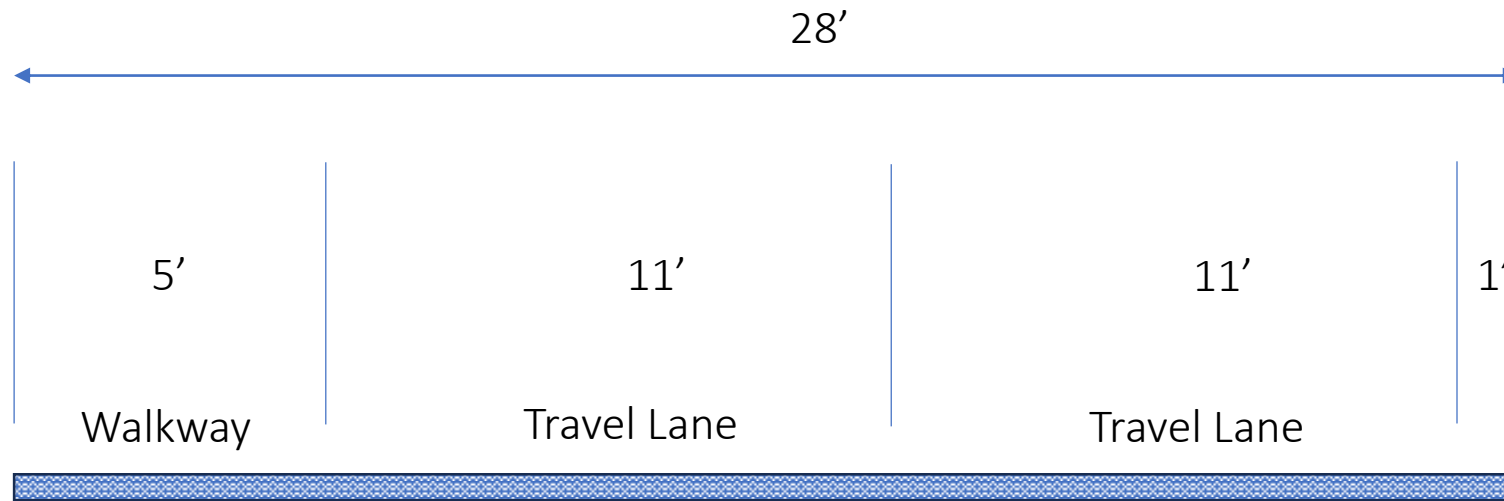
Typical Roadway Section with Walkway

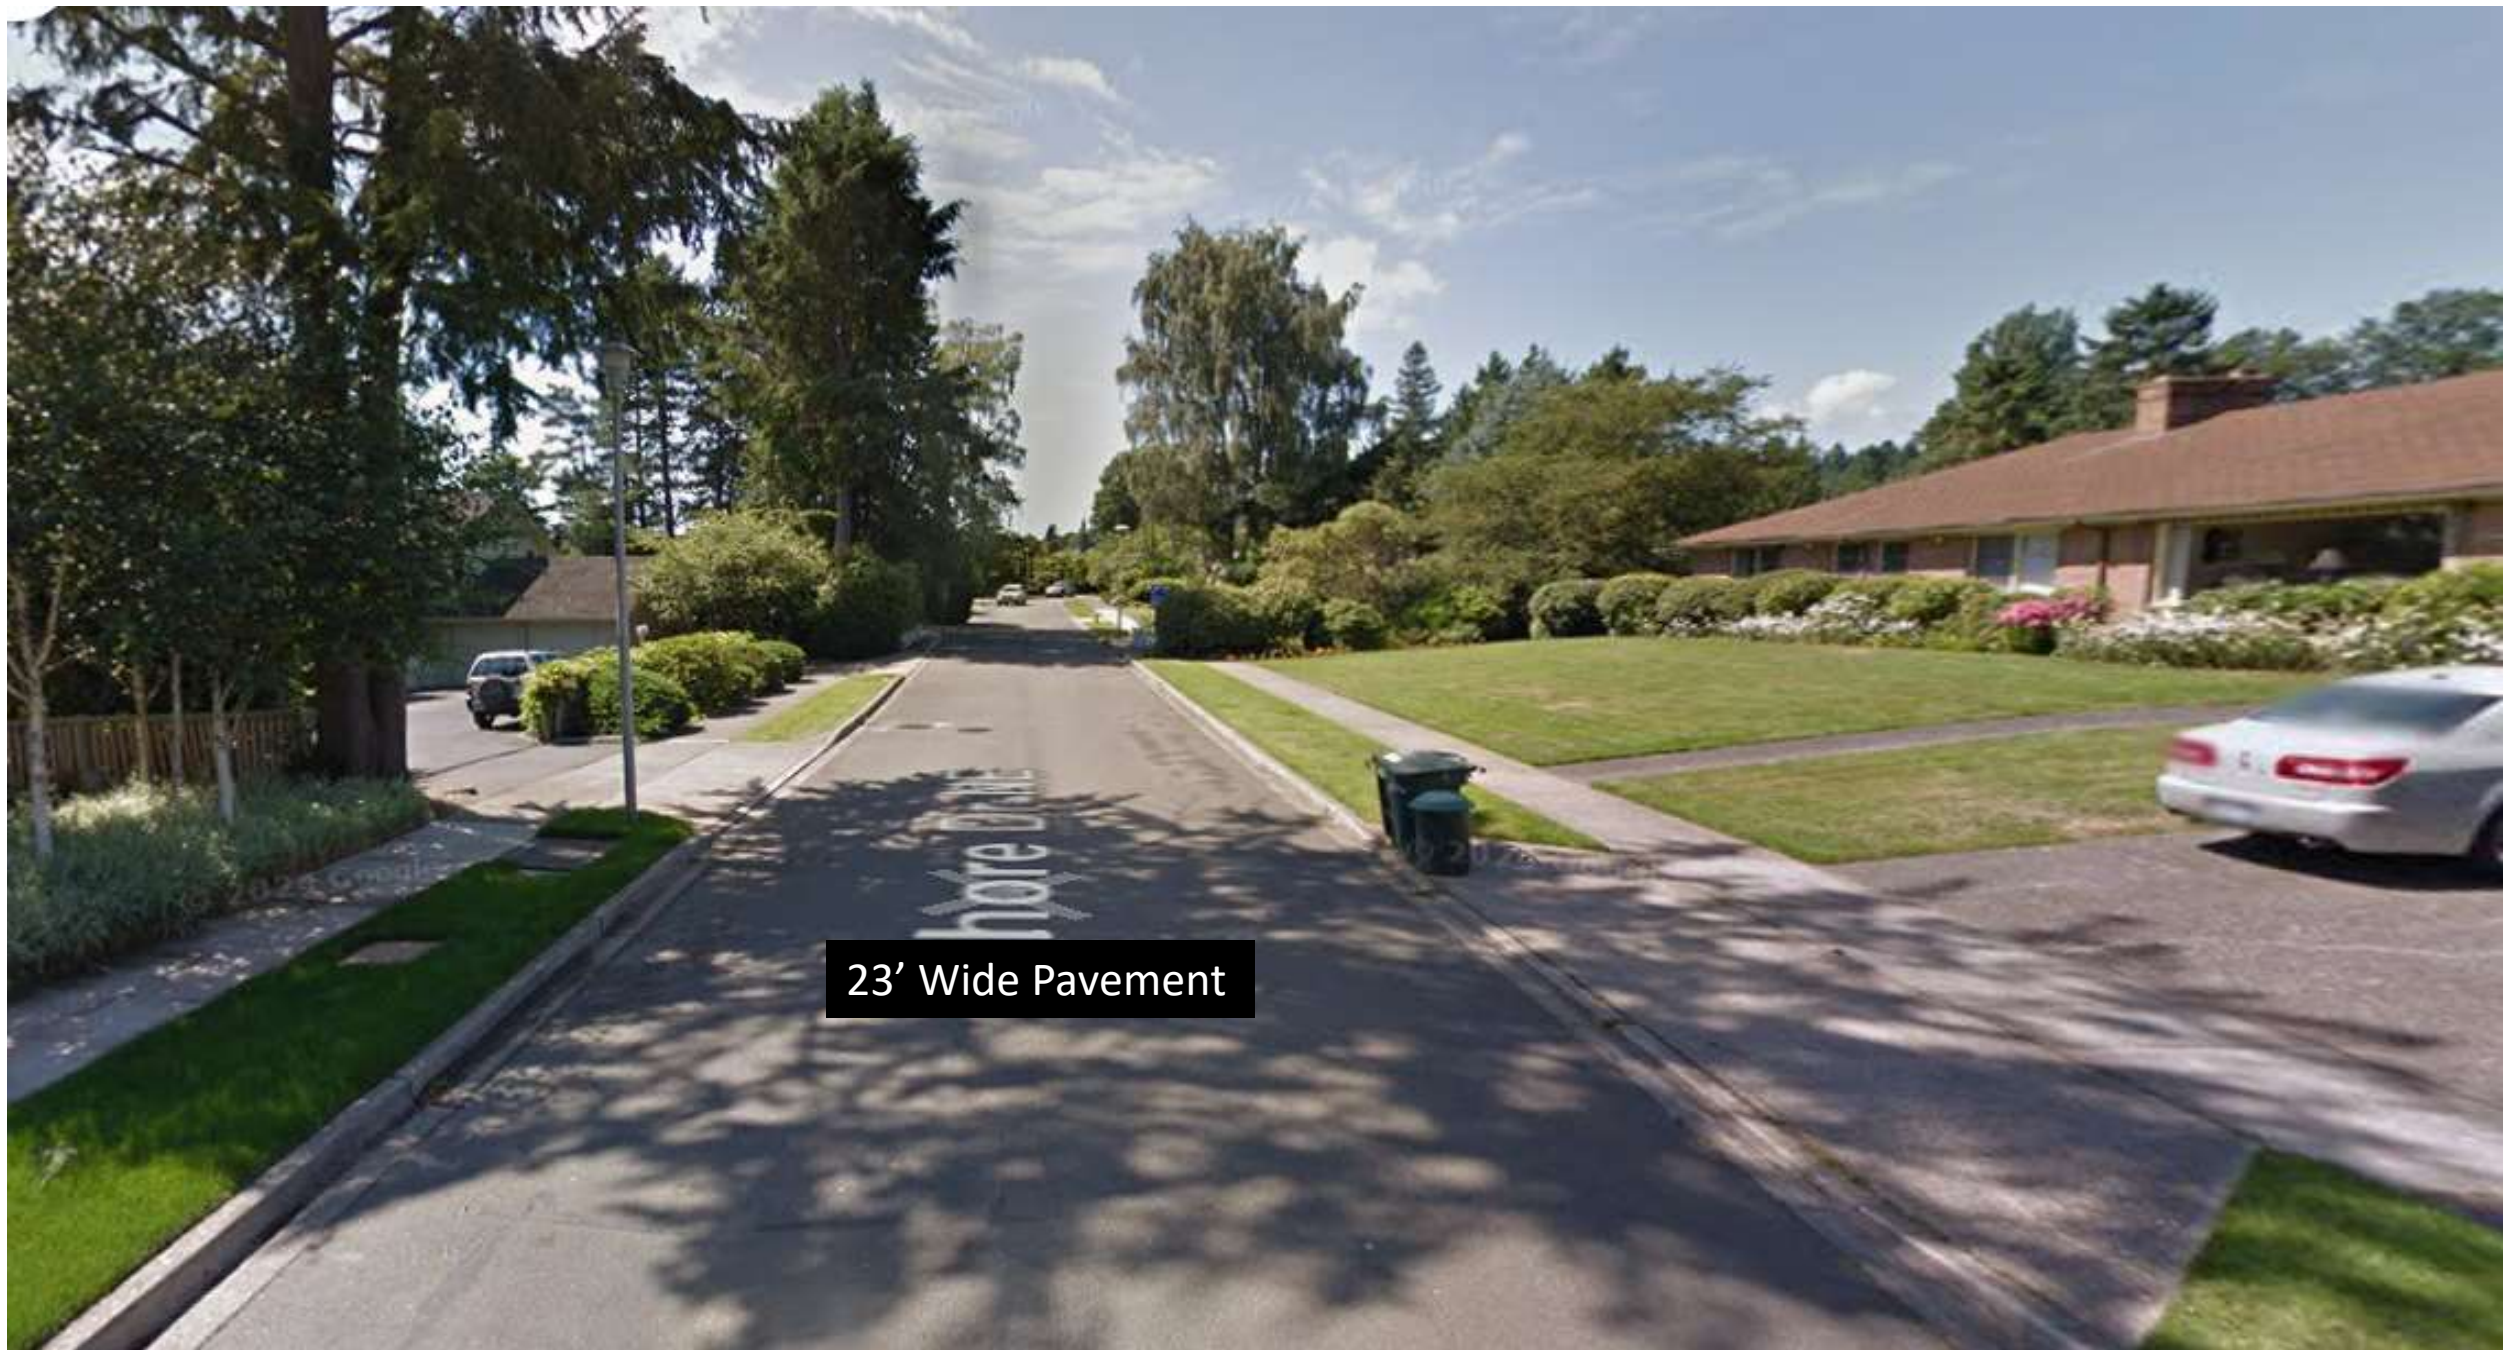
23' Wide Pavement

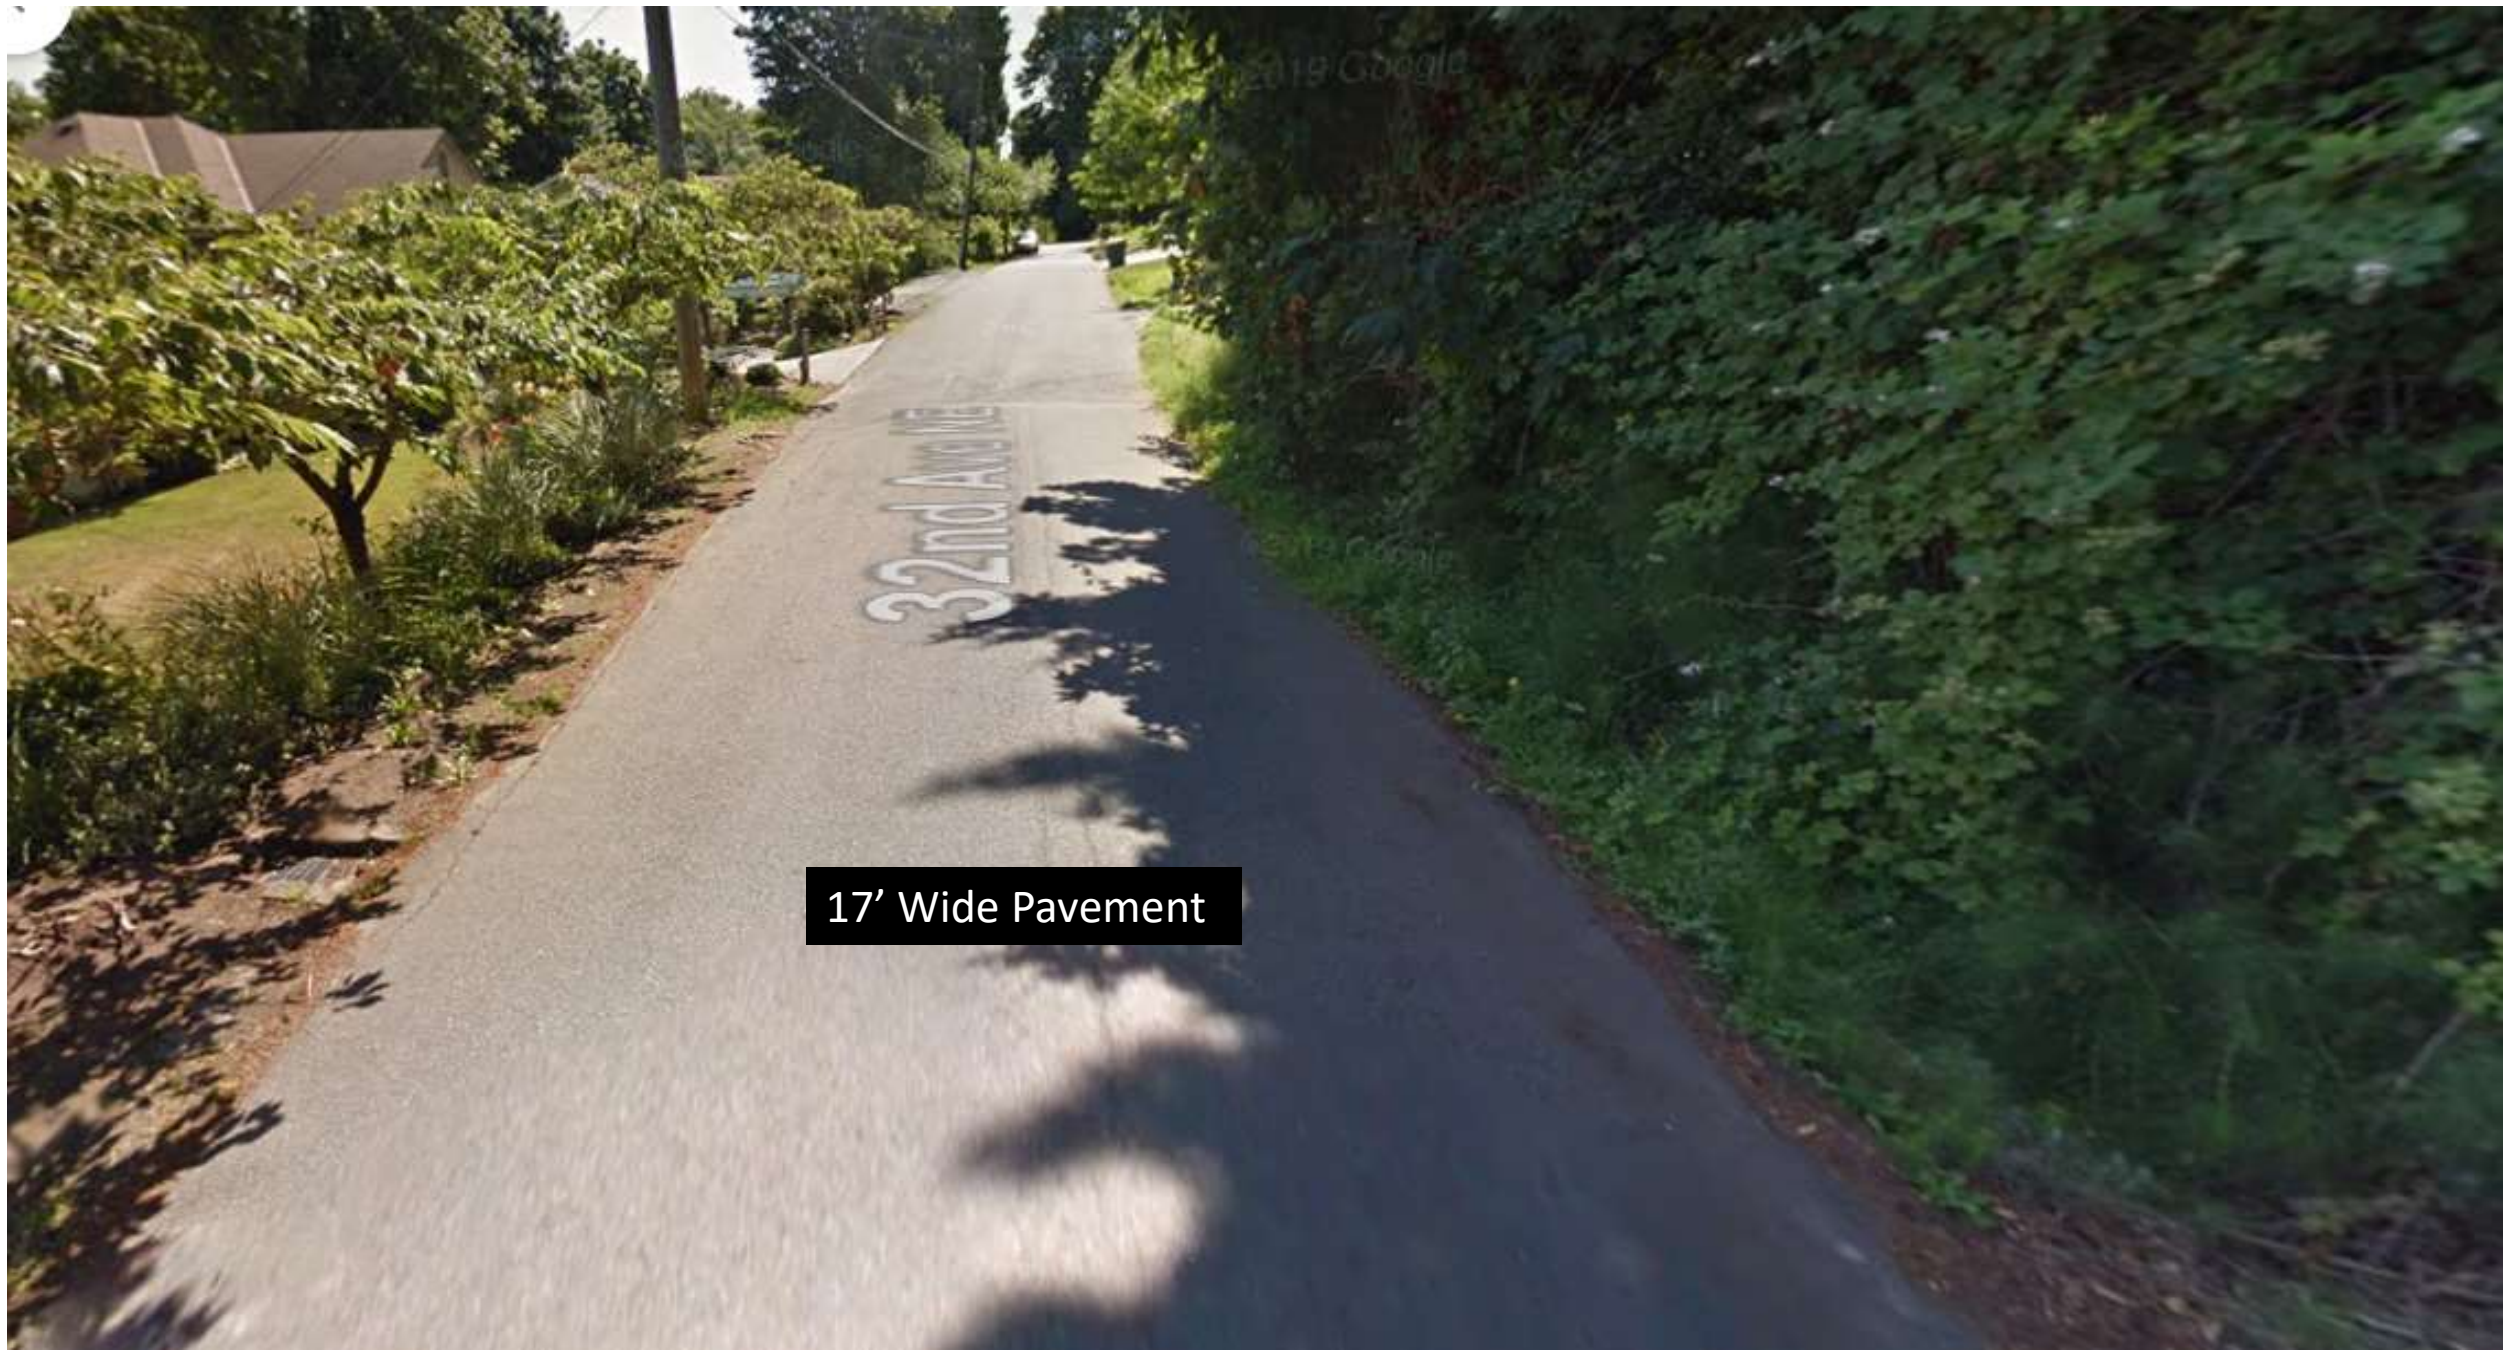
32nd Avenue

17' Wide Pavement
