Roadways and Walkways

Lake Forest Park City Council Retreat

03.23.24

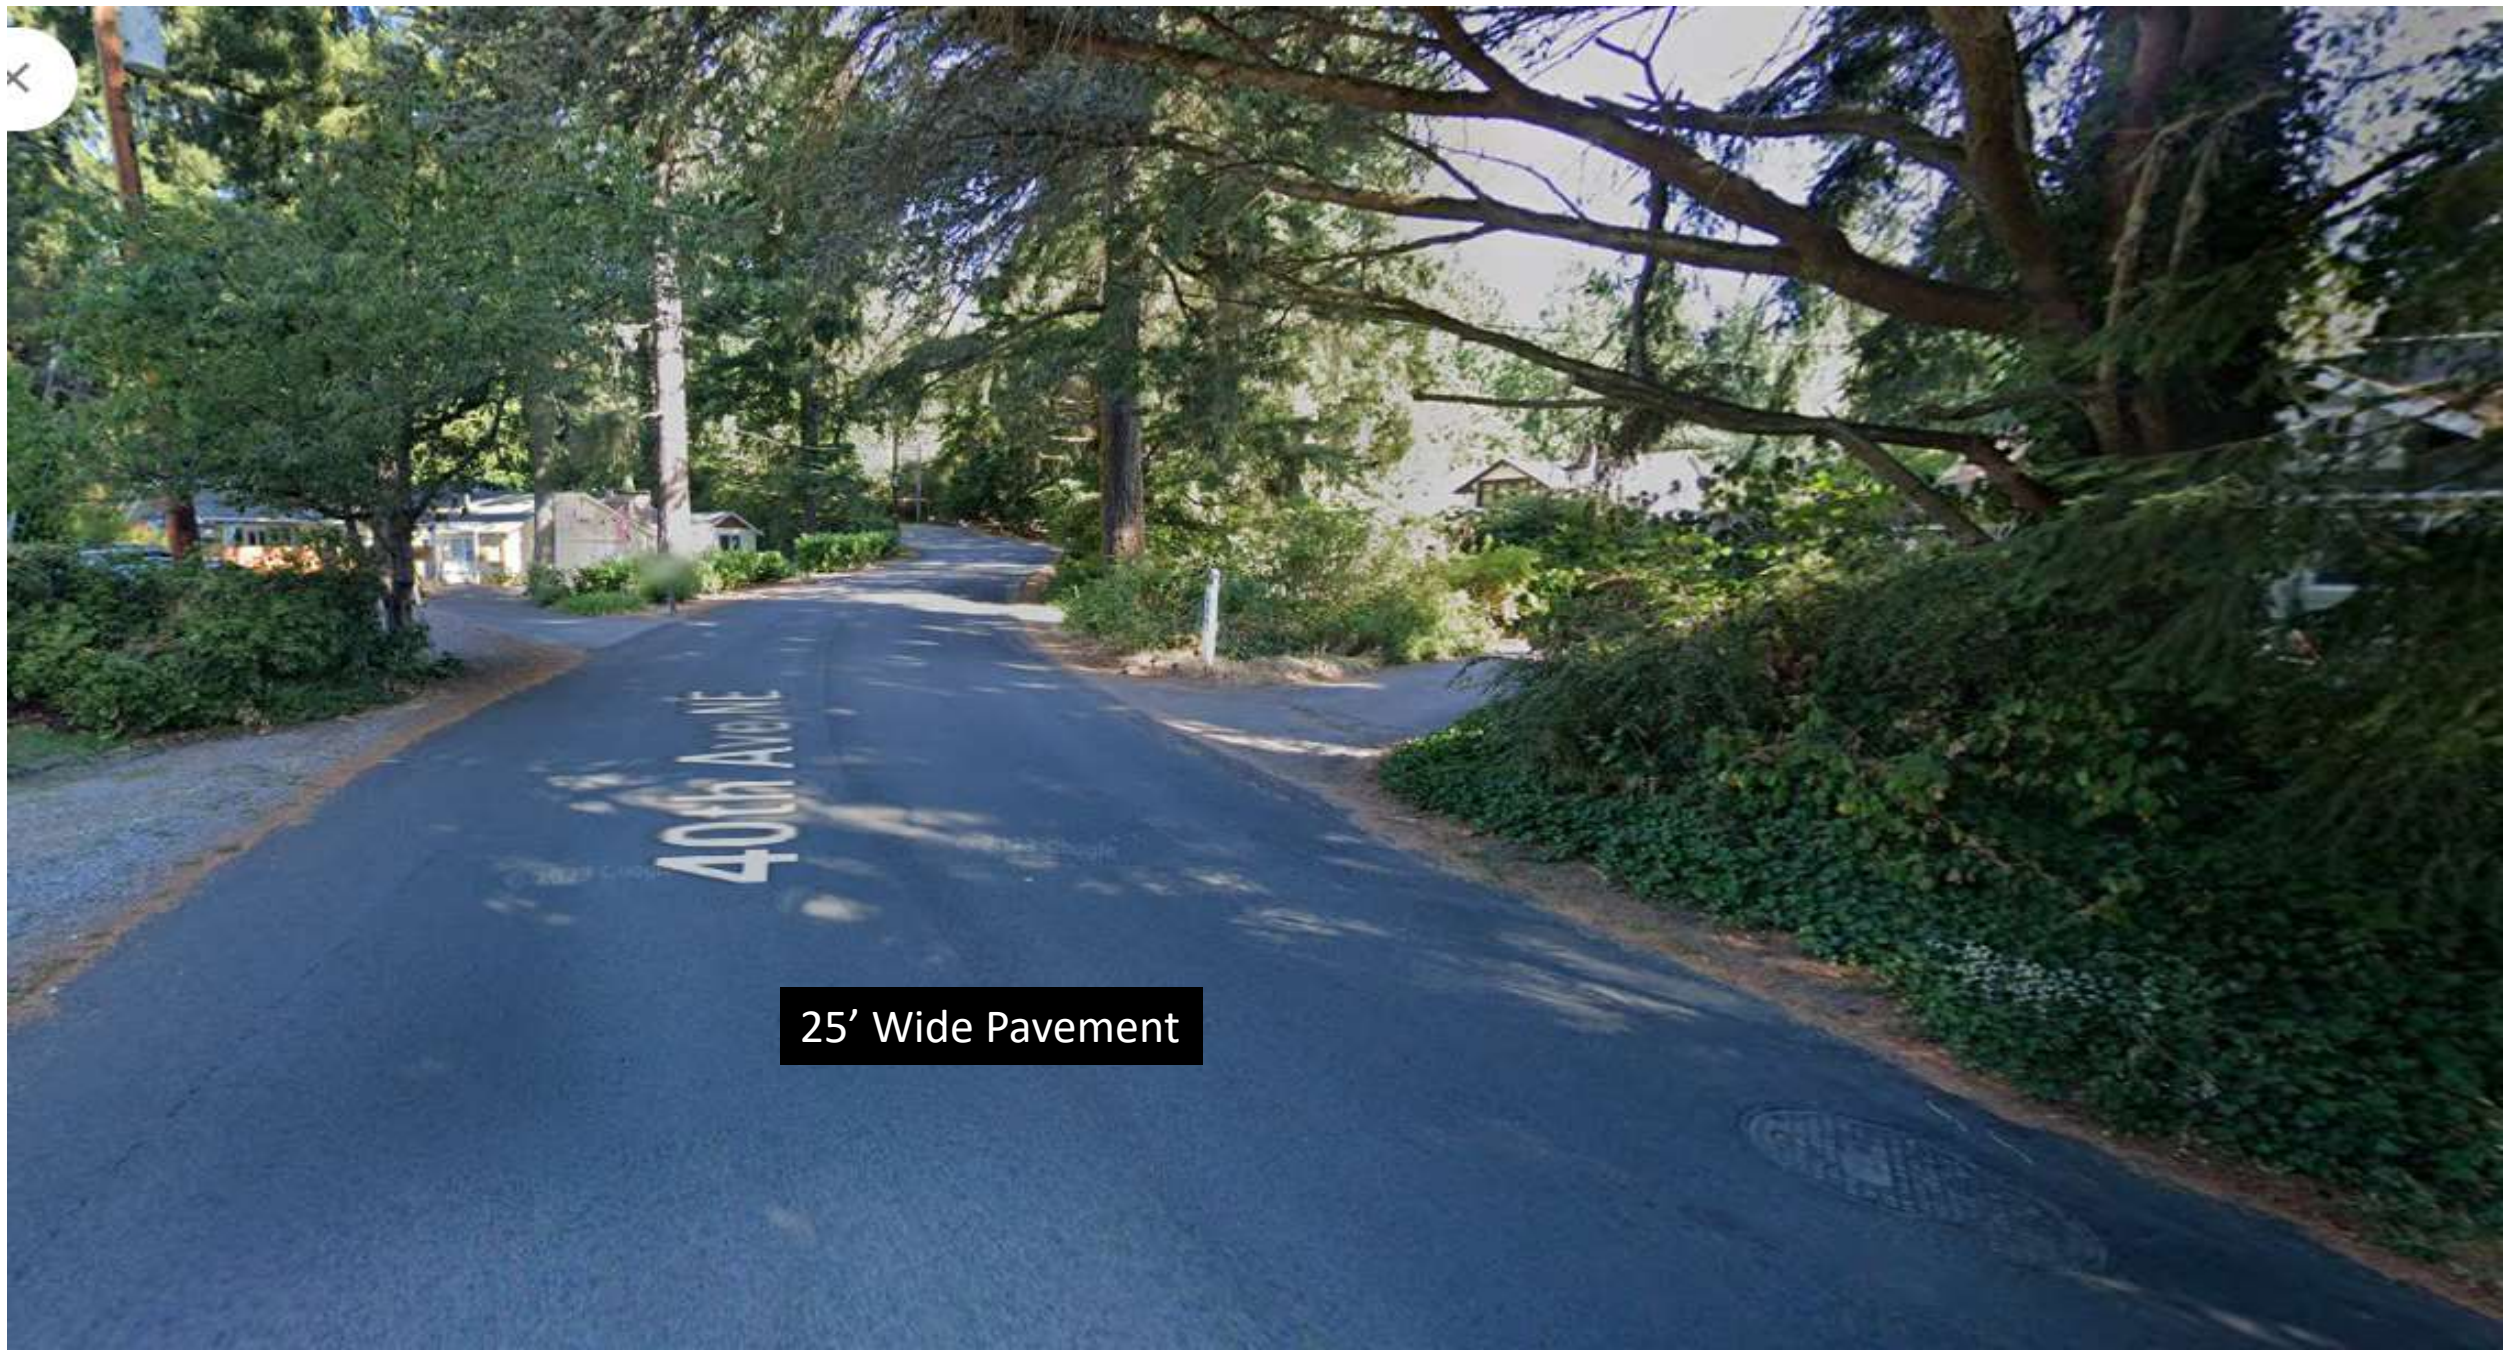
40th Avenue

25' Wide Pavement

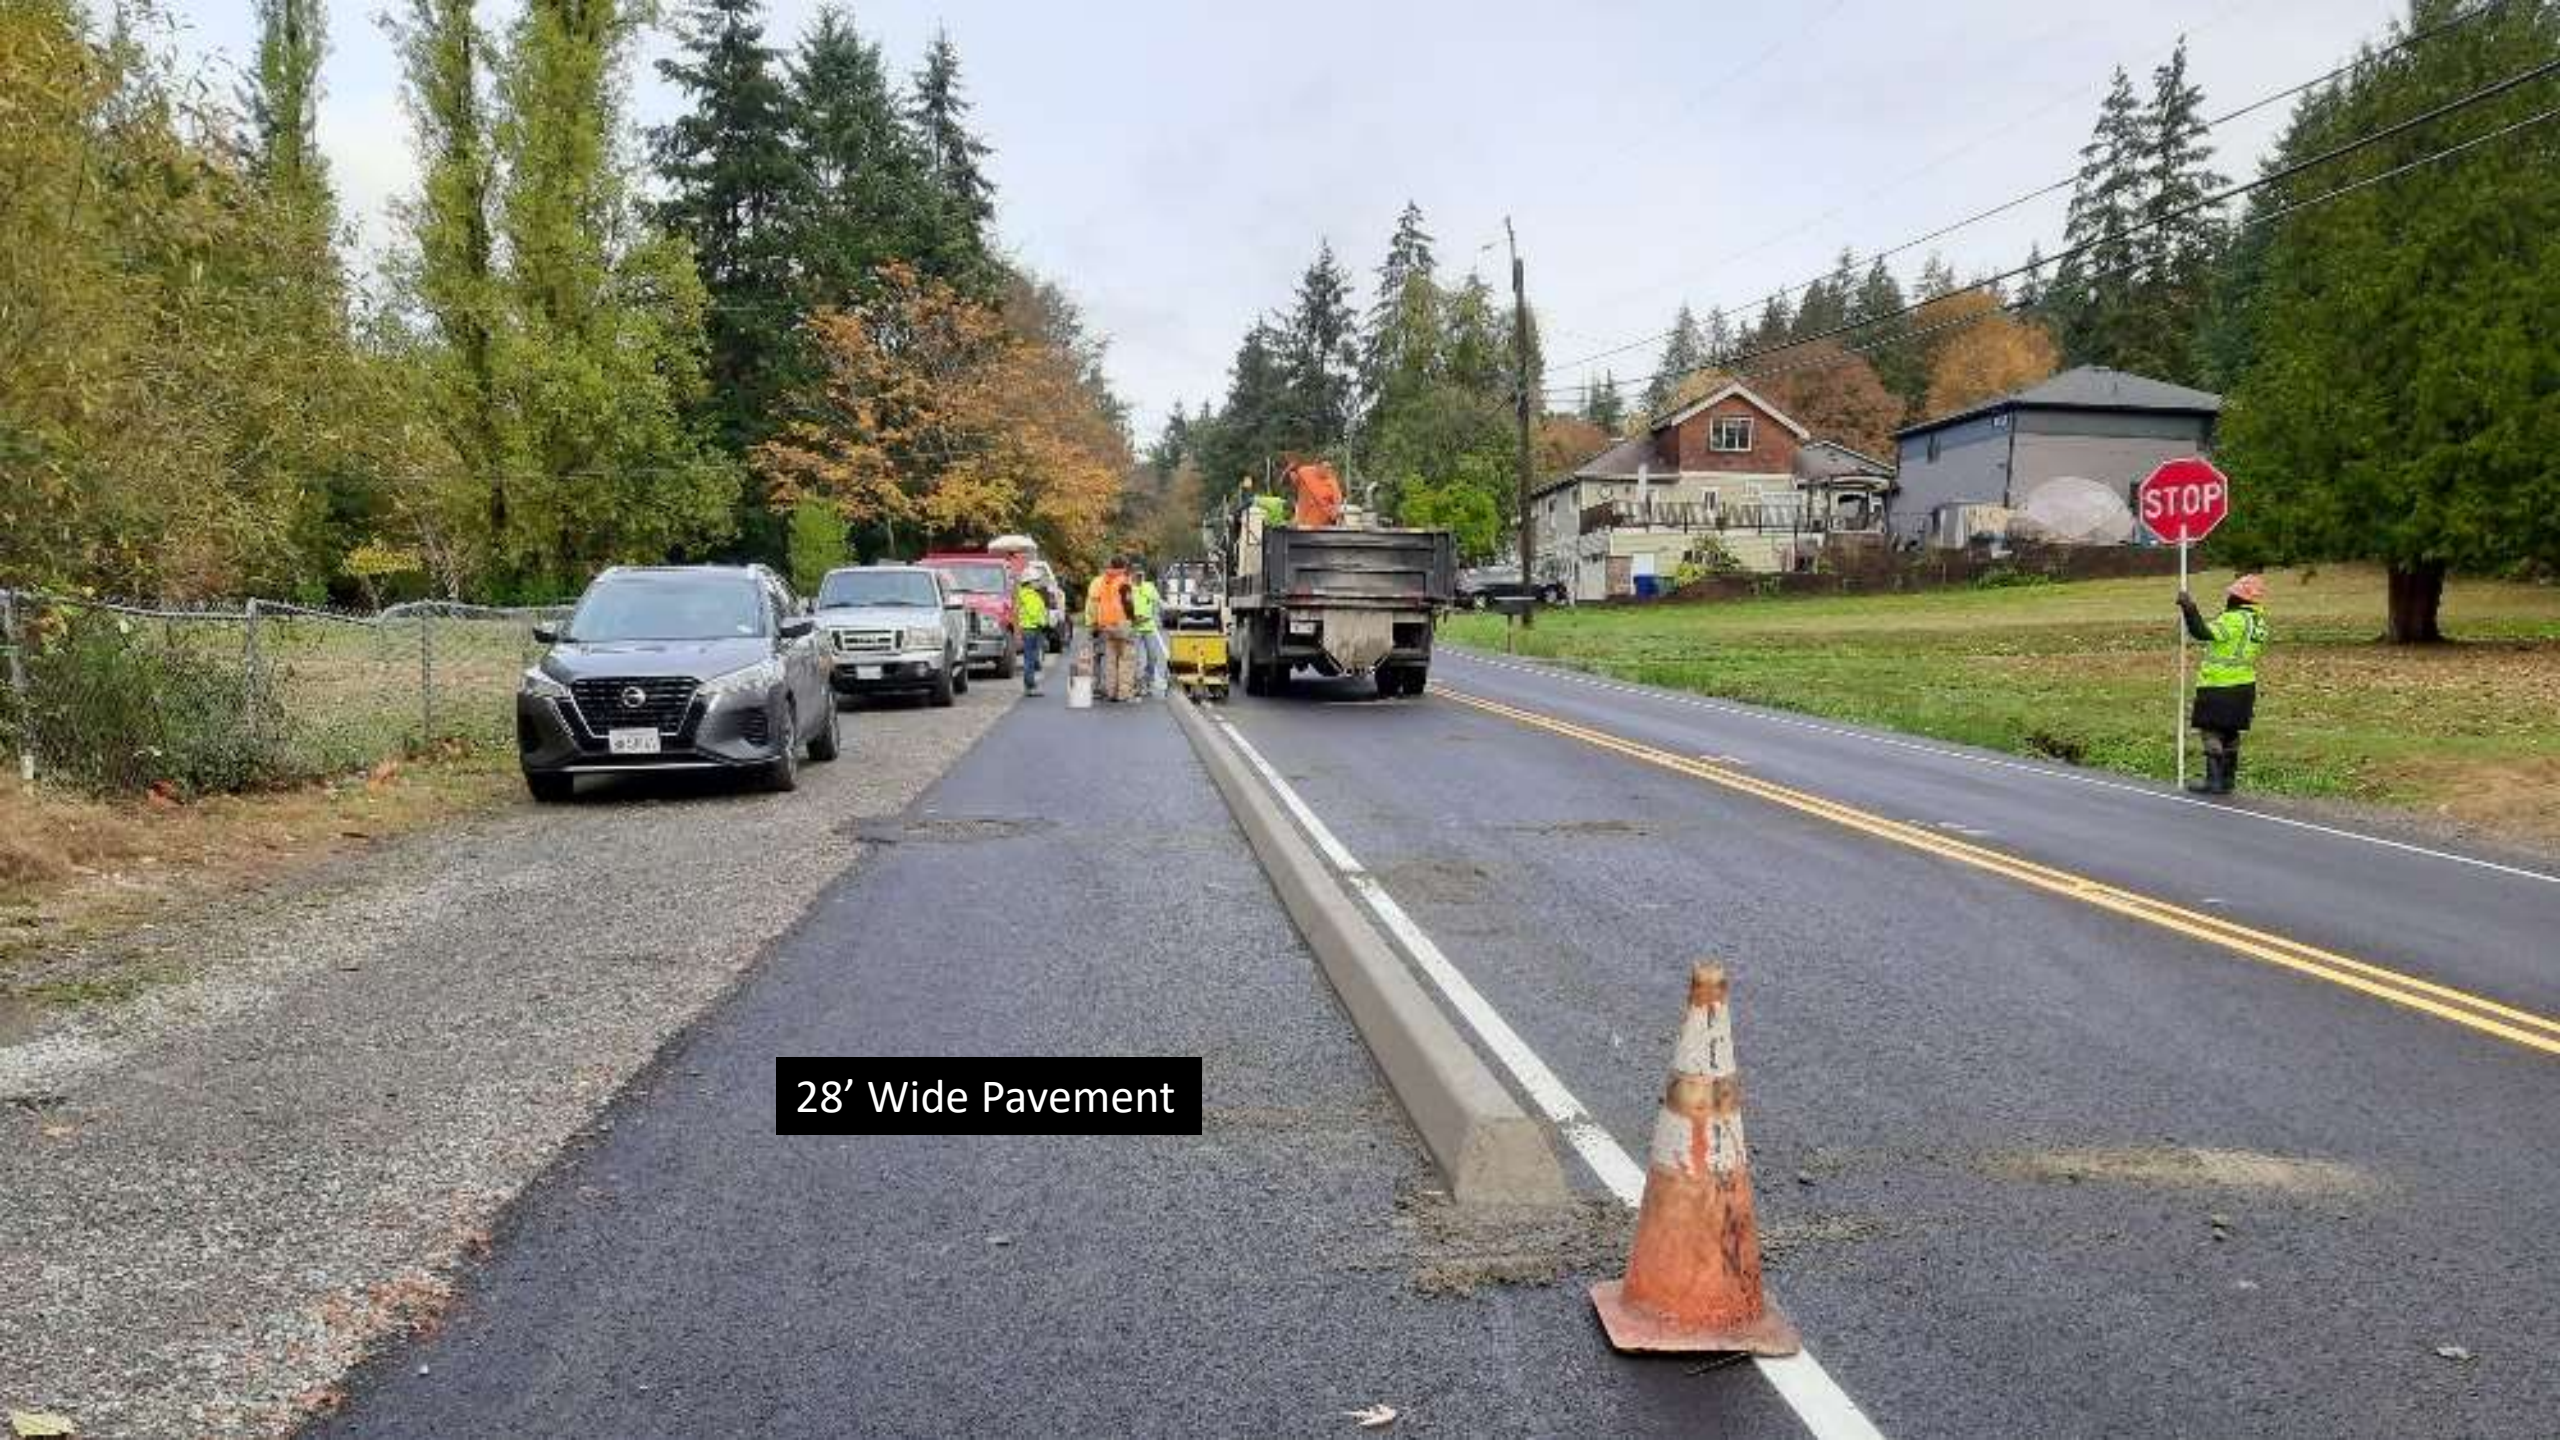
28' Wide Pavement

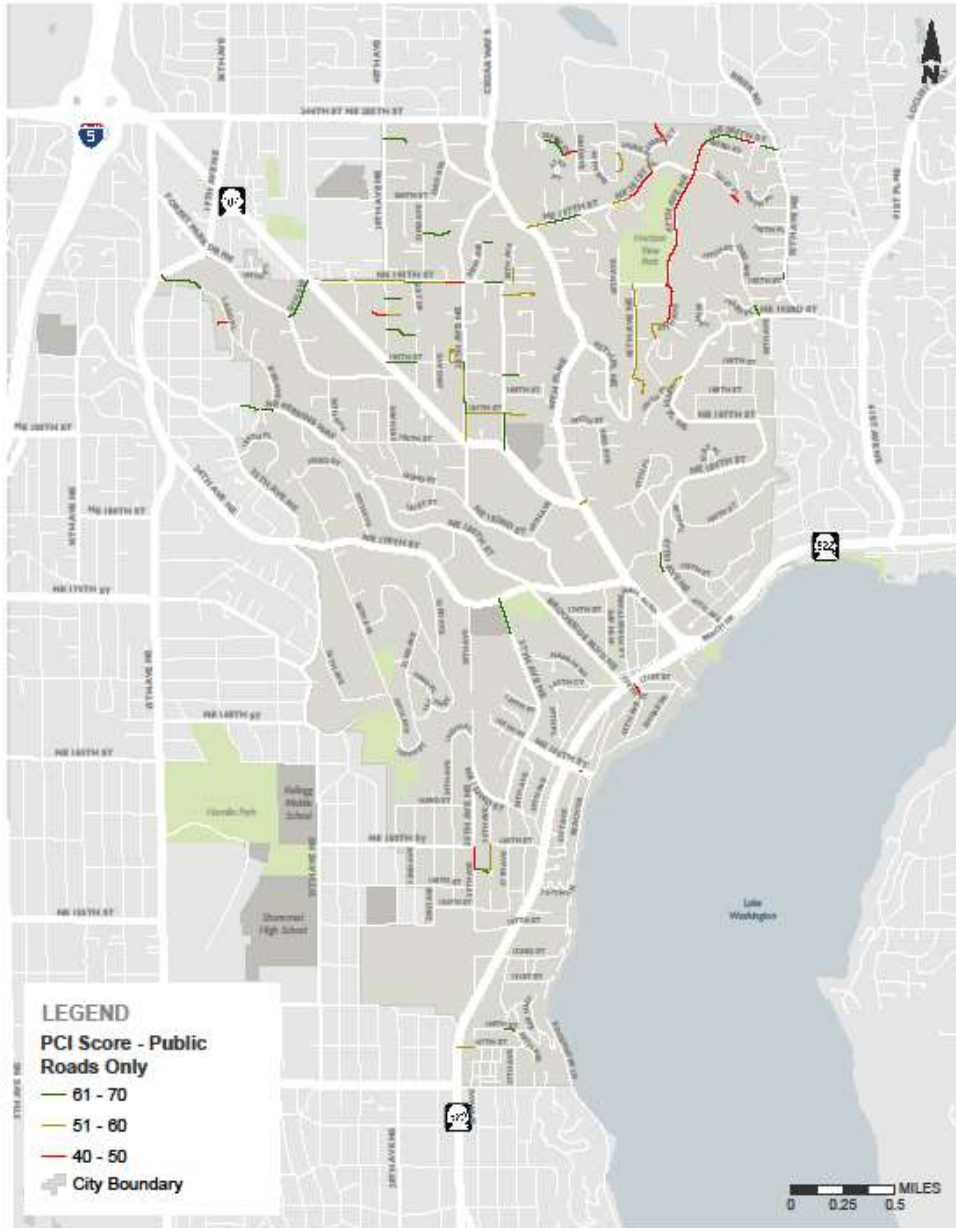
FIGURE
XX

LAKE FOREST PARK **PCI Between 40 and 70, Road 28' or Wider**
 Lake Forest Park - On Call - Task 19
