MEMORANDUM

Date:	March 4, 2025	TG:	1.23191.01
To:	Philip Hill, City Administrator, City of Lake Forest Park		
From:	Drew Heckathorn and Jon Pascal, PE, Transpo Group		
Subject:	Evaluation of New Marked Crosswalks along NE 178th Street & SR 104 Corridors

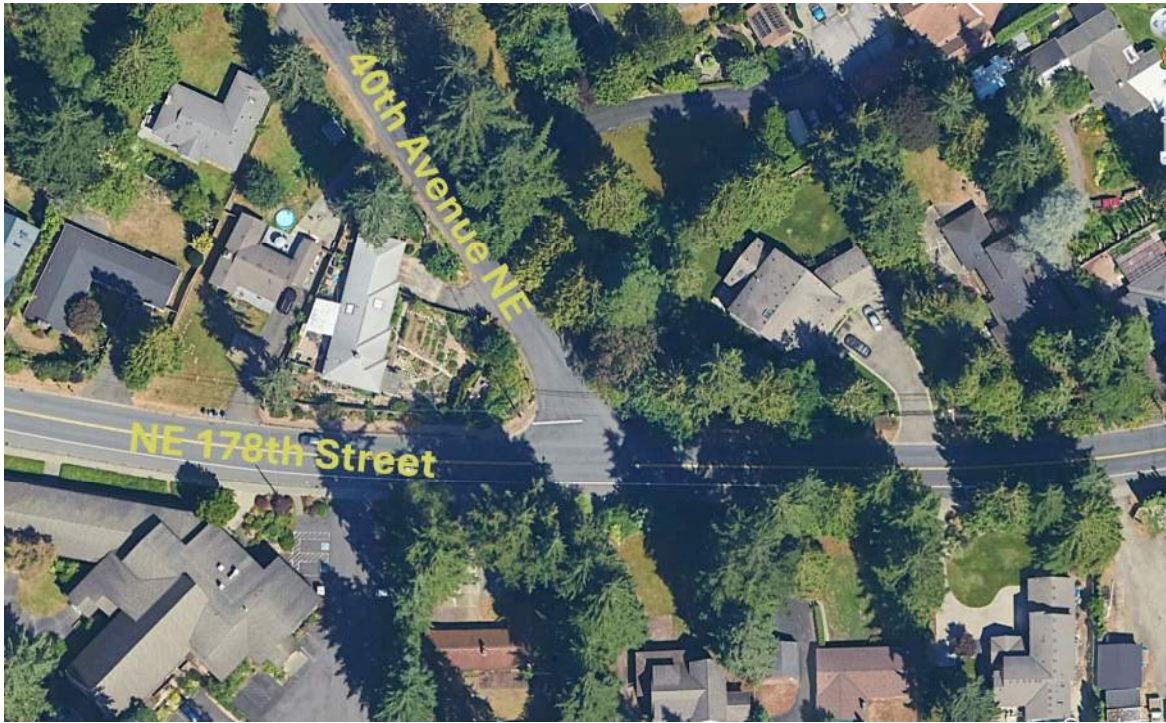
Since 40th Avenue NE approaches NE 178th Street at an angle, the intersection includes a wide turning radius on the northeast corner and blind spot challenges for drivers making a southbound left turn onto NE 178th Street. The 40th Avenue NE approach is approximately 70 feet across to accommodate the angled turns. The shallow angle of the westbound right turning movement allows drivers to make this turning maneuver at higher speeds than they could for a typical 90-degree turn. The current intersection layout is shown in Figure 1.

Figure 1 – NE 178th Street Intersection with 40th Avenue NE

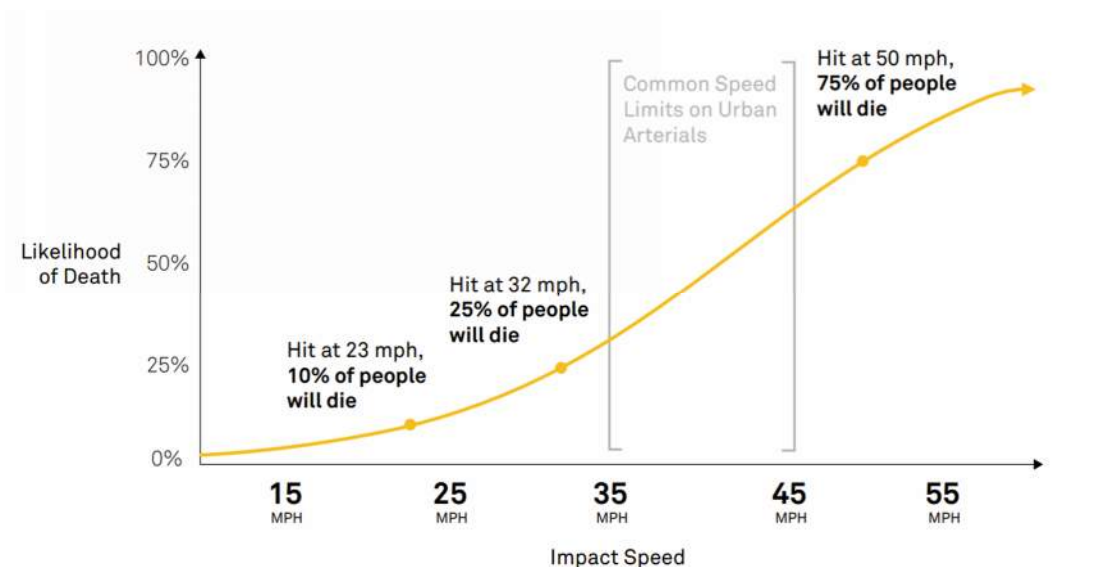
Traffic volumes and speeds are key considerations to help determine safe crosswalk treatments at unsignalized locations. Higher traffic volumes create more potential for vehicle-pedestrian conflicts and decrease available gaps in traffic for people to cross. Higher traffic speeds increase the stopping sight distance required for vehicles and further reduce available gaps in traffic. Higher traffic speeds are also associated with a greater risk of severe injuries and fatalities when collisions do occur. Figure 2 illustrates how even a small increase in vehicle travel speeds can significantly affect the risk of severe injuries and fatalities for people walking and biking.

Figure 2 - The Likelihood of Fatality Increases Exponentially with Vehicle Speed

Even at locations where marked crosswalks do exist, vehicle speed can have a significant influence on whether drivers will yield to people crossing. For example, the NCHRP Report 562 study found that the compliance rate for drivers yielding to people crossing at crosswalks with high-visibility markings decreased from approximately 60% for 25 mph speed limit roadways to below 20% for 35 mph speed limit roadways. On roadways with few available gaps in traffic and a significant number of drivers refusing to yield at crosswalk locations, people walking may be pressured to accept riskier behavior to cross the roadway such as running or crossing with a narrow gap between vehicles.

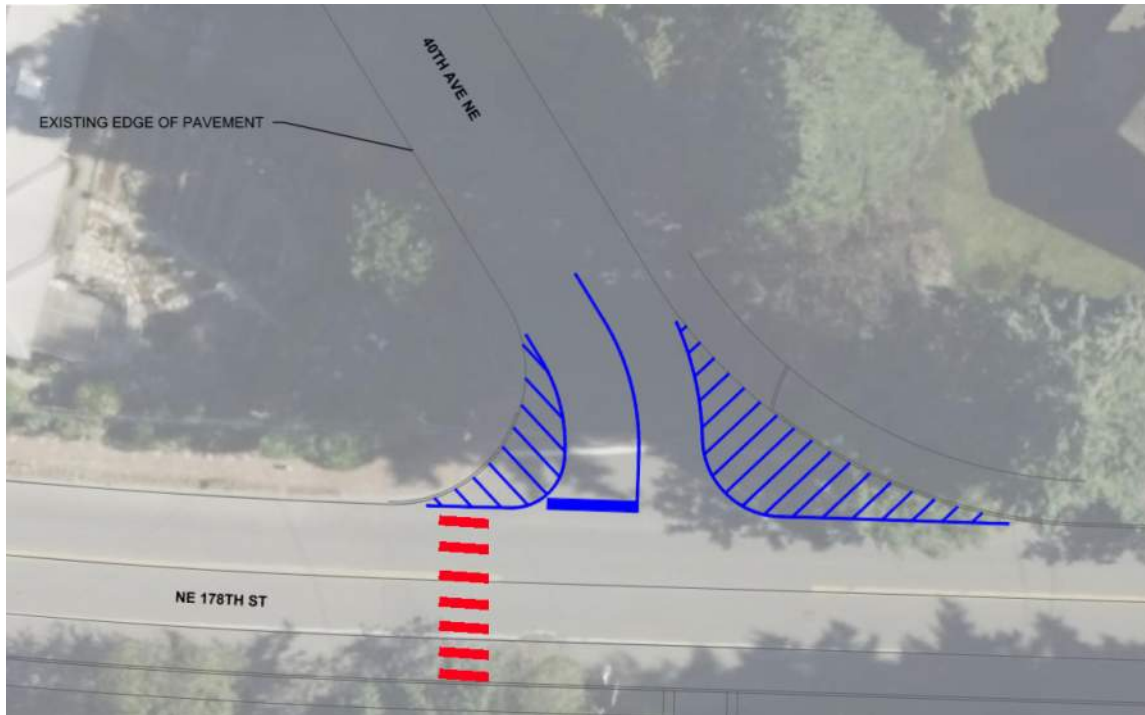
The City could also consider roadway geometry enhancements to potentially further reduce the risk of collisions from these less safe turning maneuvers. Enhancements could include curb extensions and rechannelizing the 40th Avenue NE approach to narrow the approach width and allow both southbound left and westbound right turning vehicles to make safer 90-degree turns. These enhancements could potentially be achieved with lower capital cost intensive features such as striping and “candlestick” bollards. However, depending on the final design of the enhanced intersection layout, additional features such as ADA-compliant pedestrian ramps and tactile strips, along with stormwater drainage improvements may be necessary. For example, the inclusion of pedestrian ramps on the northwest corner of the intersection may require some tunneling of the

existing drainage ditch. Also, the location of pedestrian ramps may conflict with the location of existing catch basins. Potential adjustments to the drainage system and construction of pedestrian ramps may require the crosswalk improvement to be programmed as a capital project. Figure 3 shows how these roadway geometry enhancements could alter the layout of the intersection.

Figure 3 - Potential Roadway Geometry Enhancements

- Consider additional roadway geometry enhancements, as shown in Figure 4, that would allow southbound left and westbound right turning vehicles to make safer 90-degree turns.

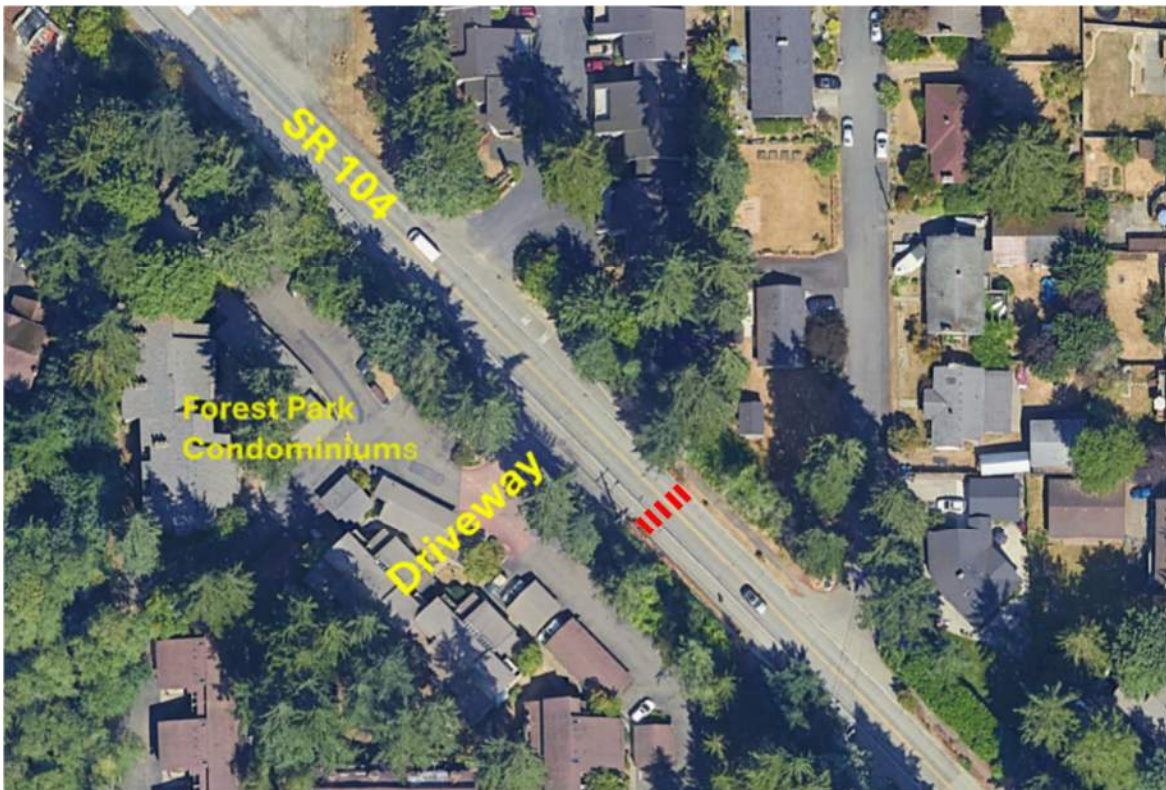
The SR 104 corridor in Lake Forest Park at the entrance to the Forest Park Condominiums (19115 Ballinger Way) has a two-lane cross-section with approximately 11-foot lanes and a posted speed limit of 35 mph. The speed limit was recently modified from 40 mph to 35 mph in August 2024. A sidewalk is located on the east side of SR 104 and a northbound bus pullout is located just to the north of the Forest Park Condominiums driveway. A southbound bus stop is also located just to the south of the Forest Park Condominiums driveway. There is a single existing streetlight on the west side of SR 104, adjacent to the Forest Park Condominiums driveway. One residential driveway exists on the east side of SR 104 directly across from the Forest Park Condominiums driveway. On-street parking is not permitted on SR 104 within the vicinity of the potential crosswalk location. A general location for a potential crosswalk is shown in Figure 5.

Figure 5 – SR 104 Intersection with Forest Park Condominiums Driveway

No marked crosswalks currently exist at this location to cross SR 104. The closest marked crossing of SR 104 is located approximately a quarter mile to the northwest at the intersection with NE 195th Street and 25th Avenue NE. This existing marked crossing is well beyond the willingness to walk distance guidance provided in the MUTCD. The lack of a marked crosswalk at this location also reduces accessibility for people taking transit at the bus stops on either side of SR 104 and prevents residents of the Forest Park Condominiums from safely accessing the sidewalk and northbound transit stop on the east side of SR 104.

A crosswalk located to the south of the Forest Park Condominium driveway would allow people to cross the roadway behind each of the nearby bus stops on SR 104. In the *Urban Street Design Guide*, NACTO recommends placing midblock crosswalks behind bus stops. This placement decreases the likelihood of bus-pedestrian conflicts due to people walking in front of buses as a bus departs the bus stop. Vehicle-pedestrian conflicts may arise when a bus driver is unable to see a person crossing the roadway due to a potential blind spot in front of the bus.
