Subject: 236 Eleanor Avenue, Los Altos

Purpose of the study: Recently the property sold to a new owner who wishes to expand the living space of the house to accommodate the family. Urban Programmers was asked to review the rehabilitation plans prepared by Chapman Design Associates for compliance with the Secretary of the Interior's Standards for Rehabilitation.

236 Eleanor Avenue, Proposed Rehabilitation Plans

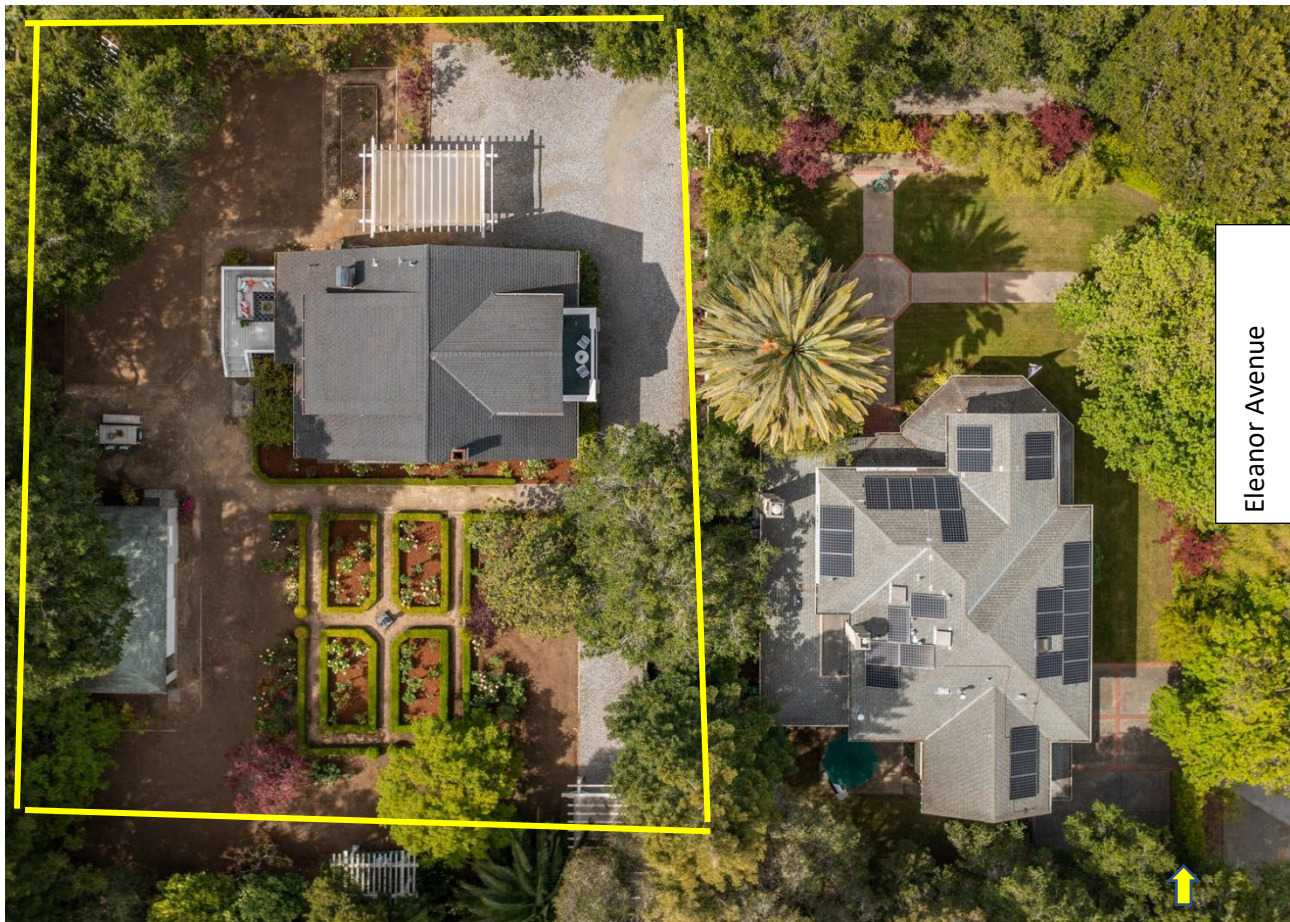
Photograph 1 236 Eleanor Avenue, Los Altos

View: An aerial view shows the house with raised garden, otherwise surrounded by crushed stone. The house faces toward Eleanor Avenue but is located behind a newer house on a rear flag lot. While the orientation of the house is to the east and Eleanor Avenue, it cannot be seen from the public way. The entry has been along the side of the front parcel creating a functional front or entry orientation of the parcel to the north

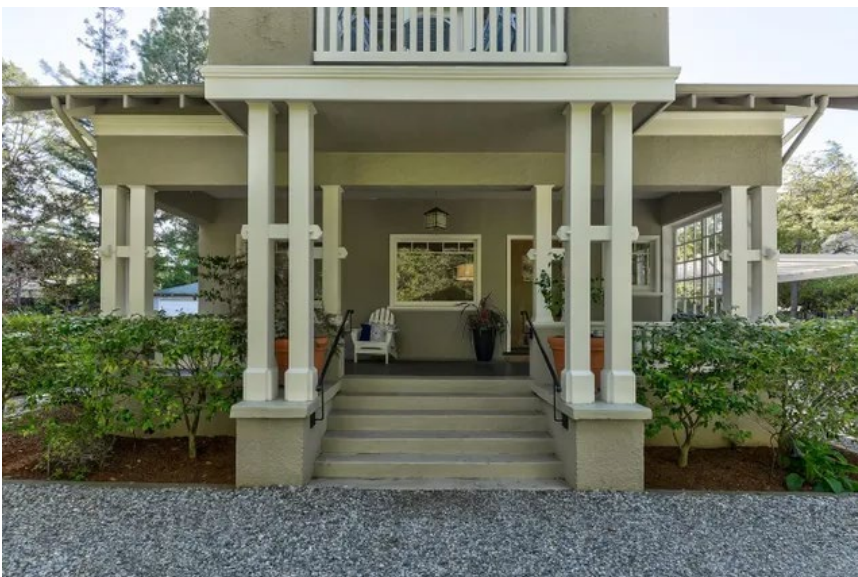
Photograph 3 36 Eleanor Ave., Los Altos

View: Front entry porch showing the low base for the paired columns and the 6 stairs to the main porch. The entry door is off set to the left.

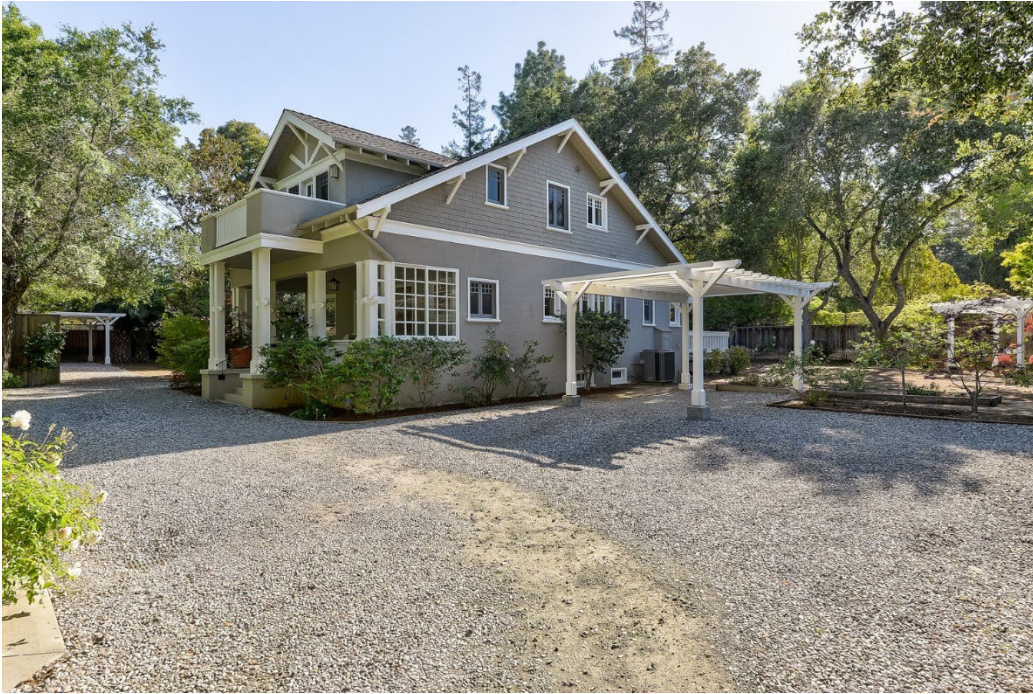
Photograph 4 236 Eleanor Avenue, Los Altos
View: The north side façade showing the window alteration to fill the side of the porch and the second level gable. A carport is under the pergola structure and the entrance to the rear of the house..

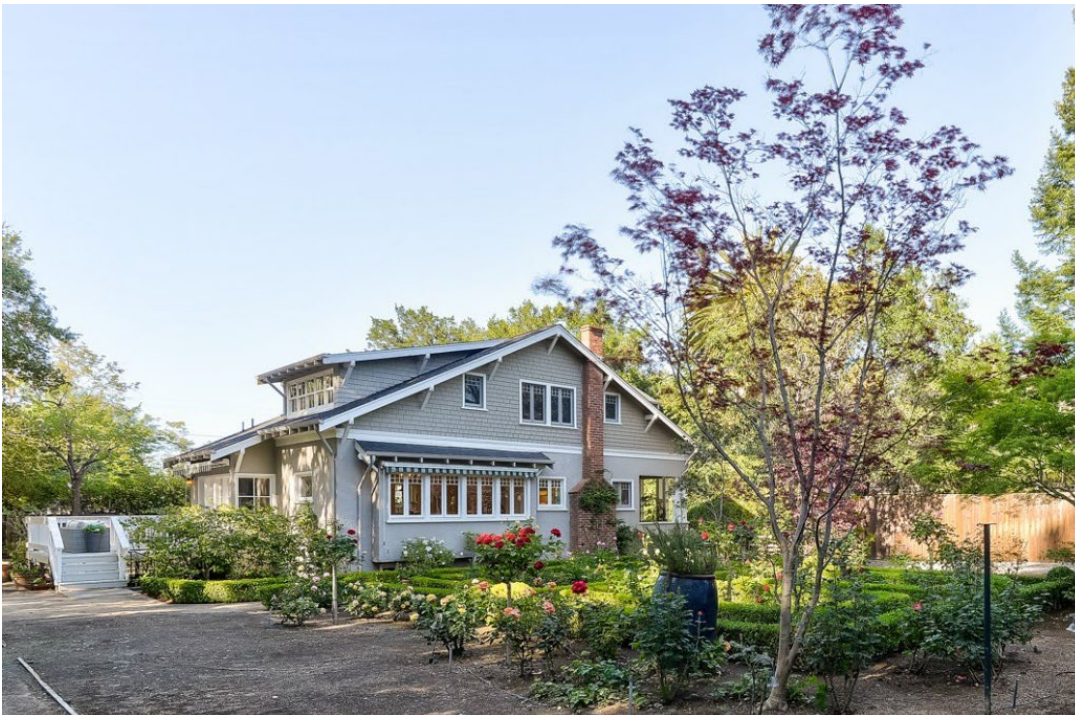
Photograph 5 236 Eleanor Avenue, Los Altos
View: Rear façade showing the pop out addition to the original design. The view shows the shed dormer on the rear second level.

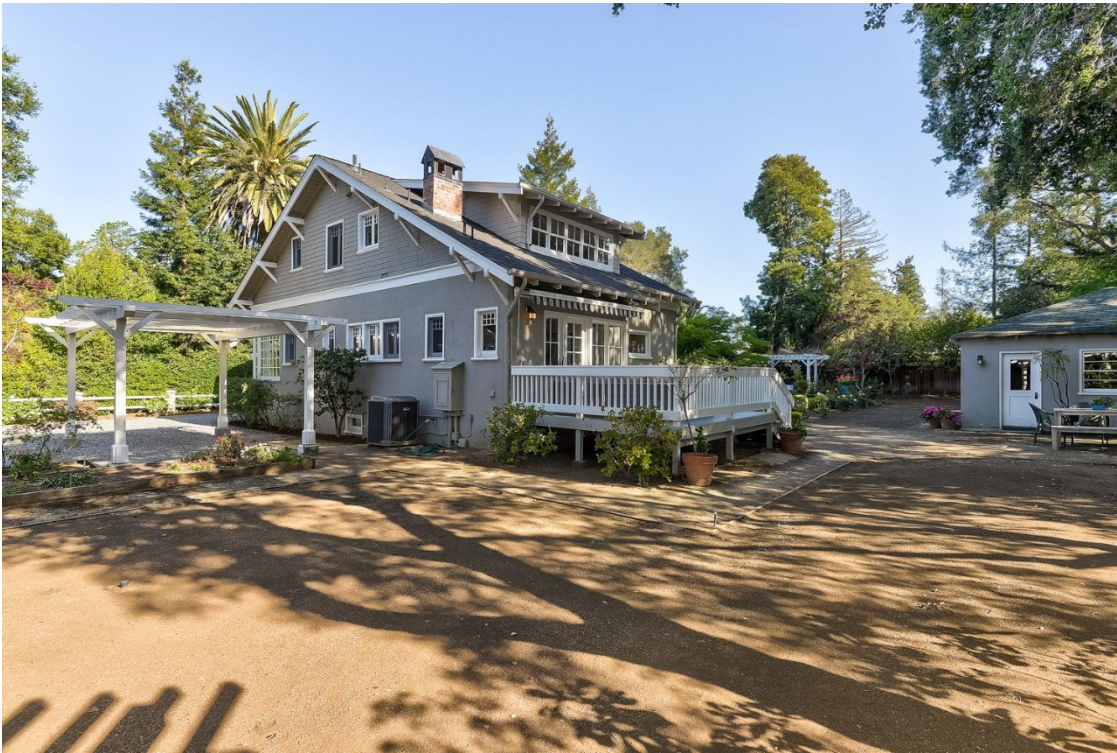
Photograph 6 236 Eleanor Avenue, Los Altos
View: Rear and north side showing the rear additions and deck addition. A shed is behind the house and the carport on the left (north) side.

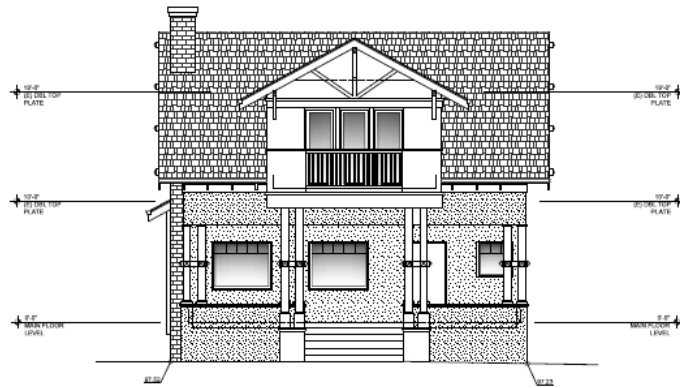
EXISTING FRONT ELEVATION
1/4" = 1'-0"

Figure 2-A 236 Eleanor Avenue - Rehabilitation Plan
View: Existing front facade

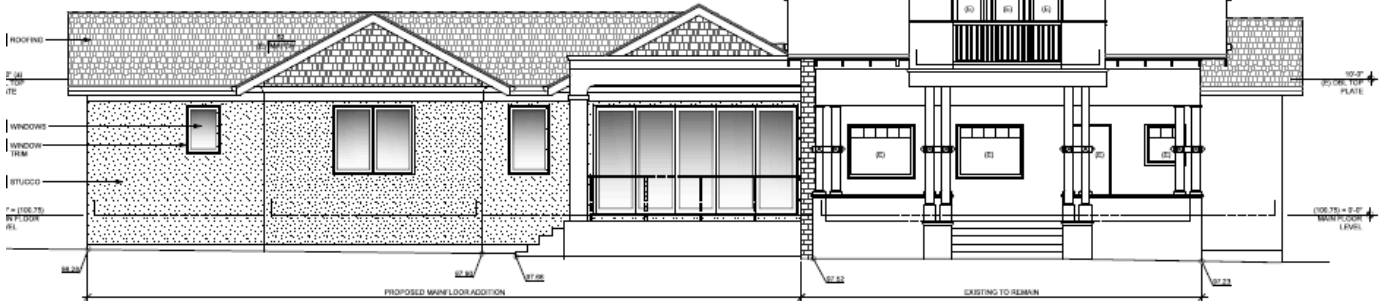
PROPOSED FRONT ELEVATION
1/4" = 1'-0"

Existing historic house to remain in front of the addition.

Figure 2-B 236 Eleanor Avenue - Rehabilitation Plan
View: Front Facade showing the existing house in white, and the proposed addition is set back to the rear from the front portico. The historic house and front roof structure are shown to remain. The proposed addition will attach to the existing roof structure and have compatible materials. The differentiation that will be in course laying pattern. An example is hanging the shingles in an offset providing a different appearance for the new construction using compatible materials
Source: Chapman Design Associates, Jacobsen/Parmacek Residence Sheet A4.0

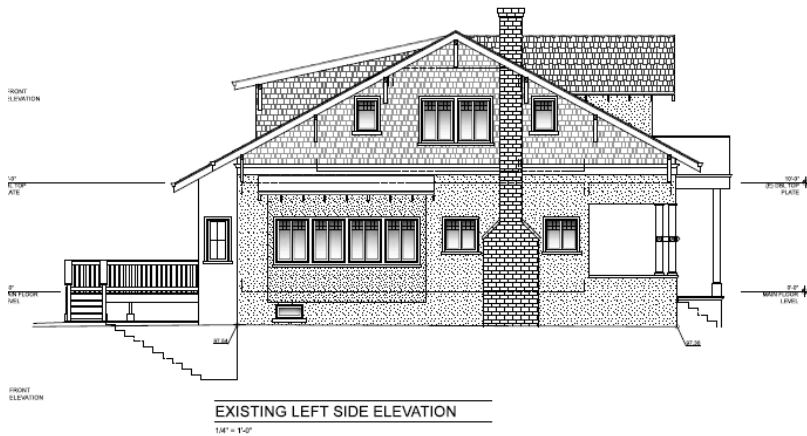
Figure 5-A 236 Eleanor
Rehabilitation Plan

View: Existing Historic
Building, Left or South
elevation.

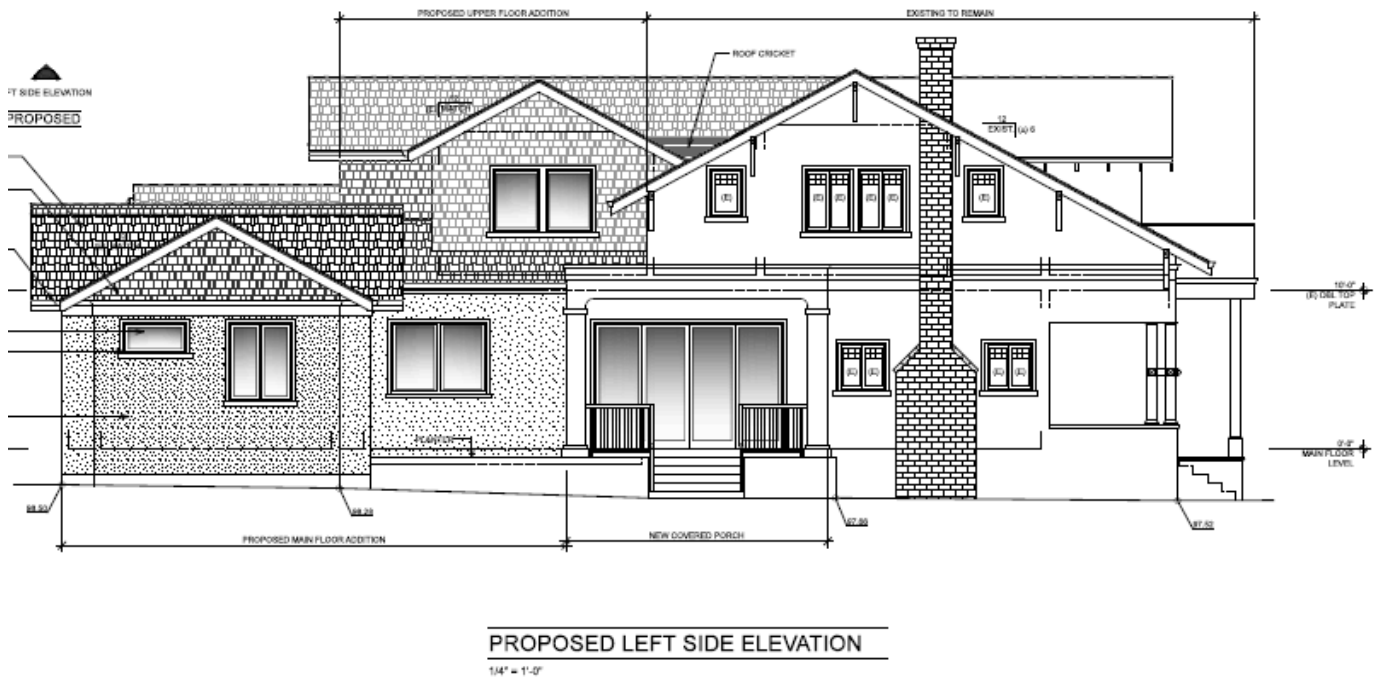
Figure 5 -B 236 Eleanor Avenue- Rehabilitation Plan
View: Left (South) Facade showing the proposed connection of the new wing. The historic house and front roof structure are shown to remain at a height above the proposed addition. The roof structure is intersected with the new roof structure to create a cross gable in the second story.
Source: Chapman Design Associates, Jacobsen/Parmacek Residence Sheet A4.0
