State of California The Resources Agency
 DEPARTMENT OF PARKS AND RECREATION
PRIMARY RECORD

Page 1 of 2 *Resource Name or #: (Assigned by recorder) 236 Eleanor Avenue

P1. Other Identifier: HRI #: 24; Morris House

*P11. Report Citation:
Los Altos Historic Resources Inventory Update Report (Circa: Historic Property Development, March 2012).

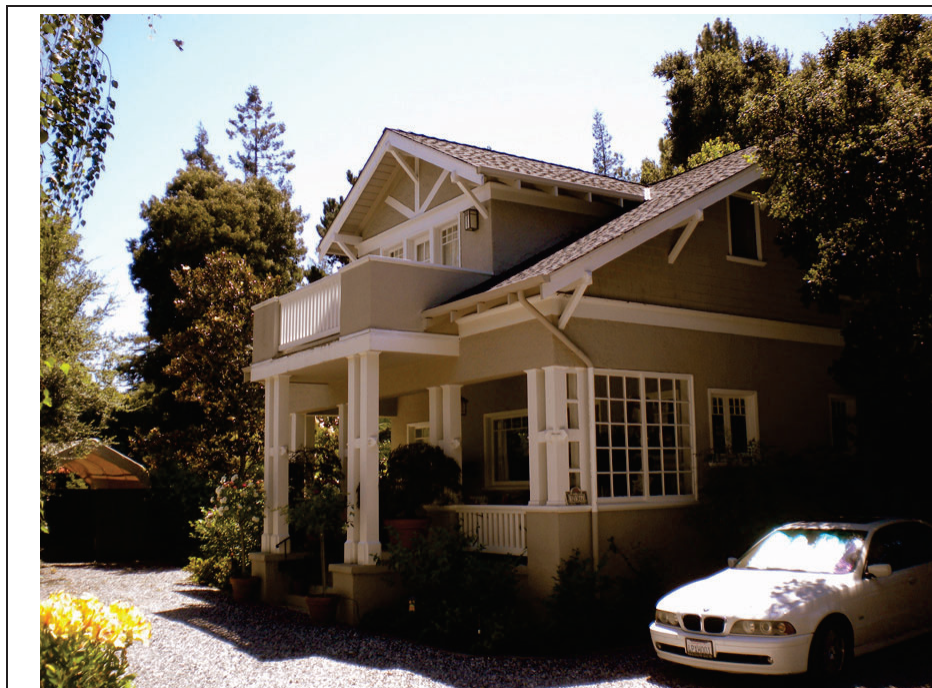
P5b. Description of Photo:
 Primary Elevation

This two-story, wood-frame residence is constructed on a square plan and topped by a side-gabled roof. Gable ends are supported by decorative wood knee brackets and the open eaves reveal exposed rafterails. A large front-facing gable with balcony is set over the ground floor entry porch. The balcony is supported from below by paired, square wood porch posts; this balcony has been remodeled since the property was recorded in 1997 with the square support posts replacing the original angled knee bracket supports. The existing balcony rail was also added at that time. Additional paired porch posts are set at either end of the full-width porch and are connected by simple wood railings. The entrance is offset to the right and two large plate glass windows are located to the left. Other original wood sash windows appear to be extant. Each has a single row of smaller panes across the top. A circular driveway surrounds a single mature palm tree in the front yard. The property appears to be in excellent condition.
