**HISTORIC RESOURCE EVALUATION AND
SECRETARY OF INTERIOR'S STANDARDS FOR THE
TREATMENT OF HISTORIC PROPERTIES REVIEW
OF THE PROPERTY LOCATED
AT 151 HAWTHORNE AVENUE, LOS ALTOS,
SANTA CLARA COUNTY, CALIFORNIA**

Updated July 8, 2022

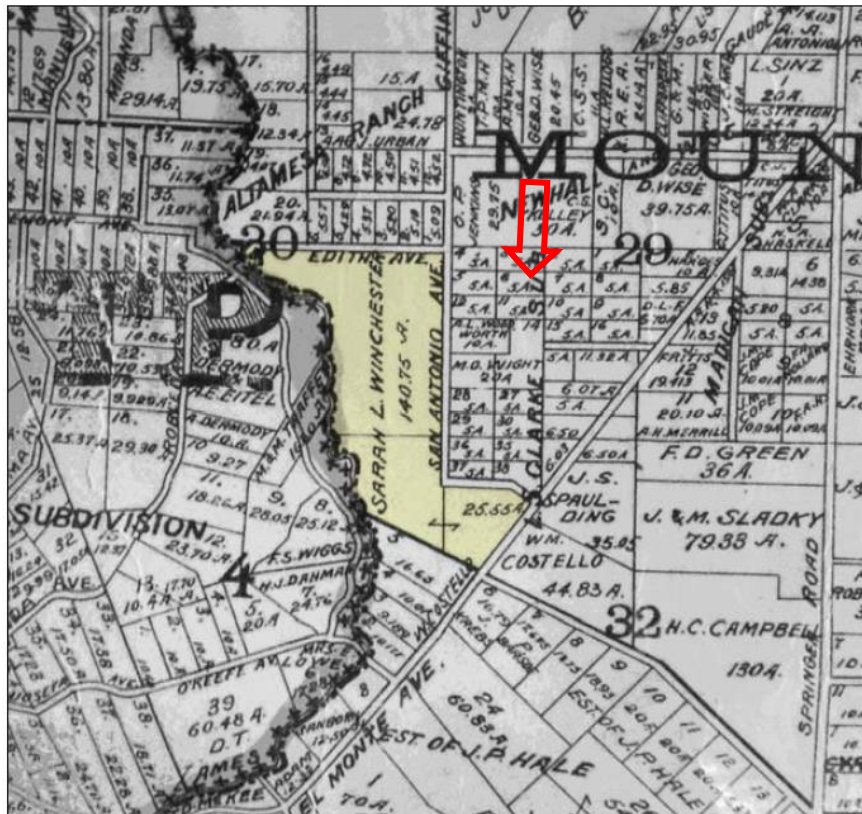
Figure 3. A 1906 tract map is showing the Property (red arrow) concerning the Sarah Winchester parcel (highlight center parcel) that was sold to the Altos Land Company and later became the townsite for Los Altos (courtesy of the Los Altos History House Museum Archives).

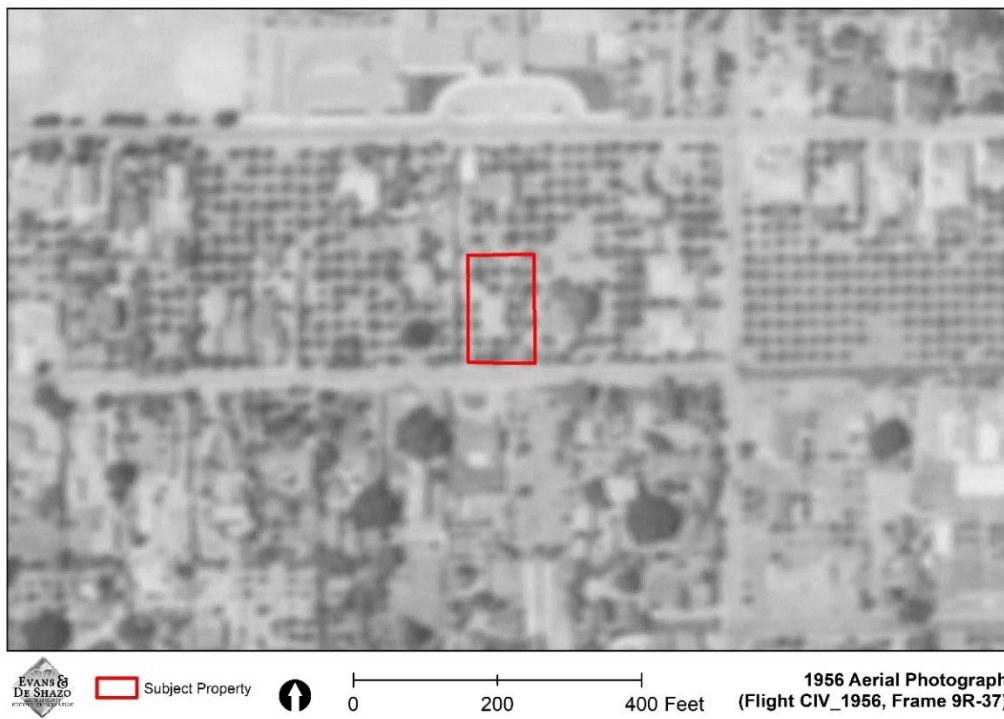
Figure 19. 1956 aerial photograph showing the Property and surrounding residential growth (courtesy of the University of Santa Barbara Library).

Year	Owner/Occupants	Details
ca. 1922-ca. 1965	Owners: unknown	<ul style="list-style-type: none">• Although EDS conducted extensive online and in-person research, the current owner, the first owners of the ca. 1922 house, ca. 1922 shed, and associated landscape were not found.• In 1922, the Property was located within Fremont Township in Santa Clara County• Based on a review of the 1930 and 1940 U.S. Federal Census records, the house addresses on Hawthorne Avenue during this time were not the same as they are today, including 151 Hawthorne Avenue; however, the research did not reveal the original address of the Property.• Aerial photographs between 1930 and 1941 show the Property, including the ca. 1922 house and ca. 1922 shed situated within an orchard. There were very few residential houses on Hawthorne Street or within the neighborhood during this time (Figure 16, Figure 17, and Figure 18).• The 1956 aerial photograph shows the ca. 1922 house and ca. 1922 shed within the Property and a reduction in the orchards and increased houses within the neighborhood (Figure 19).

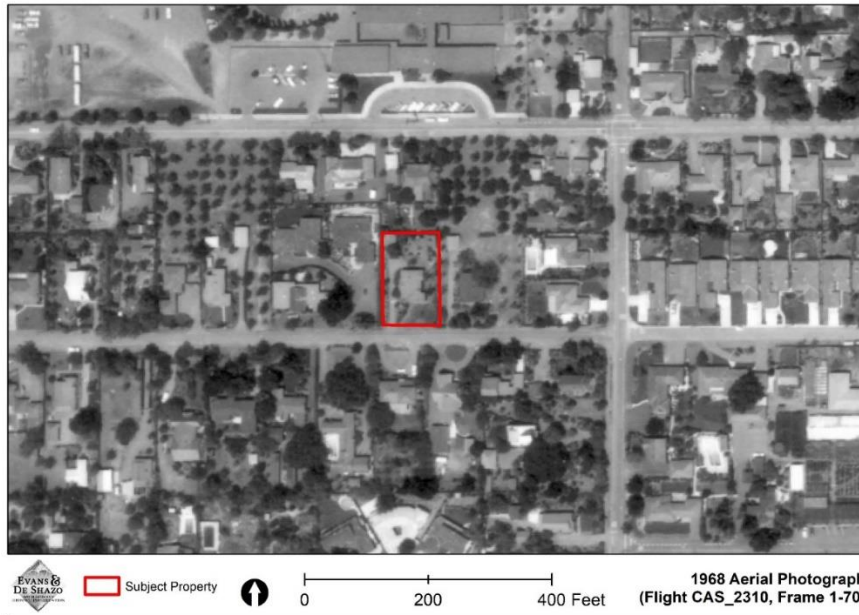
Figure 20. 1968 aerial photograph of the Property with dense residential development around it (courtesy of University of Santa Barbara Library).

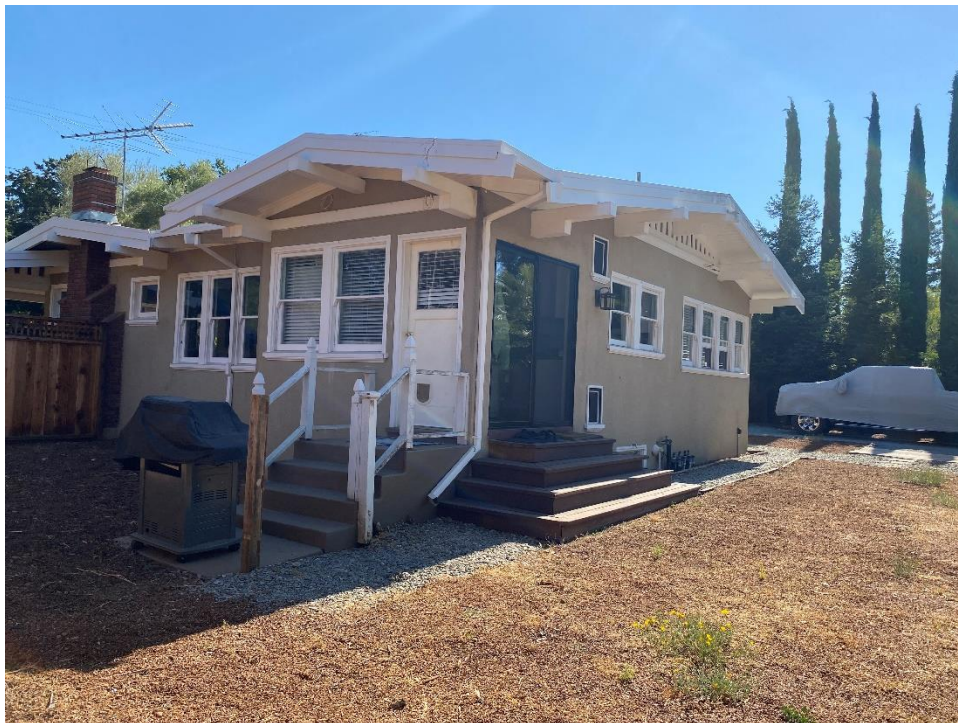
The north elevation consists of an extending gabled roof with wide overhanging eaves and wood beams (Figure 29). The rear gable mimics the front porch gable detail, with decorative, vertical wood boards with open slates that provide ventilation (Figure 30). There are changes to this elevation that includes a vinyl sliding glass door, added during the 2015 kitchen remodel, which is accessed via a set of steps constructed of what appears to be fiber cement or Hardie decking. There are two narrow, fixed windows that may be original to the house but appear to have been relocated due to either the 1985 or 2015 kitchen remodel. There are also a series of four double-hung wood windows with lugs that appear original to the house, as well as a narrow rectangular basement hopper window. There are two -square vents along this elevation that are not original and were likely added during one of the kitchen remodels.

Figure 29. Photograph showing the north elevation rear roof gable and decorative vertical wood boards along the gable, facing southwest.

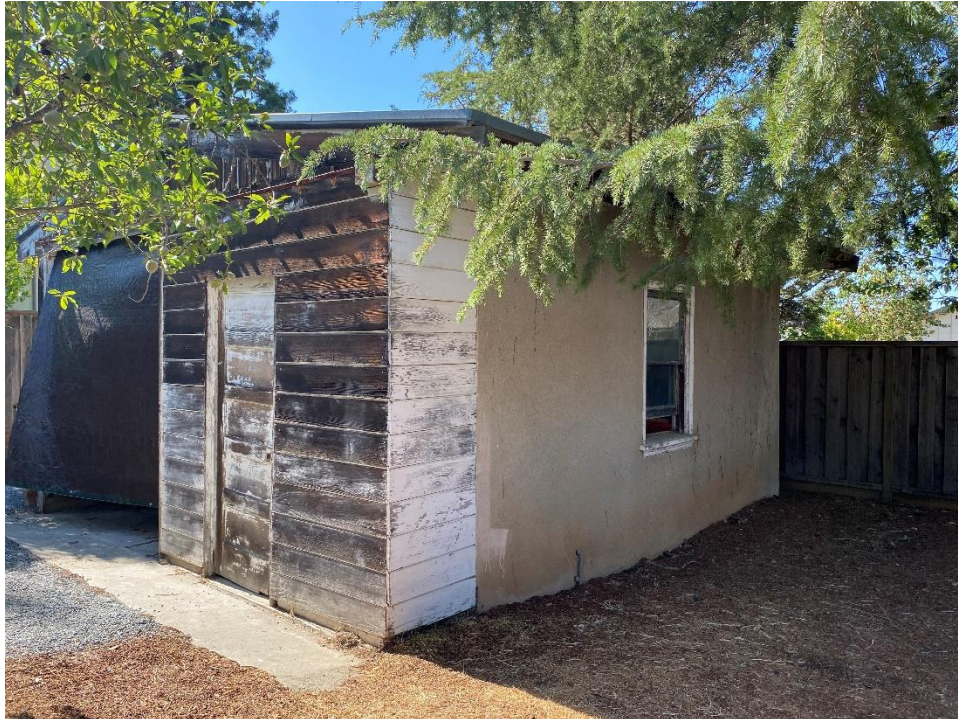
The ca. 1922 shed is a wood-framed front gable form with a low-pitched roof and a wide eave overhang with exposed rafter tails. Along the south elevation, a portion of the building is clad in original horizontal wood boards, and the east, west, and north elevations are clad in contemporary stucco (Figure 33). There are two five-panel wood doors, one along the south elevation (primary façade) and another along the north elevation. There is a tarp covering a wide door opening (Figure 34). There are two windows, including a vinyl sliding window along the north elevation and a double-hung wood window along the east elevation.

Figure 33. Photograph showing the cladding along south and east elevations, facing northwest.

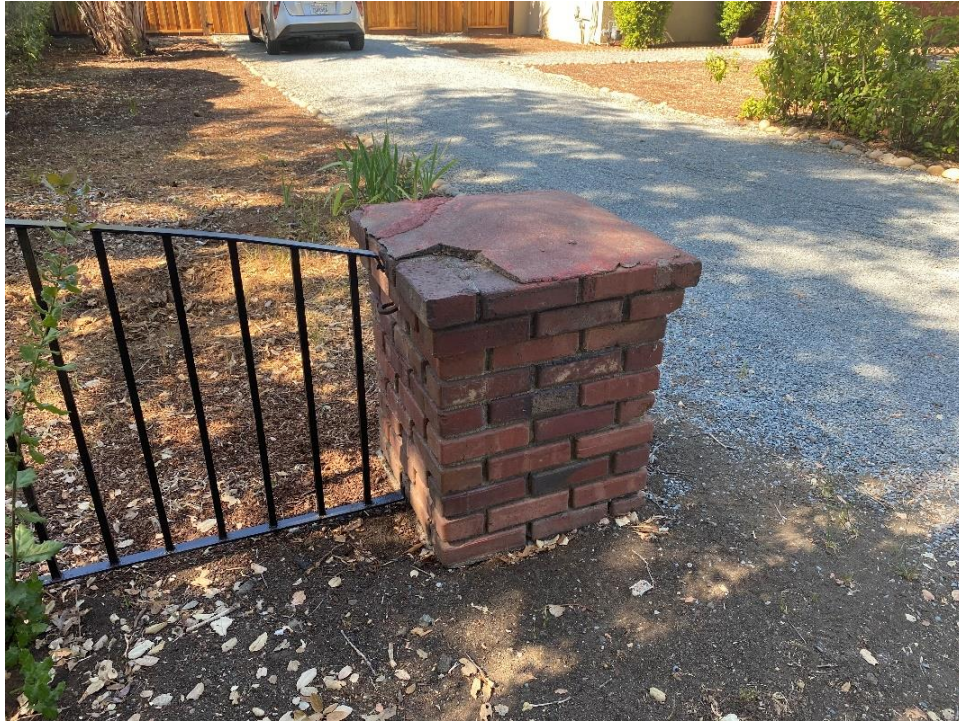
The associated landscape includes original square concrete pillars clad in decorative red brick that appear original to the house (Figure 36). The brick-clad concrete pillars are linked together by contemporary iron fencing designed in a semicircular shape. A gravel driveway leads to a wooden fence, which appears to be new (Figure 37).

Figure 36. Photograph showing a concrete pillar and contemporary iron gate along the primary façade, facing north.
