AGENDA REPORT

SUBJECT: H22-0001 – 151 Hawthorne Avenue

PROJECT DESCRIPTION

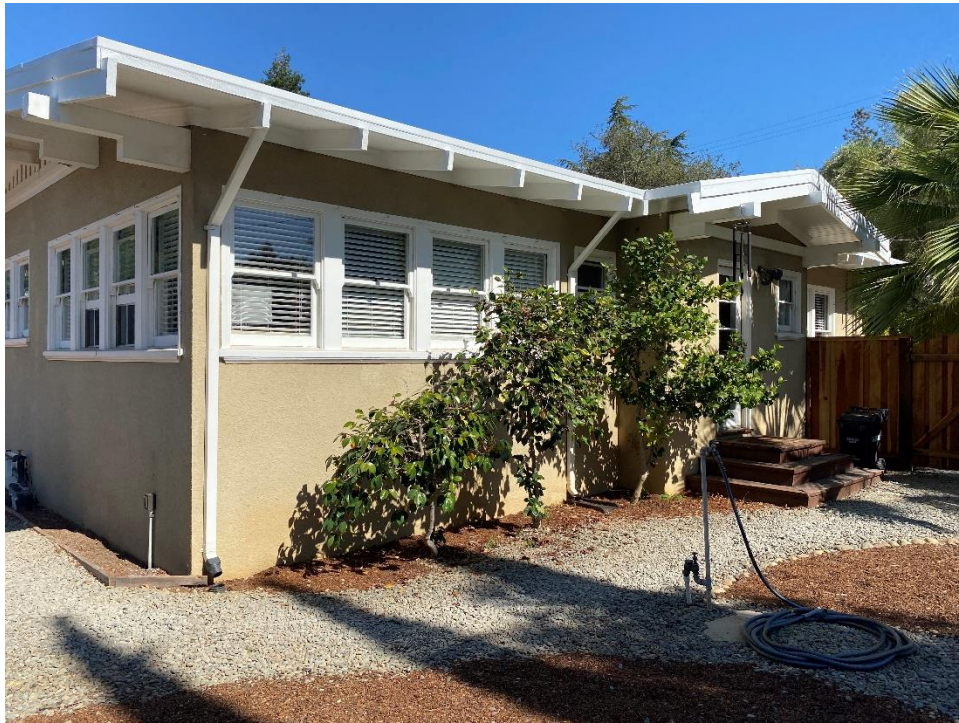
Figure 31. West elevation, facing southeast.

The west elevation consists of a projecting porch side entry gable, which appears to be an addition added in 1985 or 2015 during one of the two-bathroom remodels (Figure 31). Fenestration along the west elevation consists of a pair of double-hung wood windows with lugs (of which one consists of a replacement sash without lugs), two narrow wood windows with lugs that appear to have been relocated during one of the bathroom remodels, a series of four double-hung wood windows with lugs, and a contemporary five-light glass and wood door, added in 1972, set below the projecting gable (Figure 32).

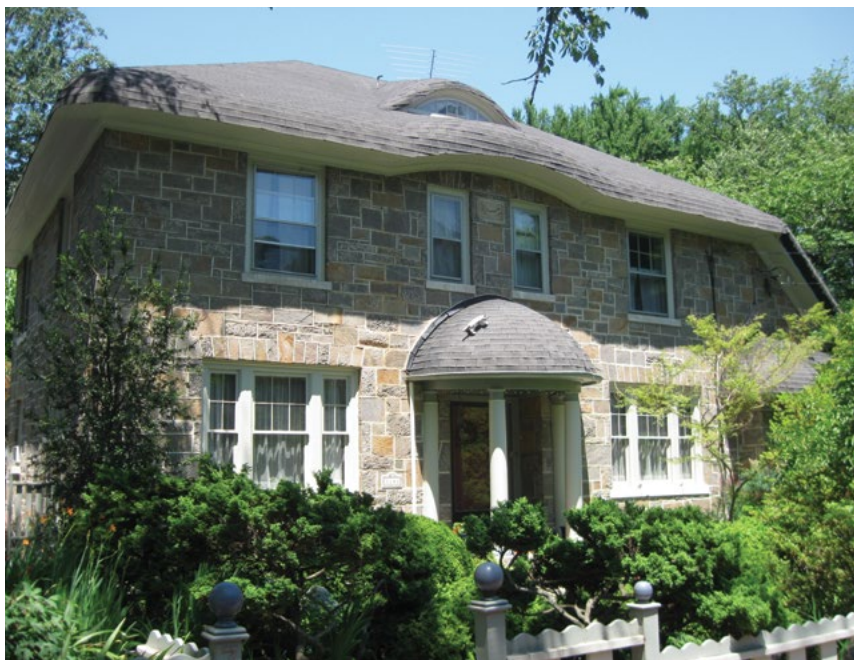
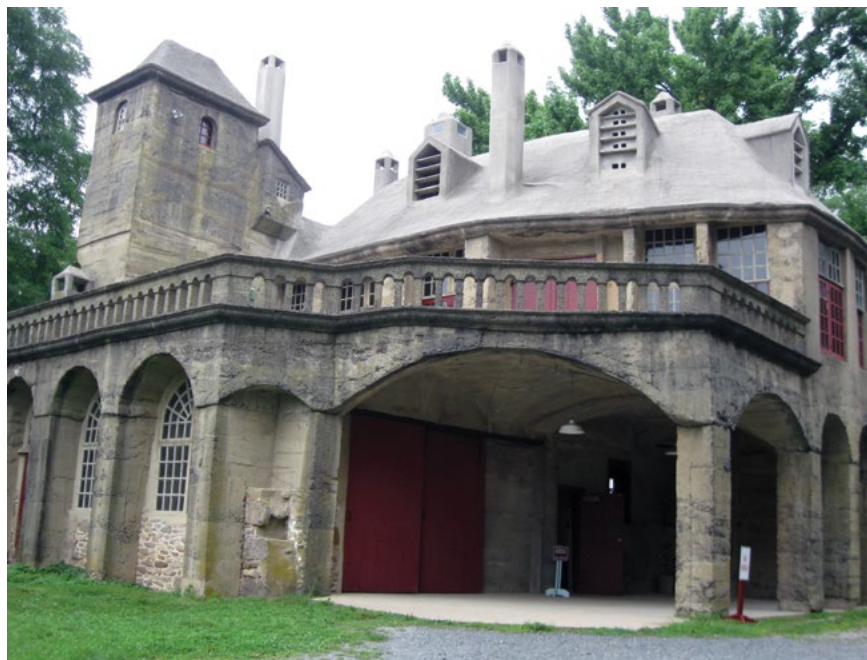
[9] Distinctively-shaped roofs are important in defining the historic character of these early 20th-century structures: (a) an asphalt shingle roof on a house; (b) and a concrete roof on Fonhill, Doylestown, PA (1908-1912), designed and built by Henry Chapman Mercer.
