# Appeal Request for Removal from the Historic Resources Inventory

Subject: **De Novo Appeal – Request for Removal from Historic Resources Inventory**  
Property: 241 Los Gatos Blvd

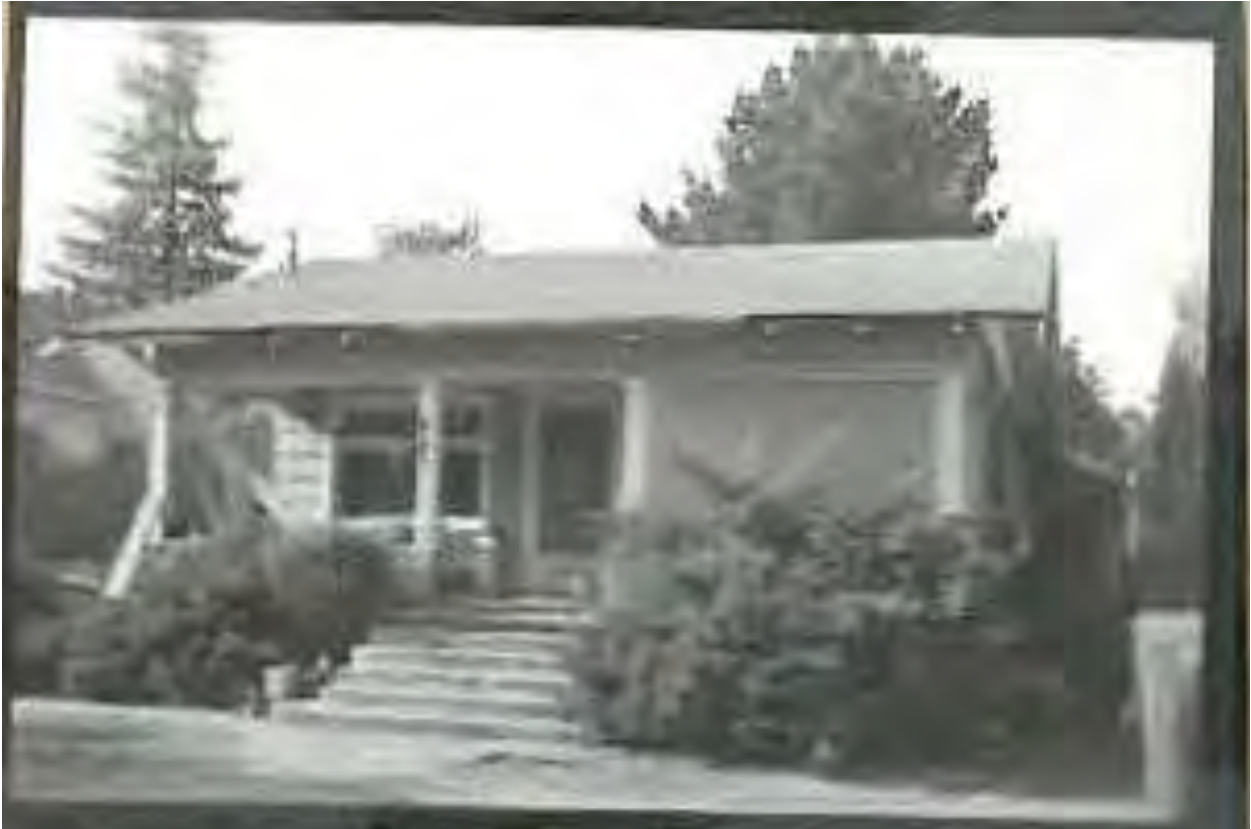
Figure 1. Bloomfield Survey Image (1990)

The oldest image of the house that was available in Town's documents belong to Bloomfield Survey. The picture below is taken from that survey.

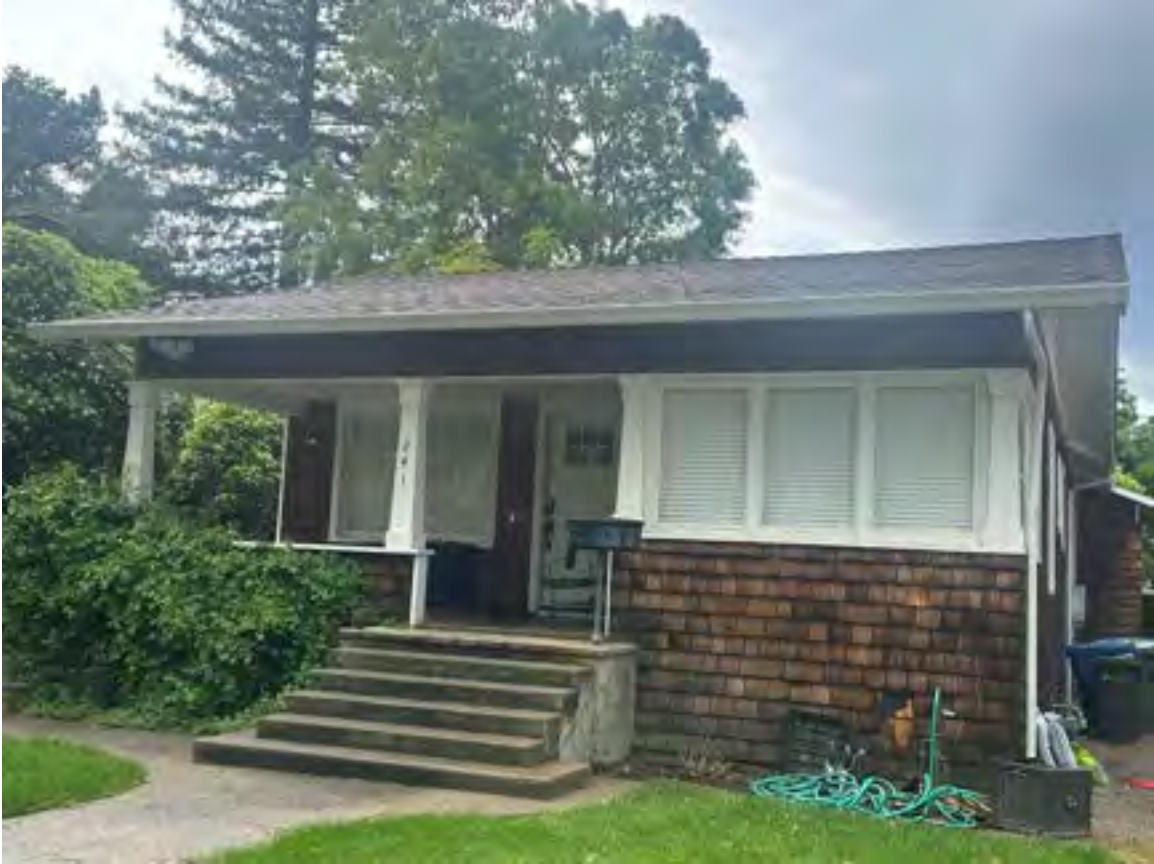
Figure 2. Property Image, Same Angle as Bloomfield Survey, 2026

To have a better comparison and understanding of extensive modifications to the front façade of the house, I took a similar picture from the same angle as the one presented in the Bloomfield survey (Figure 2).

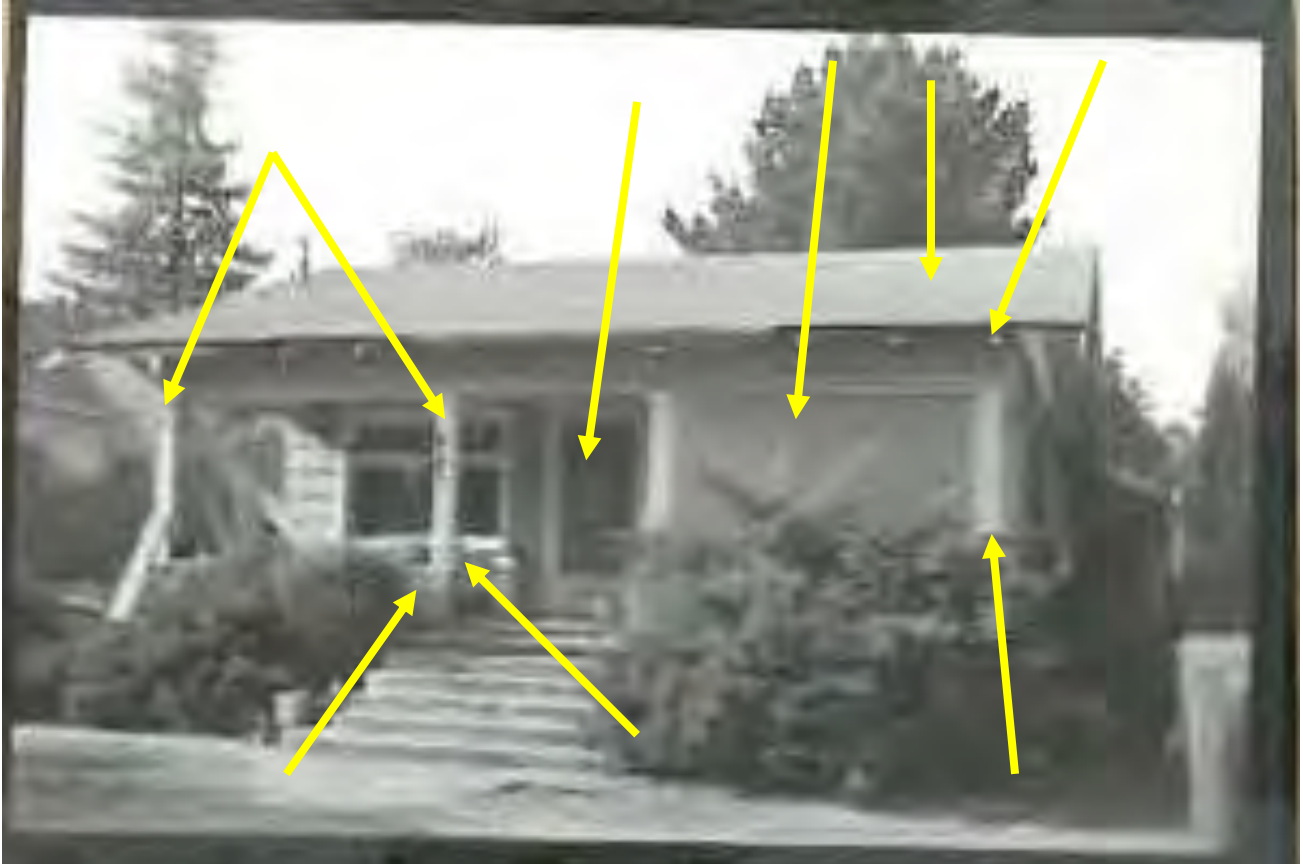
Figure 3. Bloomfield Survey Image with Major Changes Identified (1990)

Below in the same Bloomfield Survey image but with the major changes highlighted by yellow arrows (Figure 3).

Based on the highlighted areas in Figure 3, it's obvious that below changes can be confirmed:

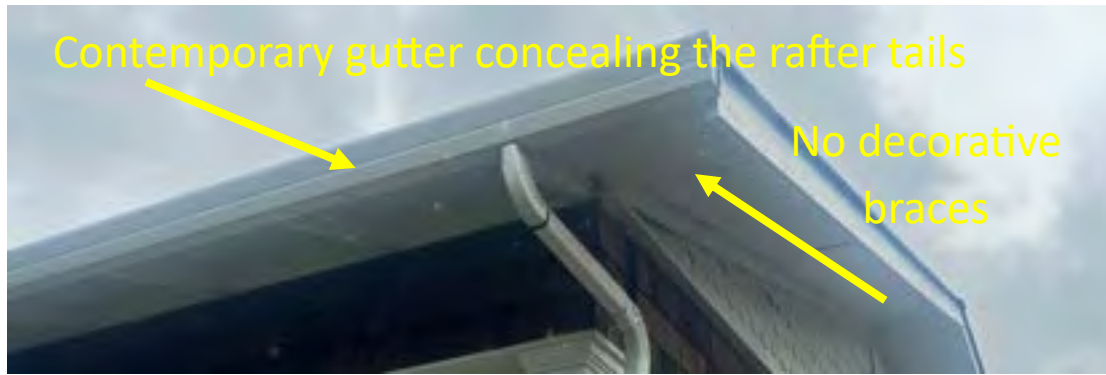
Figure 4. Covered Roof Rafters post-1990

As can be seen below, all roof rafters are covered post 1990.

The roof structure no longer expresses original construction methods. Exposed rafters, one of the defining features of Craftsman architecture, have been enclosed by modern gutter systems. Roof material has also been recently updated to composite shingles which has no historic distinction or value.

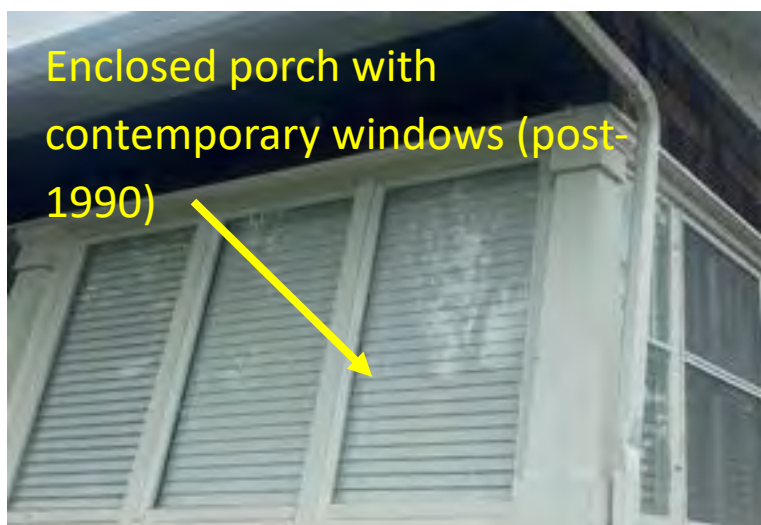
Figure 5. Contemporary Front Window

Not only the front window's size and configuration was changed after 1990, but also the current window does NOT follow the distinctive historic window configuration with multi-lite upper sash over a single pane lower sash.

The original window systems have been replaced with modern units, including vinyl sliders and non-period configurations. These do not reflect the vertical proportions or multi-pane detailing typical of bungalow-era construction. The front bedroom window is a post-1990 alteration, differing in both type and size from the window documented in the 1990 Bloomfield Survey. As such, the existing windows are not original and do not contribute to the historic significance or architectural integrity of the property.

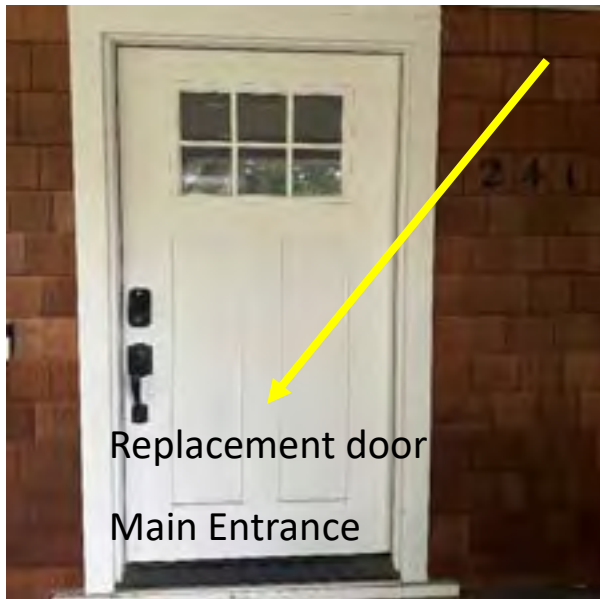
Figure 6. Contemporary Entry Door

The entry door is a modern replacement ( ) with dual-pane glazing and simulated muntin (Figure 7). This represents imitation rather than preservation of historic design

The entry door is a modern replacement with dual-pane glazing and simulated muntin. This represents imitation rather than preservation of historic design.

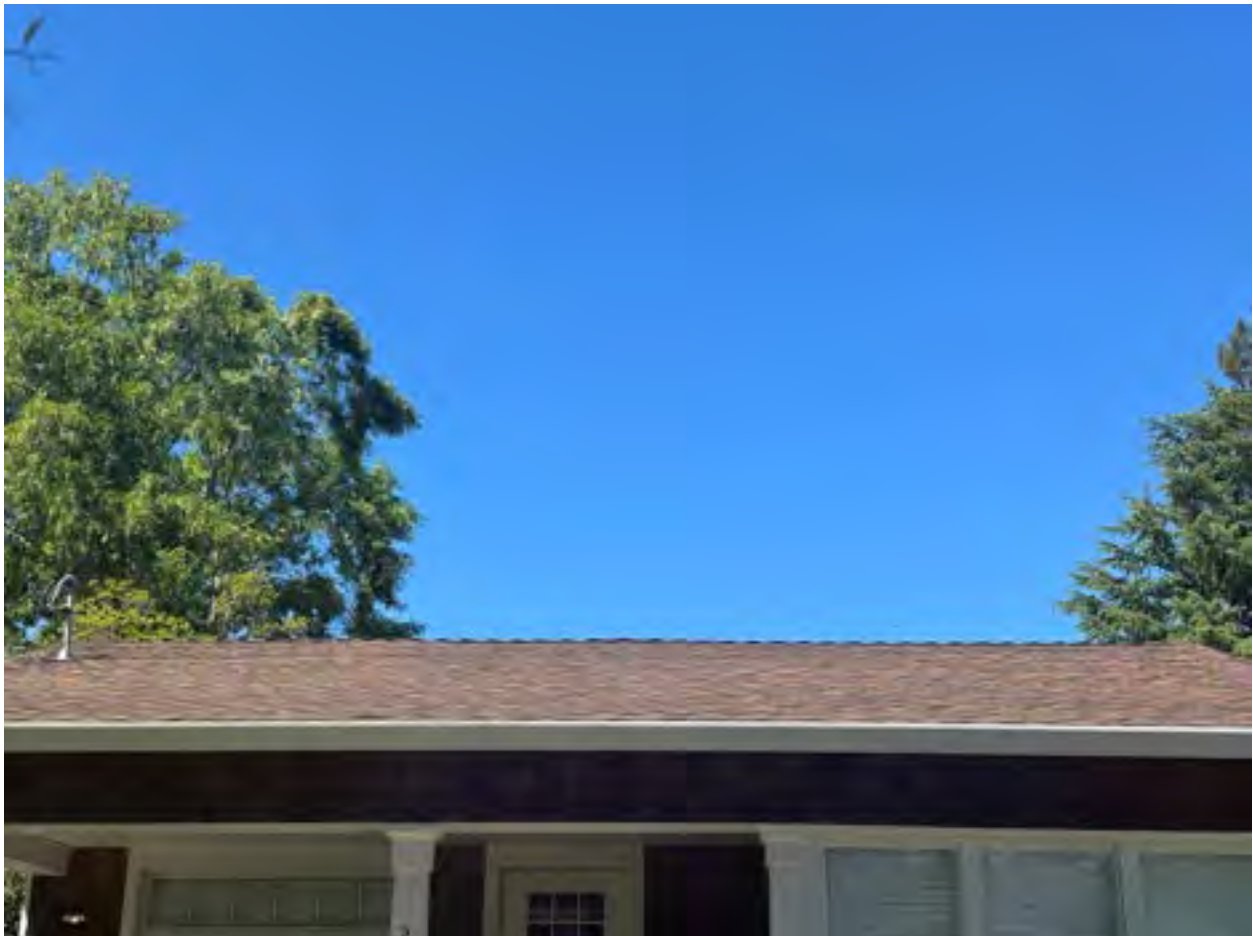
Figure 8. Roof Material: Composite Shingle

Roof material was recently changed to composite shingle which has no historic distinction or value.

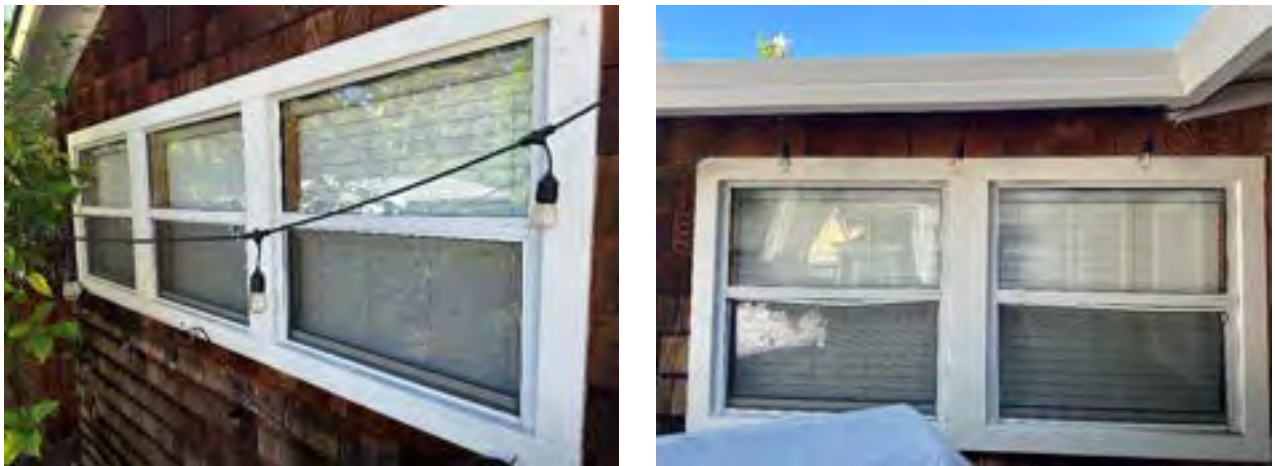
Figure 9. Contemporary Vinyl Windows

The original window systems have been replaced with modern units, including vinyl sliders and non-period configurations. These do not reflect the vertical proportions or multi-pane detailing typical of bungalow-era construction. As a result of these modifications and modification of the front window mentioned in 2 above, the existing windows are not original and do not contribute to the historic significance or architectural integrity of the property. More than 65% of the windows around the property are contemporary vinyl/metal windows. In addition, the existing wood windows are also confirmed to be mostly installed after 1990.

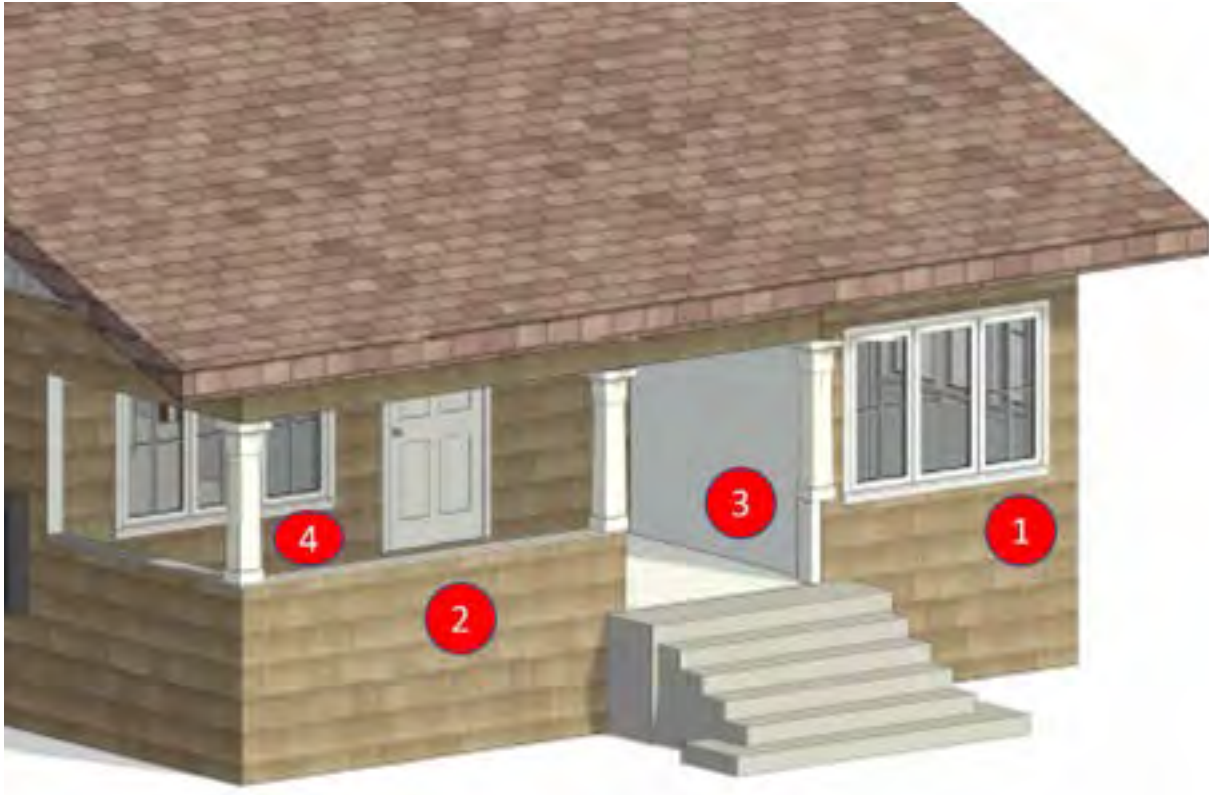
*Front Façade Plan*

## Front View and Sample Locations

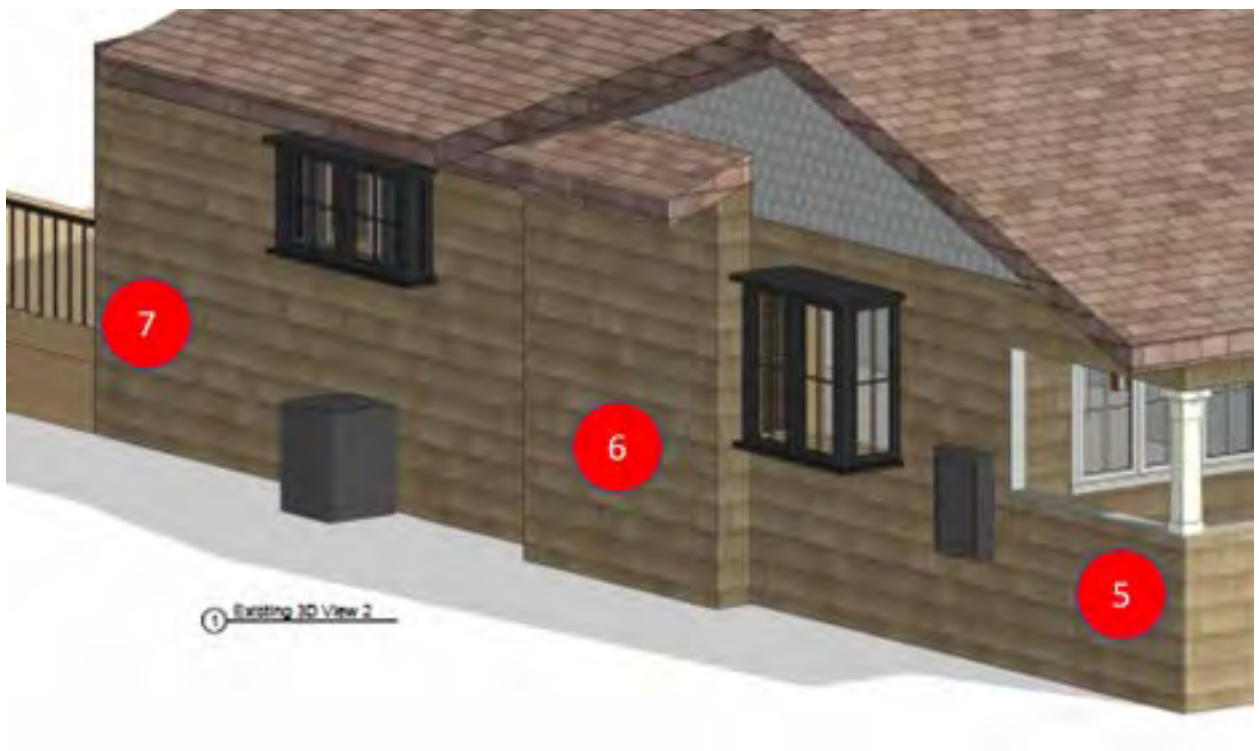
*South Side Plan*

## South Side Sample Locations

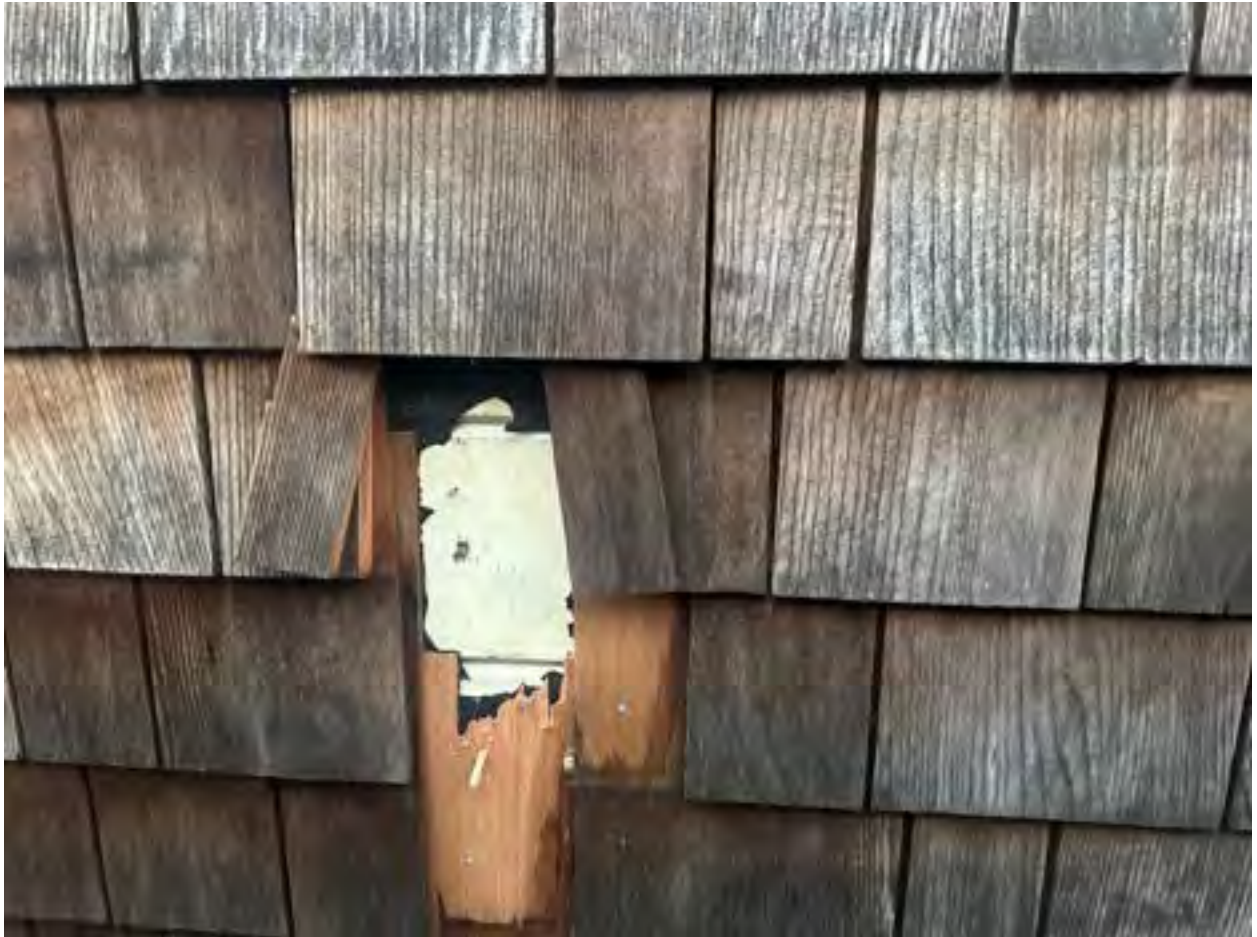
**#13: North Side – Middle (original siding):**

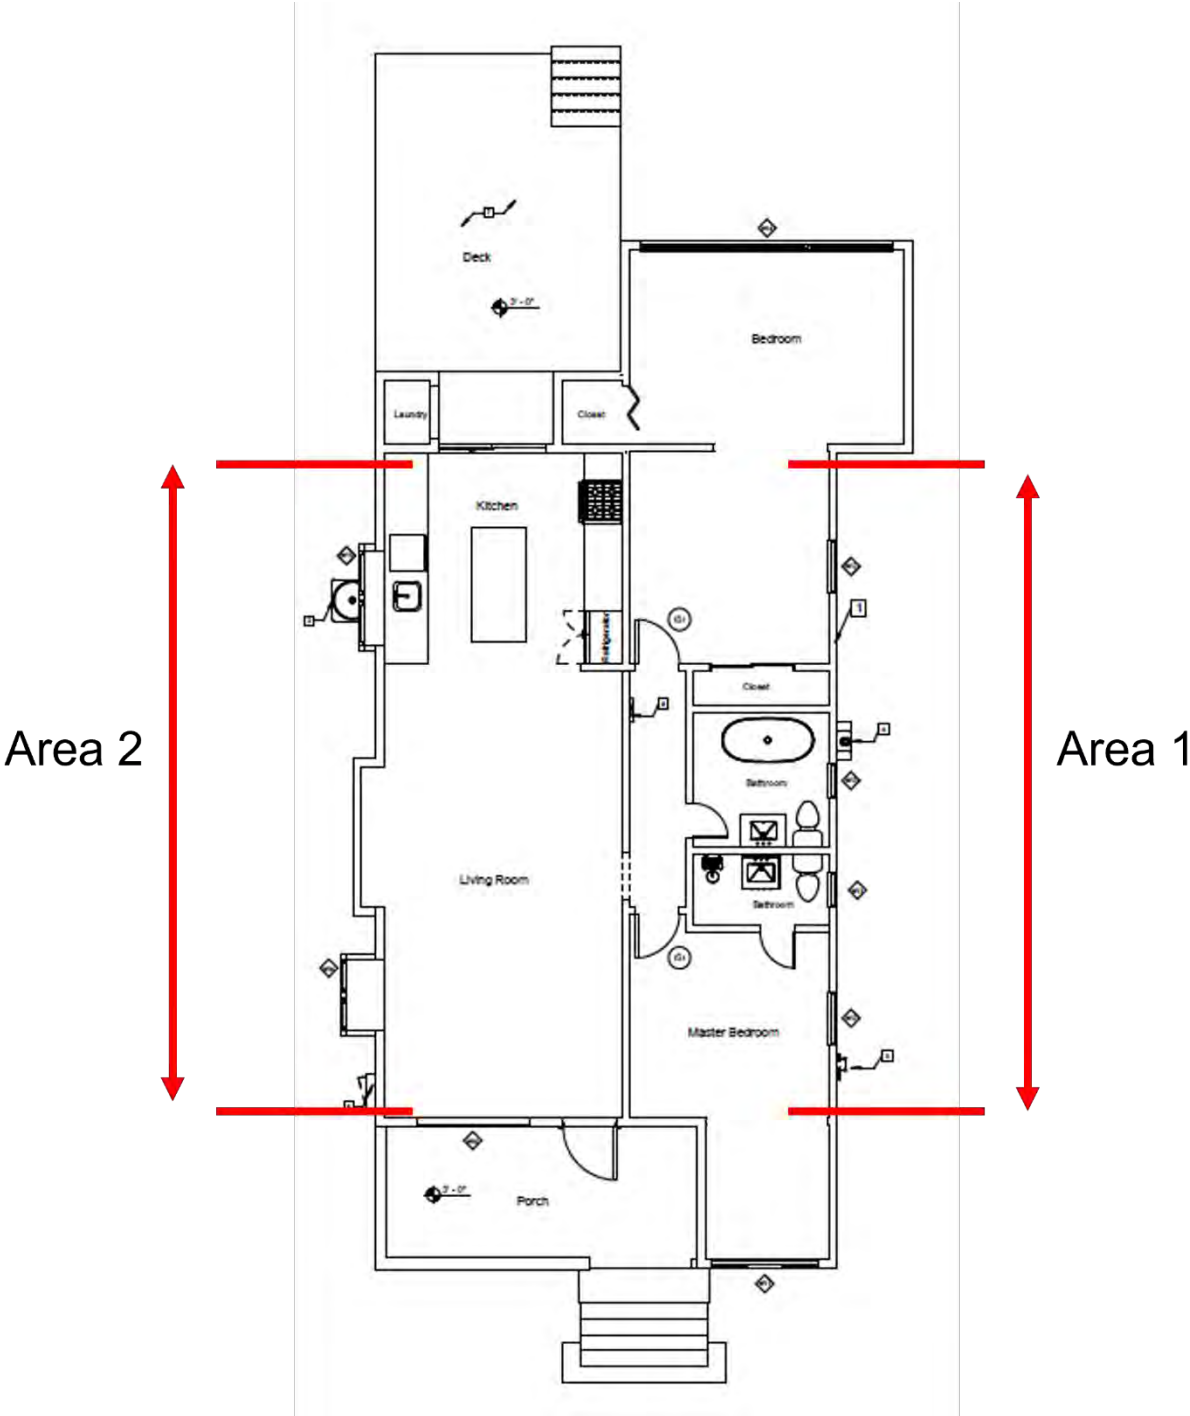
The red-marked areas are believed to be the original wood siding.

Original vs total siding MAX ratio =  $(803.16) / (1713.3) = 46.8\%$  → at least **53.2%** of original sidings all around the house was removed and replace

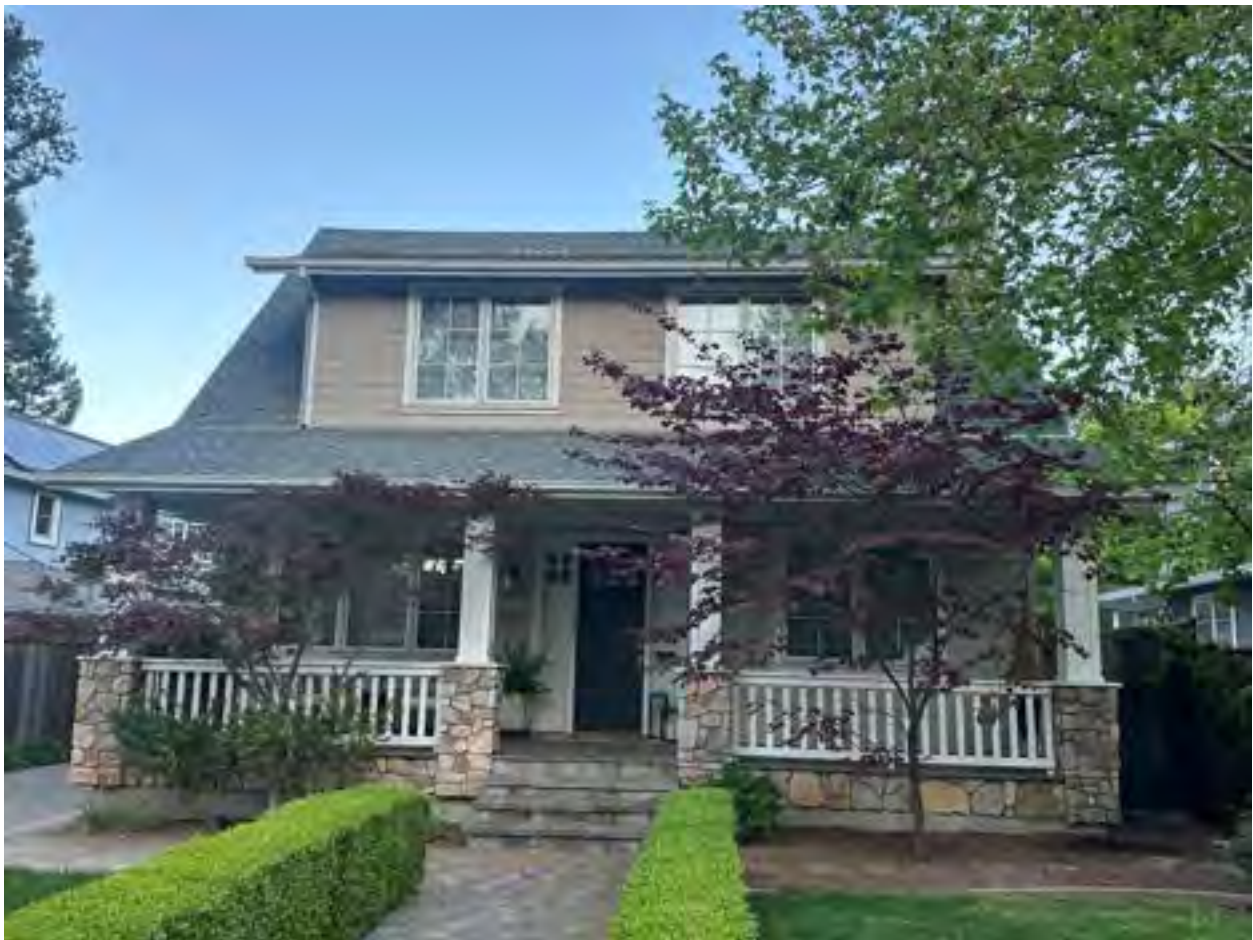
Figure 1. Property at 234 Los Gatos Blvd

Two residential properties located directly across the street from 241 Los Gatos Blvd, both constructed in approximately 2015, provide a relevant and instructive comparison. For the record, addresses of these properties are: 234 Los Gatos Blvd, and 236 Los Gatos Blvd. Despite being modern constructions and not included in the Historic Resources Inventory, these homes exhibit a more complete and cohesive set of architectural features commonly associated with Craftsman and California bungalow design than the subject property.

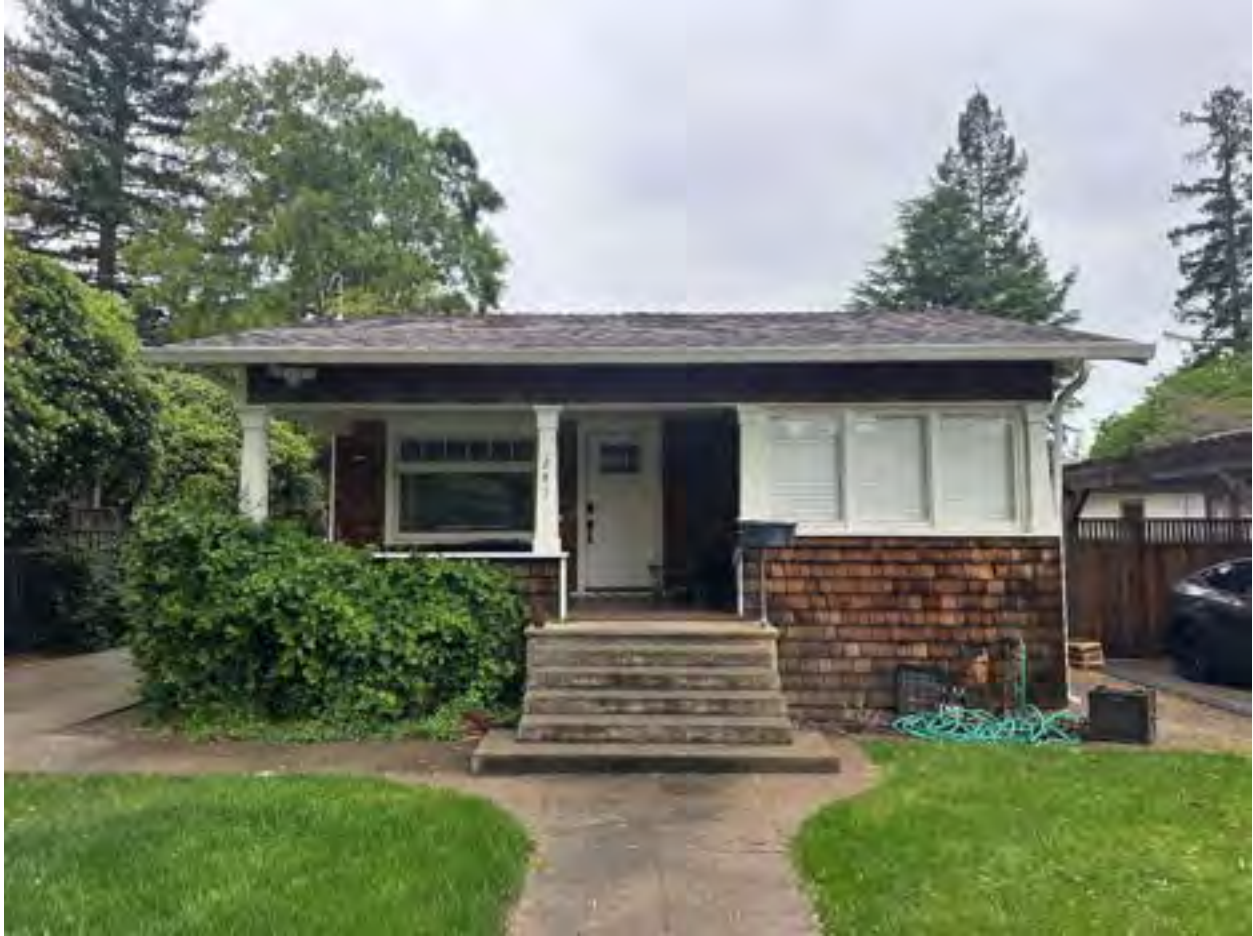
Figure 3. Subject Property at 241 Los Gatos Blvd

In contrast, the subject property does not retain these defining characteristics. As documented throughout this appeal, key architectural elements, including porch configuration, column design, window types, siding materials, roof detailing, and structural expression, have been altered or replaced with non-original and non-character-defining features.

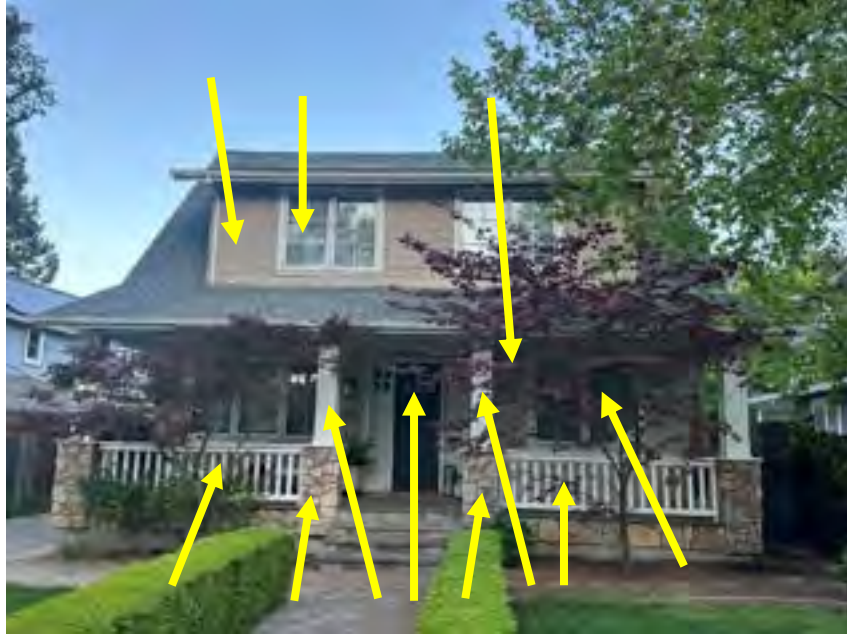
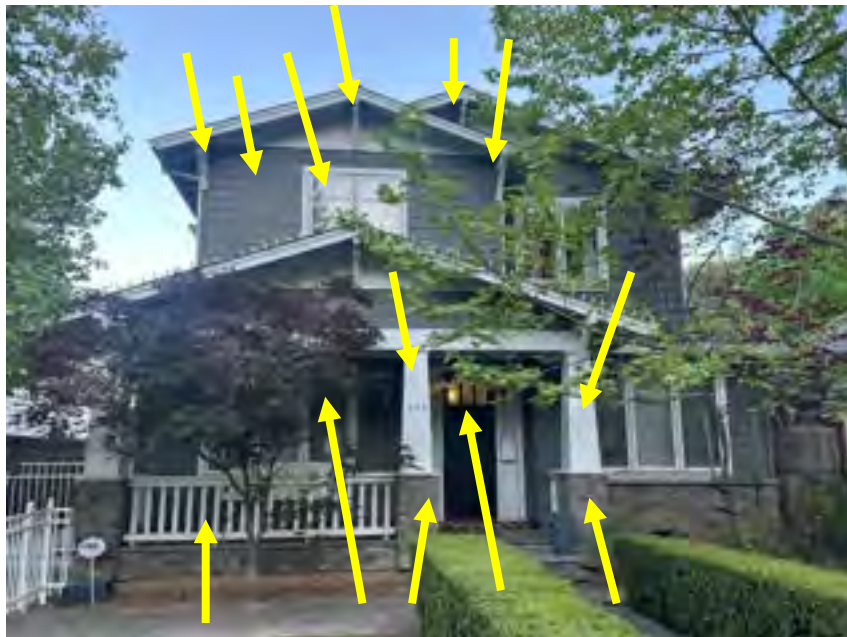
Figure 4. Highlighted Historic Features on Non-Historic Properties Across the Street

- Prominent front porches integrated under the primary roof form
- Tapered Craftsman-style porch columns set on masonry (stone) bases, including decorative column detailing
- Wood porch railings consistent with traditional bungalow design
- Decorative knee braces beneath wide eaves
- Horizontal wood clapboard siding, often combined with wood shingle siding on upper portions
- Entry door with multi-pane glass on the upper section
- Wood-framed windows with multi-pane upper sashes over single-pane lower sashes

The details are also highlighted in the images below:

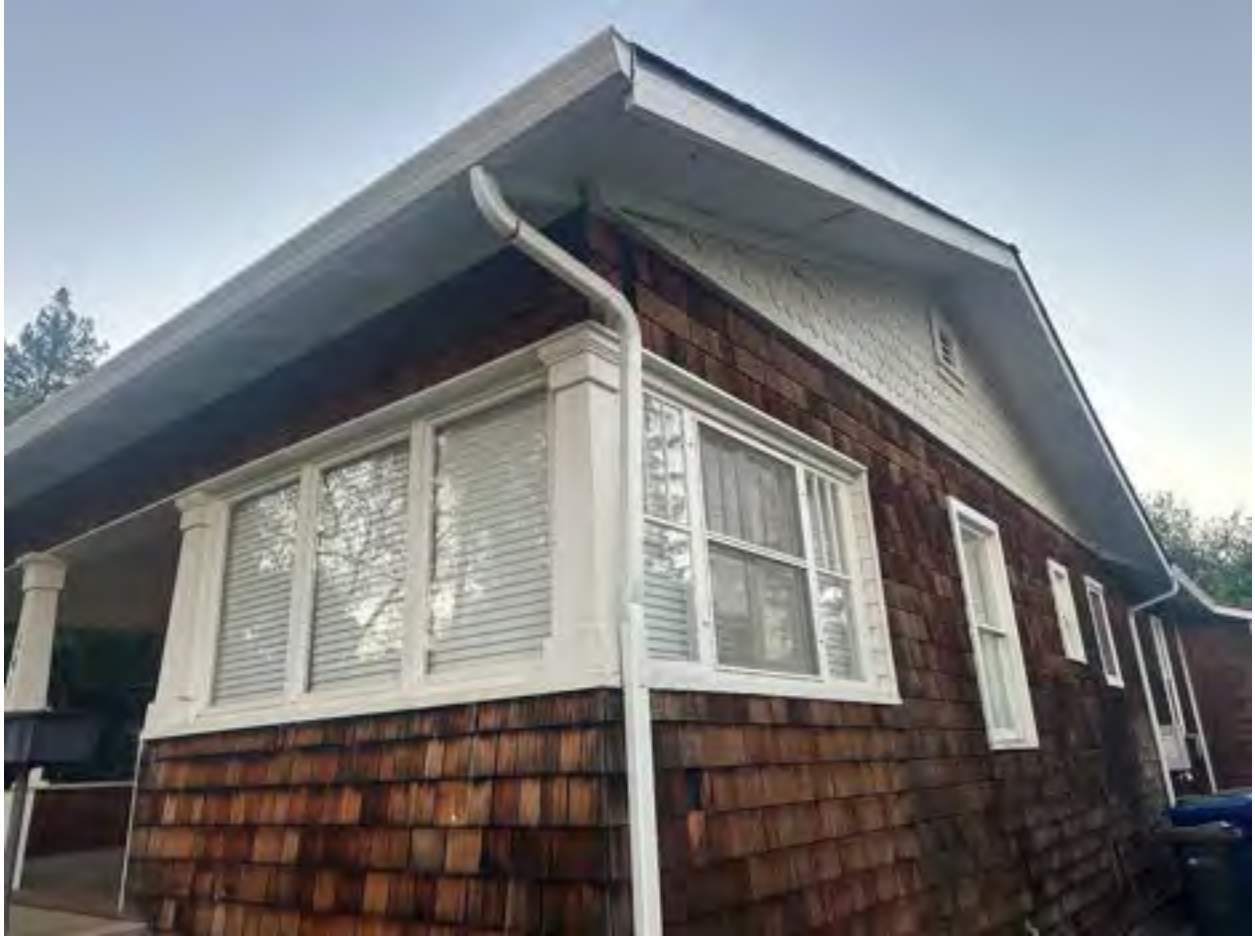
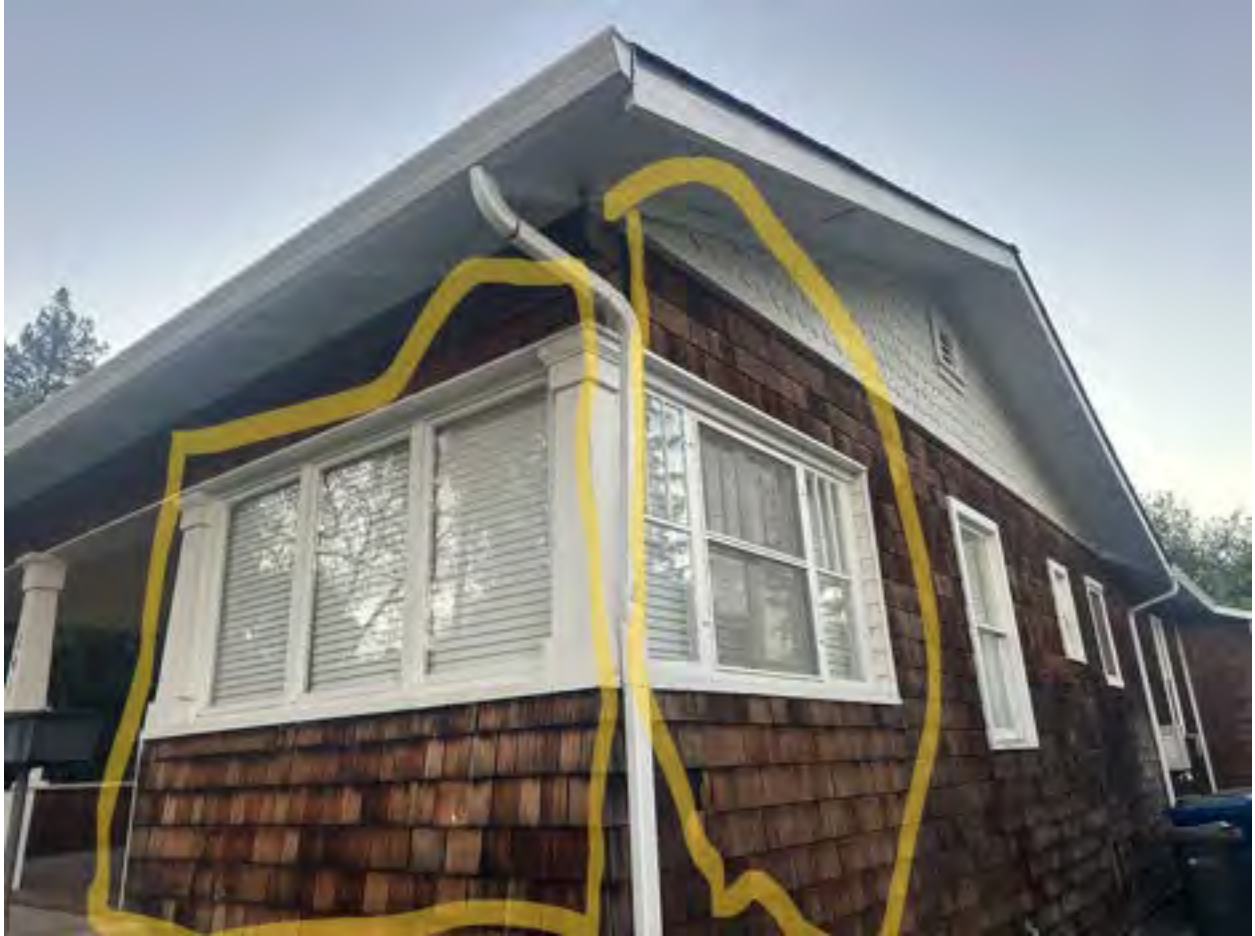
*Front Façade + North Side post-1956 Constructions (Marked Areas)*

*Front Façade + North Side post-1956 Constructions*
