Subject: Fwd: California Office of Historic Preservation Assessment of 33 Walnut

Property: 33 Walnut Avenue

Subject: Request for review of candidacy for addition to the California state historic registry

Subject: Request to Remove a Presumptive Historic Property (Pre-1941) from the Historic Inventory

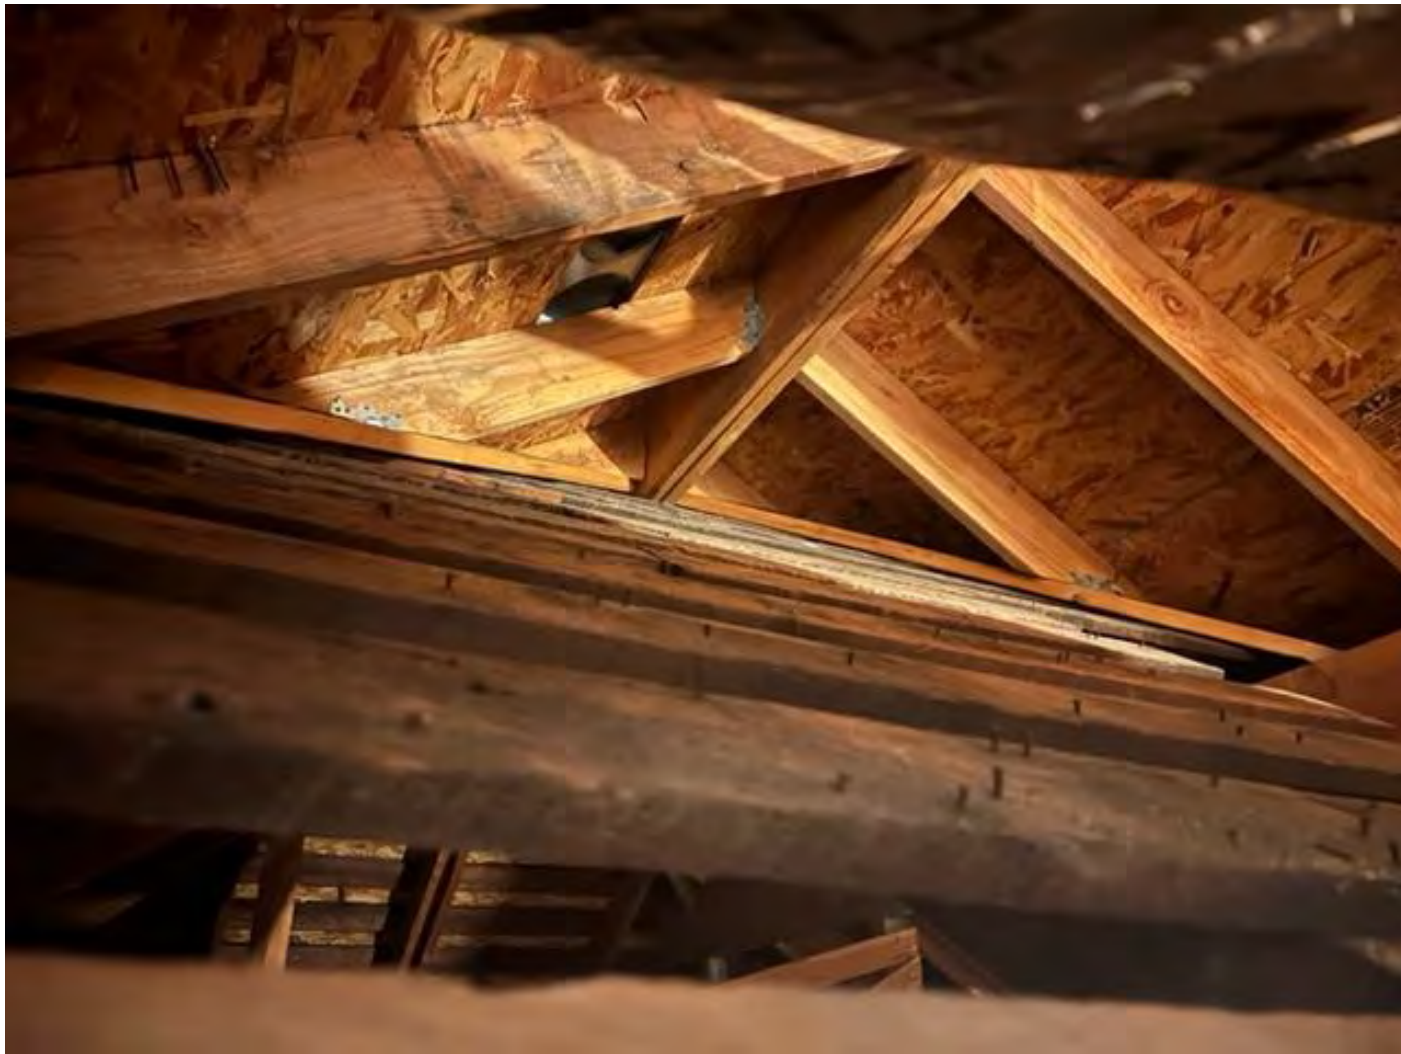
2. This photo shows the roof frame artifact remaining in the attic indicating precisely where the rear of the original house ended. This is hard evidence of the original structure not otherwise found in town records.

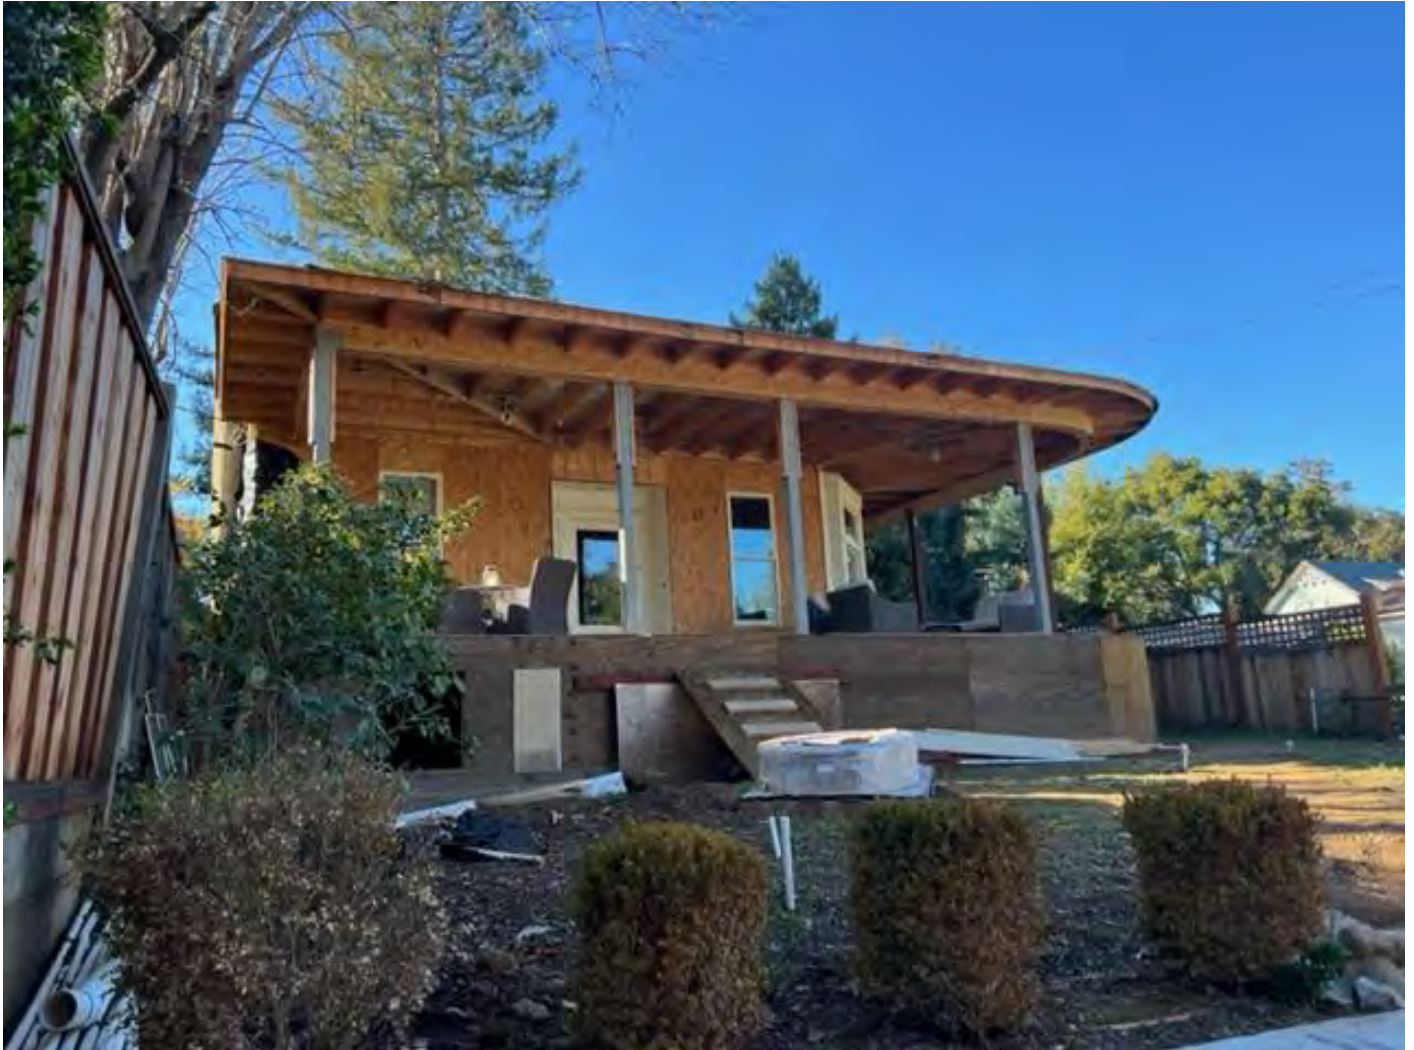
3. View of newly constructed front porch from Walnut Avenue:

While true to the Queen Anne style front porch architecture, the improvements in depth, height, and shape, together with the yet to be built new railing leaves no trace of the historic materials or construction methods..

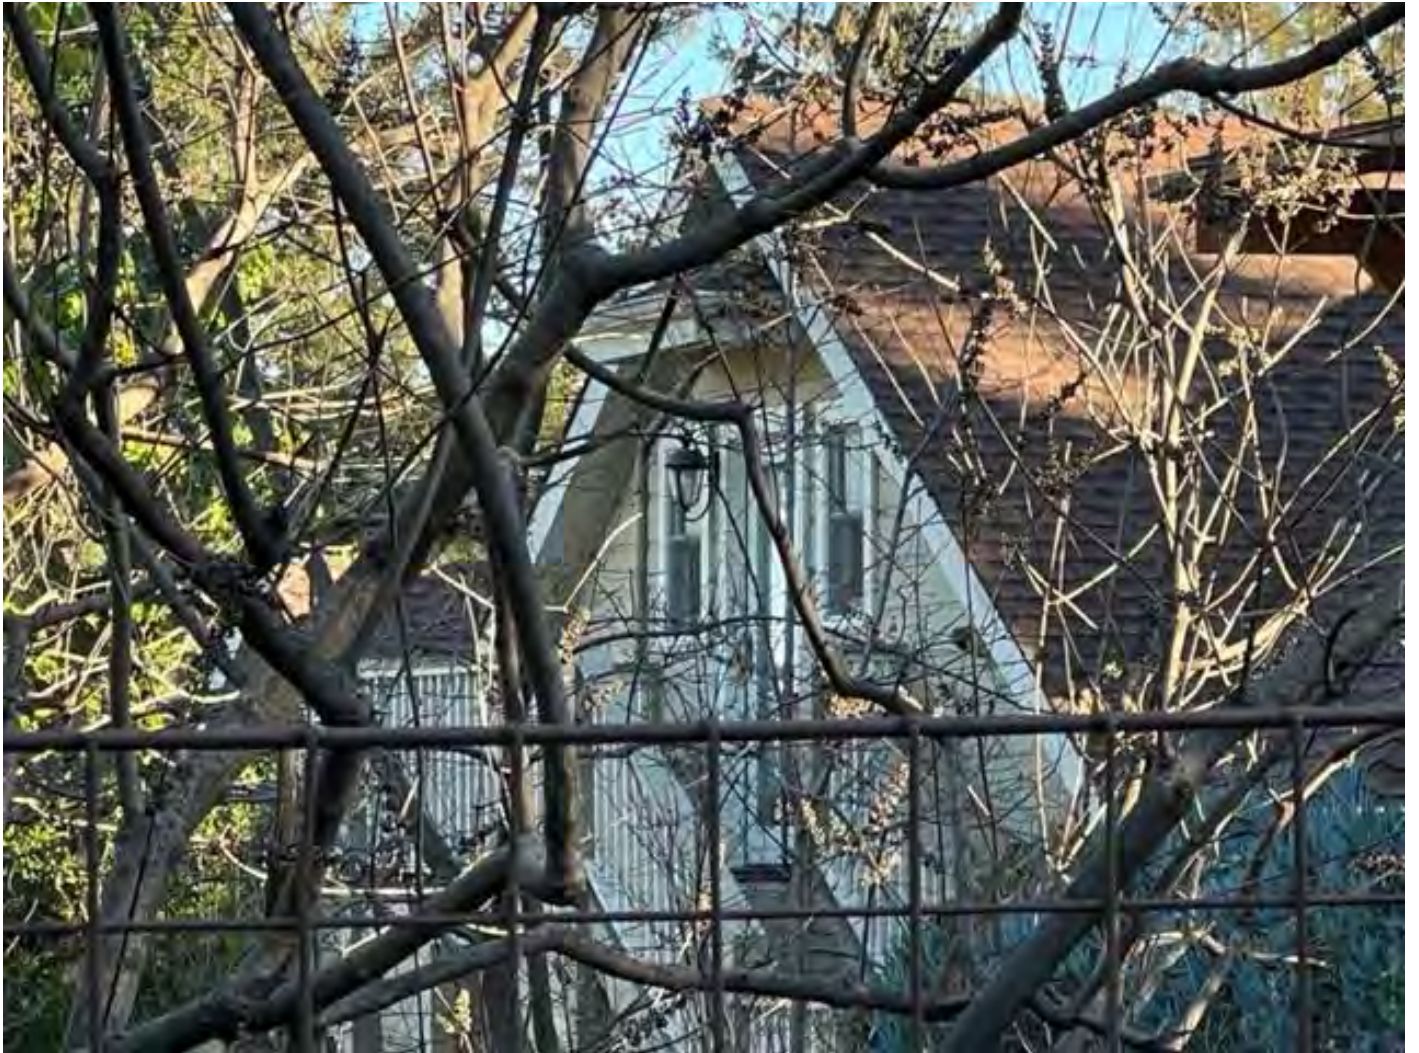
4. Northern Elevation View of 2007 massively altered second-story of 33 Walnut:
Clearly no longer a small 889 sf cottage.

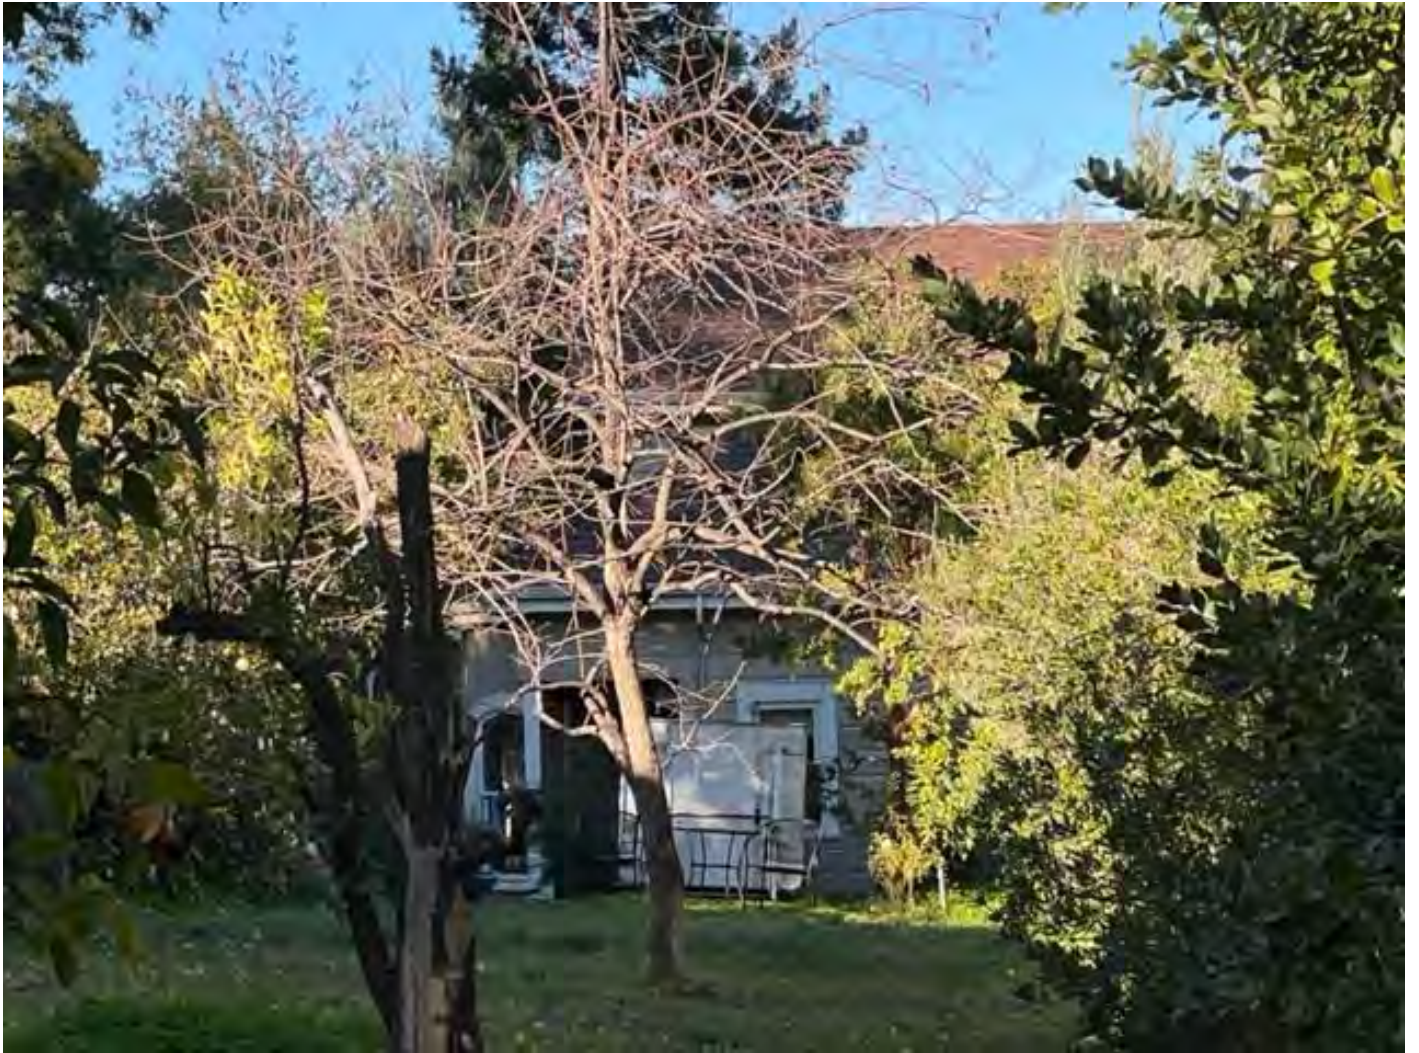
6. Southern View of the First/Second-story 2007 Additions with High Extended Roofline:
The second-story roofline dominates the view from the neighboring lot on the southern elevation.

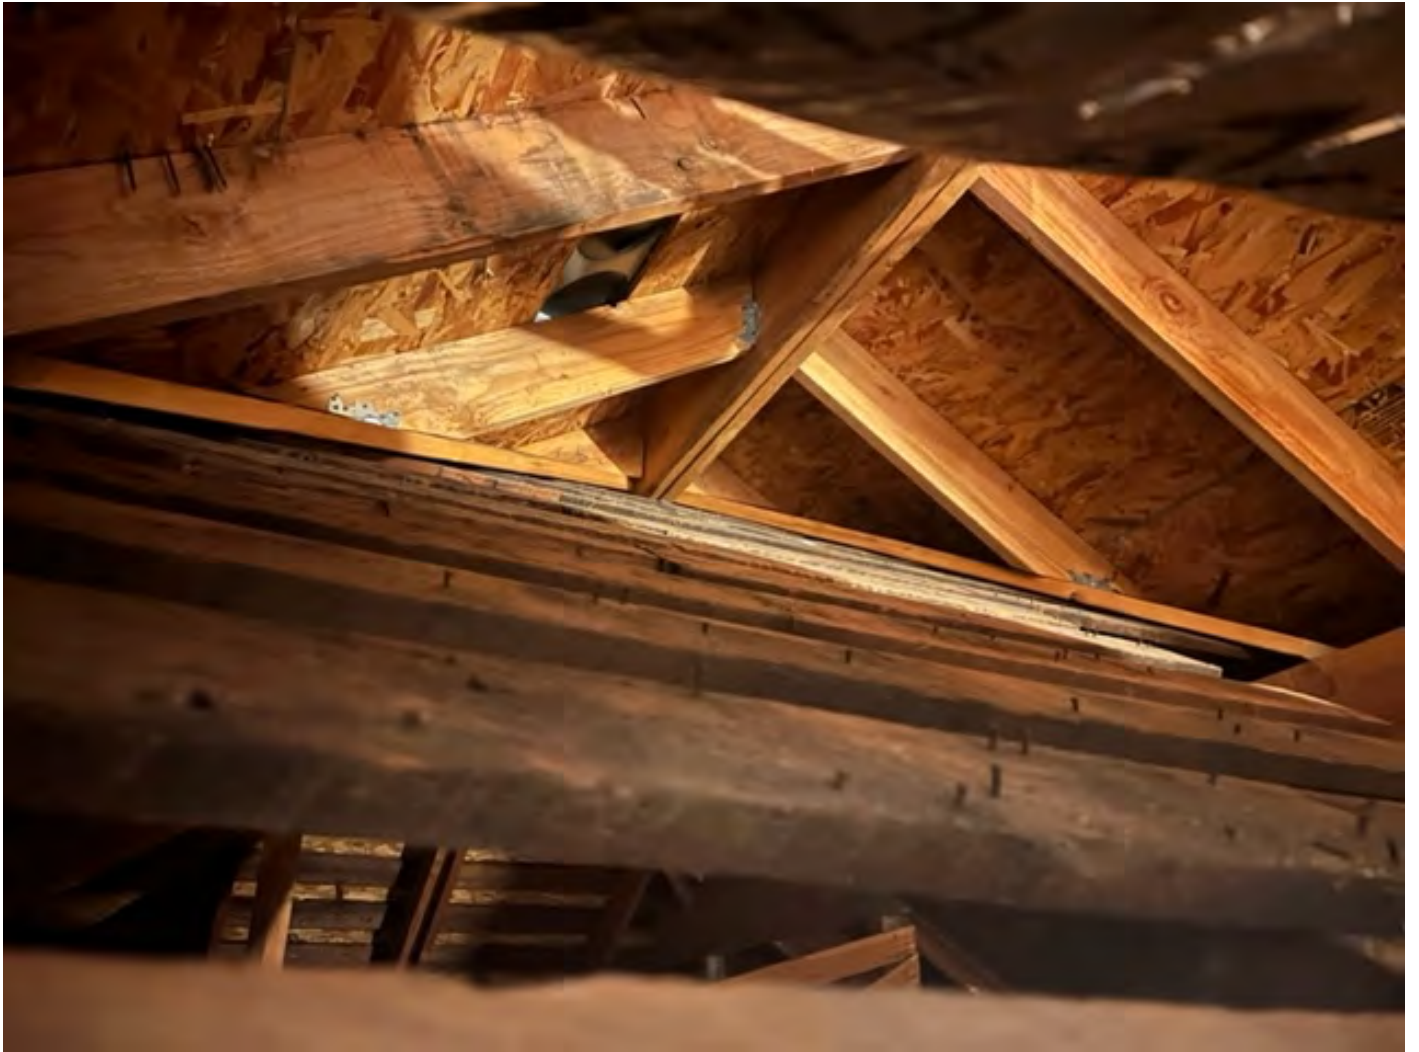
2. This photo shows the roof frame artifact remaining in the attic indicating precisely where the rear of the original house ended. This is hard evidence of the original structure not otherwise found in town records.

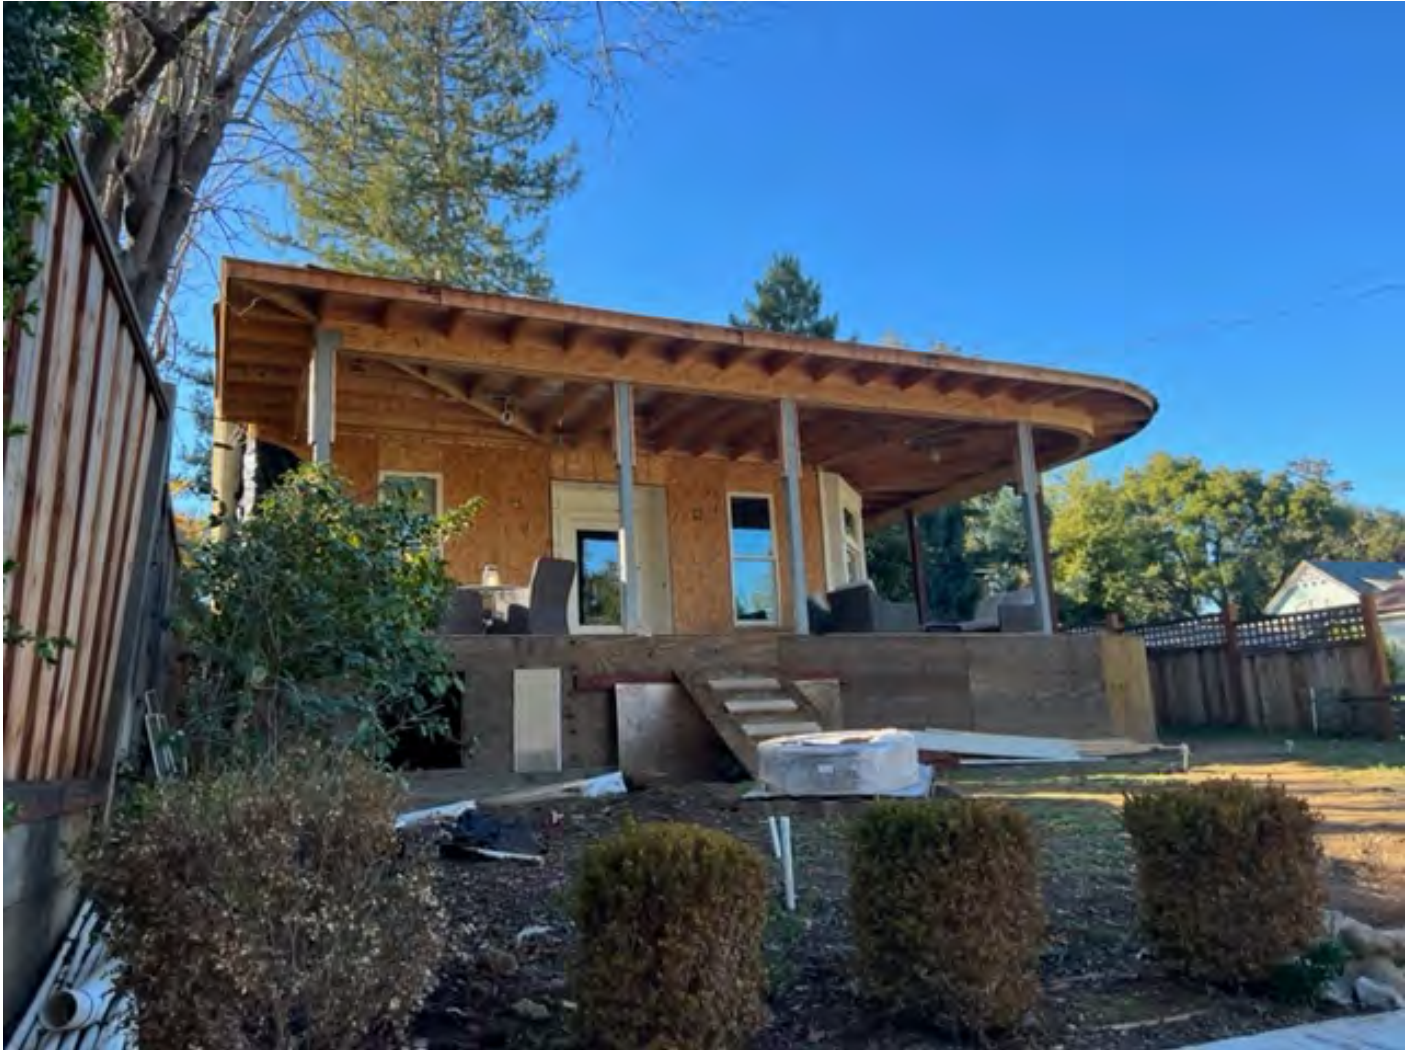
3. View of newly constructed front porch from Walnut Avenue:

While true to the Queen Anne style front porch architecture, the improvements in depth, height, and shape, together with the yet to be built new railing leaves no trace of the historic materials or construction methods..

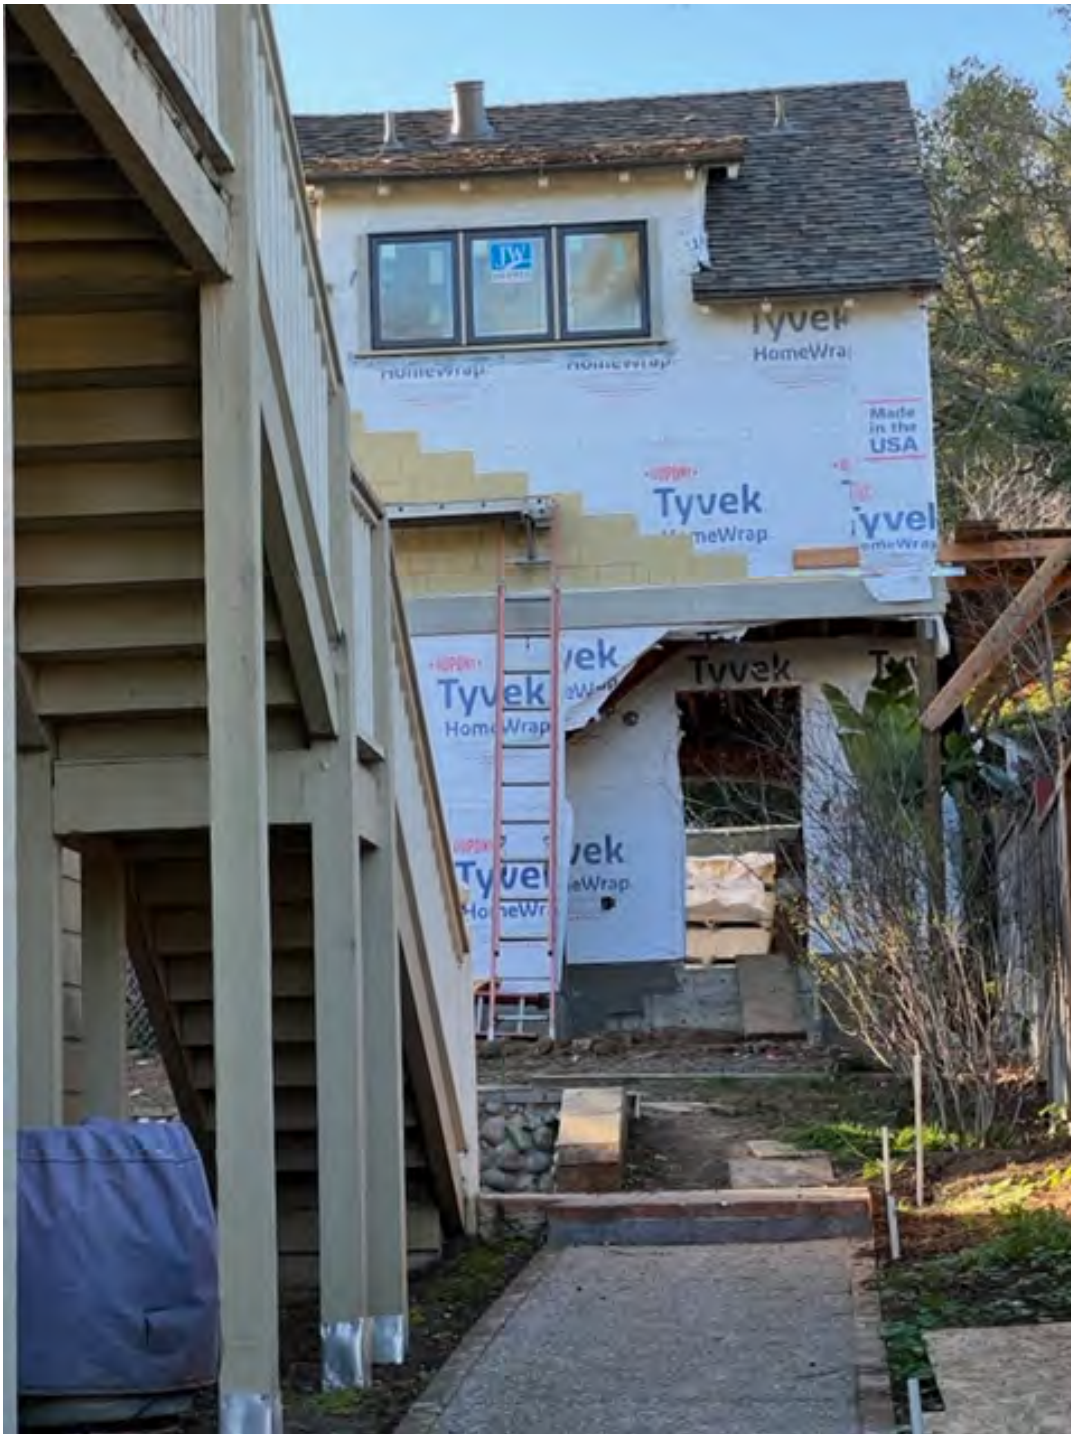
4. View from Walnut Avenue of Carriage House:

This photo shows both the 2007 built exterior staircase and the newly built carriage house structures, both visible from Walnut Avenue.

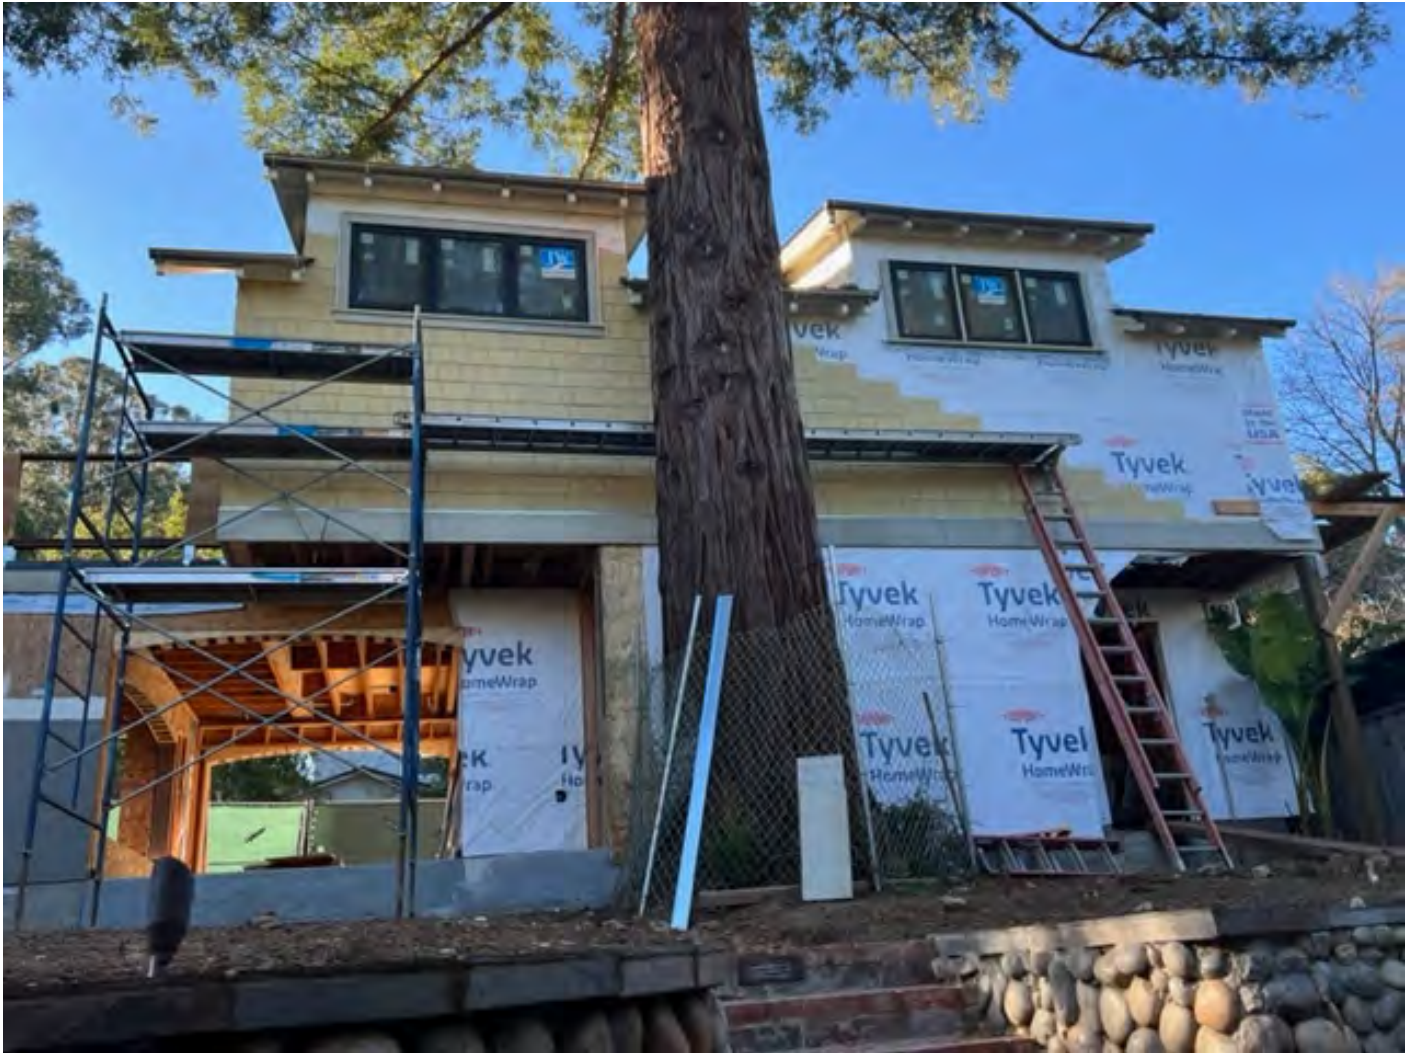
5. East-facing View of 2021/22-built Carriage House from Rear of Main Residence:
No longer is there any view looking out onto Wissahickon from the original house.

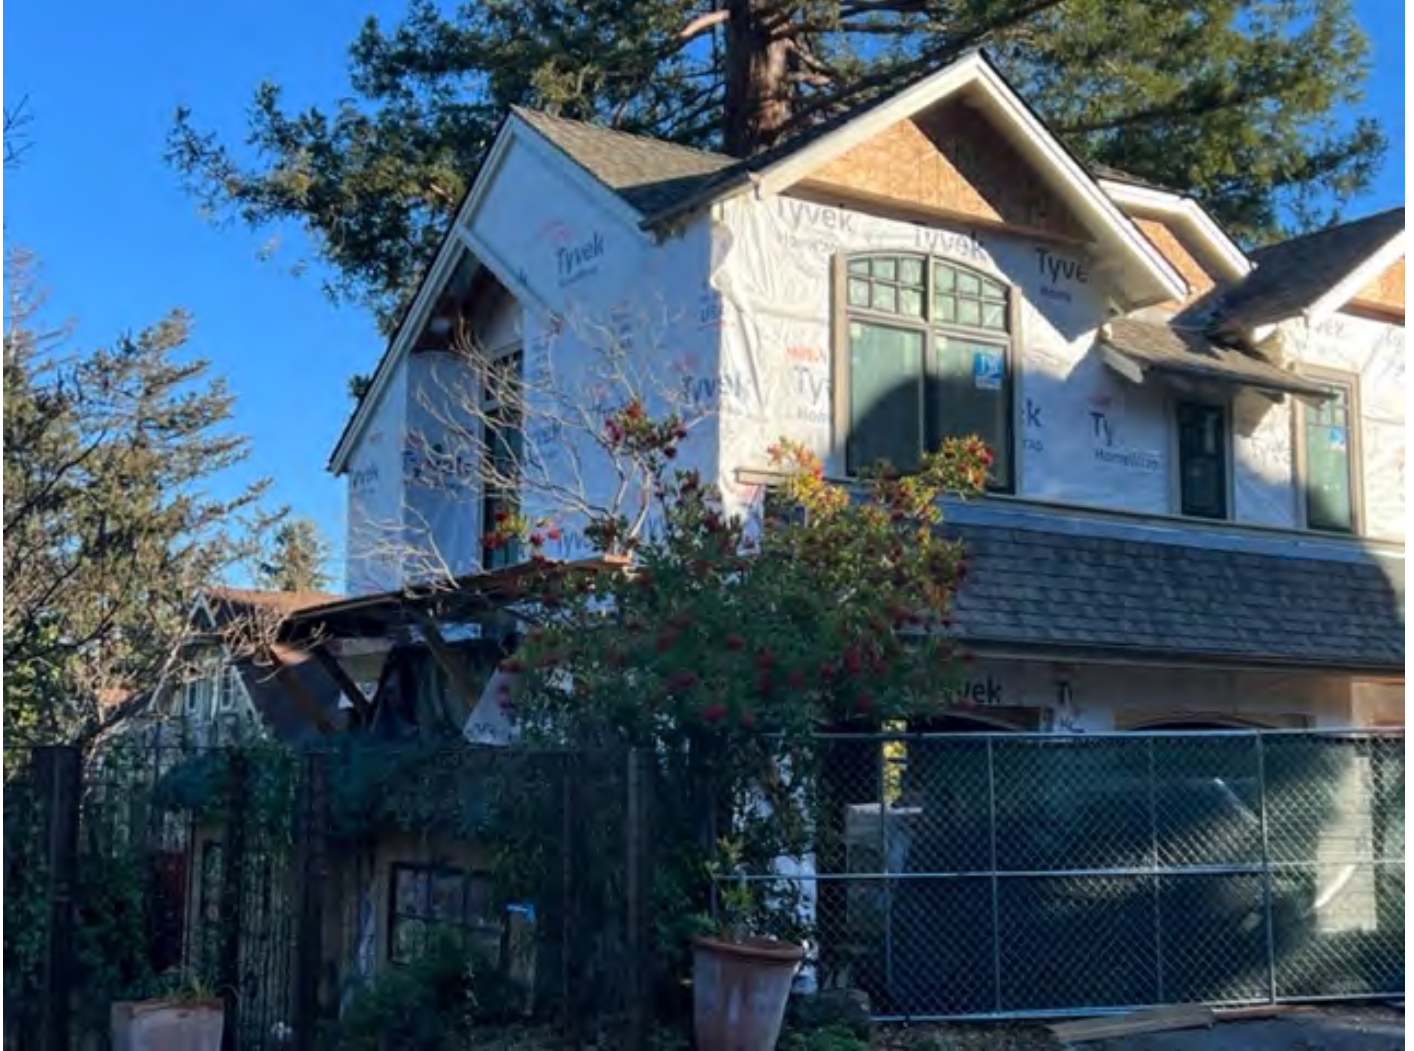
6. Northwest view of gabled 2nd-story of 33 Walnut plus 2021/22-built Carriage House:
Visibility from Wissahickon the Walnut facing house clearly reveals an entirely different residence than the single-story house originally built with a wide-open view lot.

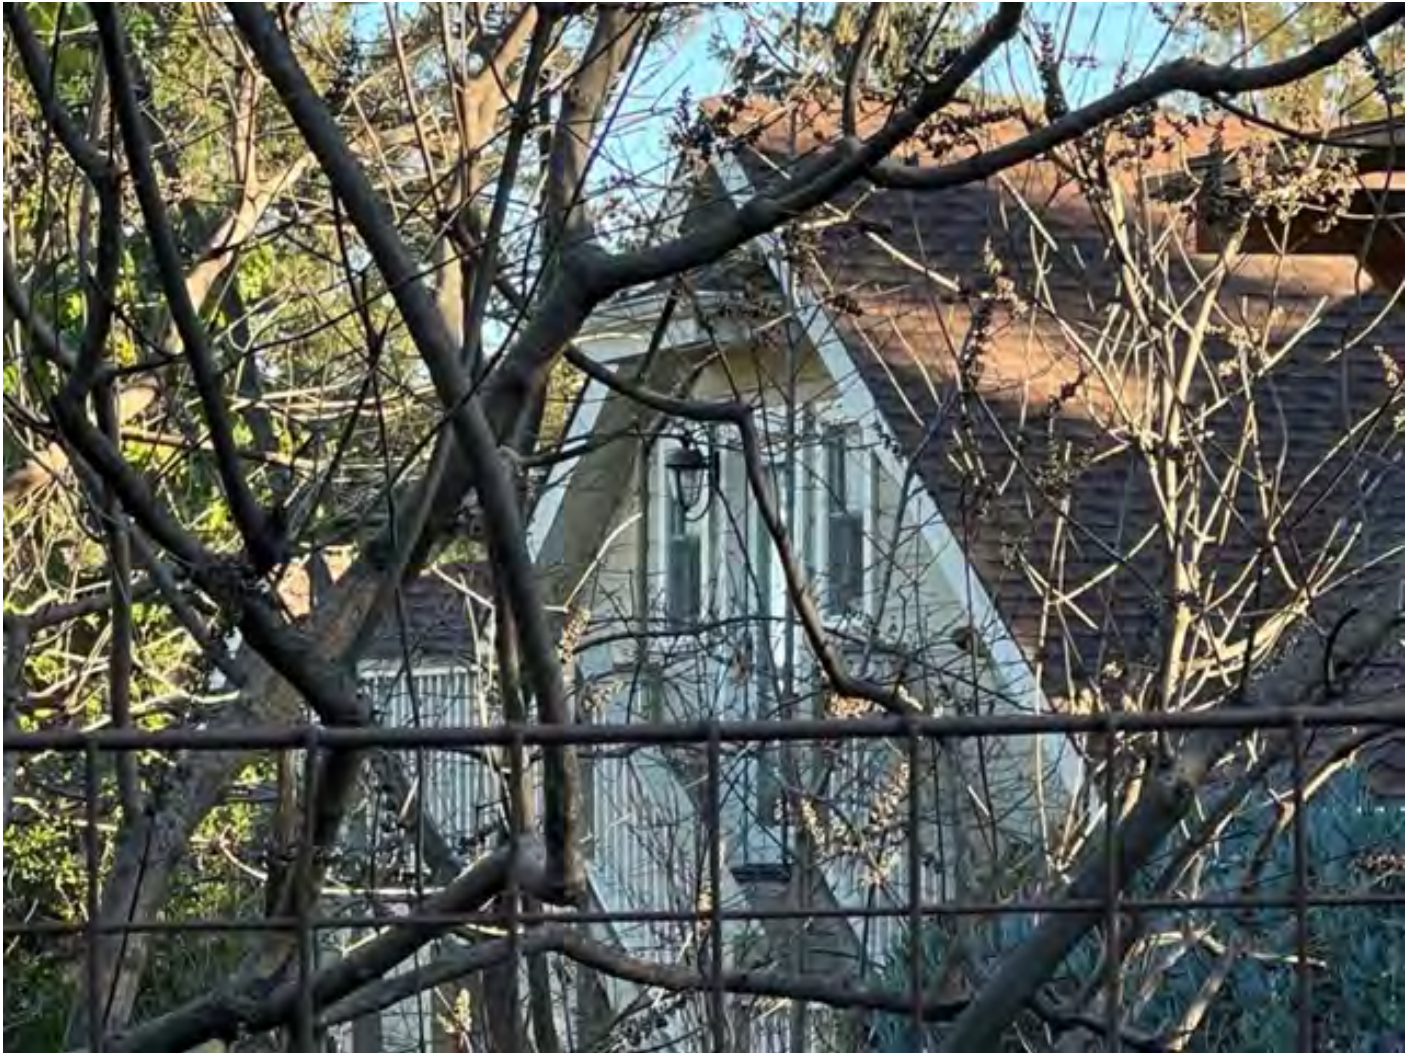
7. Northern Elevation View of 2007 massively altered second-story of 33 Walnut:
Clearly no longer a small 889 sf cottage.

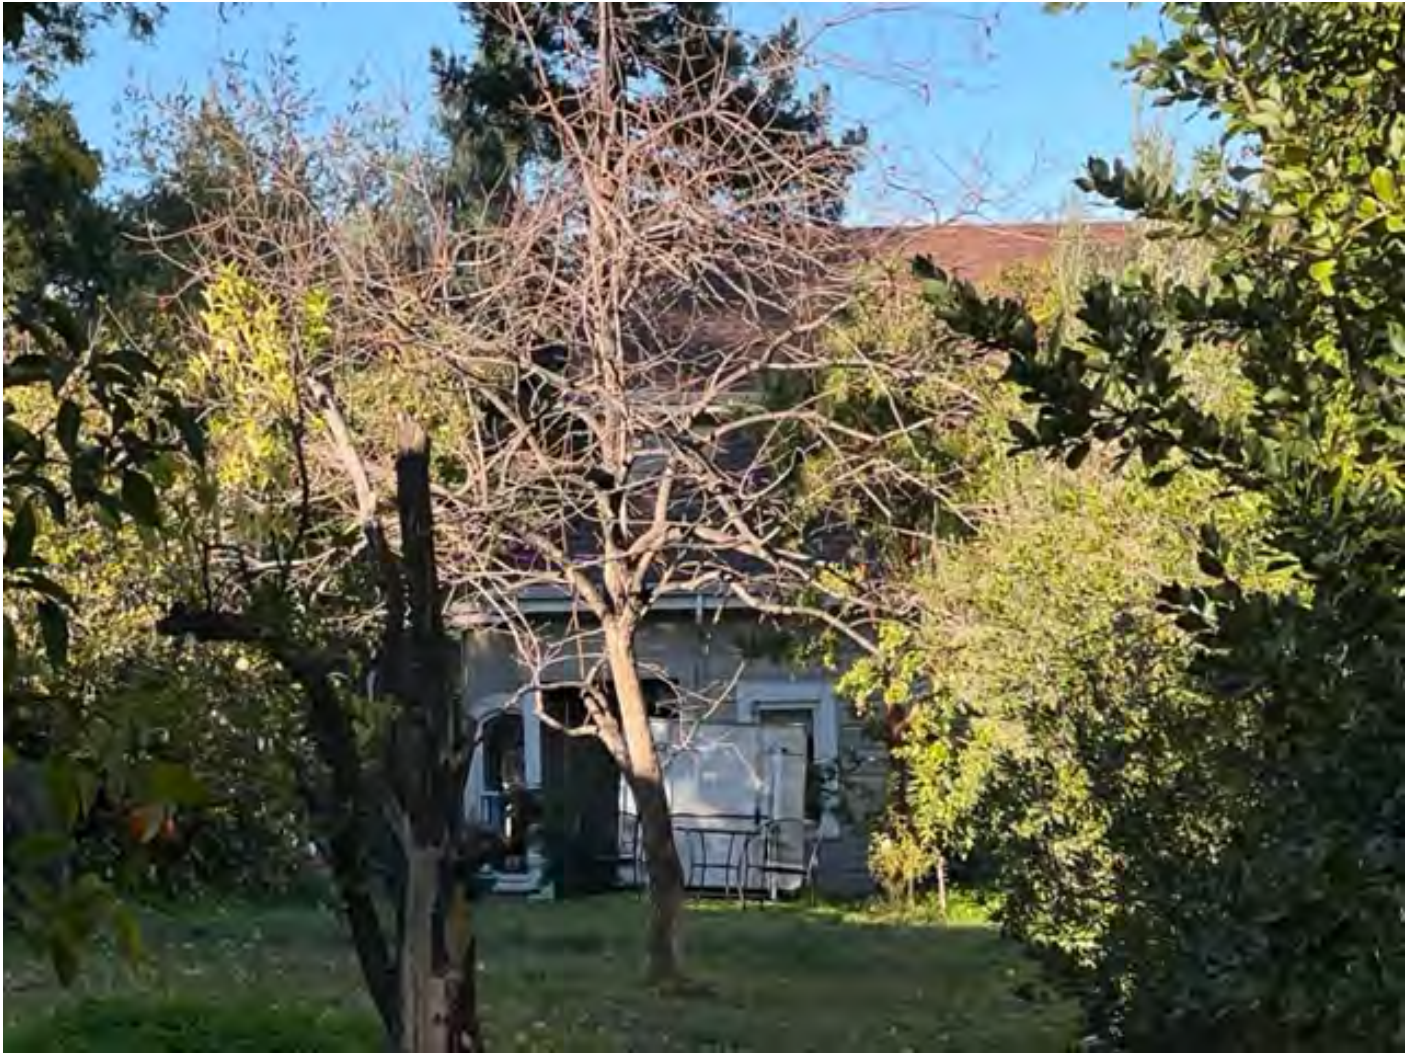
9. Southern View of the First/Second-story 2007 Additions with High Extended Roofline:
The second-story roofline dominates the view from the neighboring lot on the southern elevation.
