AddendumC- Removal of Original Front Façade Materials

Addendum D. Removal of Original South, West, and North Materials

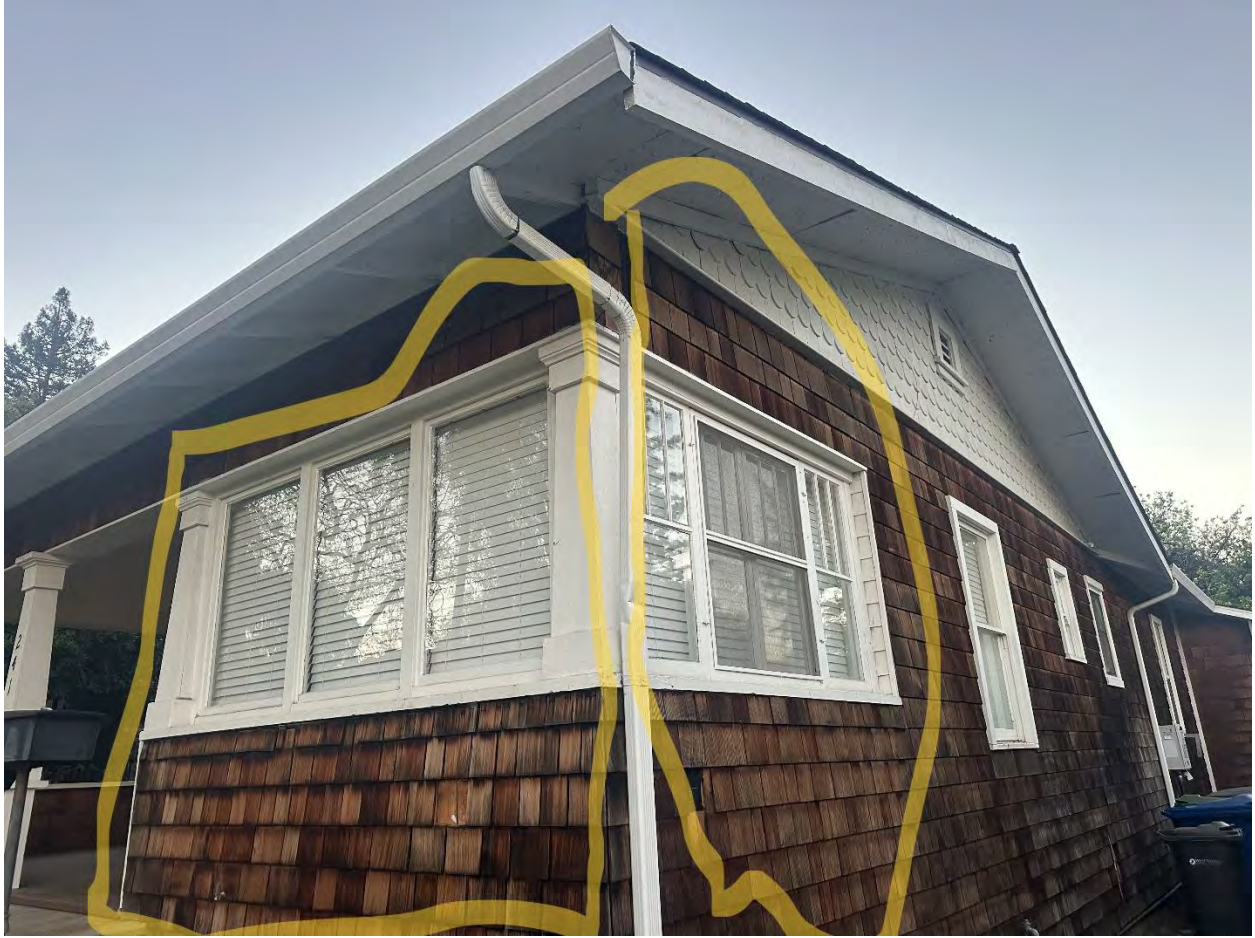
Front Façade + North Side post-1956 Constructions (Marked Areas)

Based on the above site maps, the original house was with that of a perfect rectangle with a porch covering the whole front side of the house. The current structure has and added office to the front room (adding part of the original porch to the bedroom) as well as an addition to the backside of the house. Both walls on the front and back of the house were demolished and the additional structures are made with a uniform flow within the original structure (no separating walls).
