55 Ellenwood Ave.

# **Appeal of HPC Ruling to Planning Commission**

January 8<sup>th</sup>, 2025

STUDIO**THREE**DESIGN  
ARCHITECTURE | INTERIORS

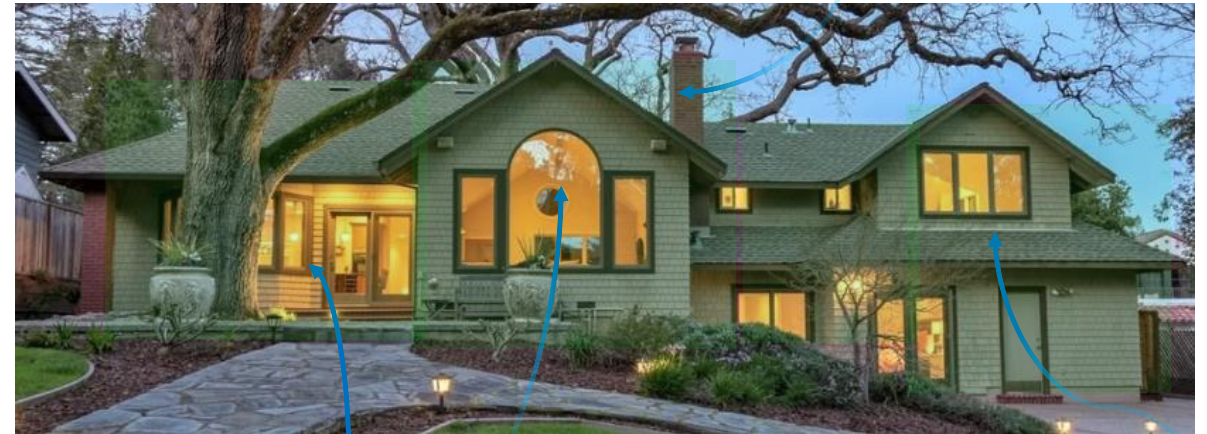
Contemporary veneer stone chimney

1998 Approved Permit

2019 Image

100% NEW ADDITION

Contemporary grand arched window at new living room addition

Contemporary windows at new game room addition

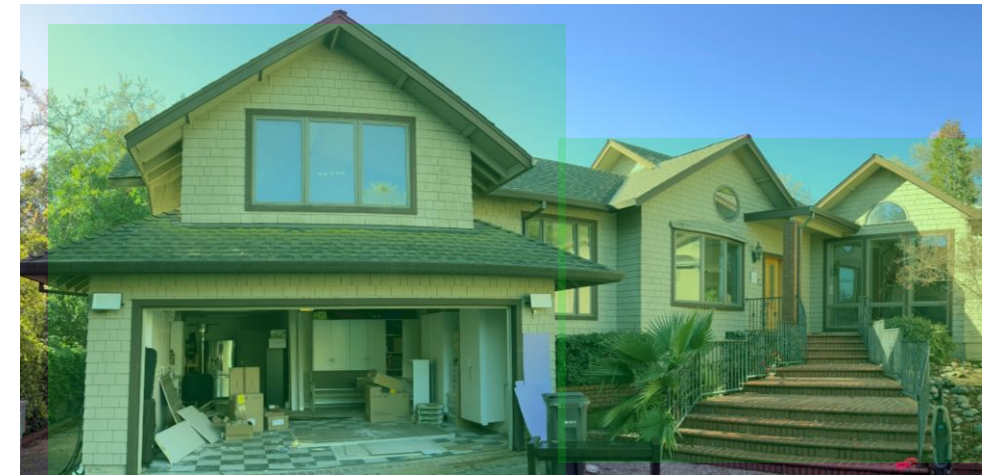
1998 Proposed North Elevation (Approved)

2024 Image

100% NEW ADDITION

Contemporary swinging windows above modern door panels

Contemporary fenestration configuration + type

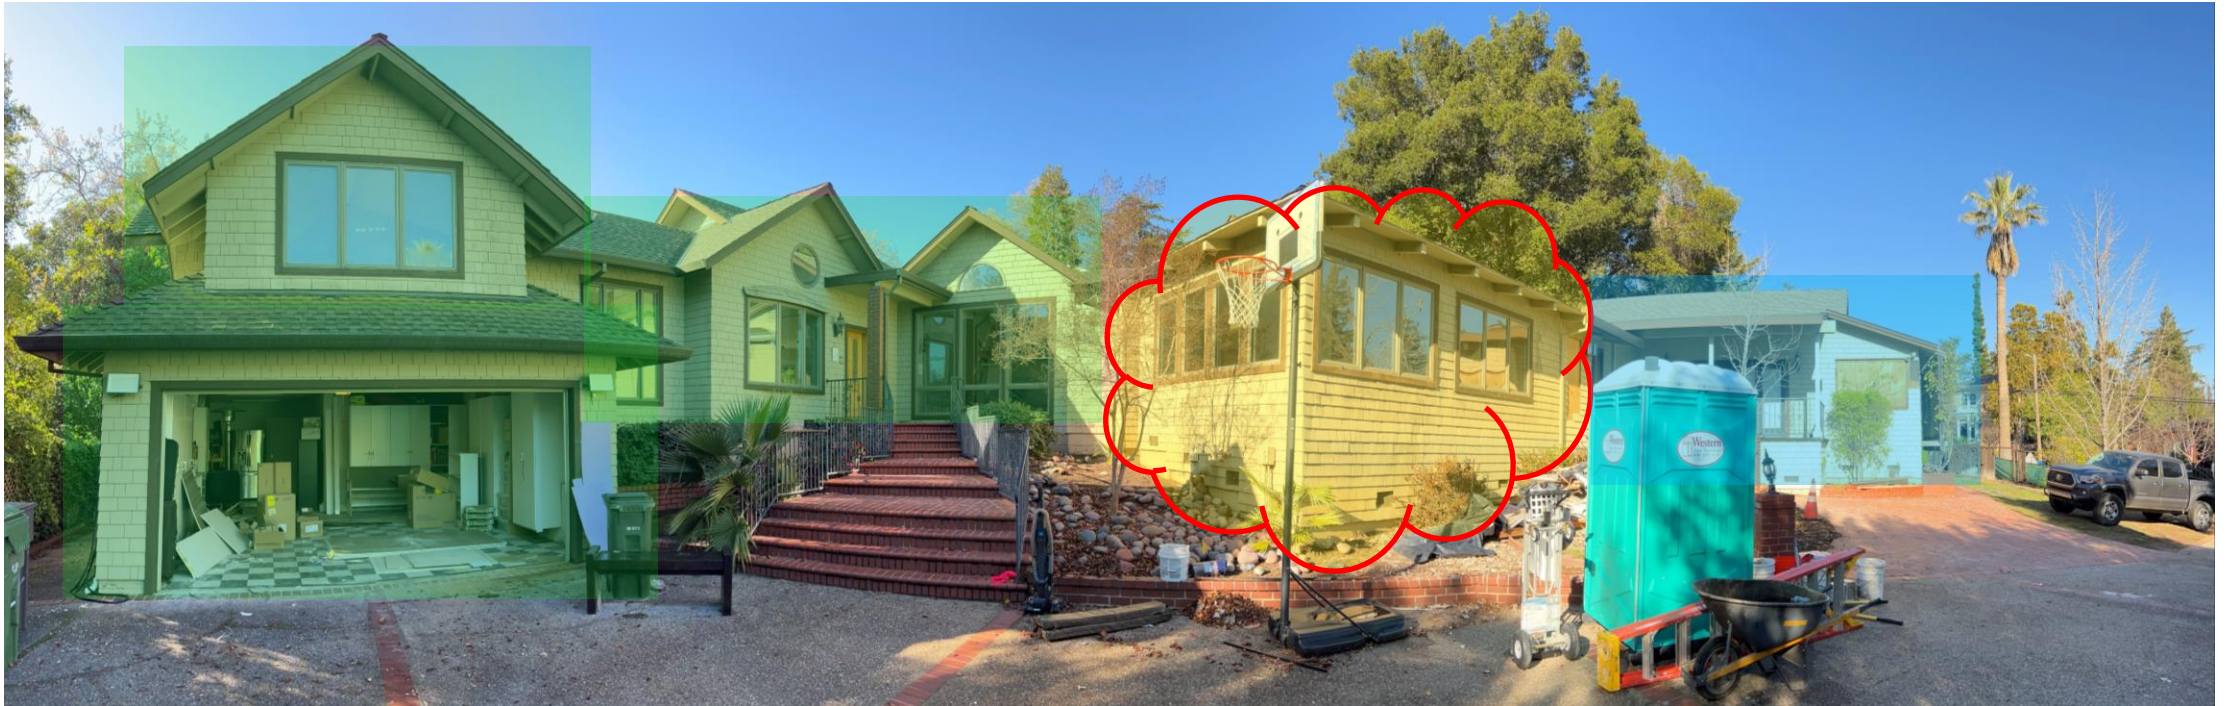
## **Current Photo of Existing House (2024)**

NEW ADDITION (1998)

ORIGINAL STRUCTURE

NEW ADDITION (1994)
