Monarch Consulting Arborists

| Subject: | Response to 4 th round Surrey Farms Consulting Arborist Review Letter | | |

This letter is in response to the latest submission for 178 Twin Oaks Drive (Surrey Farms) dated July 25, 2025. Enclosed is the prior response and the applicant's response to that submission. Enclosed are the most recent peer review comments and recommendations.

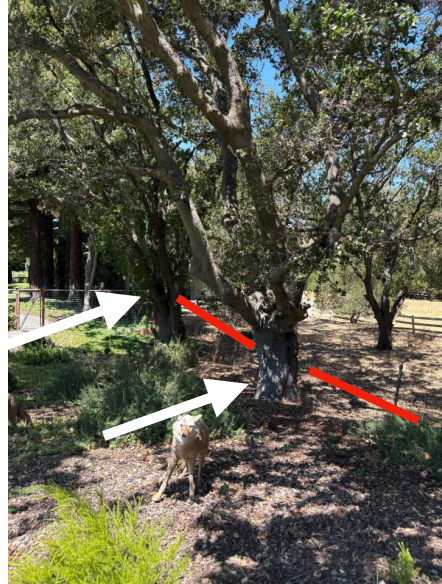
IMAGE 1: ADJACENT OAKS 221 BROOK ACRES

1. **Comment: Lot 3:** Lot 3 has a retaining wall around the site and along the property boundary adjacent to 221 Brook Acres Drive. There are two large trees, one valley oak (*Quercus lobata*) and one coast live oak (*Quercus agrifolia*) located on 221 Brook Acres Drive not accounted for in the plans, survey, or tree detail. Trees within 30 feet of the property boundary are to be included in survey and arborist's report. There are many trees "off site" included in the report but these are not.

- A. **Recommendation:** Tree protection for these two boundary trees is required. An adjustment to the wall location may be required as both trees are at or very close to the property boundary (Image 1). Include trees within 30 feet of the property in the plans and report.

- B. **Recommendation:** Work performed within the drip line or twenty feet (20') of the trunks requires monitoring and documentation from the project arborist. Any work performed to the trees requires specifications in writing according to the most recent ANSI A300 document pertaining to the activity (Pruning, Soil Management etc.)

HMH Response: Trees mentioned in comment are located within project boundary and called out in report and tagged for removal under numbers 566 and 569.

MCA: This item is currently unresolved. Ground observations of the tree locations do not appear to match what is indicated on the plans versus what is observed on site.

Recommendation: Please accurately locate the trees or verify their location accuracy. Please provide methodology used to obtain tree locations for the site. For example “the trees were surveyed by a California licensed engineer” or “trees were located with a GPS receiver with an error of “X” feet and plotted on a plan or aerial map”.

HMH October Response: Please see the updated Landscape T-Sheets for lot 3 and the “Overall” for updated tree 566 and 569 tree locations. The 2 trees are now listed to remain and protect. This information is reflected in the updated Arborist report as well.

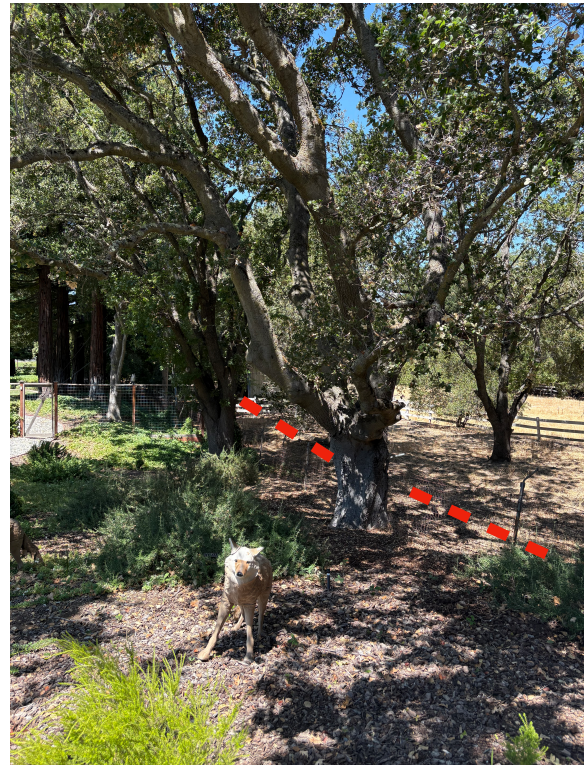
IMAGE 1: ADJACENT OAKS 221 BROOK ACRES

1. **Comment: Lot 3:** Lot 3 has a retaining wall around the site and along the property boundary adjacent to 221 Brook Acres Drive. There are two large trees, one valley oak (*Quercus lobata*) and one coast live oak (*Quercus agrifolia*) located on 221 Brook Acres Drive not accounted for in the plans, survey, or tree detail. Trees within 30 feet of the property boundary are to be included in survey and arborist's report. There are many trees "off site" included in the report but these are not.

- A. **Recommendation:** Tree protection for these two boundary trees is required. An adjustment to the wall location may be required as both trees are at or very close to the property boundary (Image 1). Include trees within 30 feet of the property in the plans and report.

- B. **Recommendation:** Work performed within the drip line or twenty feet (20') of the trunks requires monitoring and documentation from the project arborist. Any work performed to the trees requires specifications in writing according to the most recent ANSI A300 document pertaining to the activity (Pruning, Soil Management etc.)

. HMH Response: Trees mentioned in comment are located within project boundary and

MCA: This item is currently unresolved. Ground observations of the tree locations do not appear to match what is indicated on the plans versus what is observed on site.

Recommendation: Please accurately locate the trees or verify their location accuracy. Please provide methodology used to obtain tree locations for the site. For example “the trees were surveyed by a California licensed engineer” or “trees were located with a GPS receiver with an error of “X” feet and plotted on a plan or aerial map”.
