# **Erdman Conservation Area**

## **Stewardship Plan**

**October 2021**

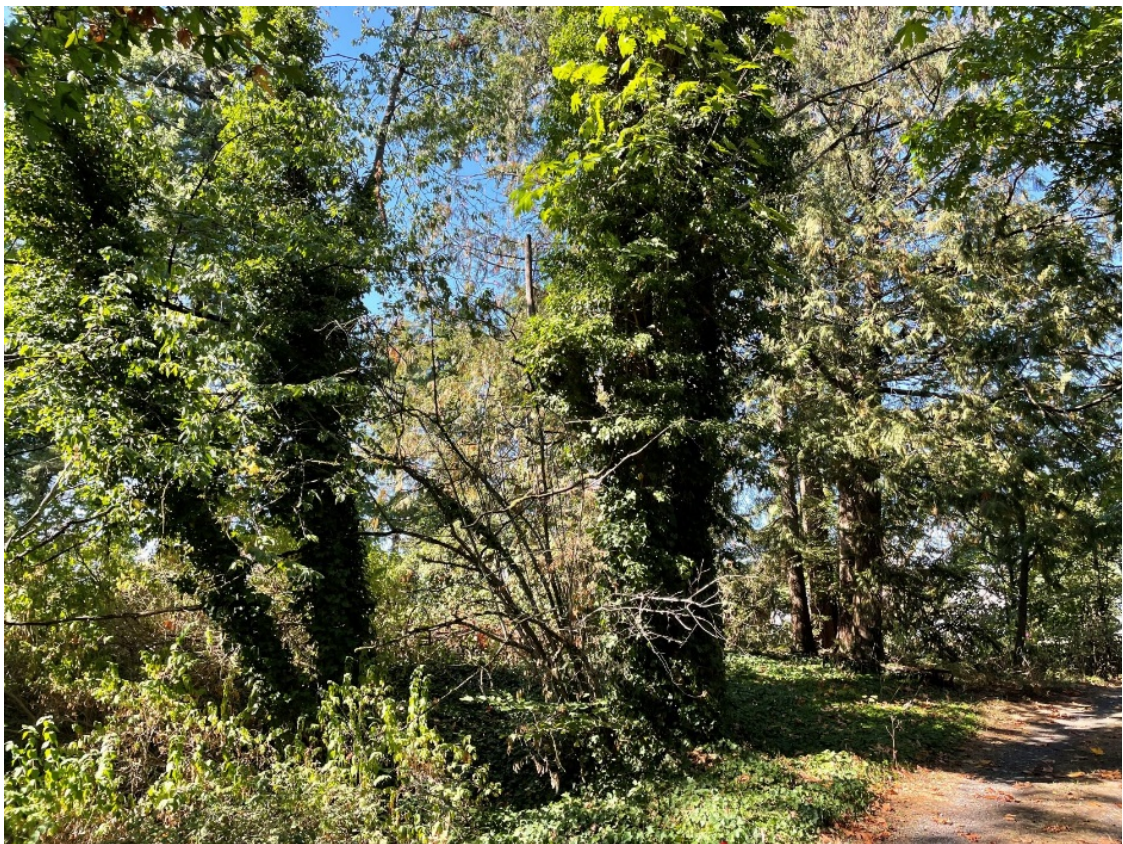
The riparian zone of Pepin Creek through this property is vegetated on the south parcel. The ground cover is dominated by invasive species, particularly English Ivy which is migrating up existing tree trunks wherever possible. The riparian zone on the north parcel contains insufficient cover, is characterized by a few scattered trees, unmaintained lawn, and the accessory structures to the house.

Care for the existing large healthy trees. Remove buildings from the parcels. Aggressive control of invasive plant species.

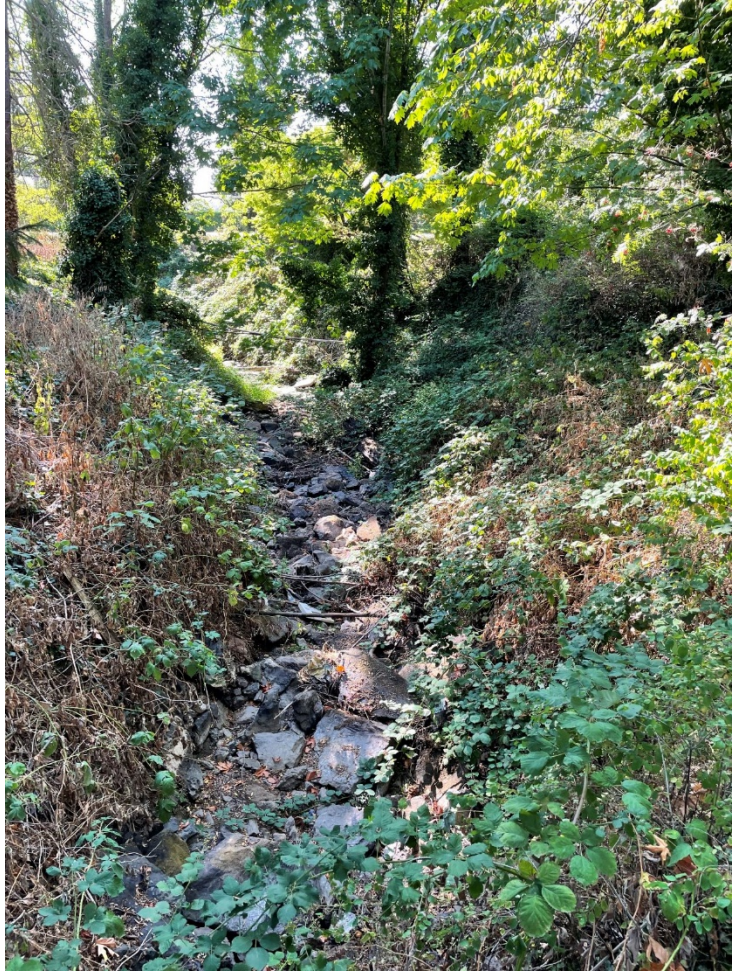
The property is dominated by the presence of the Pepin Creek channel. There are no wetlands on the property. Pepin Creek is fed by groundwater and surface water runoff throughout the watershed.

Protect the streambanks from erosion and restore natural hydrogeomorphic processes where feasible.

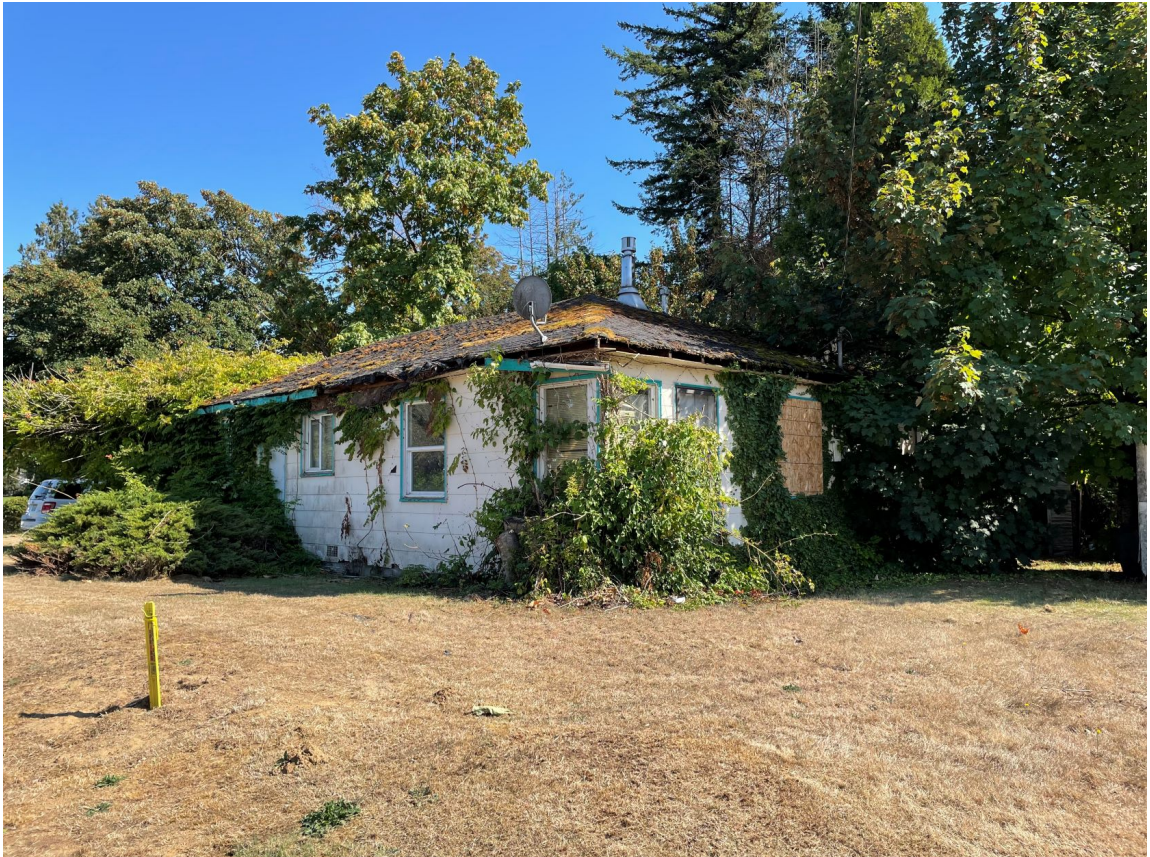
The upland portion of the Erdmann property contains the deteriorating house and accessory structures. There is also a hardened (not paved) driveway and parking area.

Appropriately remove the structures, finalize the future use of the property, and restore/enhance the existing stream buffer with native plantings and invasive species control.

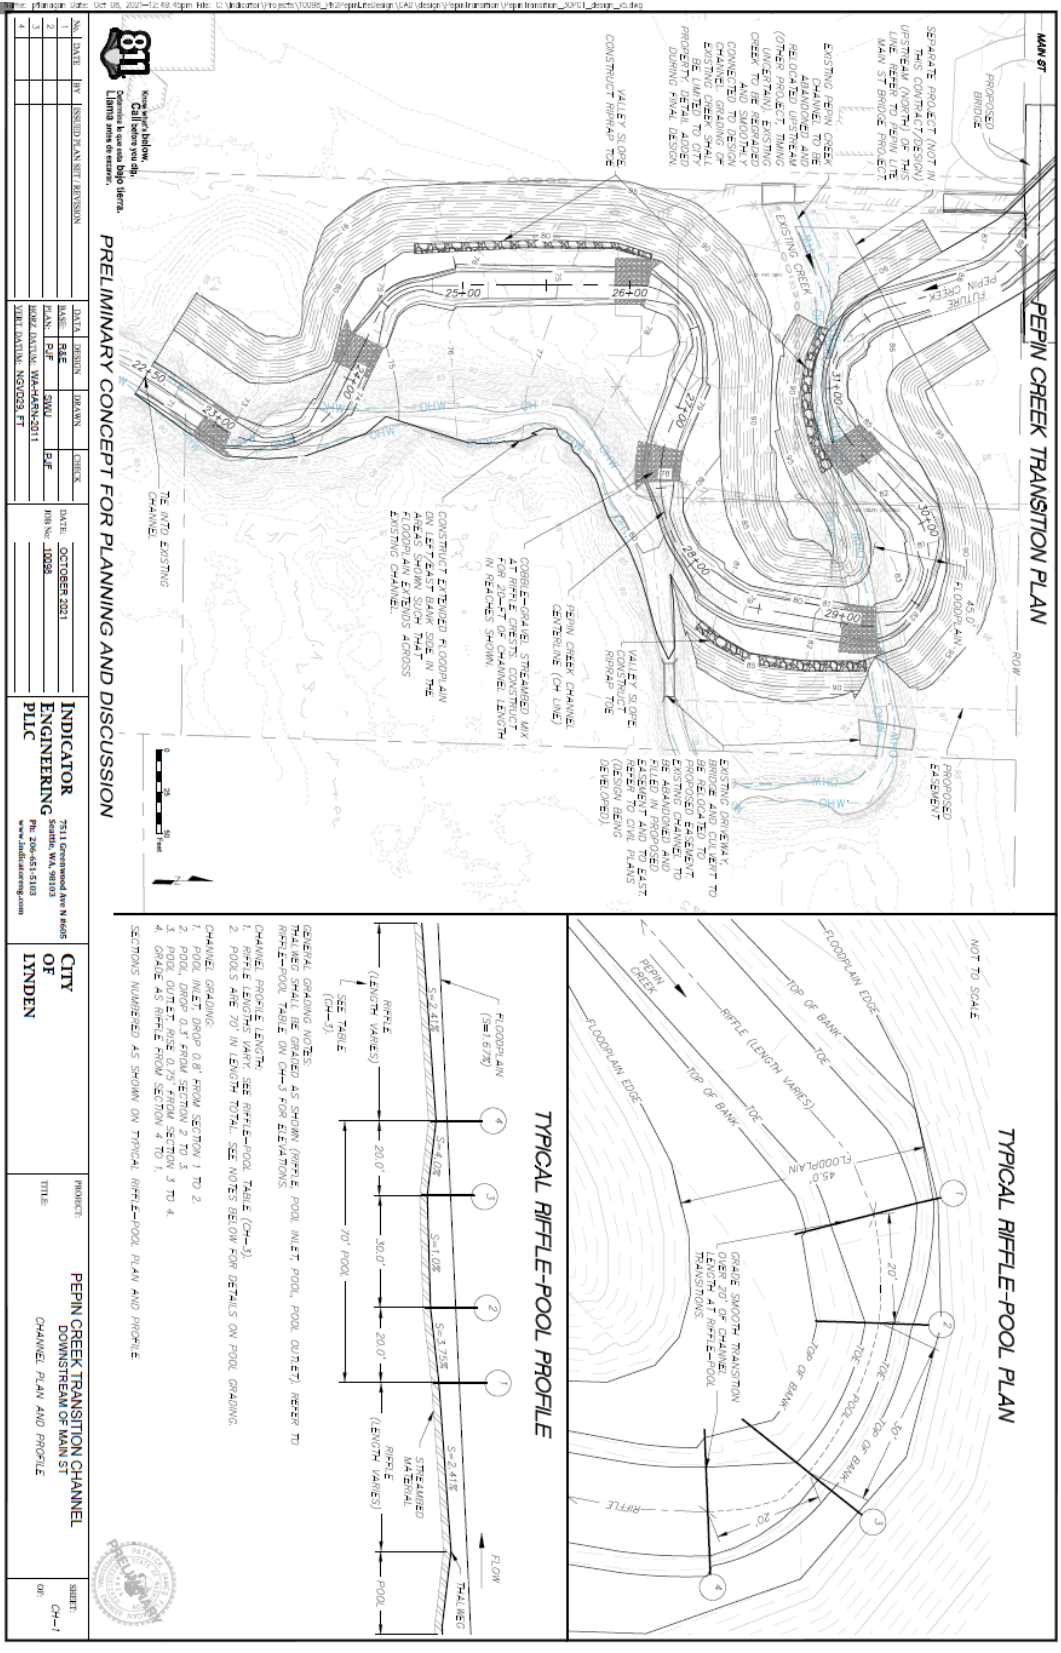
# Exhibit 1: Preliminary Shoreline Stabilization and Channel Regrade

Regrade and relocate the channel through this property. Restore natural streambank, remove concrete sidewalk pieces, and enhance spawning gravel locations throughout the system. See Exhibit 1 for preliminary regrade concept.
