**Dickinson Park Conservation Area
Lynden Parks Department**

Stewardship Plan

September 2021

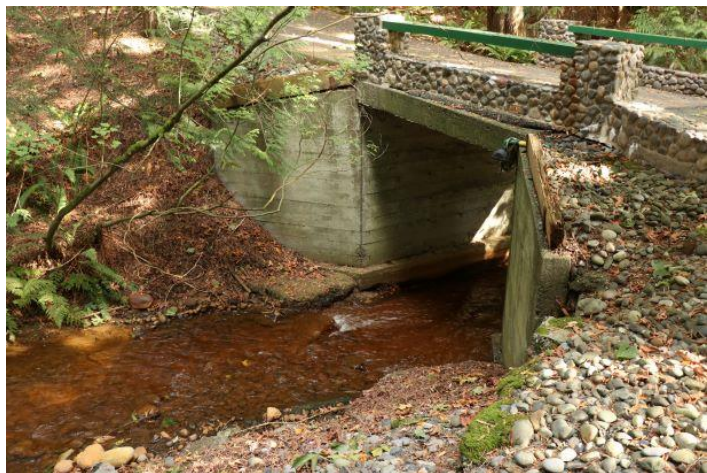
Directly downstream of the existing driveway bridge over Pepin Creek, approximately 40 feet of the left bank has been hardened with a low concrete wall and old concrete pieces. This was built to prevent the stream from pushing into the ridge on which the house is located. There are no plans to remove that wall.

Box culvert bridge on the existing driveway over Pepin

Maintain the ability of the stream to maintain its natural hydrogeomorphic course. Projects that would allow the channel to naturally migrate are limited due to this being a constrained urban stream, but the channel migration zone that does exist should be restored to native forest wherever possible. There are no plans to remove the hardened streambank downstream of the bridge.

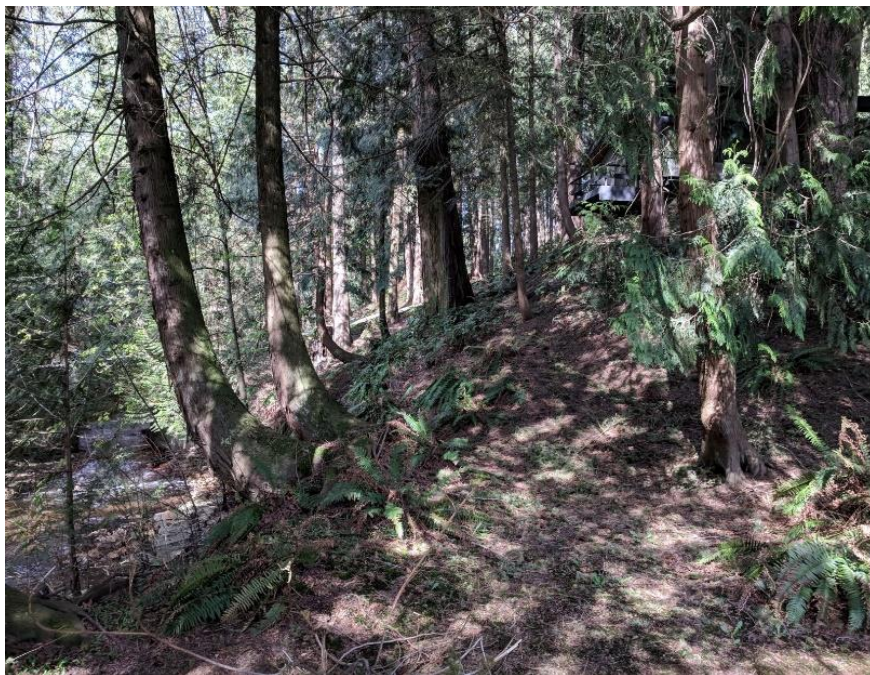
The existing Pepin Creek riparian area is in relatively good shape. As stated above, it flows in a deep ravine on the property and both banks are well vegetated with large trees. Portions of the streambank have been hardened with concrete and there are pockets of invasive plants throughout.

Well-vegetated riparian slope above Pepin Creek

Maintain the status of the well-vegetated Pepin Creek riparian zone. Aggressive control of invasive plant species, including clearing, hand pulling, and targeted herbicide treatments should occur as they are located.

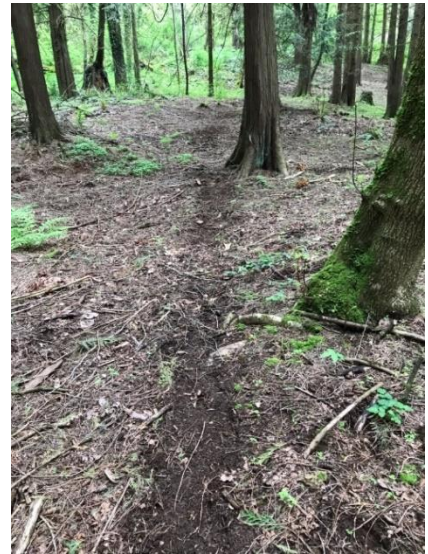
Of note, both the riparian and upland areas of this property are heavily impacted by deer. There are “game” trails crisscrossing the upland areas and obvious sign of browsing across the property. Anything that can be eaten by deer has been. The browsing activity is abundant enough to inhibit forest regeneration.

Game trail crossing the upland area

Finally, the impact to the forest by deer herbivory will need to be addressed if long-term regeneration is to continue.
