**Dickinson Park Conservation Area
Lynden Parks Department**

Stewardship Plan

July 2021

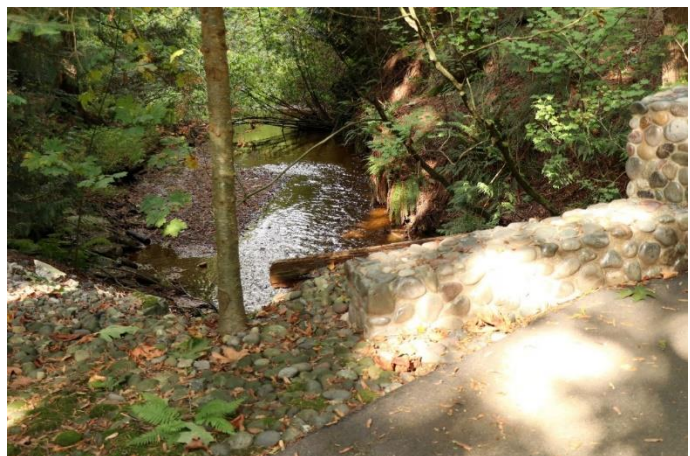
Directly downstream of the driveway and the existing box culvert over Pepin Creek, approximately 40 feet of the left bank has been hardened with a low concrete wall and old concrete pieces. This was built to prevent the stream from pushing into the ridge on which the house is located. There are no plans to remove that wall.

Maintain the ability of the stream to maintain its natural hydrogeomorphic course. Projects that would allow the channel to naturally migrate are limited due to this being a constrained urban stream, but the channel migration zone that does exist should be restored to native forest wherever possible. There are no plans to remove the hardened streambank downstream of the bridge.

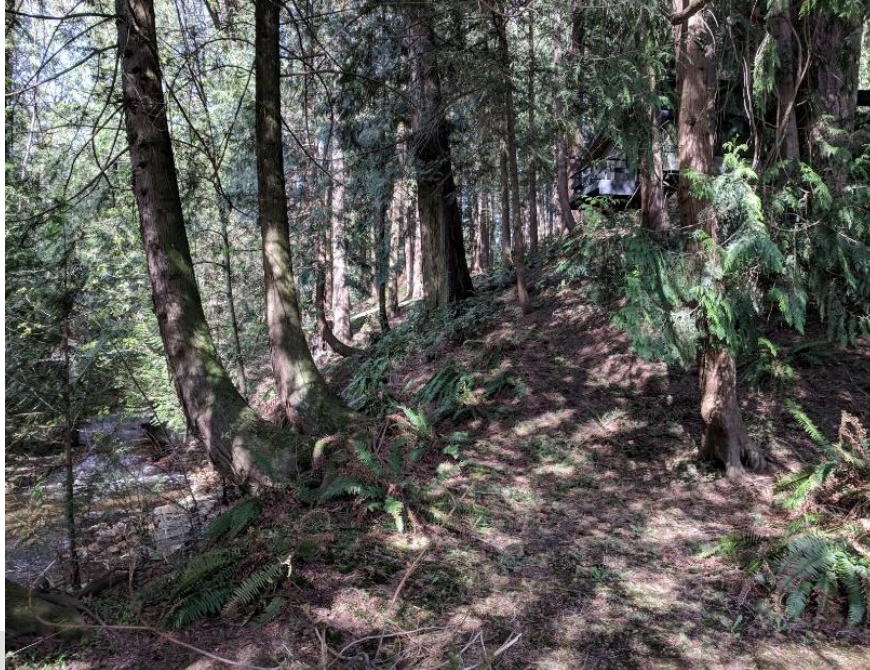
The existing Pepin Creek riparian area is in relatively good shape. As stated above, it flows in a deep ravine on the property and both banks are well vegetated with large trees. Portions of the streambank have been hardened with concrete and there are pockets of invasive plants throughout.

Maintain the status of the well-vegetated Pepin Creek riparian zone. Aggressive control of invasive plant species.

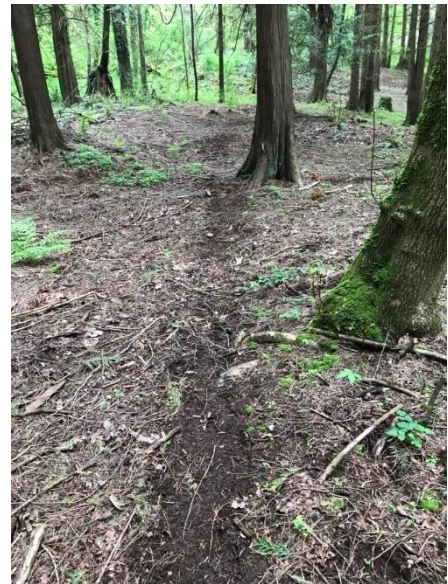
The upland slopes and ridgetop highlight the 2nd growth conifer forest that overlooks this property. The forest is dominated by varying aged Western red cedar with Oregon grape, Indian plum and sword fern in the understory and ground cover. A few large Douglas fir trees are scattered across the property. The northeastern slope of the property contains several large deciduous trees (Big leaf maple, paper birch, and cottonwood). Typical to an urban forest, there is also a heavy presence of invasive plant species – English ivy, blackberry, and herb Robert are abundant throughout the upland portions of the property.

Of note, both the riparian and upland areas of this property are heavily impacted by deer. There are “game” trails crisscrossing the upland areas and obvious sign of browsing across the property. Anything that can be eaten by deer has been. The browsing activity is abundant enough to inhibit forest regeneration.

Protect the existing forest, control invasive plant species, and manage the forest for active regeneration. The invasive plants need aggressive management to be resolutely controlled. In particular, English Ivy is currently covering significant areas of the forest floor and migrating up tree trunks in many locations. Other ground cover invasive plants should be pulled annually. Where appropriate, herbicide treatments may be necessary. Other control methods for ground cover invasive plants, such as low-intensity controlled fire, might be explored over time.

Finally, the impact to the forest by deer herbivory will need to be addressed if long-term regeneration can continue.
