## MEMORANDUM

<b>Date:</b>	November 26, 2024	<b>TG:</b>	1.21101.00
<b>To:</b>	Mark Sandal – City of Lynden		
<b>From:</b>	Brent Turley, PE – Transpo Group Jessica Lambert, PE – Transpo Group		
<b>CC:</b>	Kassi Leingang, PE – Transpo Group		
<b>Subject:</b>	Intersections of Concern – Analysis Summary

The following memorandum summarizes the analyses completed for twelve intersections of concern throughout the City of Lynden. This memorandum includes additional observations that occurred in late Fall 2024.

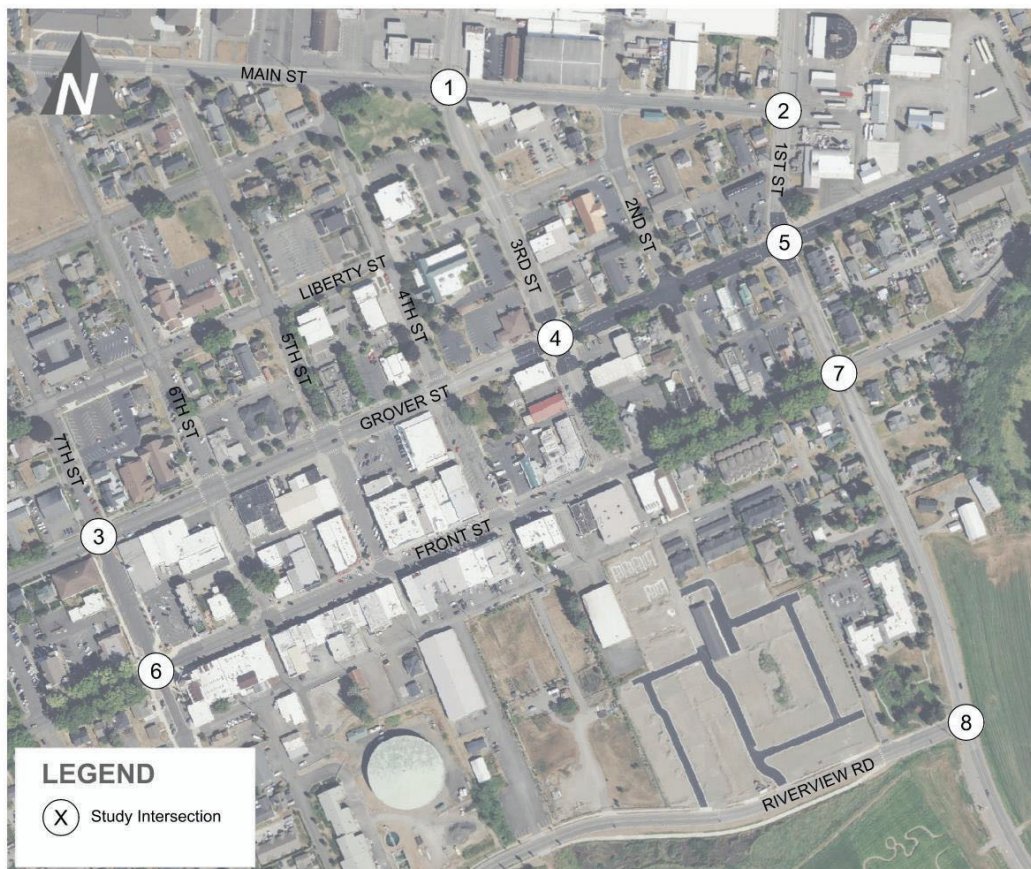
*Figure 1 Downtown Study Intersections*

1. Depot Road/3rd Street/Main Street – Signal
2. 1st Street/Main Street – Two-Way Stop-Control
3. 7th Street/Grover Street – Two-Way Stop-Control
4. 3rd Street/Grover Street – Signal
5. 1st Street/Grover Street – Signal
6. 7th Street/Front Street – Two-Way Stop-Control
7. 1st Street/Front Street – Signal
8. 1st Street/Riverview Road – Two-Way Stop-Control

An analysis of eight key intersections in downtown Lynden were evaluated with respect to operations, queuing, and safety to understand current issues and opportunities for improvement. The analysis focused on current 2024 traffic operations. Of the eight study intersections in the downtown area, four are closely spaced signals though signal timing is currently not coordinated and run with different cycle lengths. This can potentially lead to inefficient movements between the intersections. The intersections and their traffic control are listed below and shown in Figure 1.

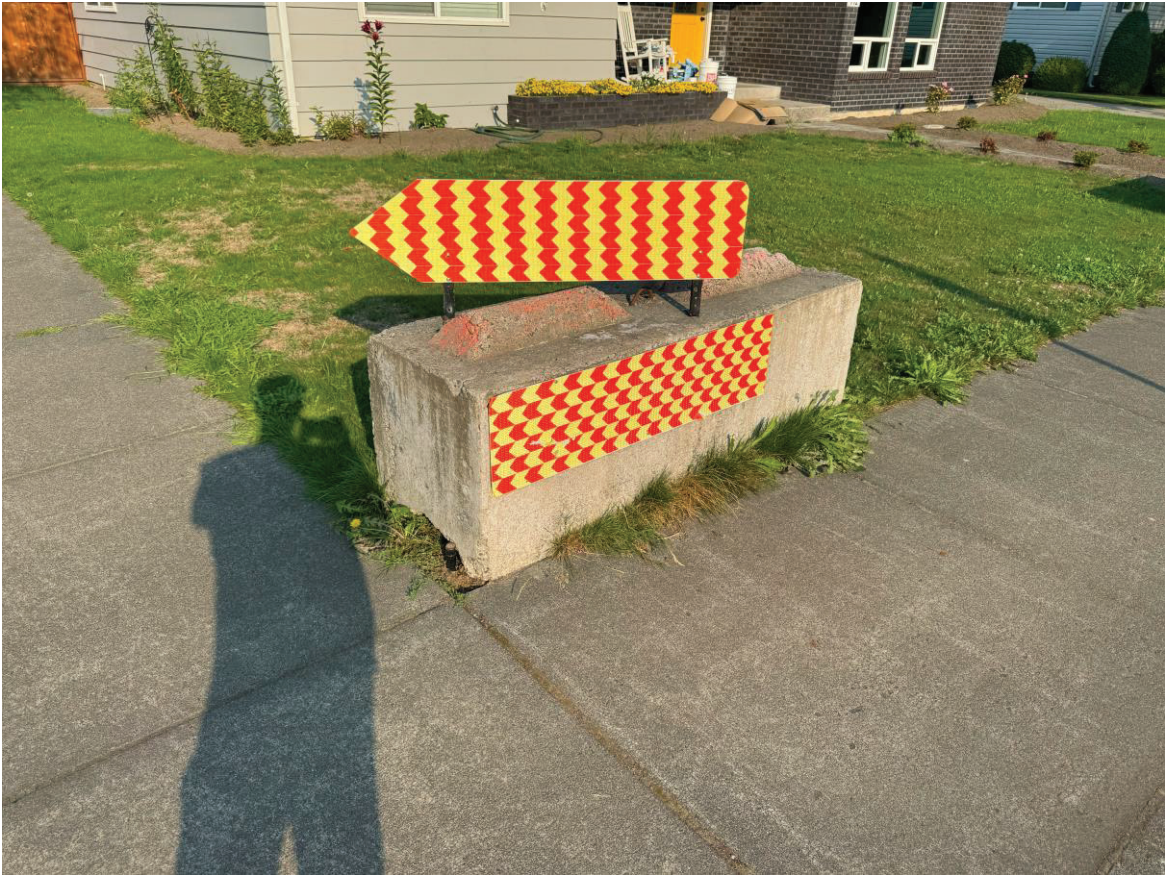
*Figure 2 Example of Concrete Block and Turn Arrow Located at Intersection*

The British Columbia Avenue/Grover Street intersection is currently a four-way intersection with stops on the minor (British Columbia Avenue) approaches. Discussion with City staff indicate there are safety concerns at the intersection, namely that drivers are failing to make the eastbound through movement and have driven on to private property at the southeast corner of the intersection. In response, concrete blocks have been placed at the edge of the property and chevron turn signs to both the eastbound and westbound approaches to the intersection have been placed to indicate the bend in the road, see Figure 2 and Figure 3, respectively.

In addition to or as a replacement for the current concrete blocks and chevron signs the City could consider the concepts listed below. These concepts could be combined into a broader solution. Concept design figures of each concept are provided in Attachment E.

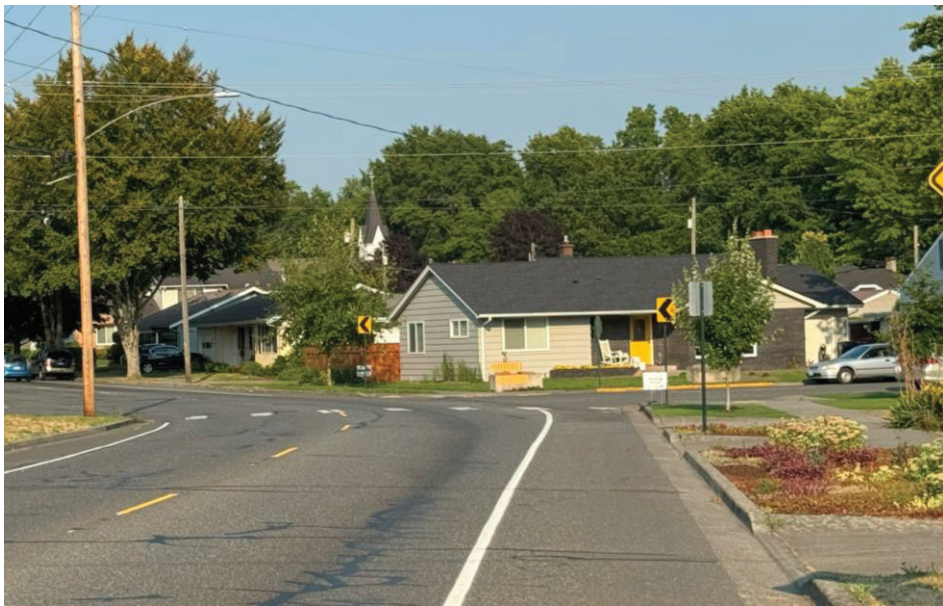
*Figure 3 Treatments at Corner of Intersection*

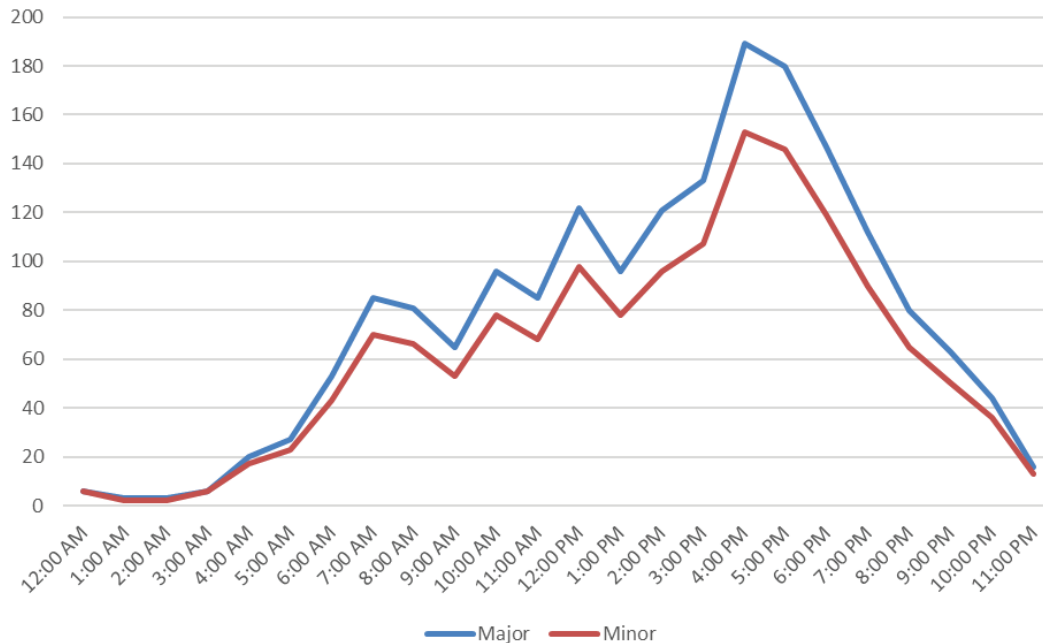
*Figure 4 Daily Distribution of Intersection Traffic Volumes*

As shown in Figure 4, there is no time period where the major (Line Road) or minor (Aaron Drive) approach exceed 300 or 200 vehicles in an hour, respectively. Even with the consideration of the school traffic it is unlikely that the volume increase would be enough over the 8-hour period to meet the warrants. The 24-hour traffic data are provided in Attachment F.

Utilizing the intersection turning movement and 24-hour counts collected at the intersection, a daily distribution of the traffic volumes was developed. The daily distribution of traffic volumes for the major and minor approaches is summarized in Figure 4.
