7347, 7315, AND 7355 MAIN STREET RESEARCH SUMMARY

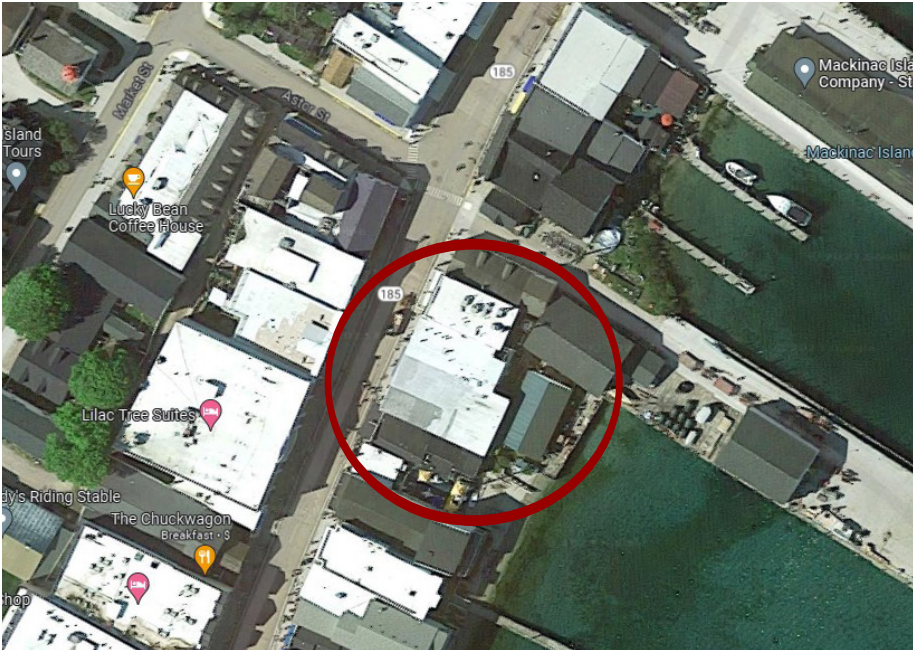
Figure 1-1. Aerial view of the subject building within the red circle (Google Maps, 2023).

The subject building is located at 7347-7355 Main Street on Mackinac Island, Michigan (Figure 1-1). The building is sited on a rectangular lot south of the junction of Main Street and Astor Street. The rear (southeast) of the site abuts Lake Huron. The subject building is a ca. 1900, two-story wood-frame building with a rectangular footprint and three commercial storefronts. It is clad in wood and has a stone foundation with a flat, sloping roof. The cornice has decorative brackets. Windows are one-over-one, double-hung, aluminum-clad wood units. The building currently houses the Trading Post in the northernmost storefront, May's Fudge in the center, and Baxter's in the southernmost storefront.

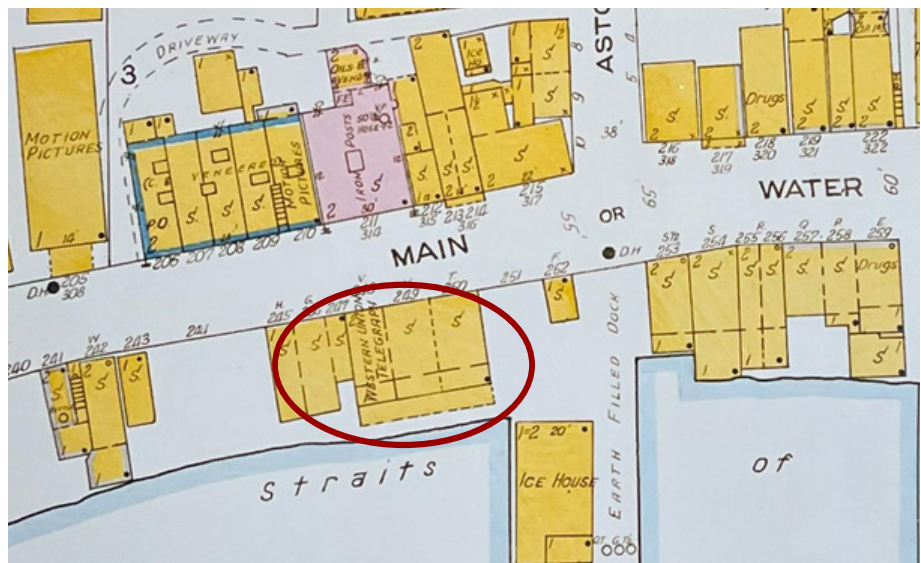
Figure 1-4. Sanborn Fire Insurance Map of Mackinac Island, 1923, with what appears to be the building noted in red (Mackinac State Historic Parks Archives).

The building is depicted on the Sanborn Fire Insurance Map in 1923 with three storefronts separated by a wood frame wall, similar to today’s configuration.⁴ The storefront at 7355 Main Street (Baxter’s) is noted as a Western Union Telegraph location. The other two businesses are not named but are noted as stores (labeled with the “S”) (Figure 1-4).

In the ca. 1950 photograph in Figure 1-8, the door to the stairway south of the Trading Post did not have the current log cladding application. The stairway appears on the 1900 Sanborn (Figure 1-3) and was likely simply excluded from the 1923 Sanborn drawing (Figure 1-4). Based on this, the stairway door is likely what is visible on the right side of Figure 1-7. In 1998, the log cladding was extended to incorporate the stair entry (Figure 1-9).

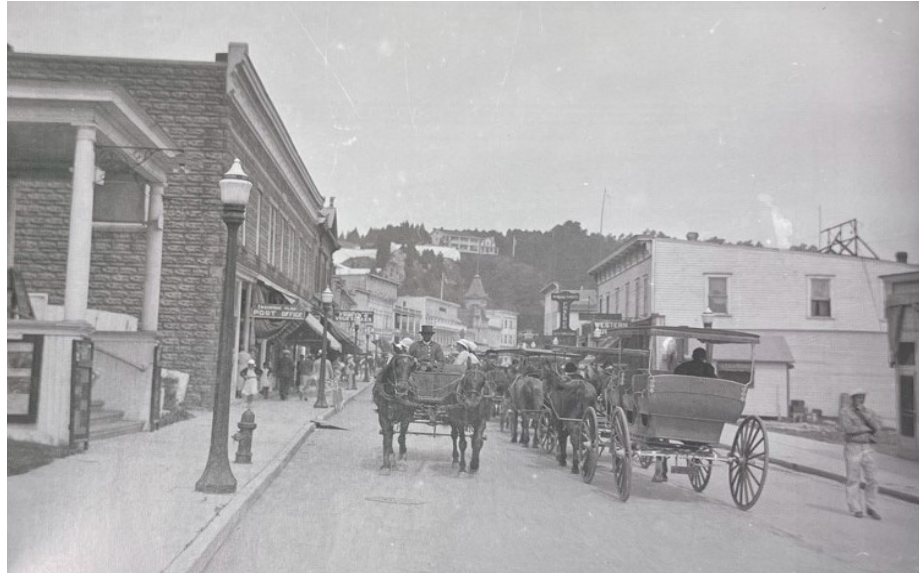
Figure 1-5. Looking northeast at Main Street from closer to Hoban Street, with the subject building on the right. The Western Union sign is visible. Ca. 1920 (Mackinac State Park Archives).

There is a newspaper reference to a Western Union located on the island in 1930, though it does not indicate the exact address.⁶ Both ca. 1920 photos of the building depict the Western Union in the southeastern storefront (Baxter's) (Figure 1-5 and Figure 1-6). In one of these photos (Figure 1-6), longtime tenant Murdick's candy store is clearly visible in the current May's Candy Shop storefront.

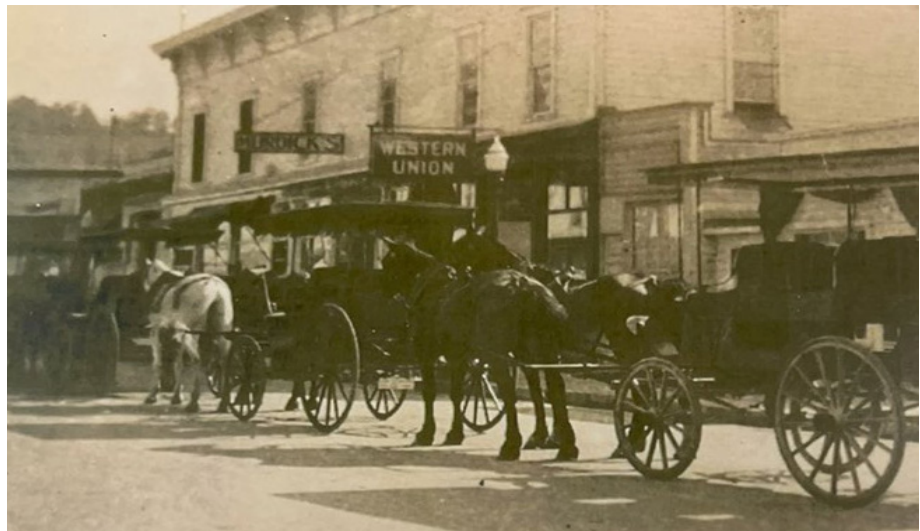
Figure 1-6. Similar view looking northeast at Main Street from closer to Hoban Street, with the subject building on the right. Again the Western Union sign is visible, but the building to the south has changed. Ca. 1920 (Mackinac State Park Archives).

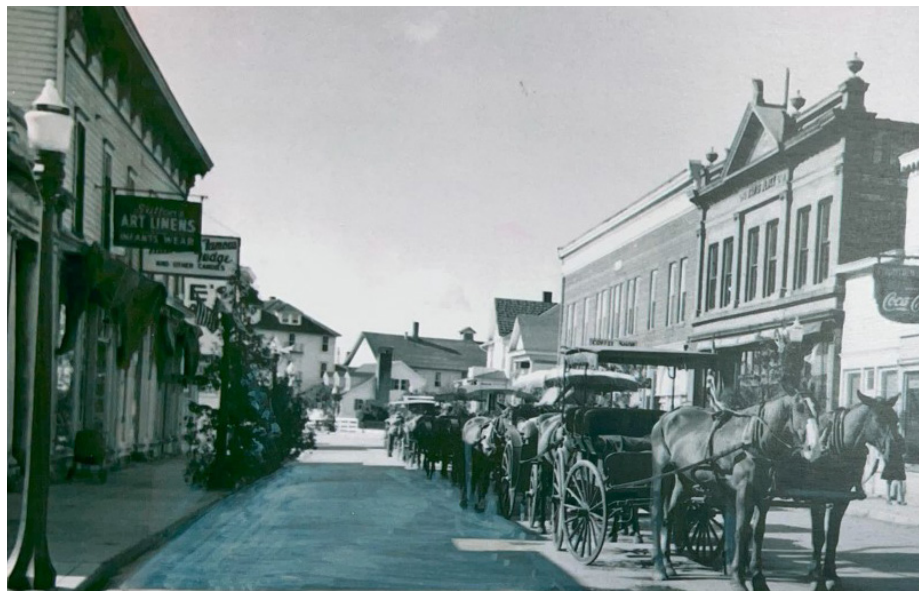
Figure 1-7. Sutton's linen store in the subject building on the left side of the image. Ca. 1945 (Mackinac State Park Archives).

Based on the historic images and interviews with Anthony Trayser, Sutton's linen shop was located in the Trading Post storefront in the mid-to-late 1940s (Figure

1-7).⁷ According to the deed abstract, the Bogan family sold the property to Henry Sutton in 1944. The Traysers purchased the building from Sutton ca. 1947 and changed the Trading Post facade to its current appearance ca. 1948.
