Marshall Aquatics Center Study

Marshall, Minnesota / July 2019

Prepared By
292DesignGroup

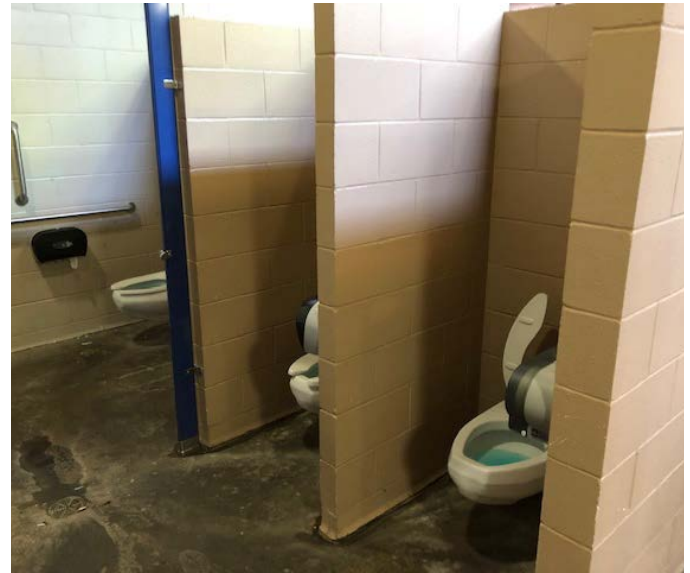
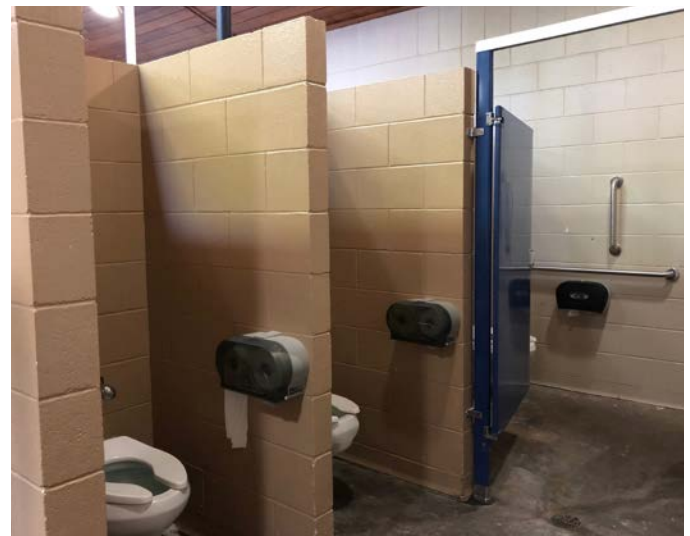
The interior poses the greatest challenge to the building. Much of it is in poor and unattractive condition. Today's users of recreation facilities expect the facilities to have a high-quality, attractive finish and fit their expectations of a good recreational experience. The current facility does not meet that standard. The locker rooms and restroom facilities need extensive remodeling. Today's users also expect greater privacy in the changing and showering area. The existing building's changing, shower and toilet areas are wide open with little privacy screening. The changing areas should be divided into smaller bays for more privacy and showers should be the individual type rather than open. (There are some individual showers in the women's locker room, but they are small and makeshift.) The restroom areas need to be replaced, in total, with new ADA compliant fixtures and a more useful layout.

Existing toilet rooms that lacks privacy screening

Remodeling locker rooms and rest rooms is costly. There is extensive plumbing work, expensive wall construction (tile, concrete masonry, etc.), tile floors and plaster ceilings. In addition, much of what is existing would need to be demolished, which is another expensive cost.

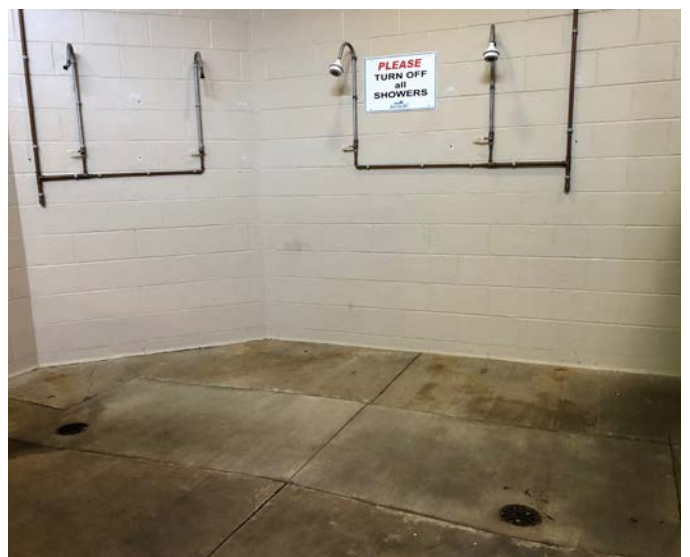
Existing, open shower area

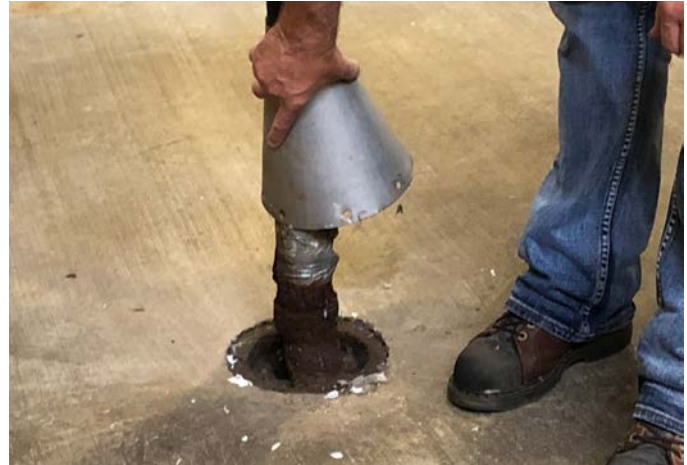
The mechanical and electrical systems have deteriorated and in need of repair. Water line breaks are common and waste lines are failing. There is a significant problem of sewer gas entering the shower area of the building and staff have made a makeshift repair that needs replacement.

Makeshift sewer gas repair in shower area

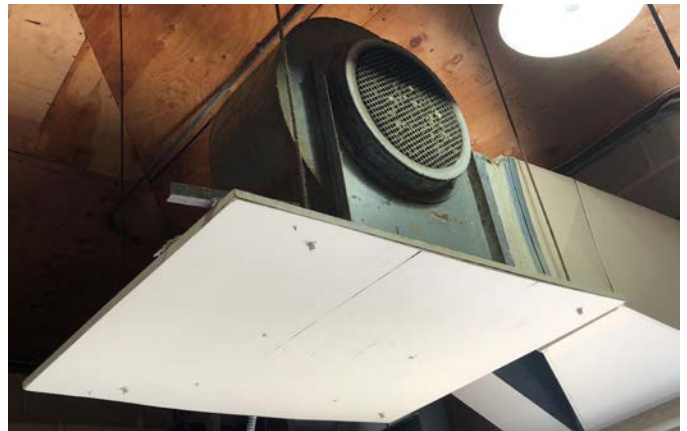
The staff has had to make many repairs to the plumbing systems and these repairs are exposed and add to the poor appearance of the building. Exhaust fans are old and inadequate and provide poor ventilation within spaces. Electrical systems are original. The main service panel is outdated and beyond its life expectancy and needs immediate replacement.

Outdated exhaust fan

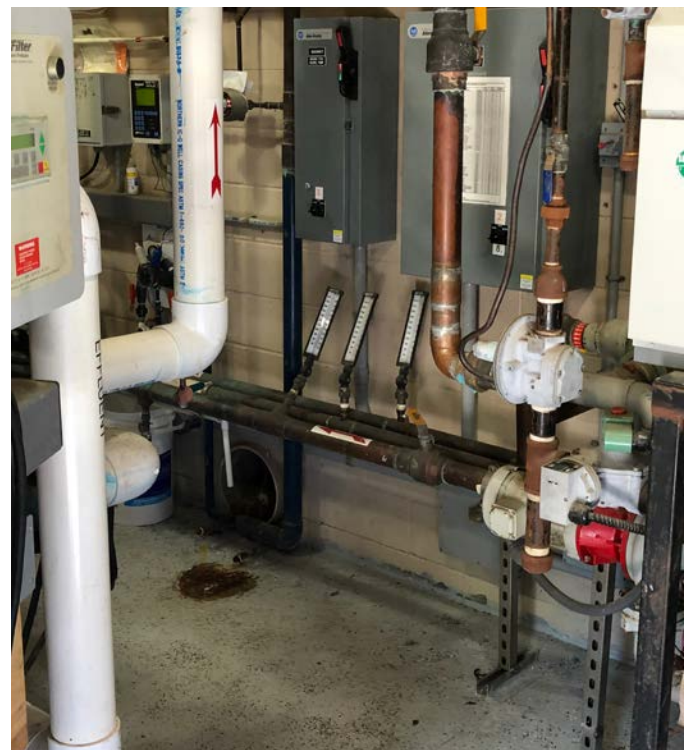
Existing service panels

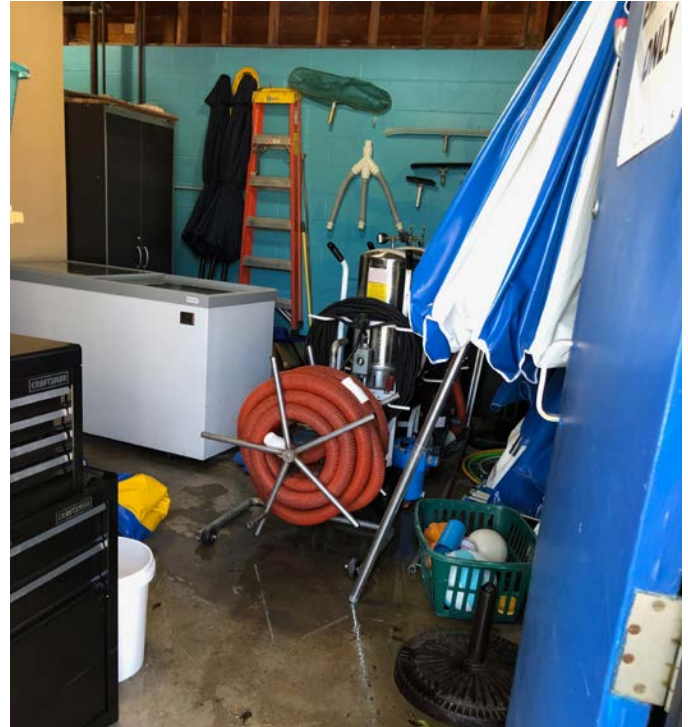
- » Storage space is insufficient as well. Winter storage severely limited.

Storage space

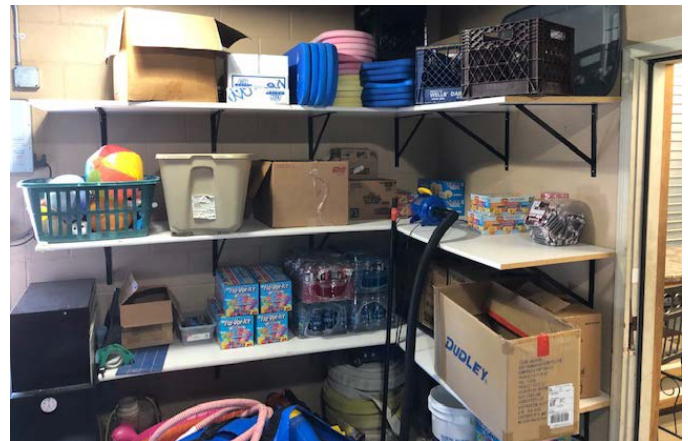
- » Staff workspace is inadequate with little room for life-guards, program staff, and management staff in the office area. This area has largely become a storage area due to the lack of storage space.

Storage in the office area

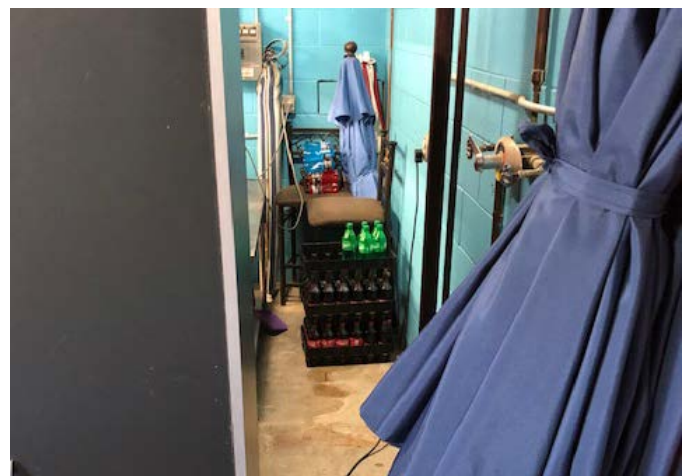
The concessions area has numerous deficiencies. Most critical is that it does not meet Minnesota Department of Health requirements. Floor, wall and ceiling finishes do not comply. The sinks for hand washing, food prep and dish wash are inadequate. The layout is extremely inefficient which limits the ability to serve the customers and affects potential income from food and beverage sales. There are also significant issues regarding the plumbing, ventilation and electrical systems.

Concessions storage

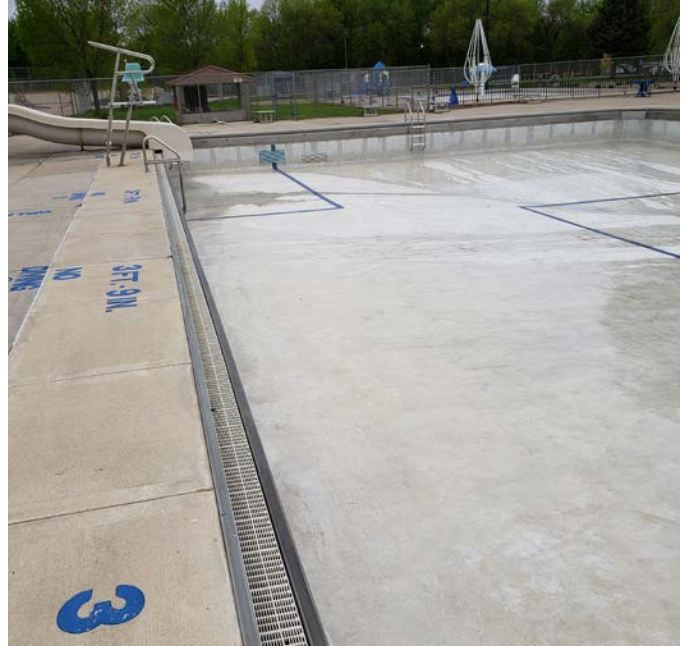
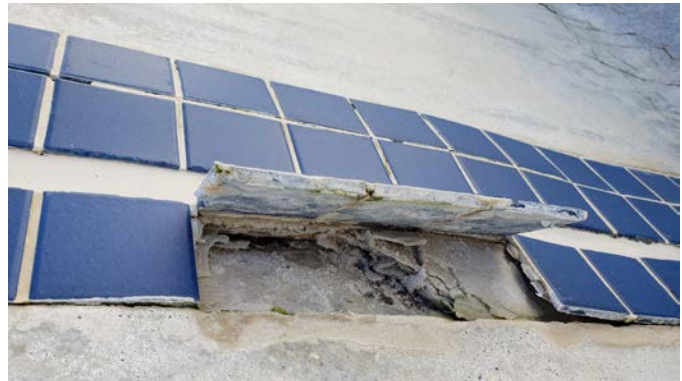
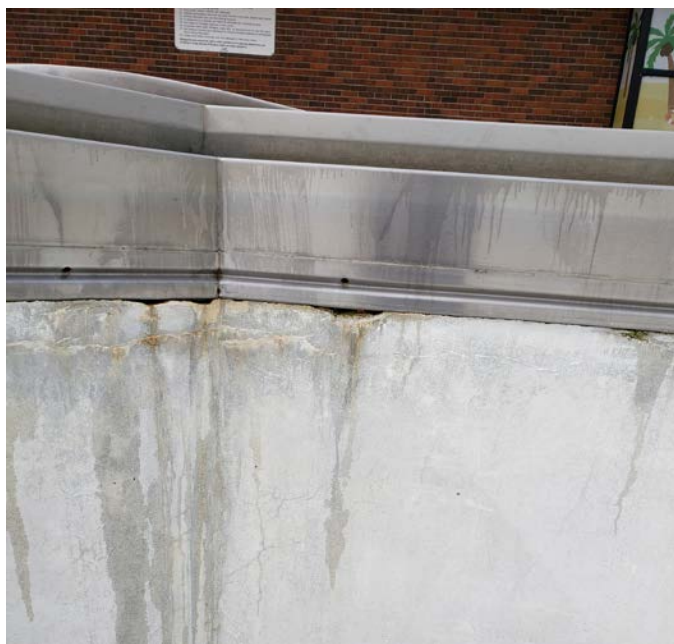
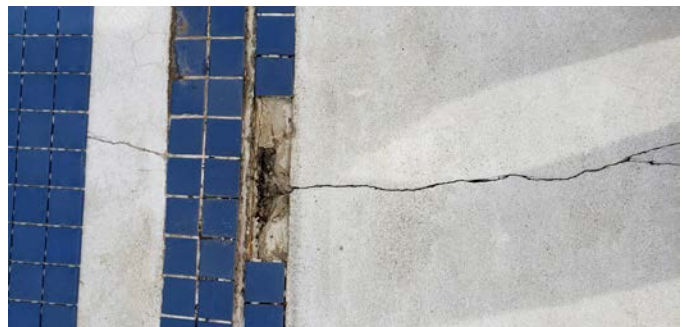
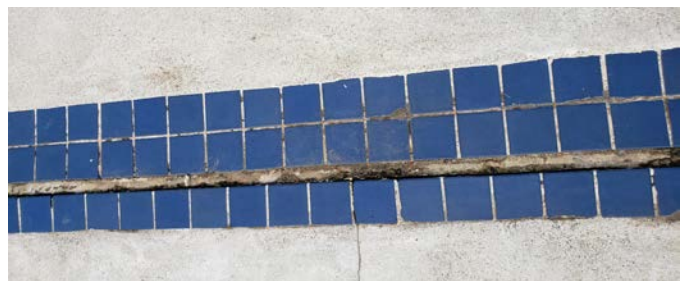
The lap/general-use pool and diving pool were renovated in 2008, including repair of significant structural failures within the diving pool. Structural failure of the vessels has reoccurred since the 2008 repairs. The structures of both the lap/general use-pool and diving pool have significant cracking and structural deterioration at the gutter joint, internal expansion joints, and wall to floor interface. Water intrusion is evident by the delamination of the concrete surface and associated tile and plaster finishes at these locations. City staff has documented that the lap/general-use pool and diving pool are currently losing water due to leaks at a rate of 12,000 to 15,000 gallons per day (1,080,000 to 1,350,000 gallons per summer based on a three month use period). This is an extreme amount of water loss for a pool vessel. Movement and flow of this magnitude of water around and beneath the vessels is likely creating significant unseen issues within the supporting soils and exterior face of the unseen concrete vessels beneath. It is extremely likely that the internal steel reinforcing is severely corroded in areas around and near the points of significant leakage.

The pools have many problematic conditions. Tile is coming loose and missing in some areas, the concrete has separated from the gutters, there are numerous cracks throughout all the vessels, and caulking is failing. In general, the pools have outlived their expected life. Minnesota winters are hard on pools and 50 years is a long time frame.

Given the age, observation of structural failures, and verification of extreme leakage, it is our opinion that the pool vessel structures have exceeded their usable lifespan and need full replacement. It is also our opinion that vessel replacement should also include full replacement of all pool equipment—given the proximity to anticipated end of lifespan of the existing equipment and availability of new products and technology within the market.

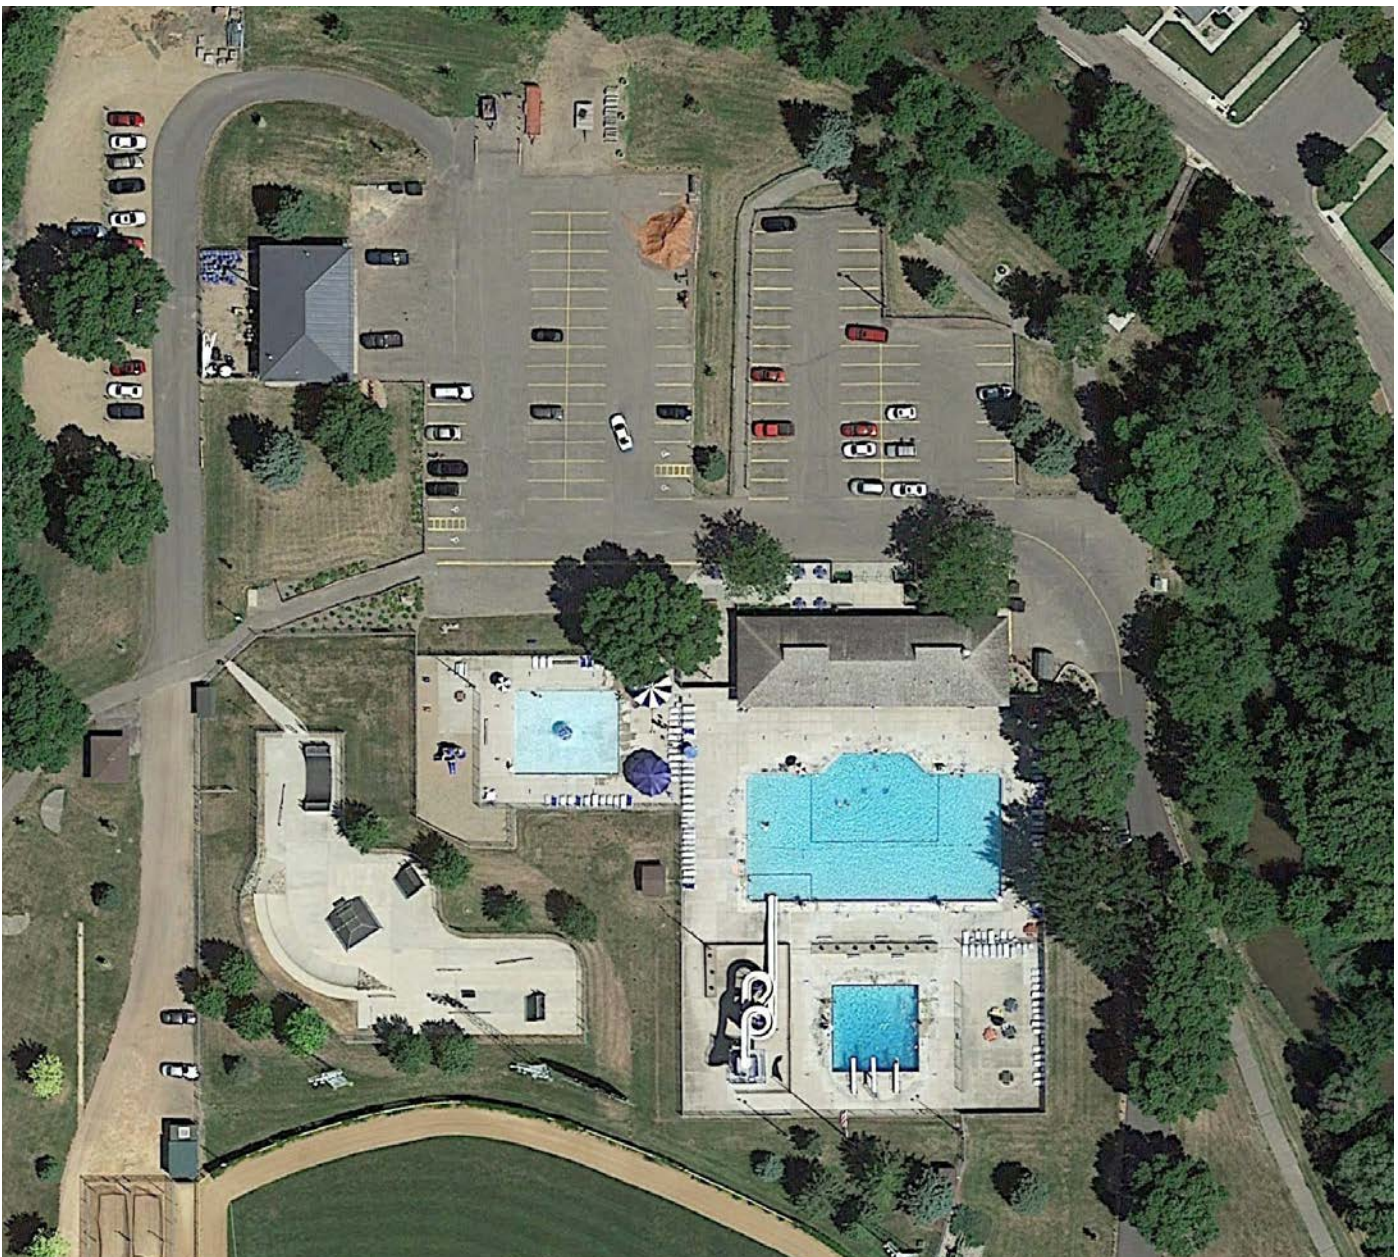
Access, traffic flow, and parking at the aquatic center have several conditions that should be addressed. The aquatic center, located within Legion Field Park, isn't visible from West College Drive, so signage is required to find the center. Access can be confusing to the first-time visitor. Within the park, the bicycle path crosses the drive near the aquatic center. This condition causes concern as children riding their bikes on the trail dart across the entry drive, often unaware of cars on the road. This situation should be addressed in any reconfiguring of the aquatic center and park. Another concern is that the main drive passes directly in front of the building entrance where there are conflicts between people walking across the drive from their parking space, or from people dropping off pas-

Aerial photograph of existing Marshall Aquatics Center

sengers (sometimes on the parking side of the entry drive) at the main entry. This study suggests a rerouting of traffic to a one-way system within the center's parking lot and entry drive to help alleviate this condition. There is a substantial need for bicycle parking within the site as well.

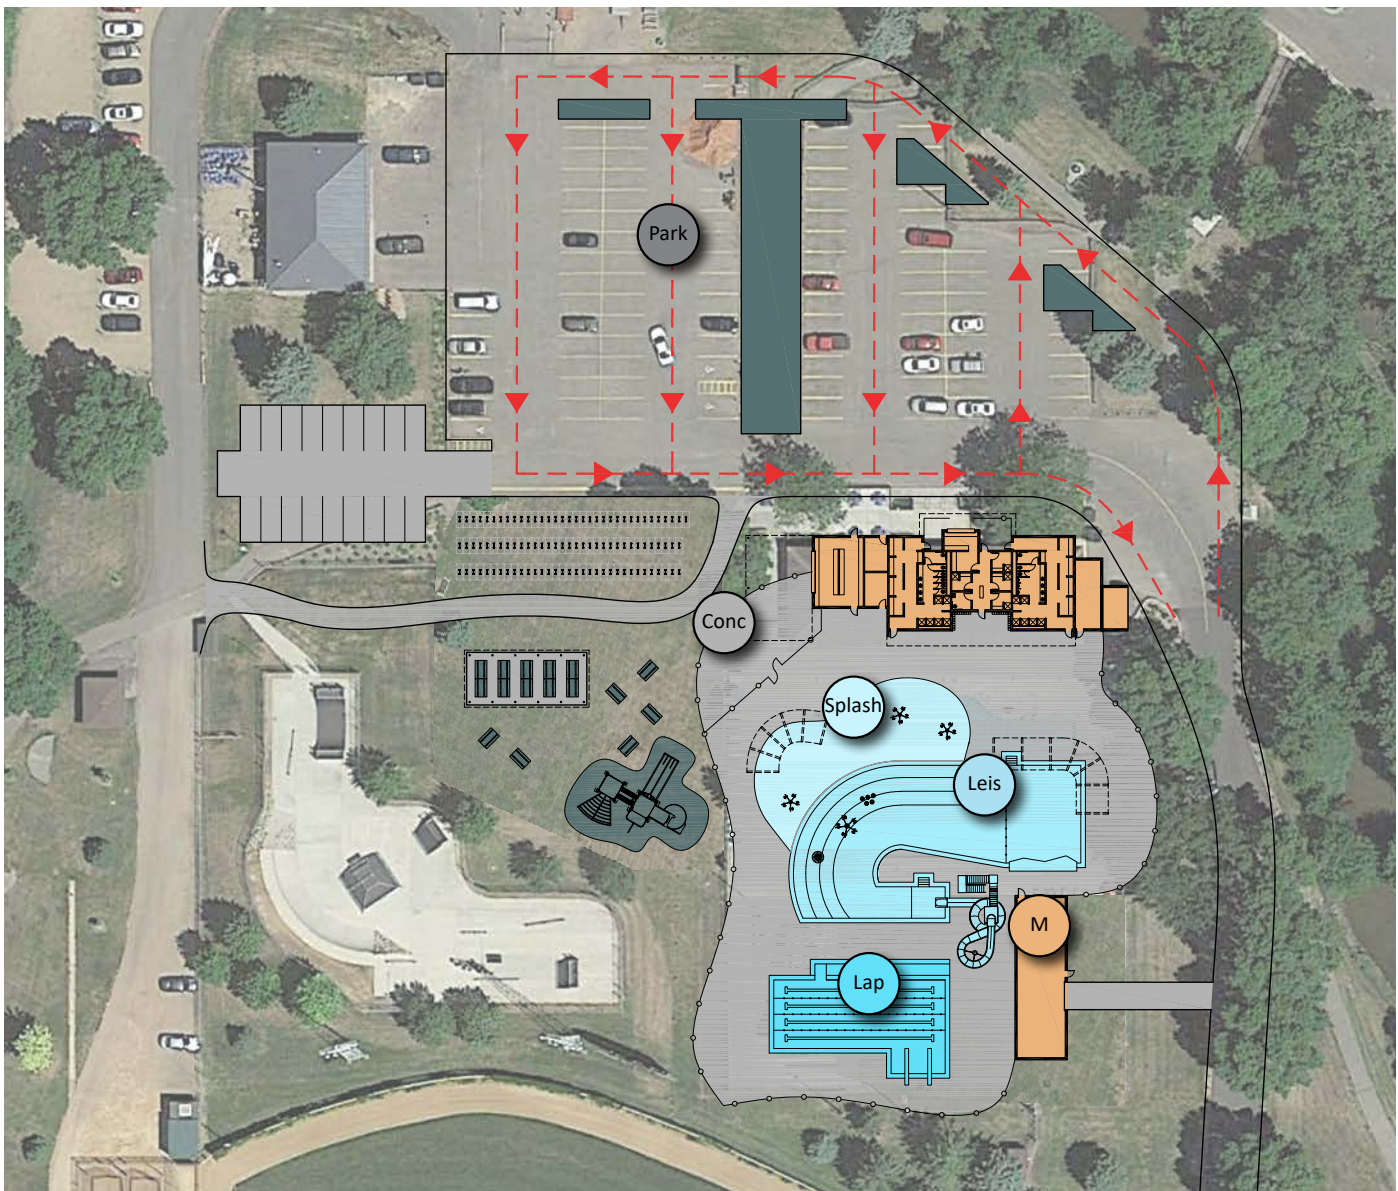
Re-striped parking area and one-way, vehicle circulation path

Bath house including concessions, office and changing areas.

Splash pad with water play features and no standing water

Outdoor seating area for concessions, within view of aquatics area

Pool equipment and mechanical space

Leisure pool with zero-depth beach entry, water play features, water slide and climbing wall

Lap pool (4-lanes) with diving well (3-meter and 1-meter boards)

Site plan of recommended aquatics center

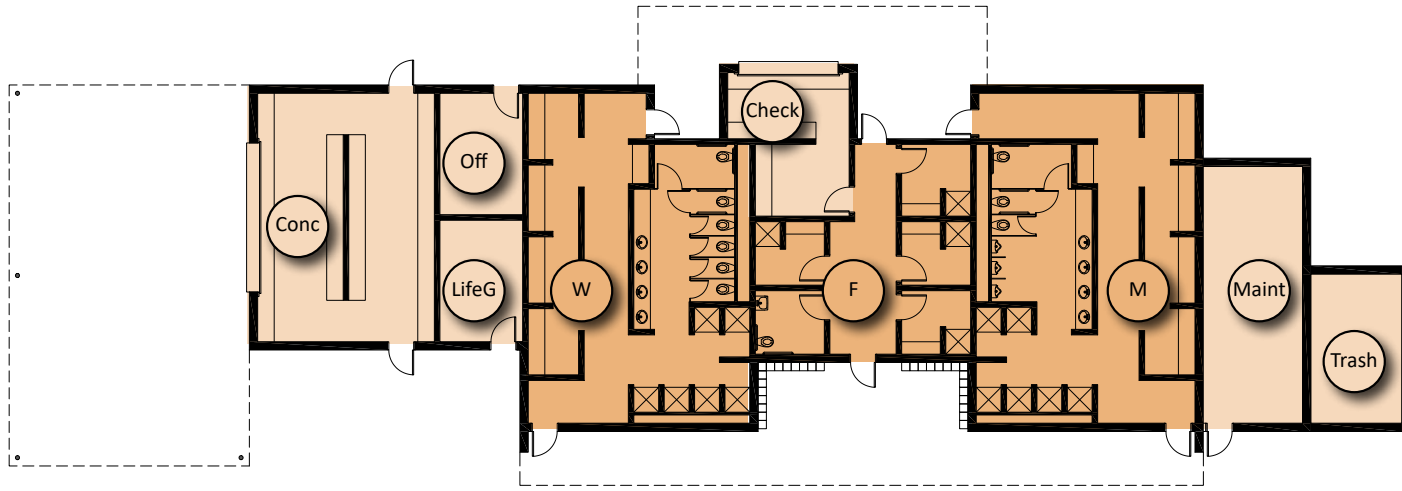
The concessions area includes serving and storage space for an enhanced menu. It can service both aquatic center and park patrons and is adjacent to outdoor seating areas.

The office area includes work space for the aquatic director and assistant.

The life guard room includes space for lockers and staff breaks.

The check-in area is expanded to accommodate large groups.

The maintenance area includes space for cleaning and pool supplies, access to utilities and general storage.

A trash enclosure is located near maintenance and accessible from an adjacent drive.

The changing rooms for women and men include semi-private changing areas, individual showers and toilets.

The family changing area includes individual changing rooms with showers, a common area with lockers, and toilet room.

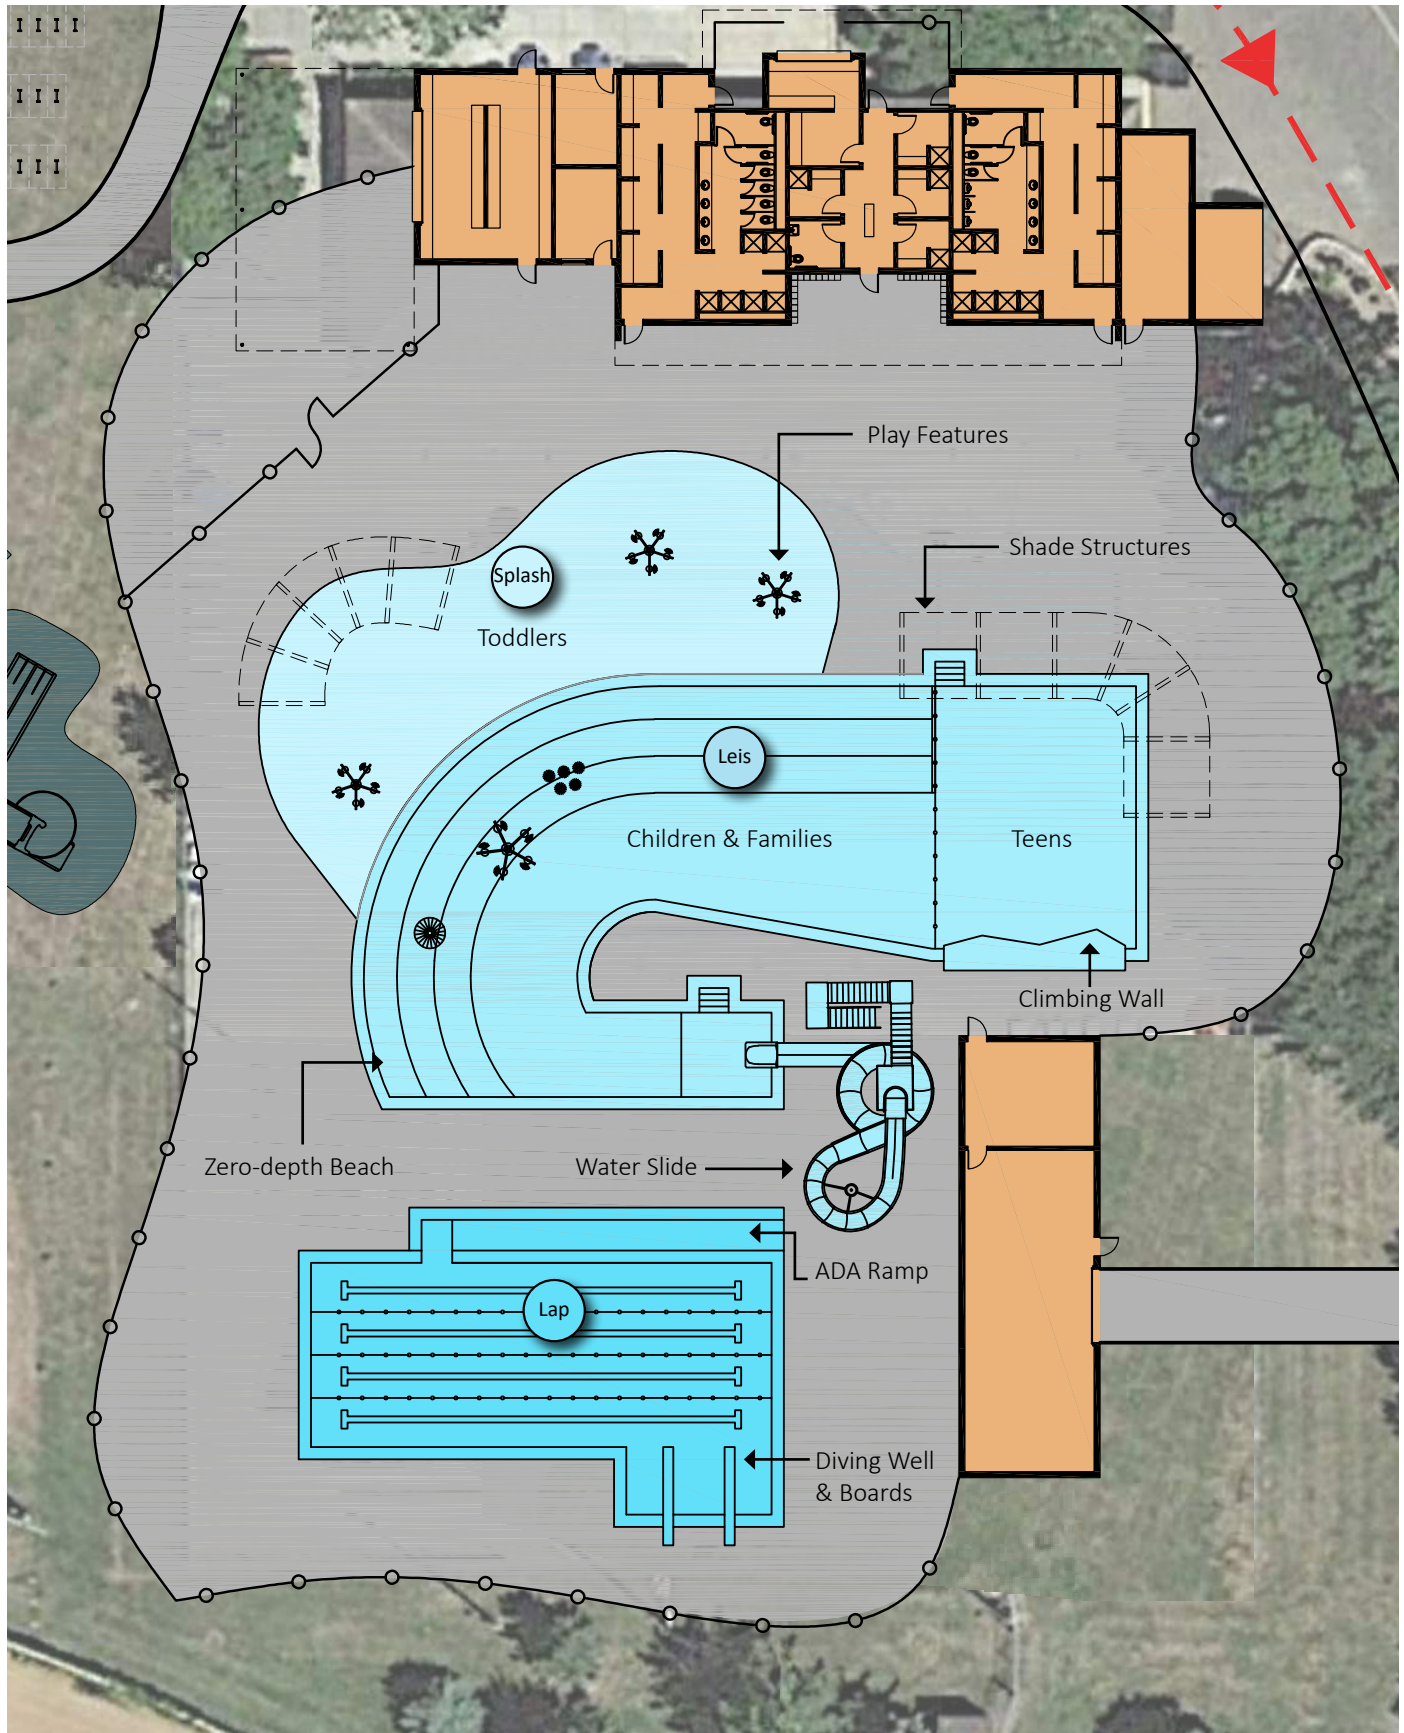
The splash pad is a dry area (no standing water) with shade structures and interactive play features that spray, dump or shoot water. The water is immediately drained from the surface. Splash pads are appropriate for all, including toddlers.

The leisure pool includes a zero-depth beach (a gradual deepening of the water) with interactive water features, shade structures, a slide and plunge pool, and a climbing wall. It includes areas for young children and families (zero-depth beach with play features) and teens (water slide and climbing wall).

The lap pool includes four, 75-yard long swimming lanes, a diving area with 1-meter and 3-meter diving boards, and an ADA ramp entry.
