**Causes and Mitigation of Sedimentation along the
Northern Side of Johns Pass Channel**

Final Report

**Ping Wang and Jun Cheng
Coastal Research Laboratory
School of Geosciences
University of South Florida
Tampa, FL 33620**

**Pinellas County
22211 US Hwy. 19 N.
Clearwater, FL 33765**

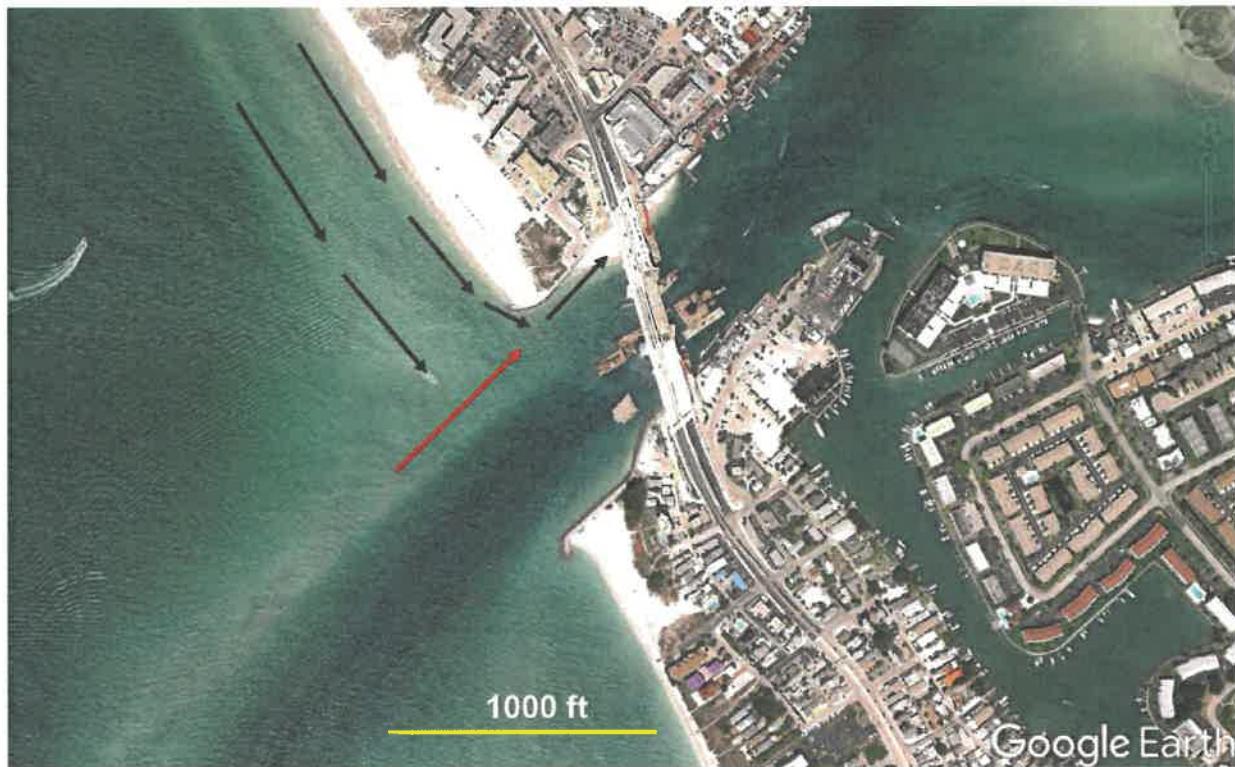
Sedimentation within an inlet channel is controlled by two main factors. The first factor is sediment supply. Generally, the sand that is deposited within the channel can come from the updrift beach driven by longshore transport which is sand that moves along the shoreline. For the case of Johns Pass (Figure 2), this longshore moving sand would go around the seaward tip of the north jetty (black arrows) and enter the inlet channel. The sand can also come from the ebb shoal, mainly the shallow channel margin linear bar (red arrow). The channel margin linear bar refers to the shallow linear feature over which the red arrows were drawn. In both cases, the intense turbulence associated with breaking waves play a major role in suspending sediment into the water column, which can be subsequently transported into the inlet by flood tidal current and landward propagating breaking waves.

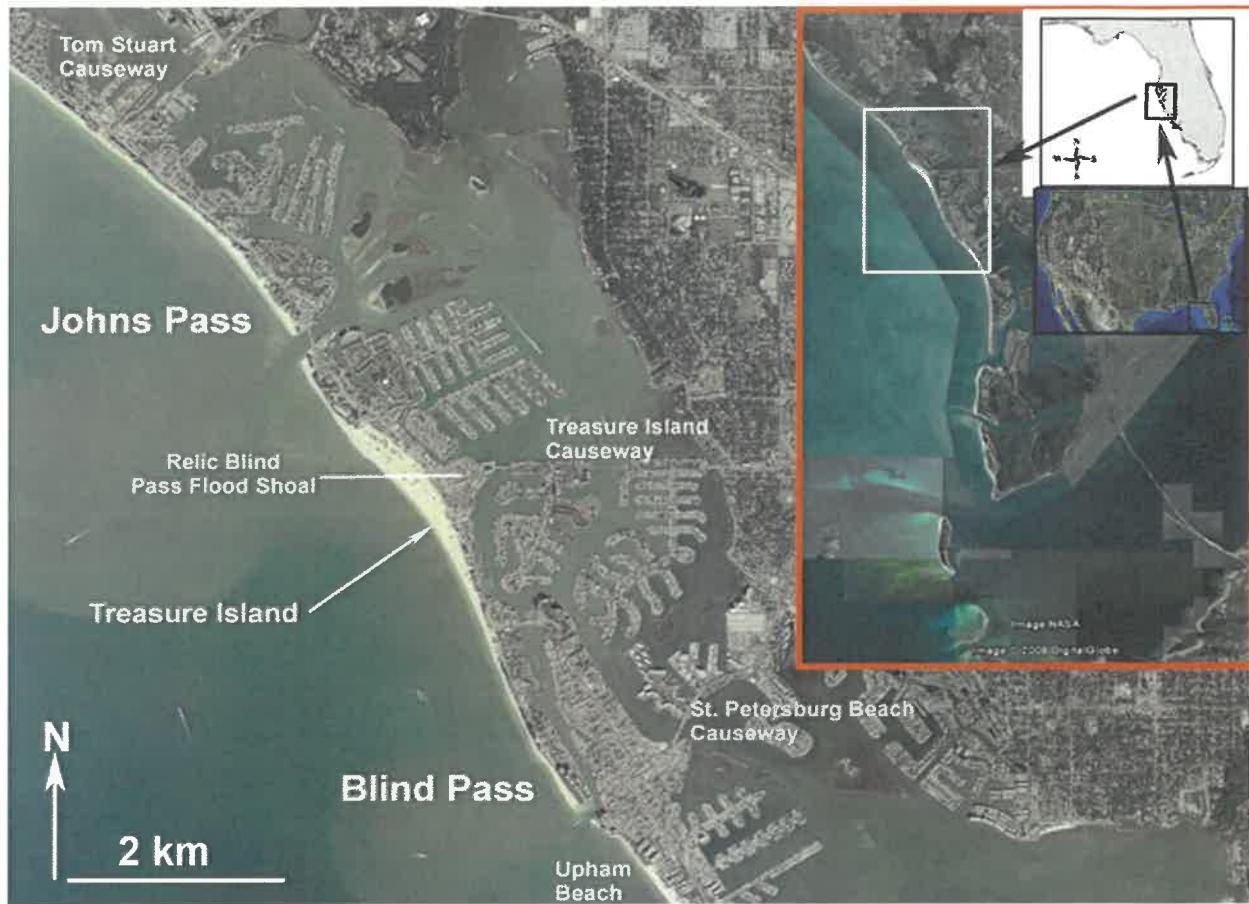
Figure 3. Johns Pass and Blind Pass inlet system.

The greater study area of Johns Pass and Blind Pass is described systematically in the inlet management study and other studies (Wang et al., 2016; Beck and Wang, 2019; Beck et al., 2020). Here, a summary of the Wang et al. (2016) report is provided with an emphasis on Johns Pass, particularly the channel between the two barrier islands. Regionally, the Johns Pass-Blind Pass system is part of the west-central Florida barrier-island chain that extends north from the mouth of Tampa Bay (Beck and Wang, 2019). The entire area, from the beaches to the inlets to the back-bay, is densely populated and heavily developed since the 1930s. Several causeways and bridges and numerous dredge and fill finger channels dissect the back-barrier bay (Figure 3).

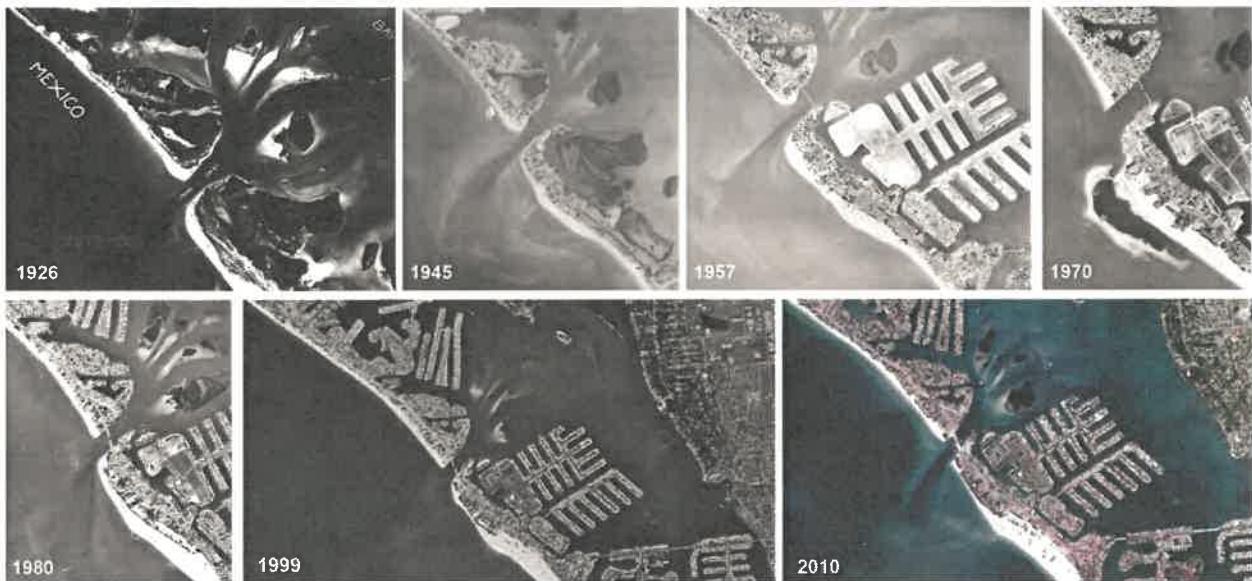
Figure 6. Time-series aerial photos of Johns Pass from 1926 to 2010.

Once public road access between Sand Key, Treasure Island, and Long Key was established, extensive development of the barrier islands, as well as the back-bay began, as evident from the time-series photos (Figure 6). Some of the developments were accomplished without adequate consideration of their long-term effects on beach and inlet morphodynamics, often reflecting historically lower environmental standards and more lenient regulations. Limited knowledge of the cause-and-effect relationships between the back-bay, inlets, and adjacent beaches at the time was also a factor. Following the bridge and road construction, one of the earliest

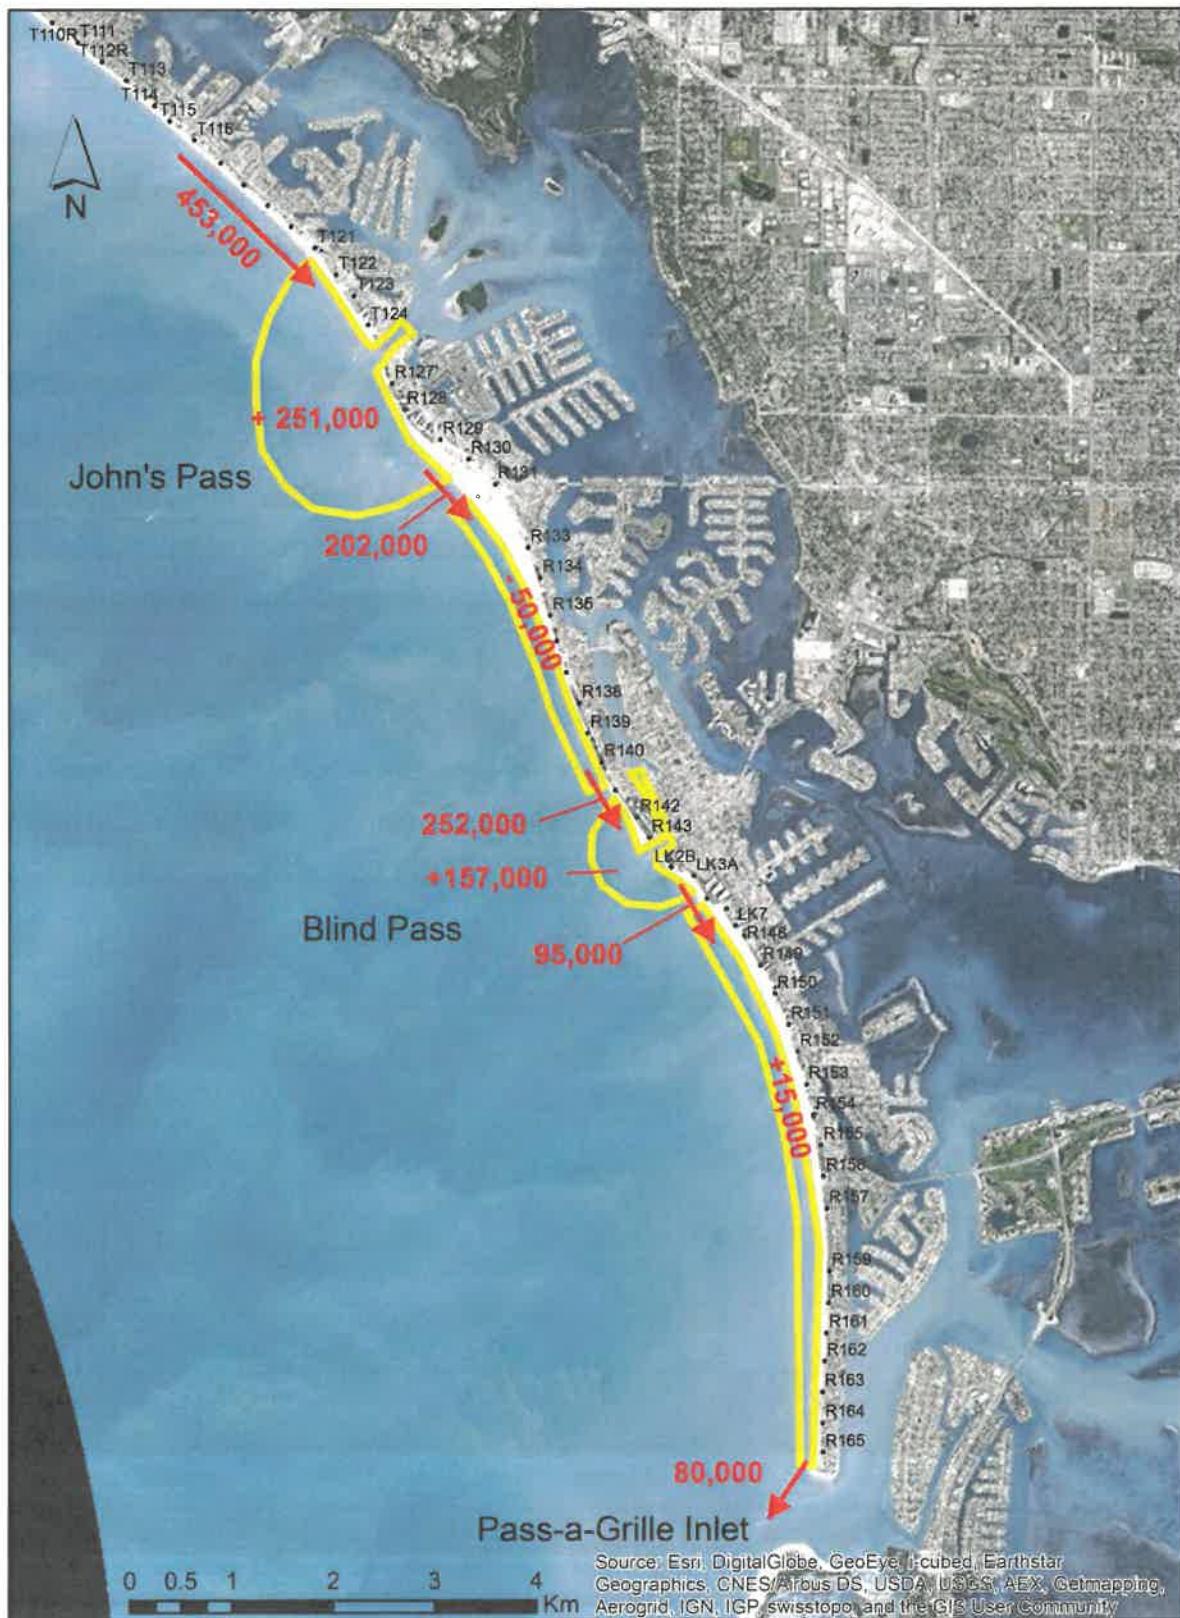
Figure 10. Regional sediment budget of Johns Pass and Blind Pass system, in m^3 .

The Wang et al. (2016) regional balanced sediment budget for the entire Johns Pass and Blind Pass system is illustrated in Figure 10 and Figure 11. Figure 10 illustrates the entire sand budget over the 44-month (or 3.7-year) period. Figure 11 illustrates the annualized budget. Over the 44-month period, a total of 453,000 m³ (593,000 yd³) (or 122,000 m³/yr (160,000 yd³/yr)) of sand from Sand Key entered Johns Pass inlet system, including the ebb shoal, channel and immediate adjacent beaches. The 2012 Sand Key beach nourishment contributed significantly to the sand input. The Johns Pass inlet system gained 251,000 m³ (328,000 yd³) of sand over the 44-month period, or at 68,000 m³/yr (89,000 yd³/yr). A total of 202,000 m³ (264,000 yd³) of sand bypassed Johns Pass onto Treasure Island beach over the 44-month period, at 54,000 m³/yr (71,000 yd³/yr) annual rate. The entire Treasure Island beach lost 50,000 m³ (65,000 yd³) of sand over the 44 months, or at 14,000 m³/yr (18,000 yd³/yr). Most of the sand loss can be attributed to Sunset Beach.

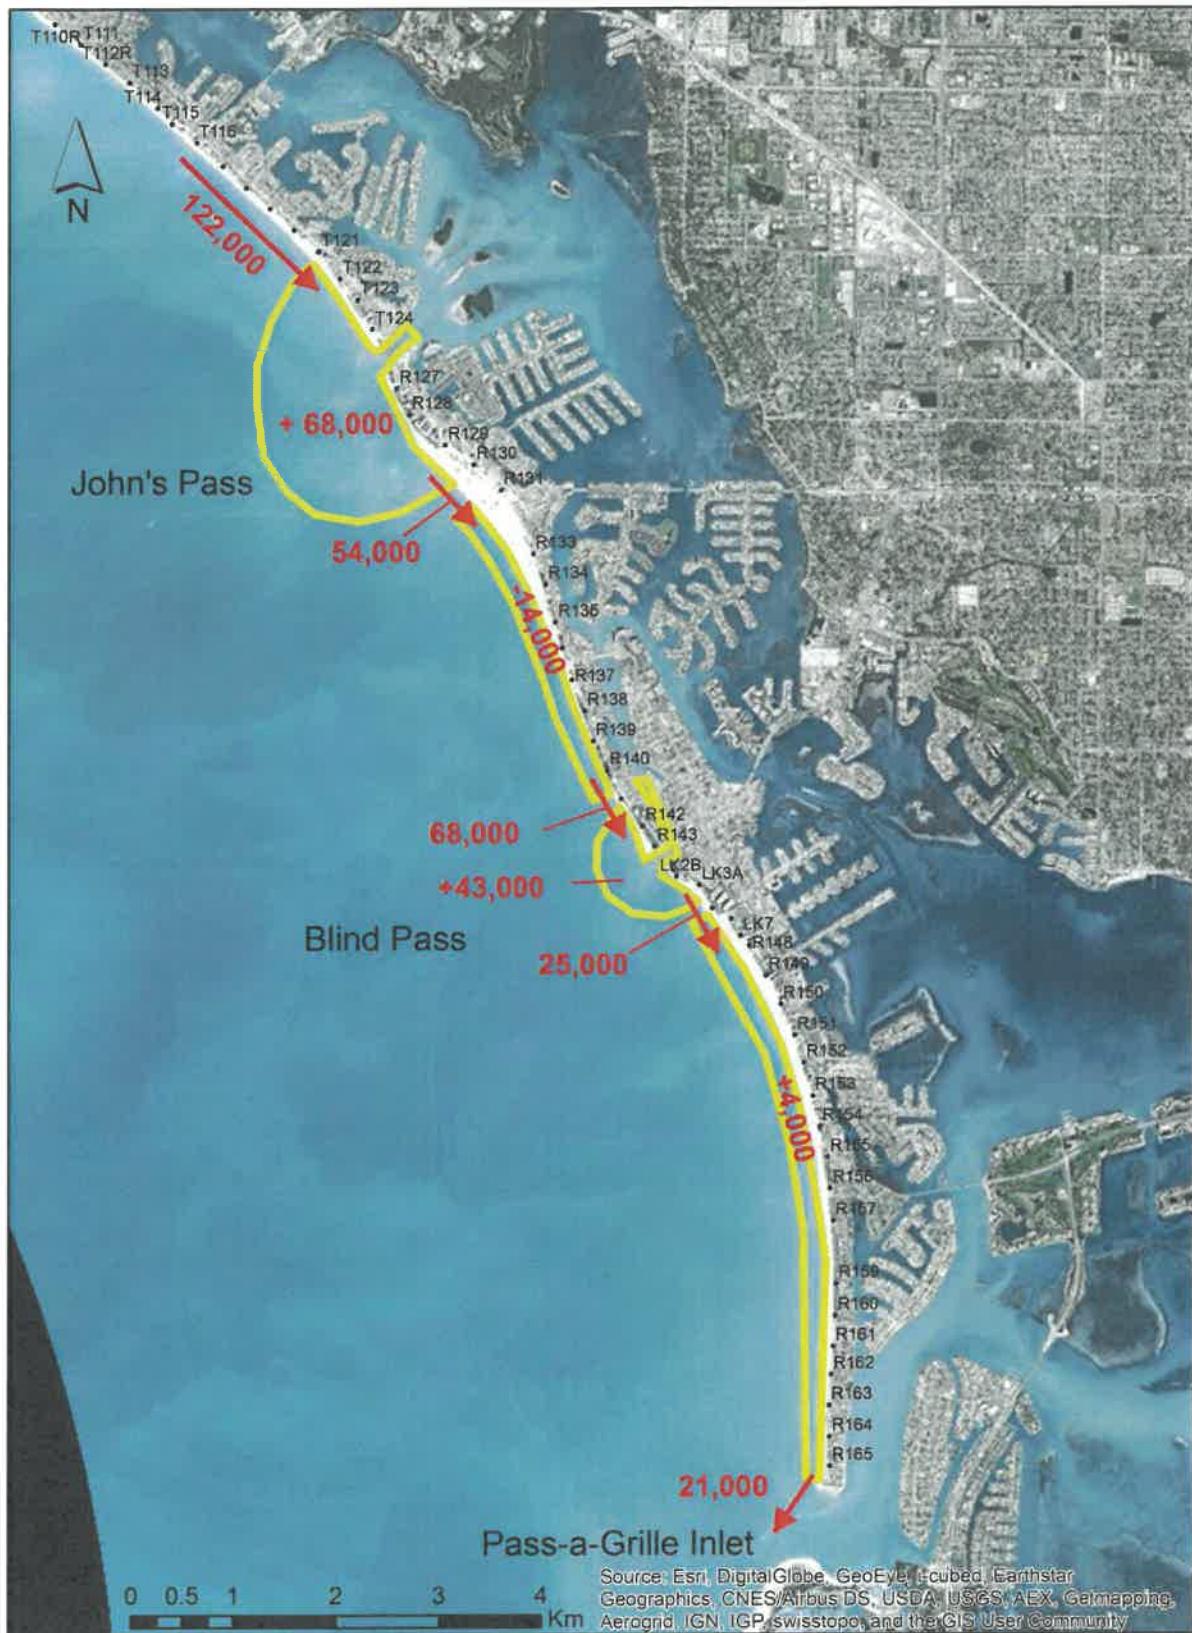
Figure 11. Regional annualized sediment budget of Johns Pass and Blind Pass, in m^3/yr .

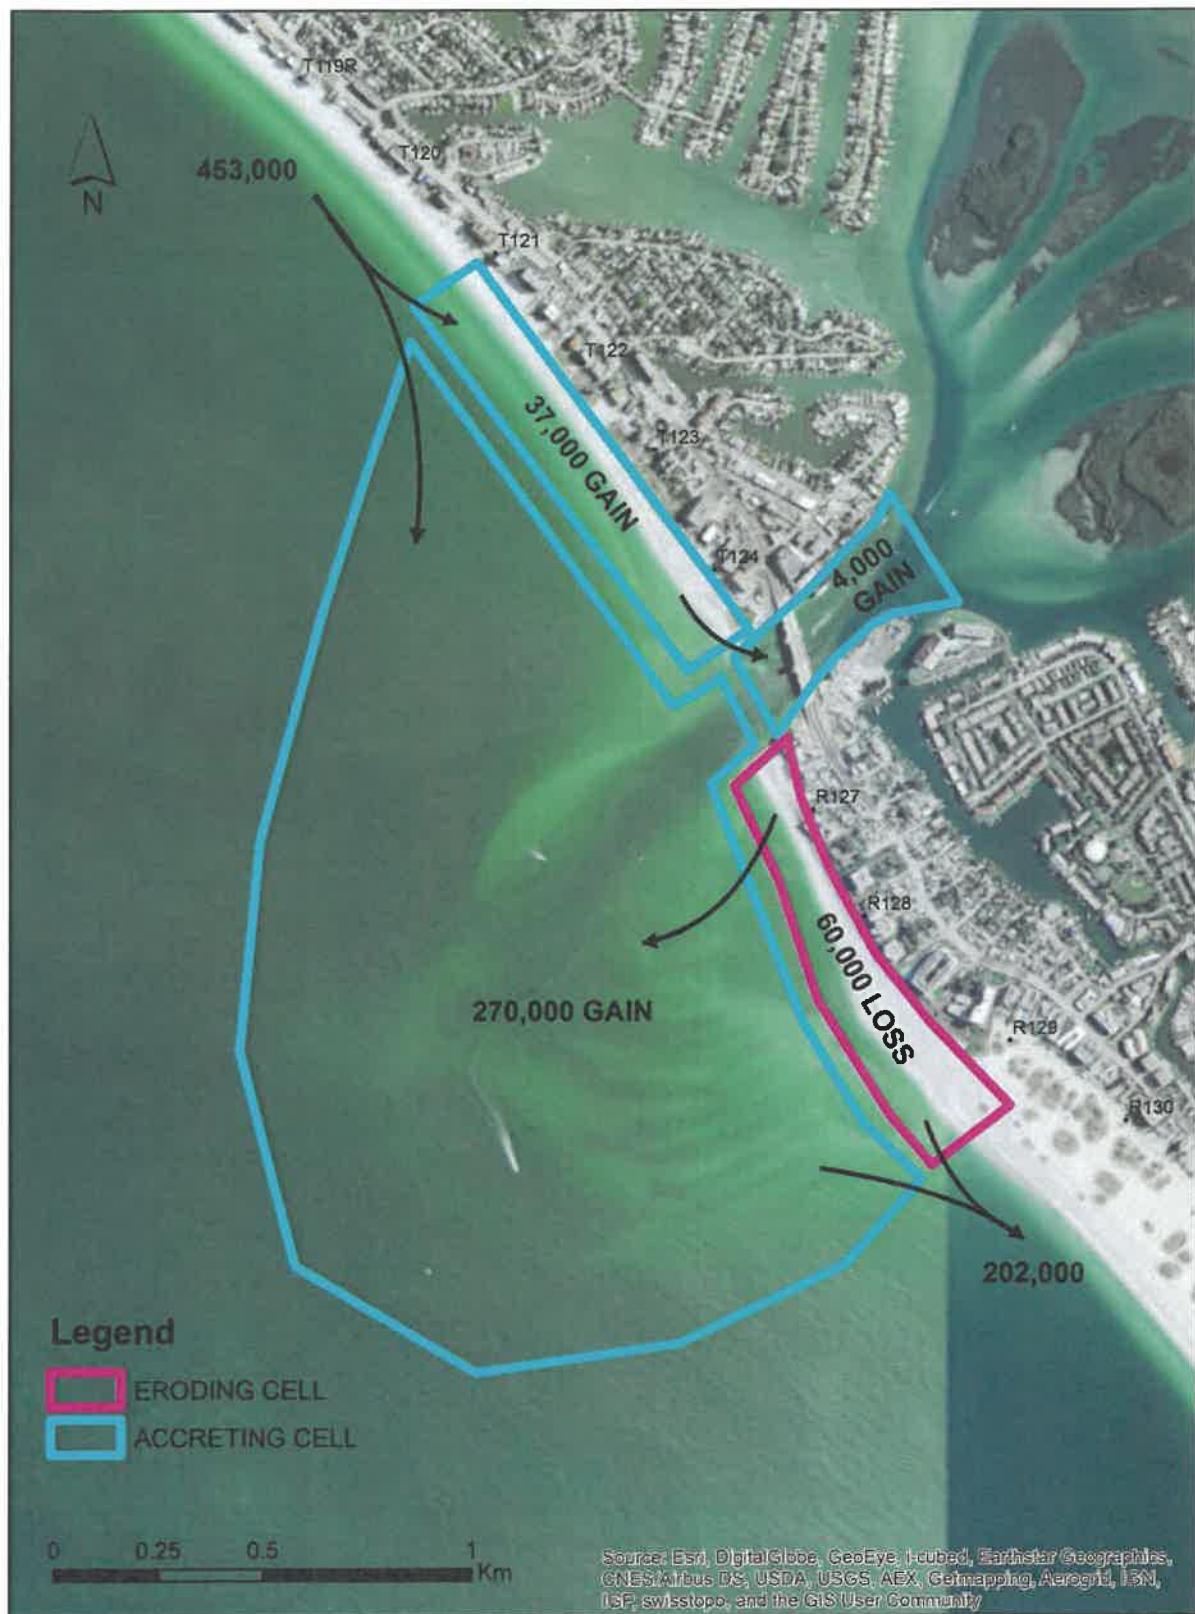
Figure 12. Sediment budget at Johns Pass, in m^3 .

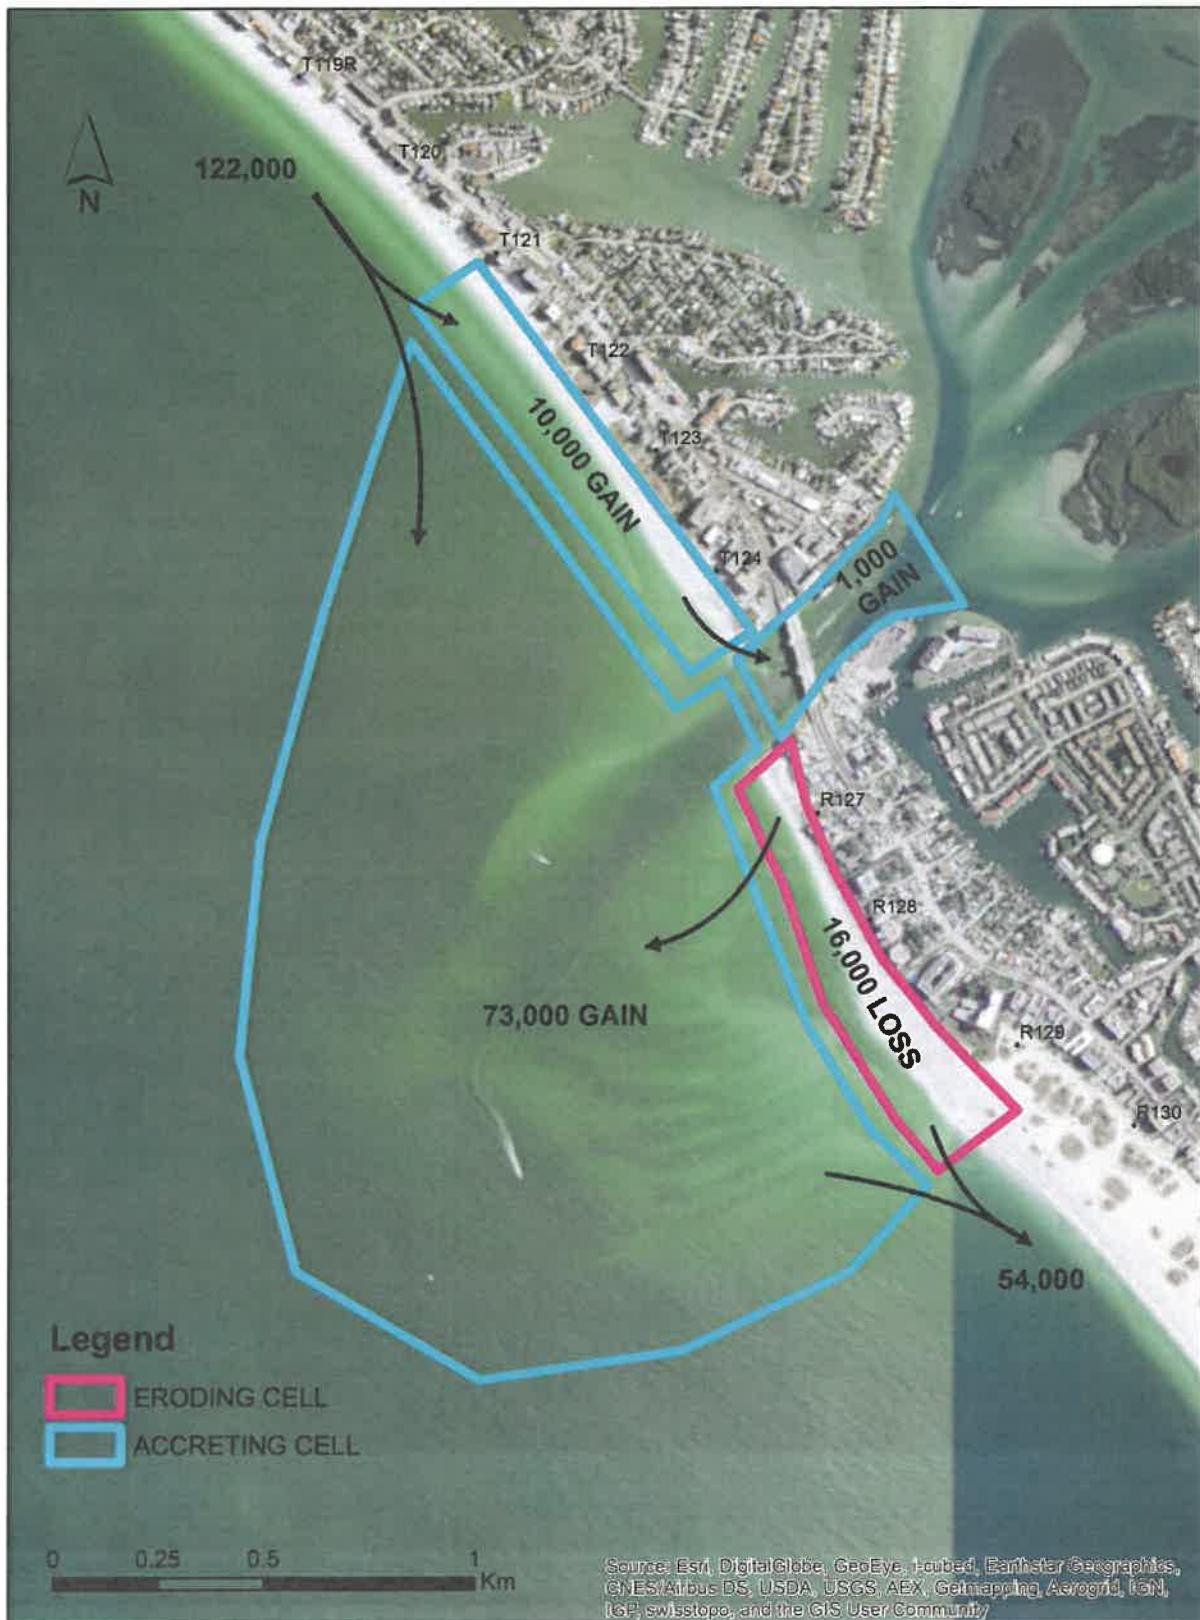
Figure 13. Annualized sediment budget at Johns Pass, in m³/yr.

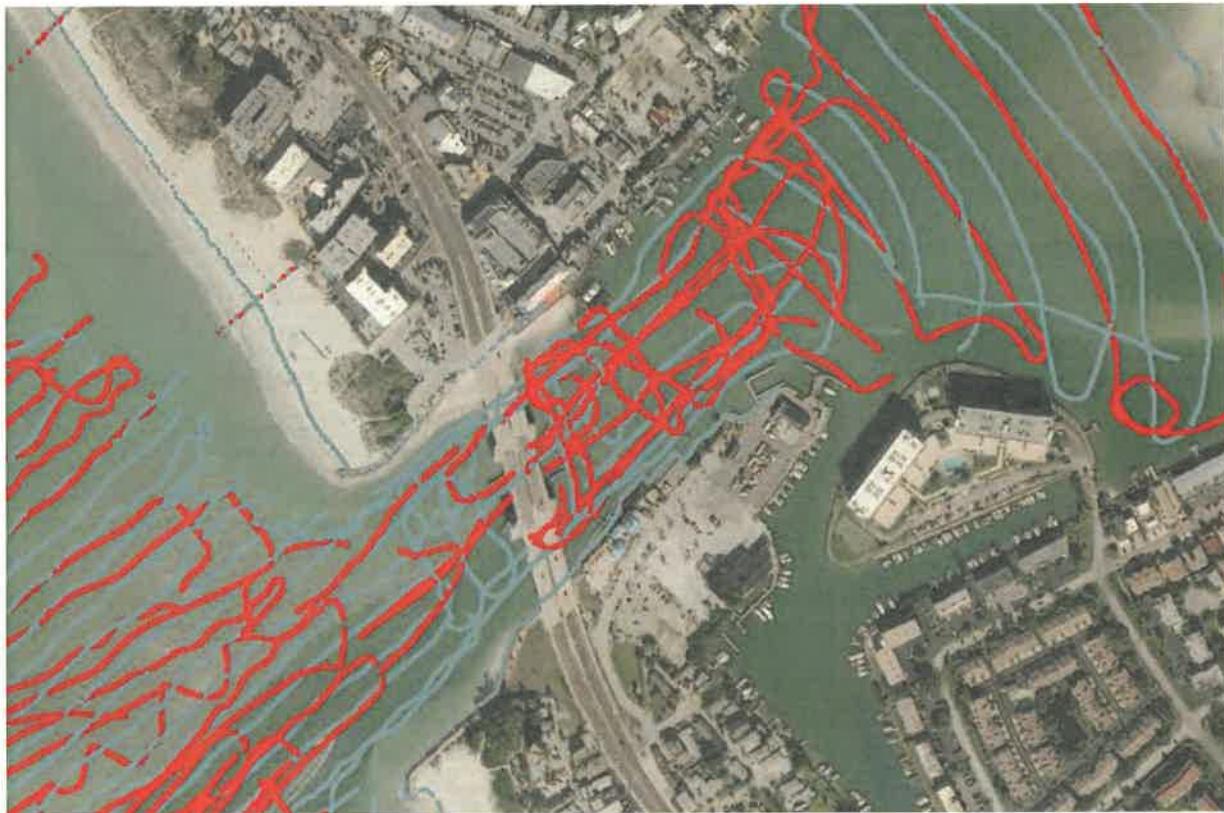
Figure 16. Coverage of the multi-beam bathymetry surveys conducted in 2018 and 2019.

The survey with the most areal coverage was conducted in 2014 using a multi-beam echo sounder during the inlet management study (Figure 15). Like the 2020 and other surveys (Figure 16), the 2014 survey coverage was limited by the boat docks and the bridge. In addition, the survey vessel could not get close to the north jetty. The poor coverage in the 2018 survey (Figure 16) was caused by the dredging operation during that time.

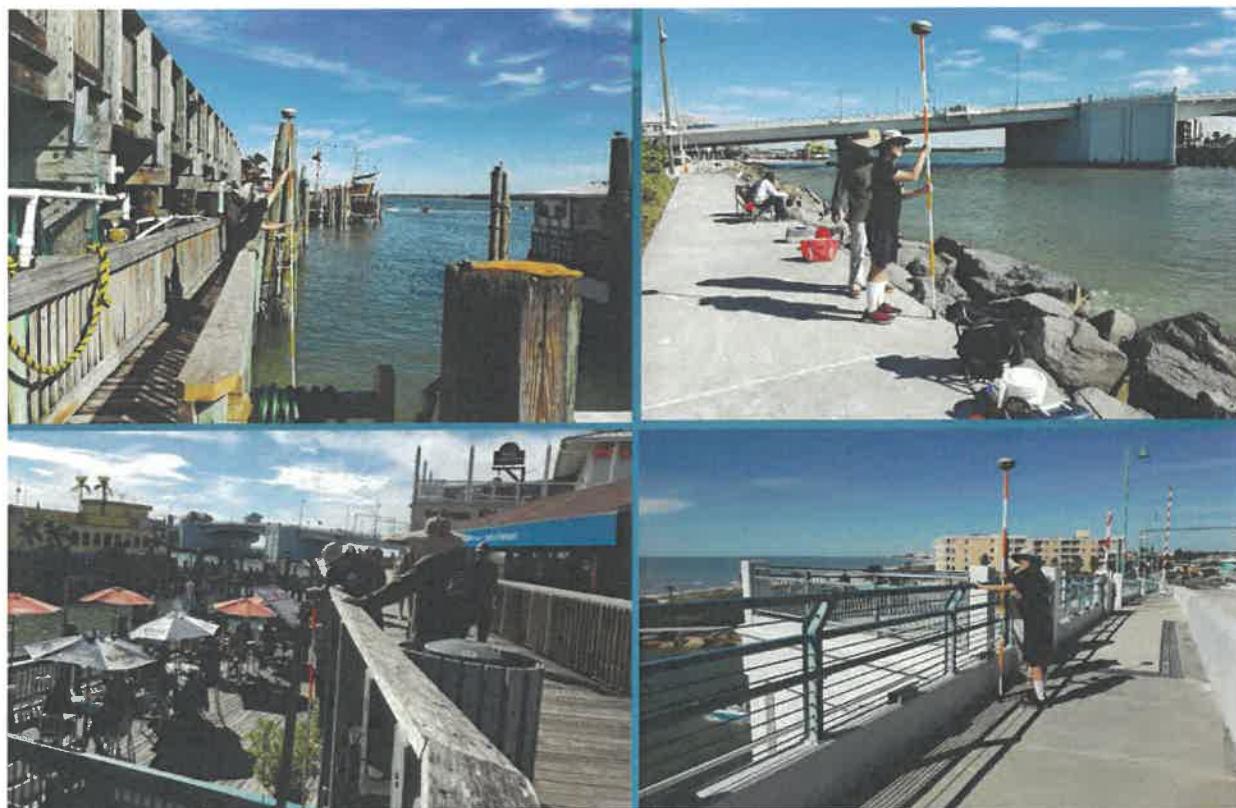
Figure 17. Survey of land boundary and the bridge piling positions using RTK GPS.

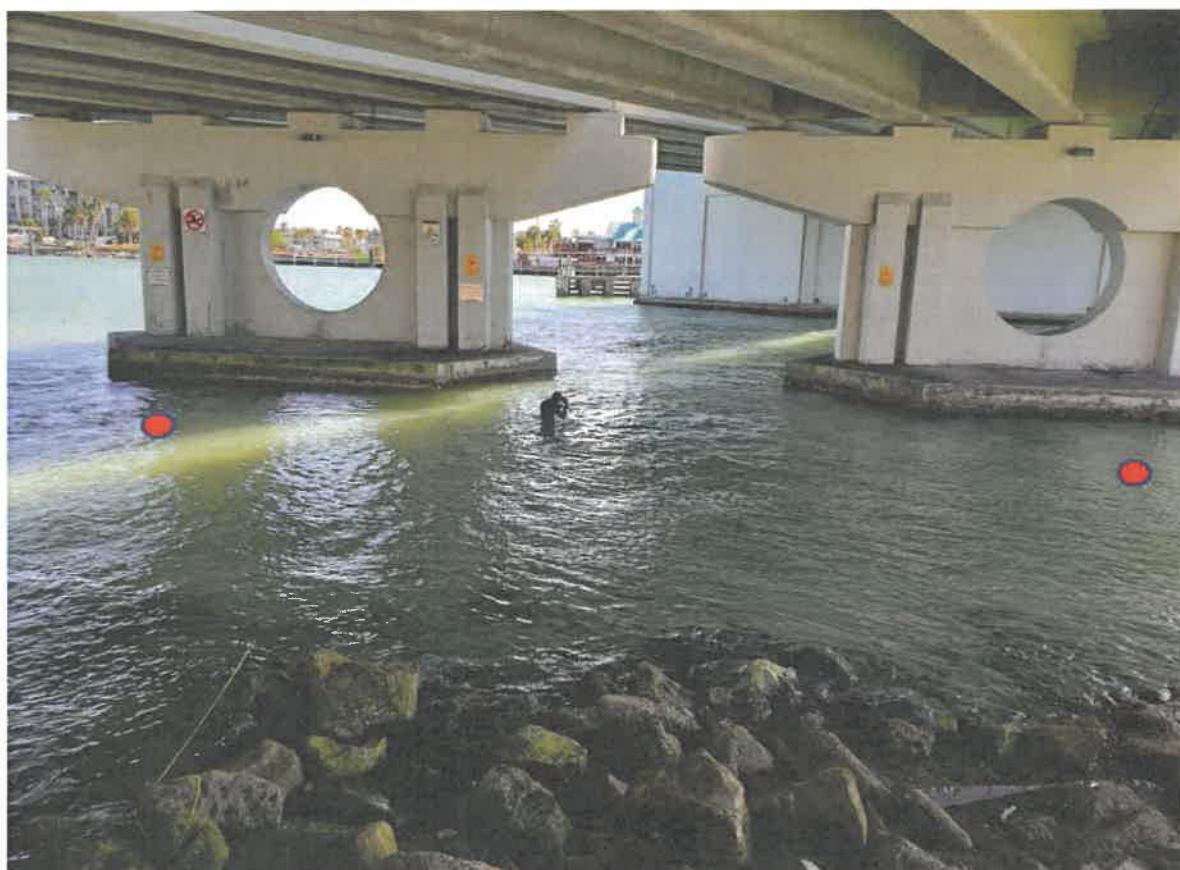
Figure 18. Short-term tidal current measurement at the project site.

To ensure that the model yields accurate current velocities at the project site, short-term current measurements were conducted between the shoreline and the north most bridge piling. A considerable amount of rocks is distributed between the shoreline and the bridge piling, which may change the bottom friction. The measured tidal current velocities were also used to define the friction coefficient in this area (Figure 18) to ensure the numerical model captured this local condition.

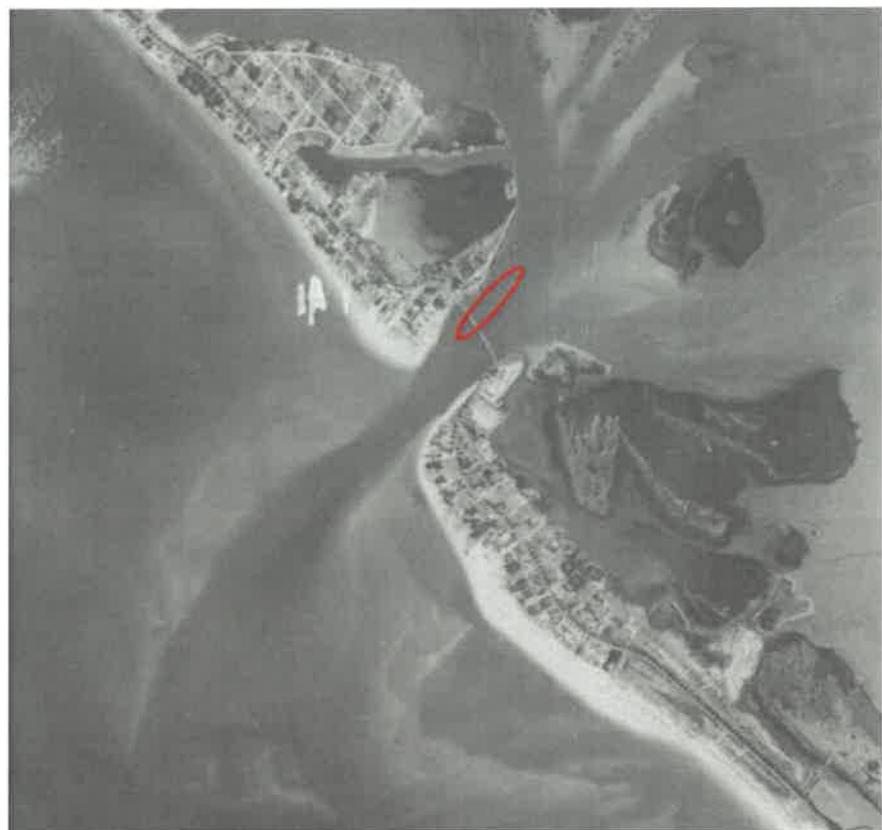
Figure 28. 1945 aerial photo of Johns Pass.

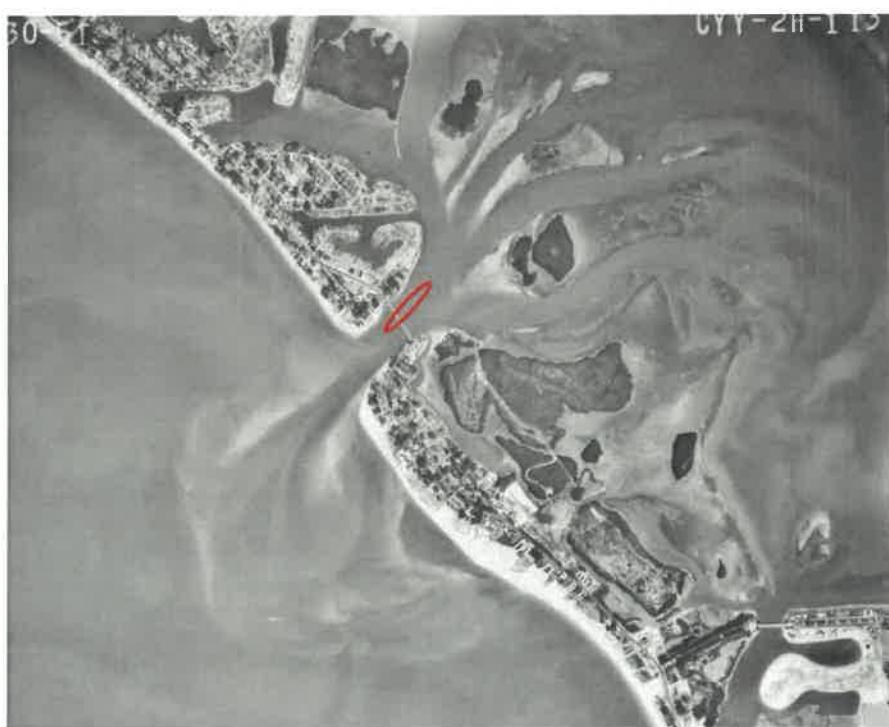
Figure 29. 1951 aerial photo of Johns Pass.

Rapid human development in the vicinity of Johns Pass can be seen on the 1951 aerial photo (Figure 29). It appears that marina installation had occurred by that time. Different from the 1945 view of Madeira Beach, the depleted shoreline was replaced by a healthy-looking sandy beach. A rather extensive emerged sand body was present in the interior of the Johns Pass channel directly seaward of the developing marinas. The finger island dredge and fill operations had also started in the back bay.

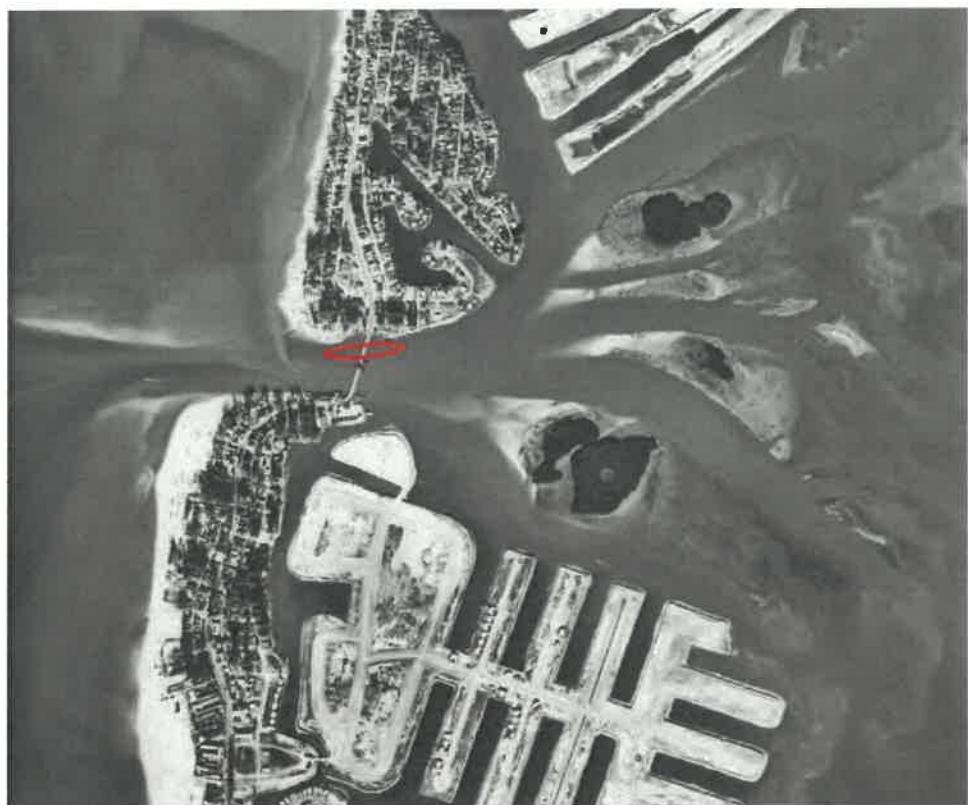
Figure 30. 1957 aerial photo of Johns Pass.

The 1957 aerial photo (Figure 30) shows considerable changes at Johns Pass, as compared to the conditions in 1951. Aggressive erosion at Madeira Beach seems to have resumed, leading to the installation of the 37 low-profile groins, which still exists today. The sand accumulation directly seaward of the marina remained. A dredge-pit looking feature occurs directly channel-ward of the sand pile. However, no dredging record can be found in the literature (Appendix I). Given the active dredge and fill development during that period, sand removal from the shallow inlet entrance would not be unreasonable. As a matter of fact, the most striking change illustrated by the 1957 aerial photo is the aggressive dredge-and-fill development in the back-bay, converting a large portion of the mangrove environment into finger-channel islands. As discussed in the inlet management study (Wang et al., 2016), this finger-channel development resulted in a roughly 20% reduction of the back-bay area, and subsequently a 20% reduction in tidal prism.

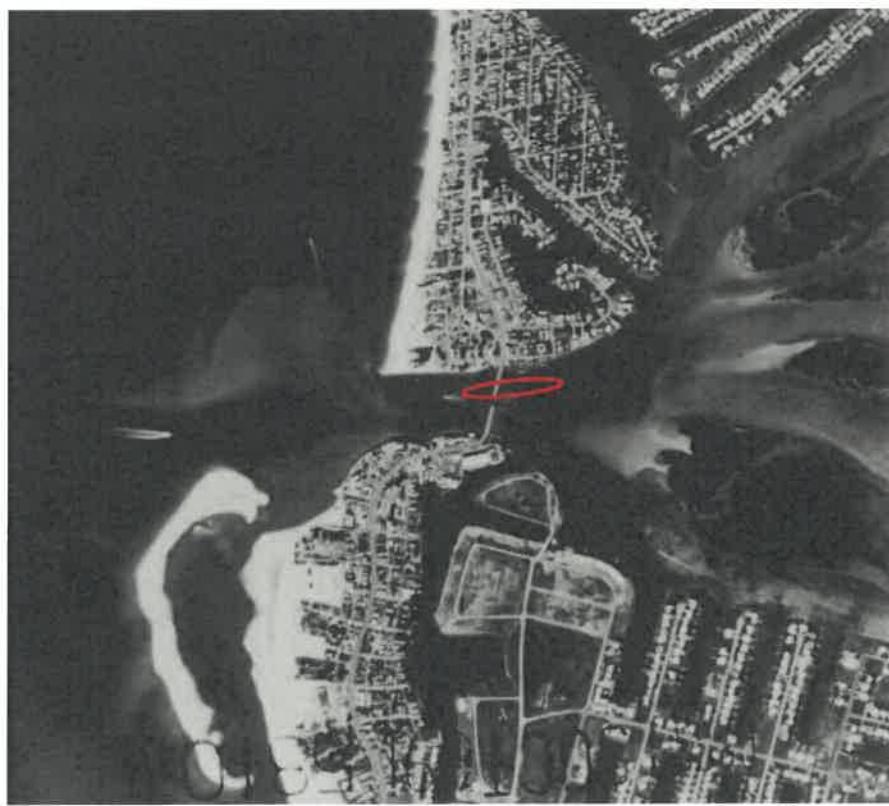
Figure 33. 1969 aerial photo of Johns Pass.

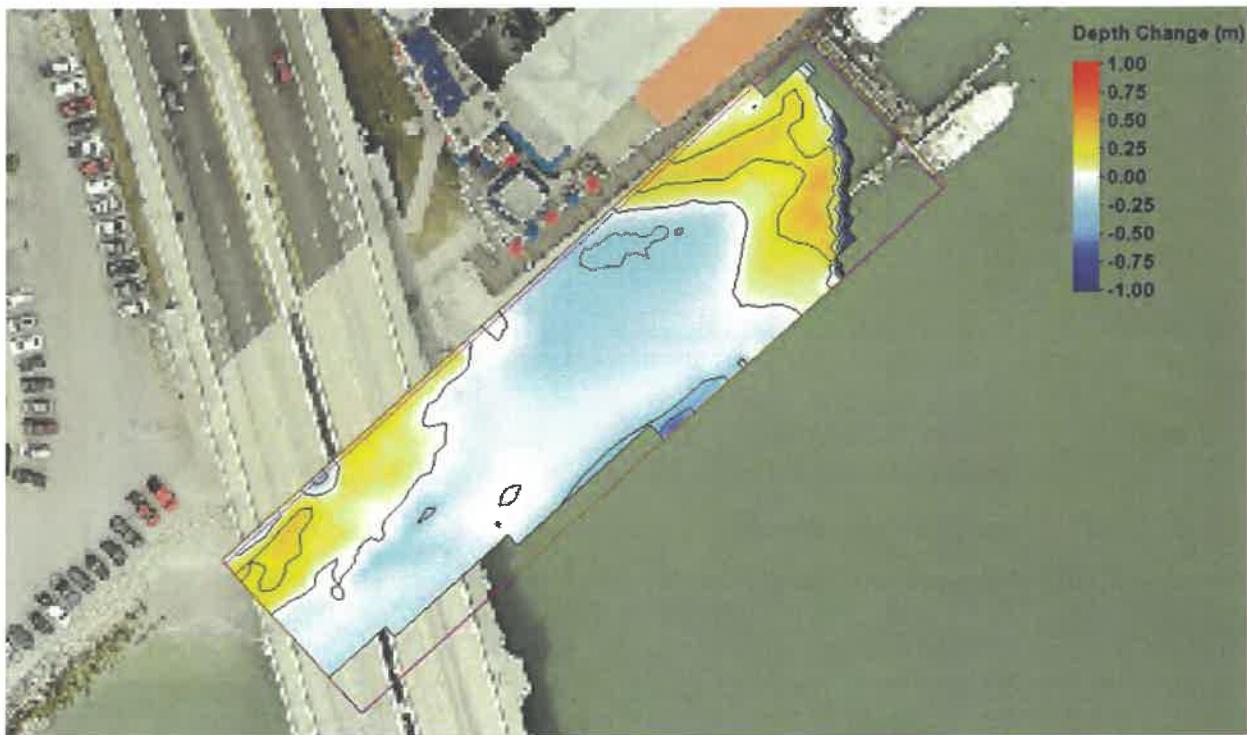
Figure 36. Sedimentation and erosion pattern measured between 12/22/2020 and 02/24/2021.

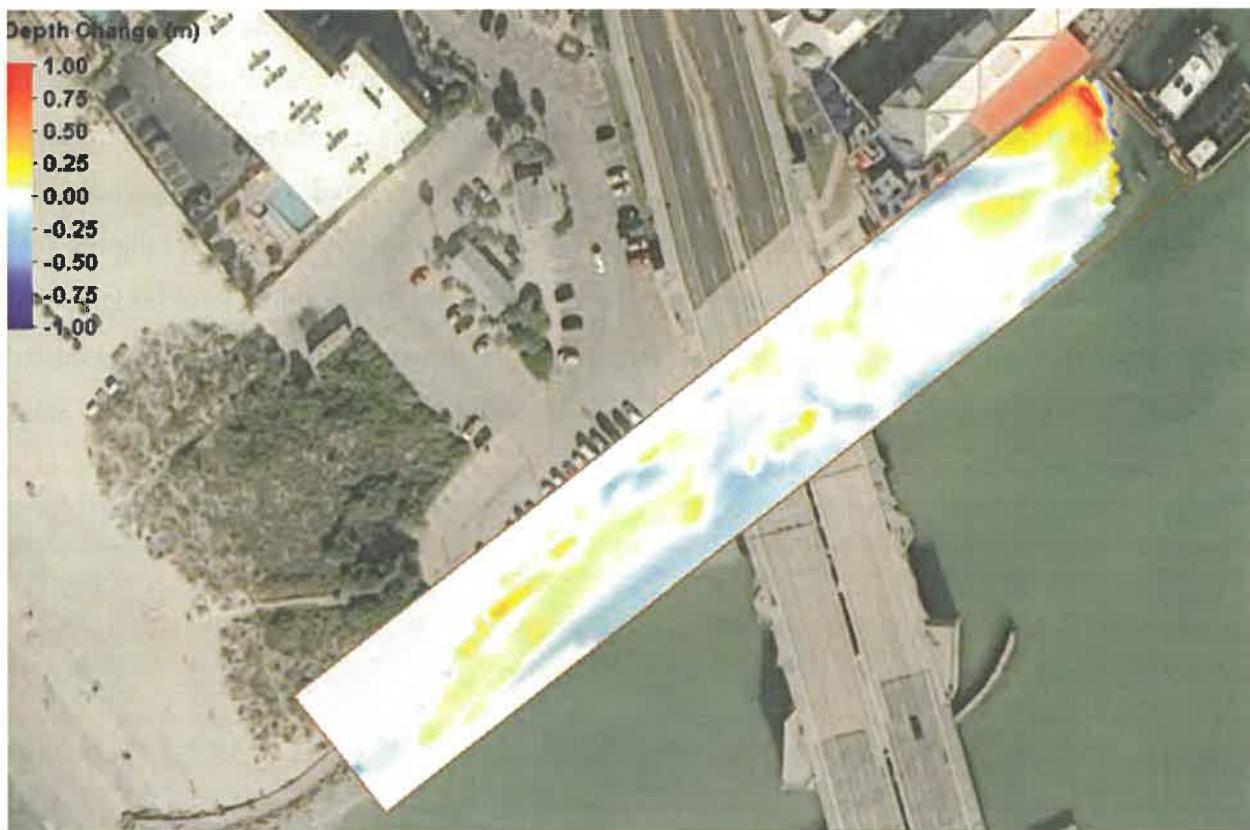
Figure 37. Sedimentation and erosion pattern measured between 02/24/2021 and 03/29/2021.

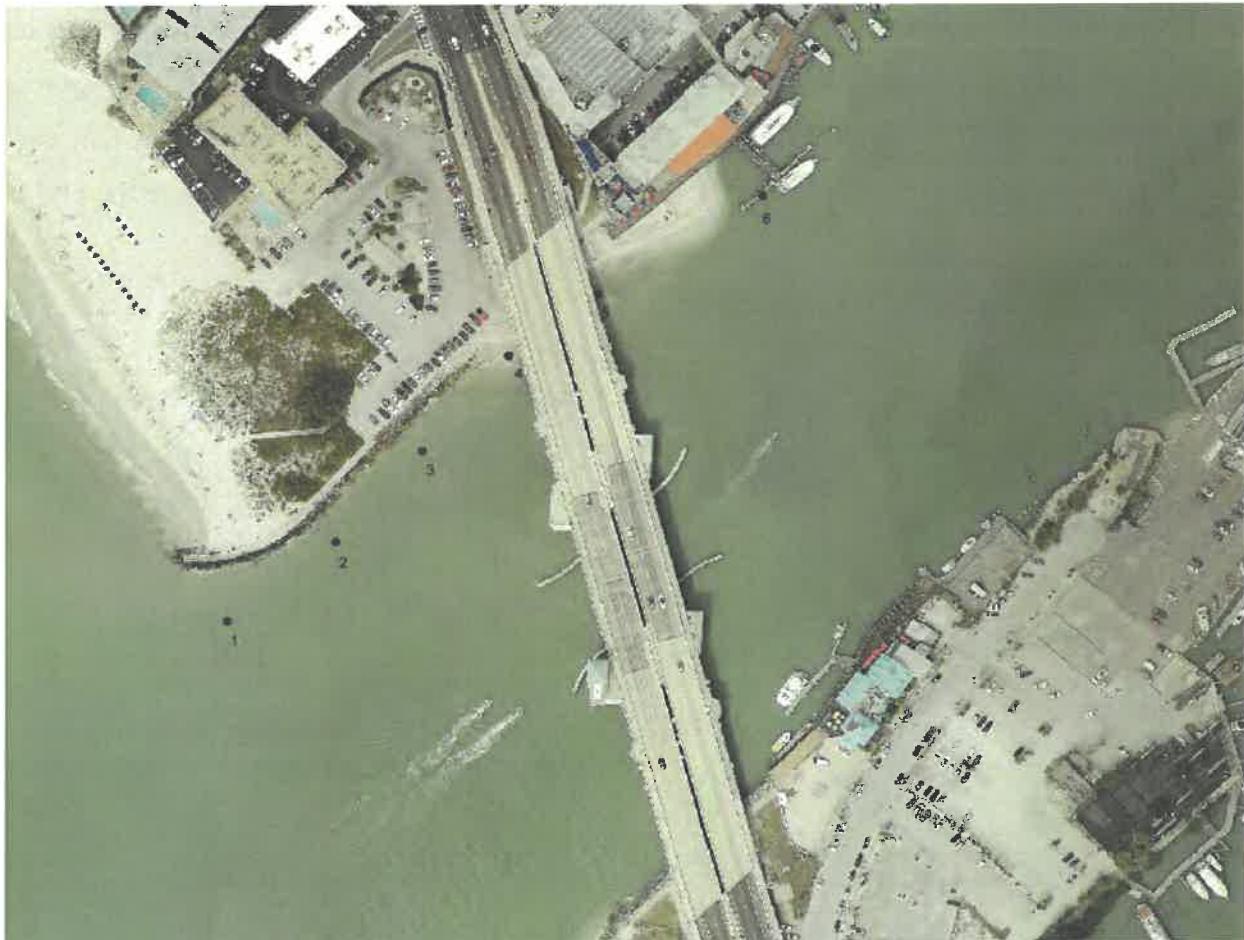
Figure 41. Six locations where time-series of tidal flow are extracted from numerical model

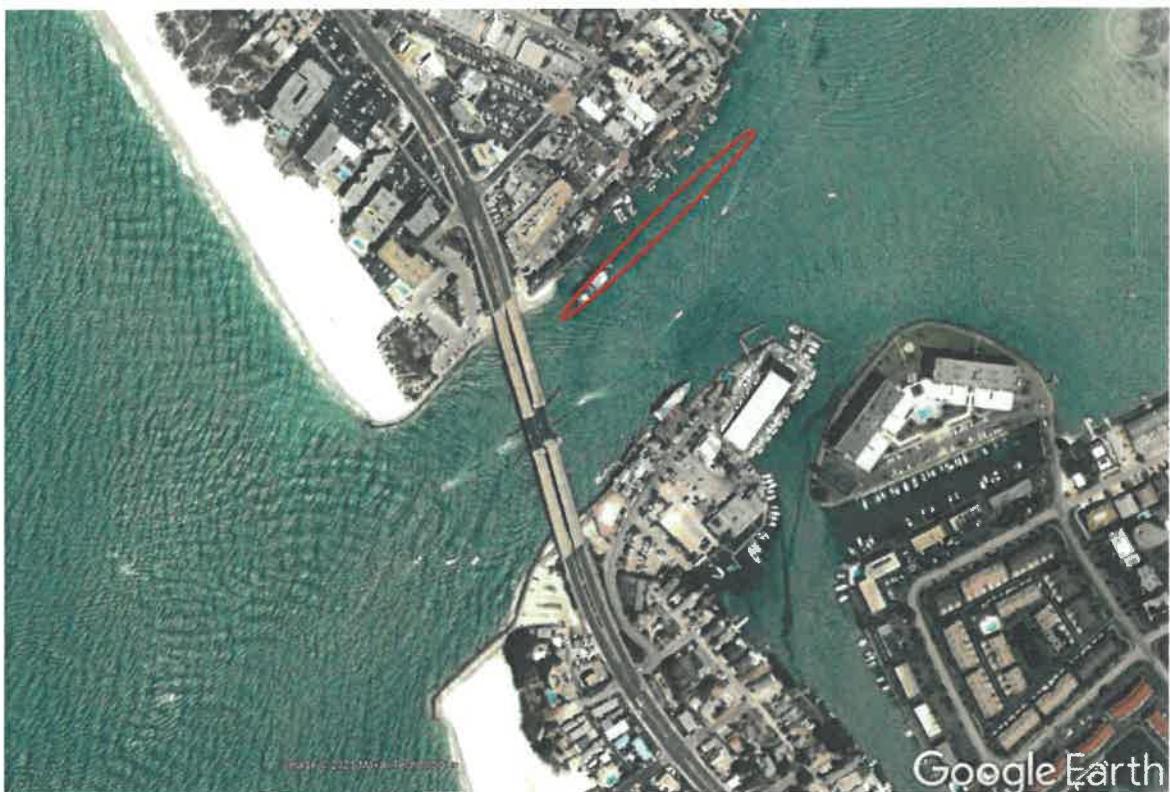
Figure A9. 2002 aerial photo of Johns Pass.
