**Causes and Mitigation of Sedimentation along the
Northern Side of Johns Pass Channel**

Final Report

**Ping Wang and Jun Cheng
Coastal Research Laboratory
School of Geosciences
University of South Florida
Tampa, FL 33620**

**Pinellas County
22211 US Hwy. 19 N.
Clearwater, FL 33765**

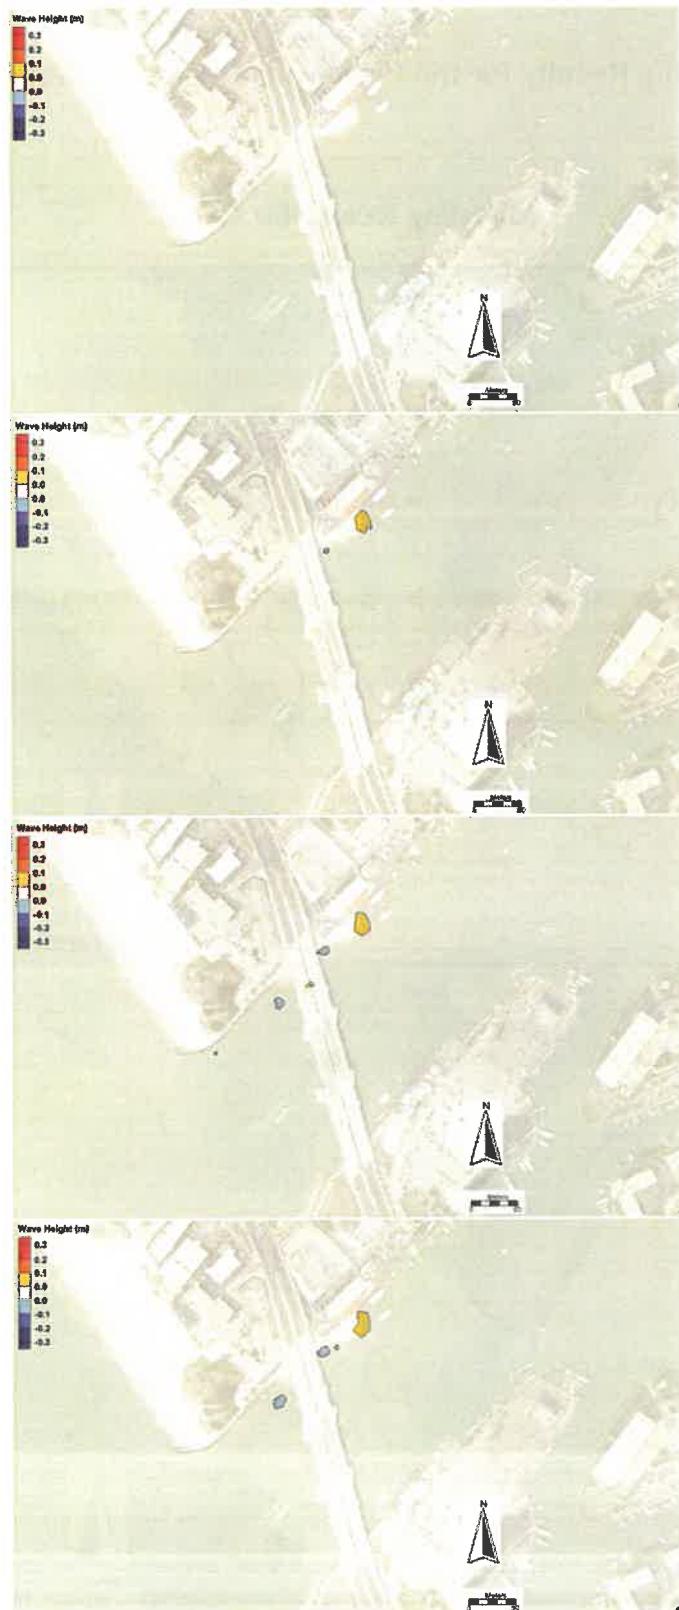
Figure A28. Wave-height difference at high tide between C1-A1 and existing conditions. Positive values indicate higher waves for C1-A1. From top to bottom, incident wave angles are 173.25, 196.25, 218.75, and 286.25 degrees.

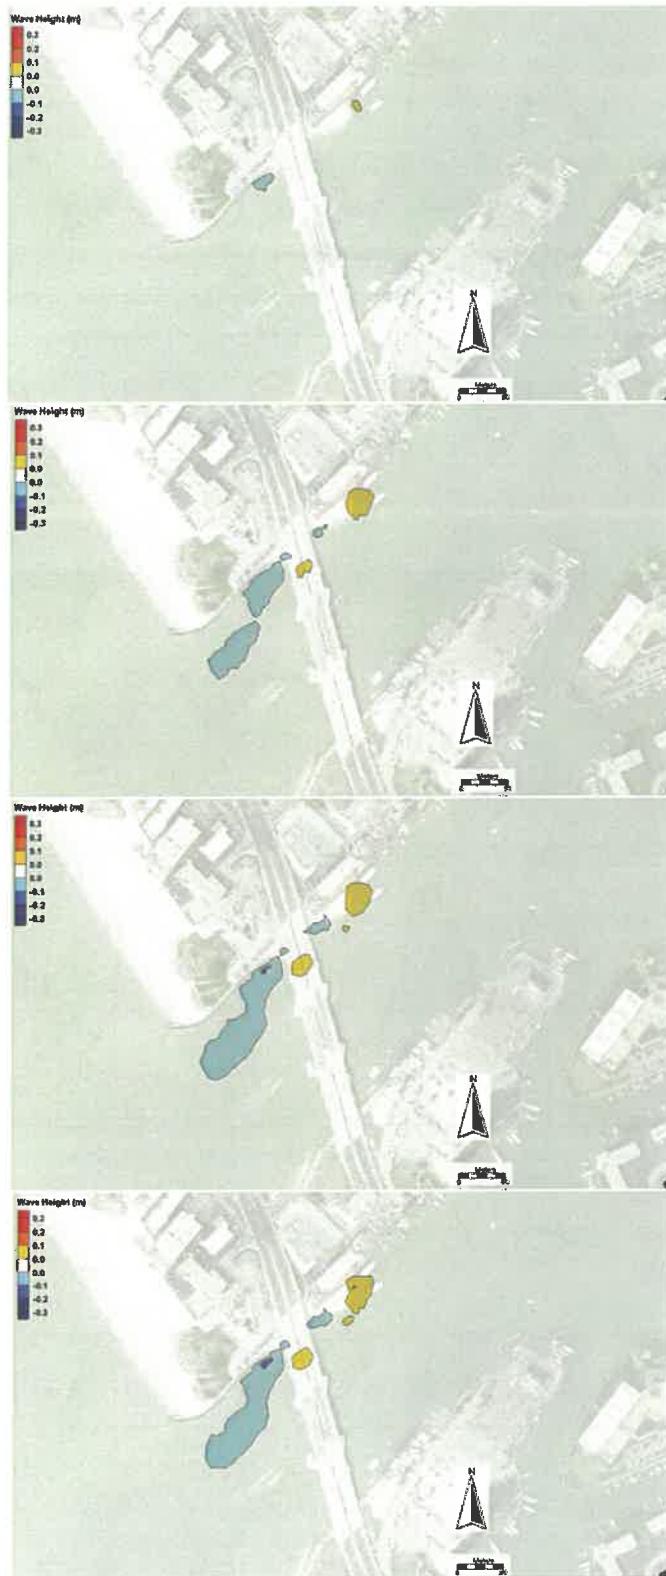
Figure A31. Wave-height difference at high tide between C1-A3 and existing conditions. Positive values indicate higher waves for C1-A3. From top to bottom, incident wave angles are 173.25, 196.25, 218.75, and 286.25 degrees.

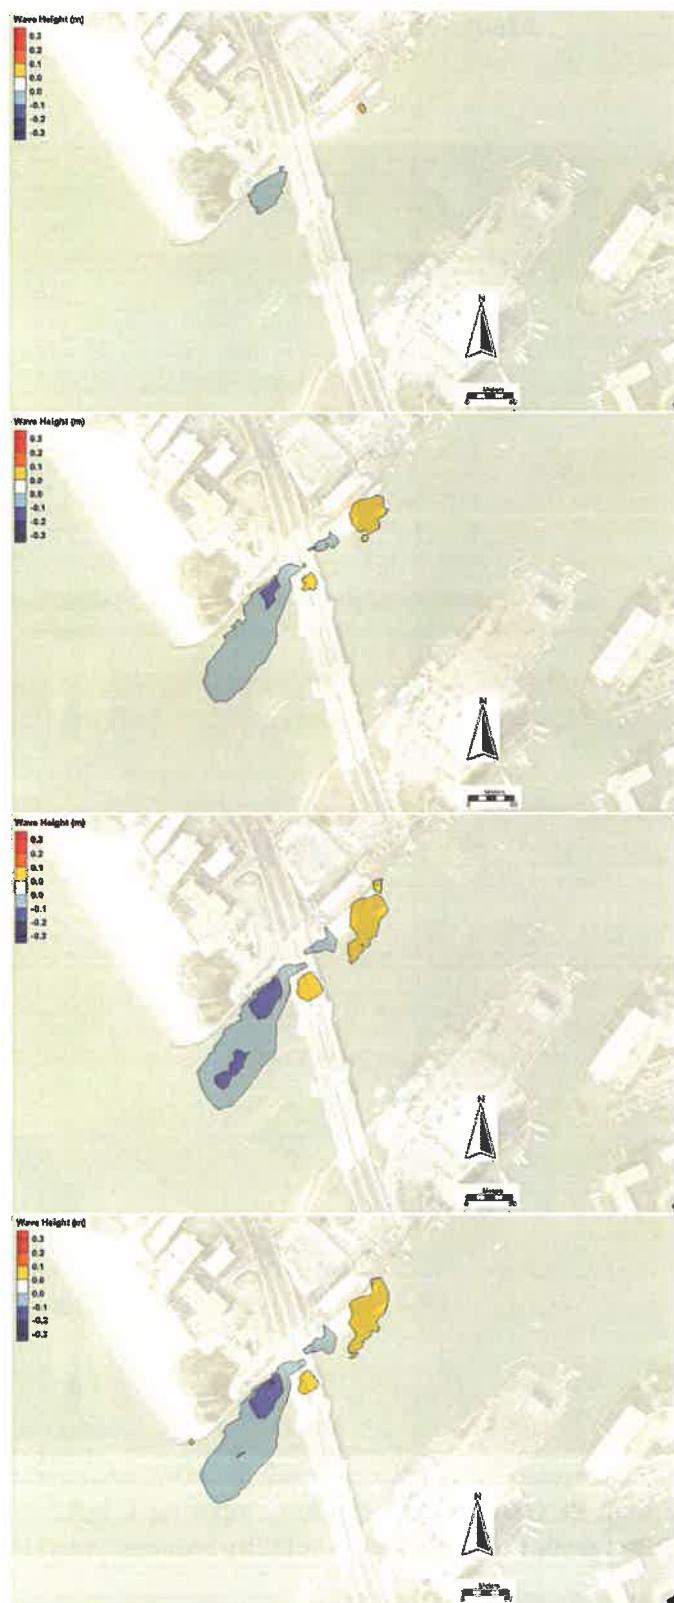
Figure A34. Wave-height difference at high tide between C1-A5 and existing conditions. Positive values indicate higher waves for C1-A5. From top to bottom, incident wave angles are 173.25, 196.25, 218.75, and 286.25 degrees.

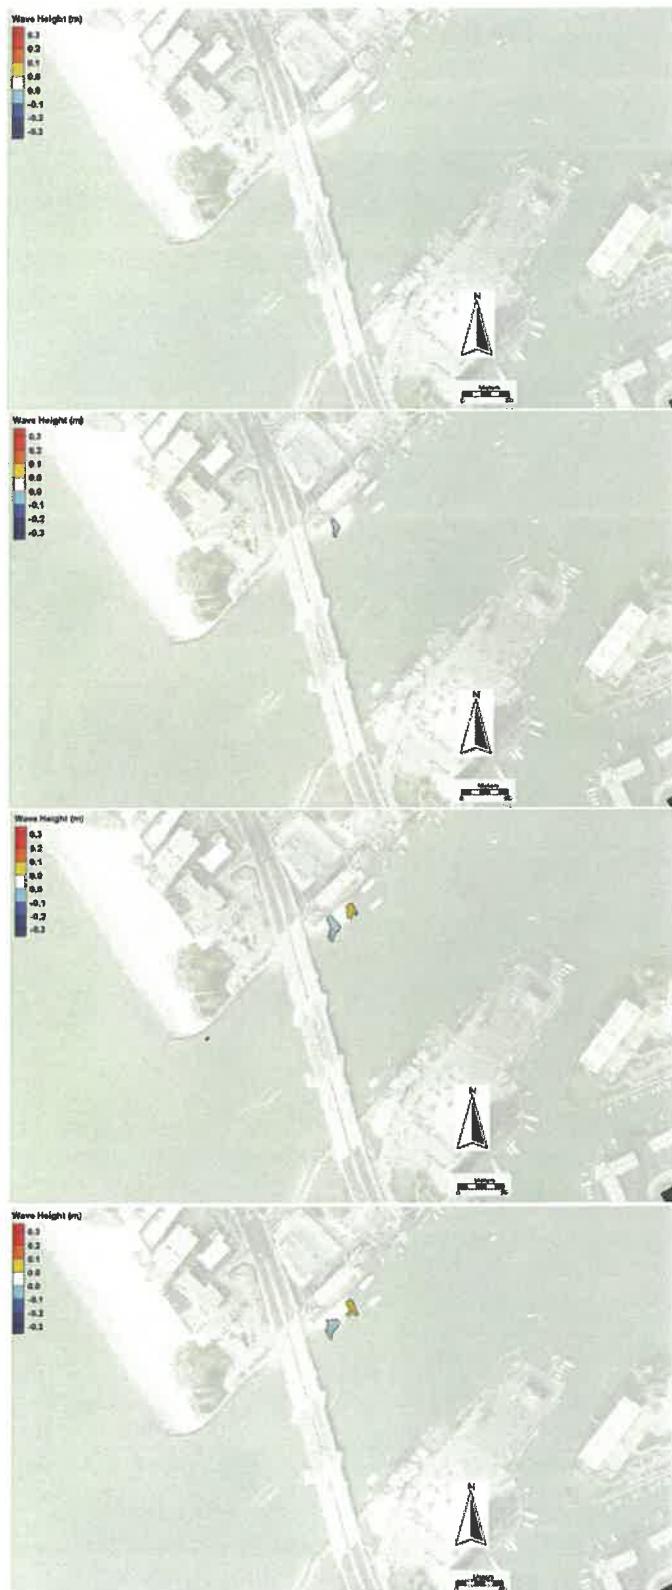
Figure A37. Wave-height difference at high tide between C2-A1 and existing conditions. Positive values indicate higher waves for C2-A1. From top to bottom, incident wave angles are 173.25, 196.25, 218.75, and 286.25 degrees.

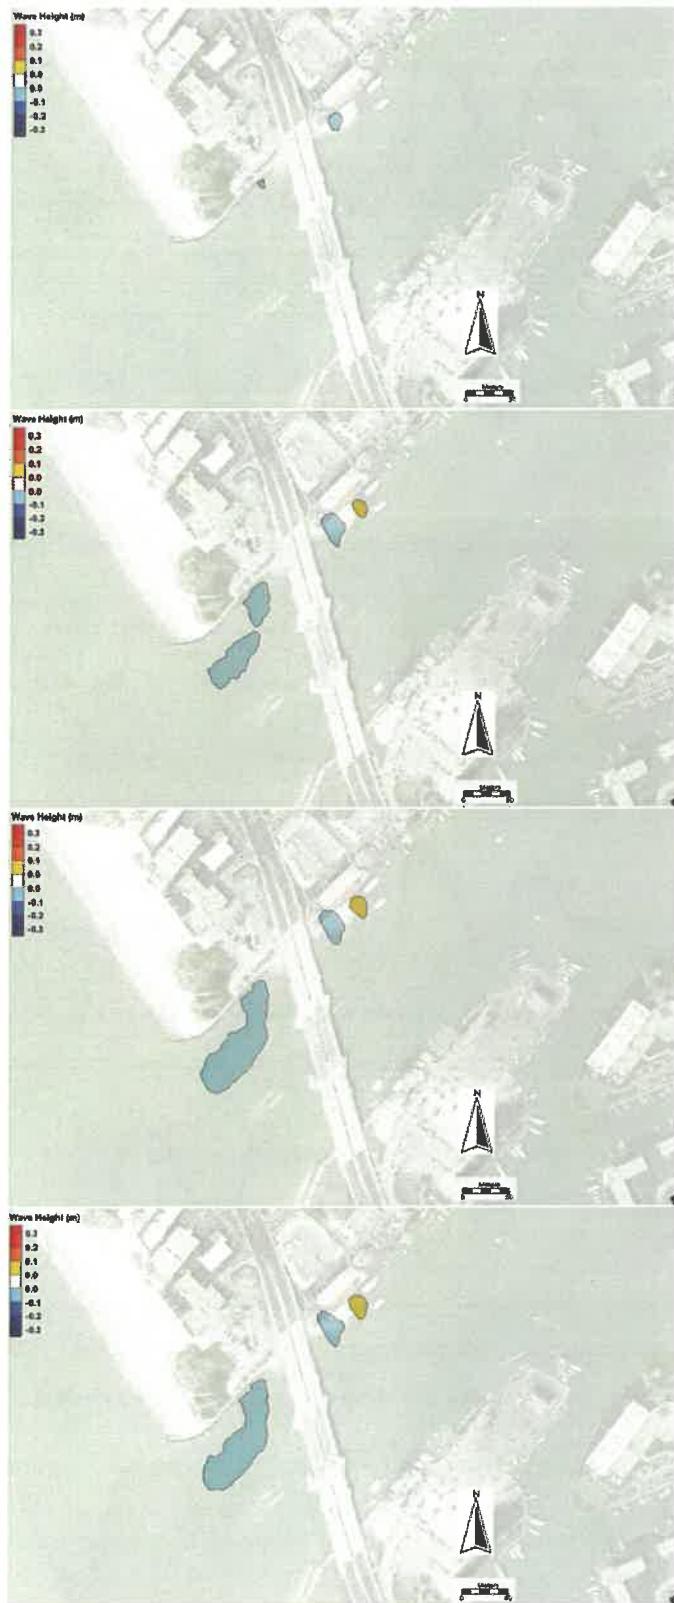
Figure A39. Wave-height difference at high tide between C2-A3 and existing conditions. Positive values indicate higher waves for C2-A3. From top to bottom, incident wave angles are 173.25, 196.25, 218.75, and 286.25 degrees.

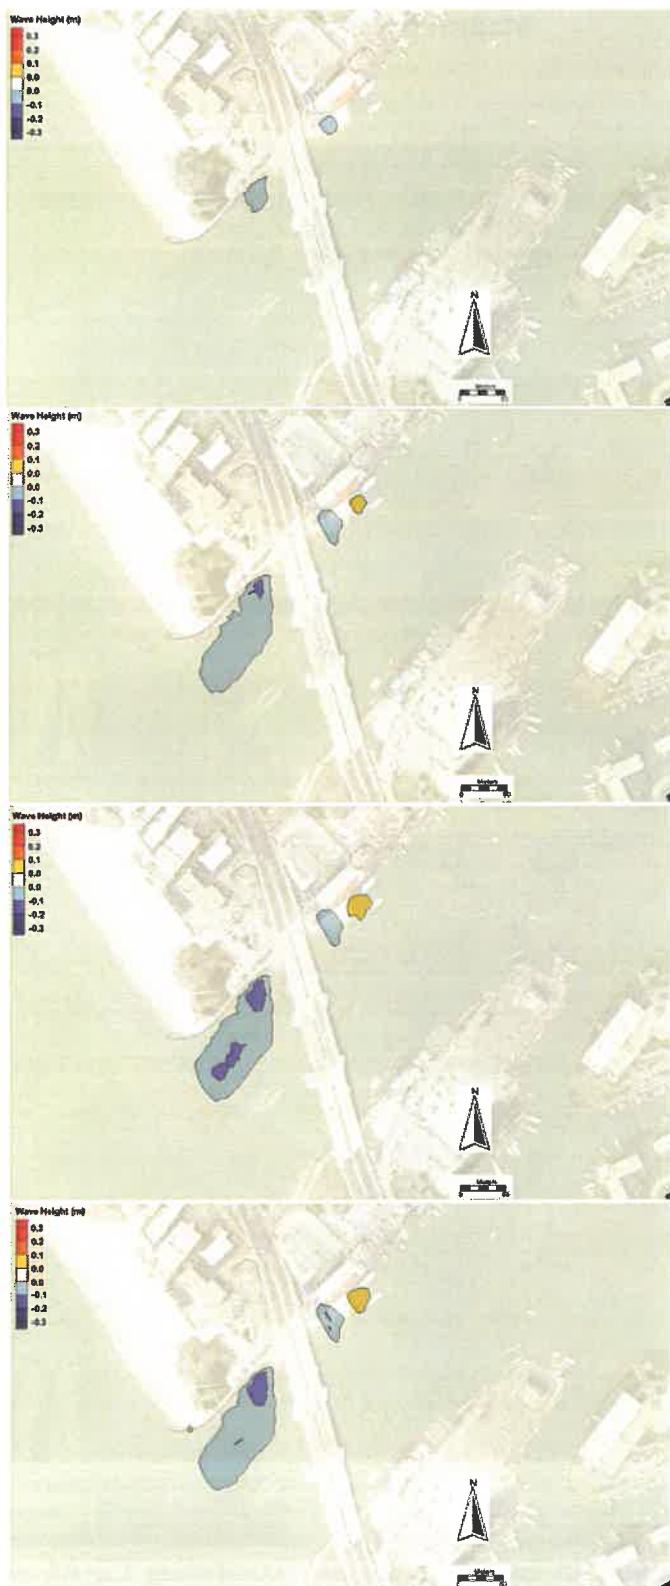
Figure A42. Wave-height difference at high tide between C2-A5 and existing conditions. Positive values indicate higher waves for C2-A5. From top to bottom, incident wave angles are 173.25, 196.25, 218.75, and 286.25 degrees.
