# AB 6308 City Hall Closure Update

Mercer Island City Council | July 18, 2023

# Overview & Purpose

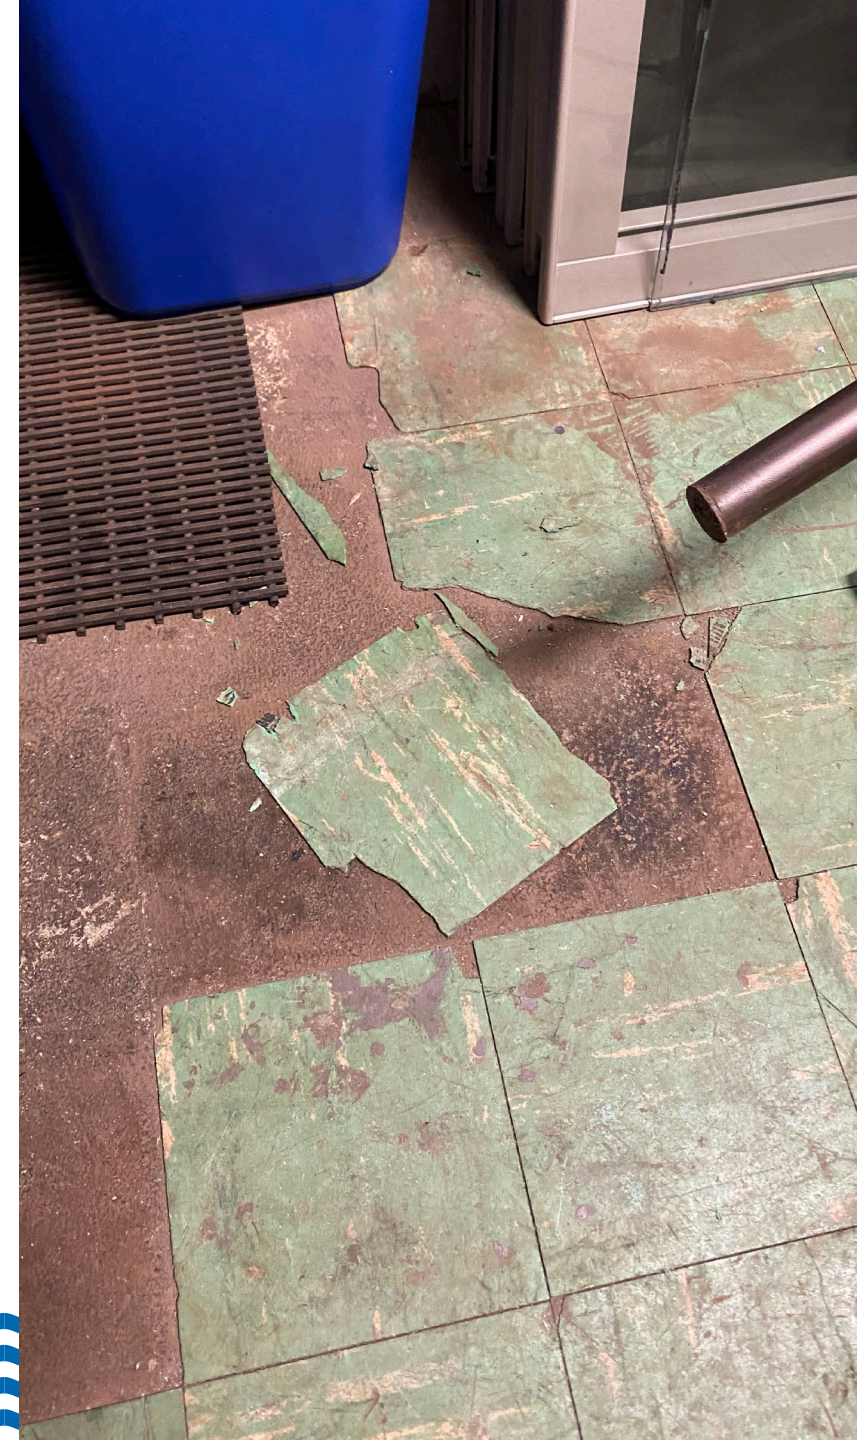
- Broken tiles and tile adhesive in the basement Mechanical Room of City Hall were identified as possibly containing asbestos.
- The tiles were discovered by a staff person while inspecting the Mechanical Room and may have been in that condition for some time.
- Same-day tests confirmed that both the tiles and adhesive contained asbestos.
- The Mechanical Room also contains an air handling unit for the City Hall HVAC system.
- City Hall was immediately closed to further investigate.

**Picture:** Broken tiles in Mechanical Room

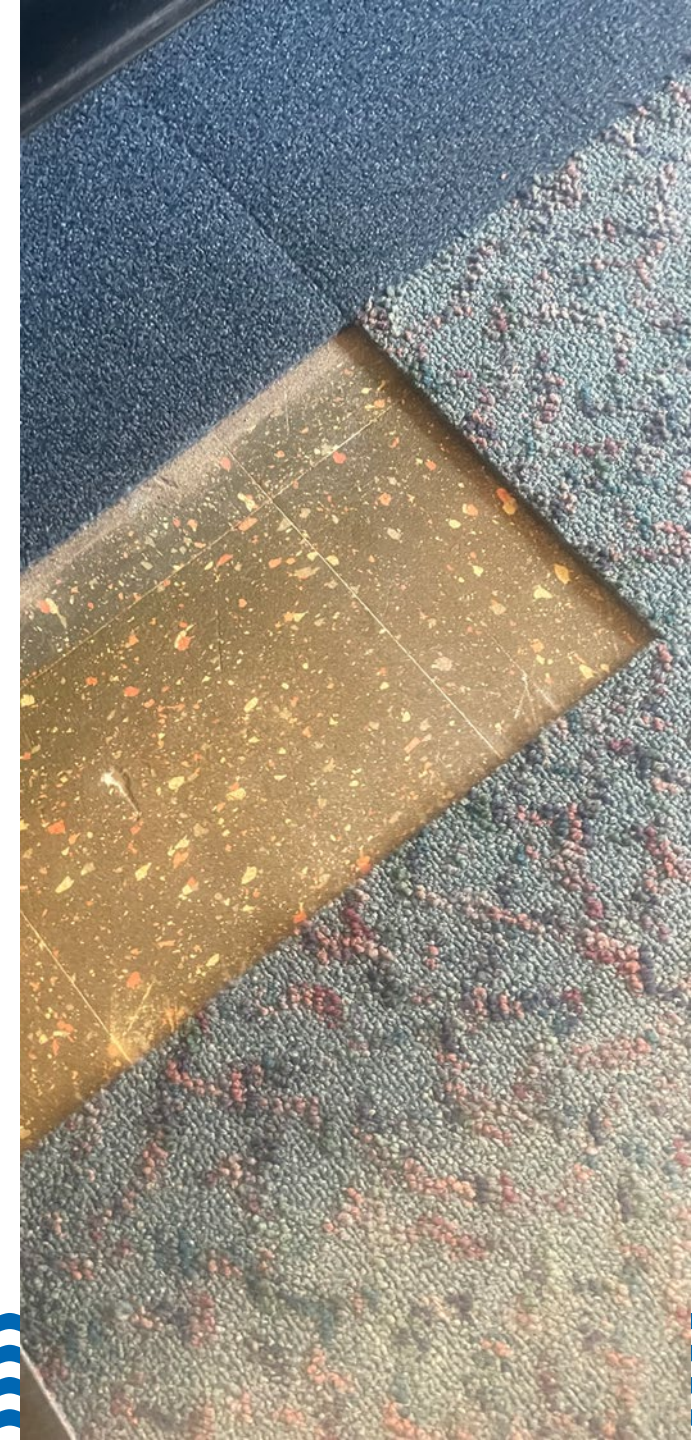
- The asbestos abatement contractor performed an initial building walk through.
- Additional floor tiles on the Main Floor of City Hall also tested positive for asbestos. These tiles are intact, undisturbed, and under carpet tiles, and do not present an immediate hazard. However, they will require abatement in the event of a renovation involving the floor plate in the areas where present.
- The contractor conducted initial air quality testing throughout the building; there were no positive tests for airborne asbestos.

**Picture:** Asbestos-containing tiles under carpet floor tiles on first floor of City Hall.

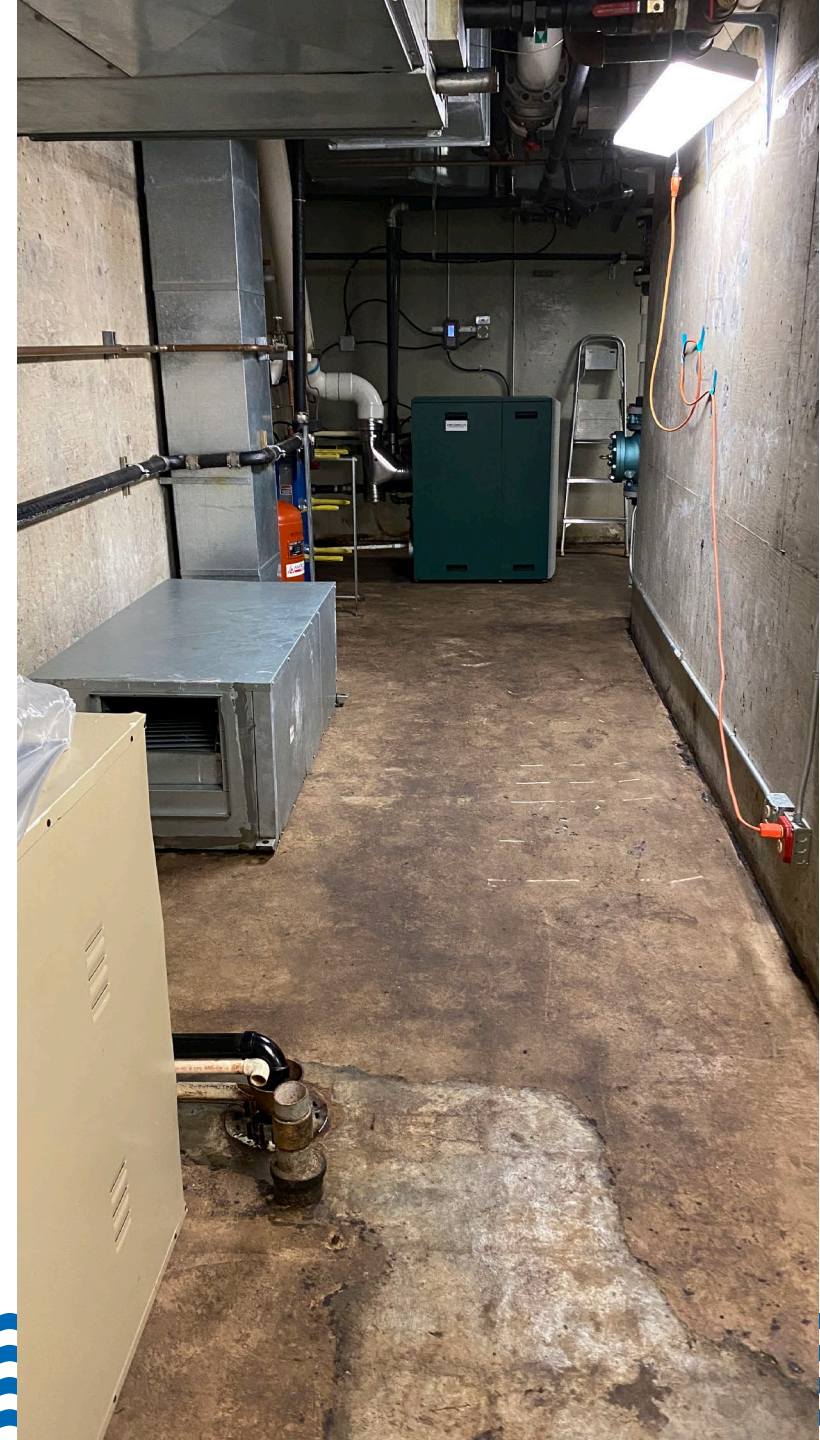
- Boiler room flooring materials abated (pictured)

**Picture:** Basement mechanical room post-abatement.

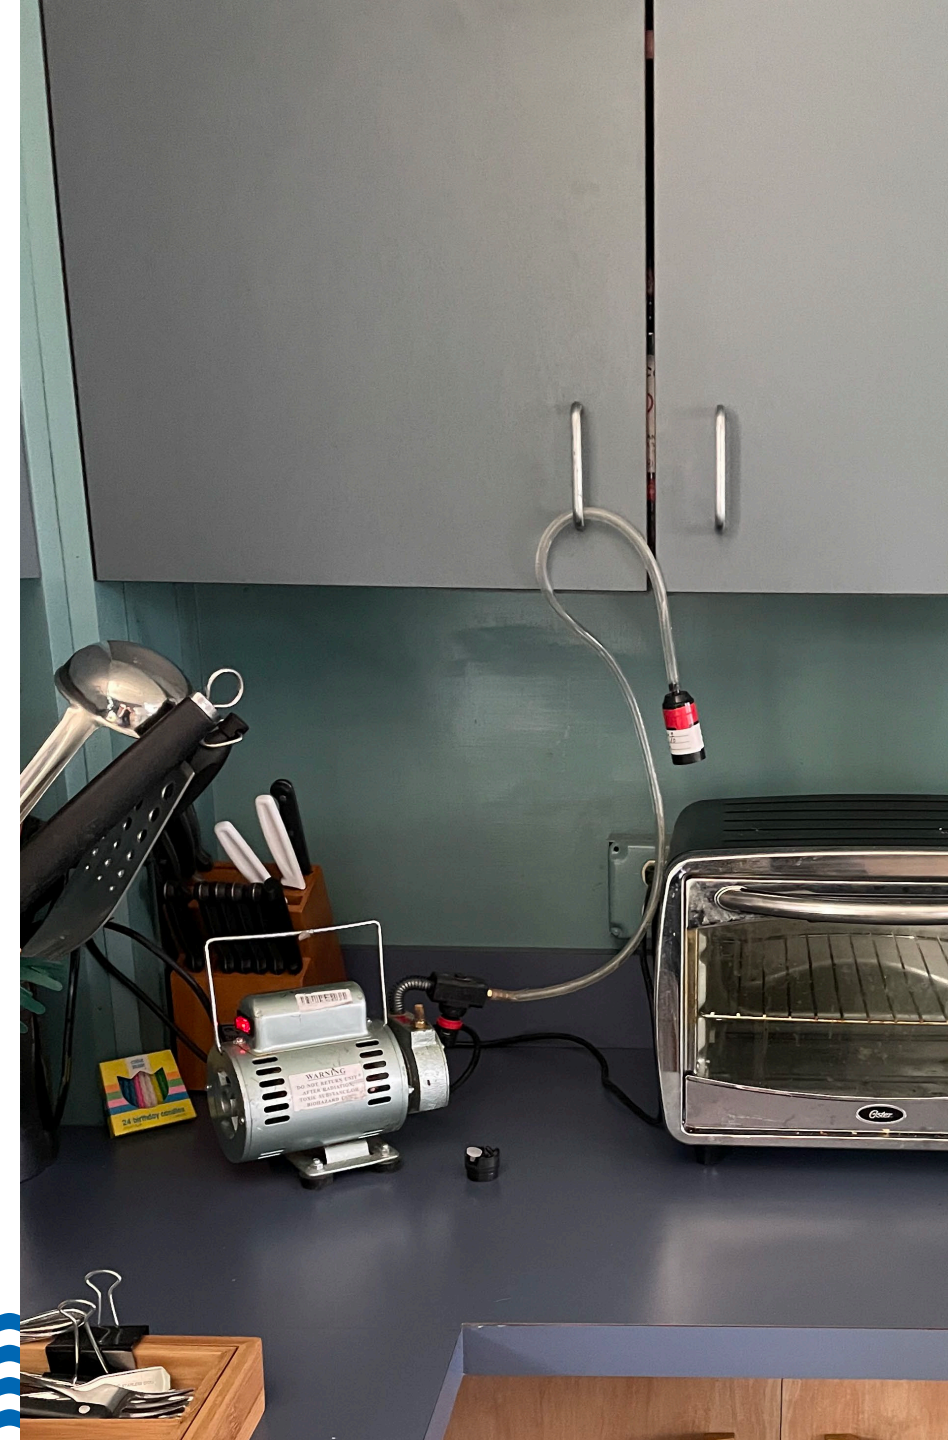
- Air testing for asbestos collects interior air to screen for airborne asbestos fibers.
- 20 samples were collected throughout City Hall and tested using high volume air pumps.

- No asbestos fibers were identified in any air testing samples.

**Picture:** Air sampling performed in City Hall kitchen.

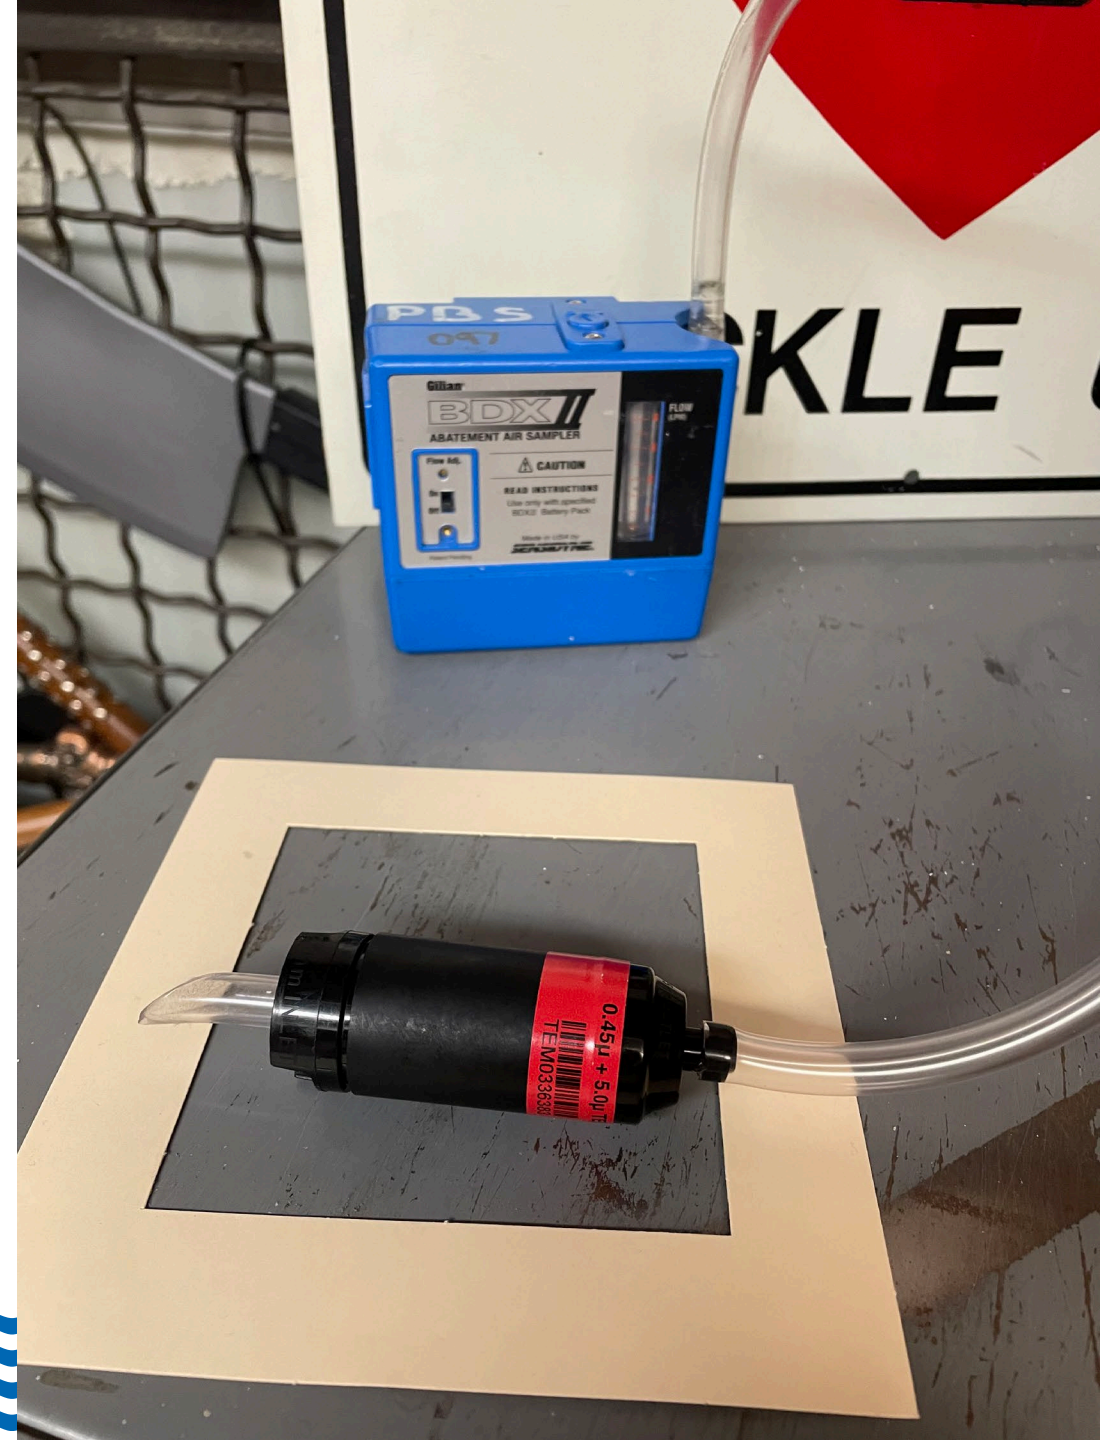
- This testing method evaluates settled surface dust in the building and in the HVAC system for asbestos fibers.
- 73\* samples were collected and tested using a device similar to what is shown in the picture.
- Results indicate the asbestos concentration based on the area sampled.

- Asbestos detected in 11\* settled dust samples from 10\* locations:
  - Five samples:  $>10,000$  s/cm<sup>2</sup>
  - One sample:  $>13,000,000$  s/cm<sup>2</sup>

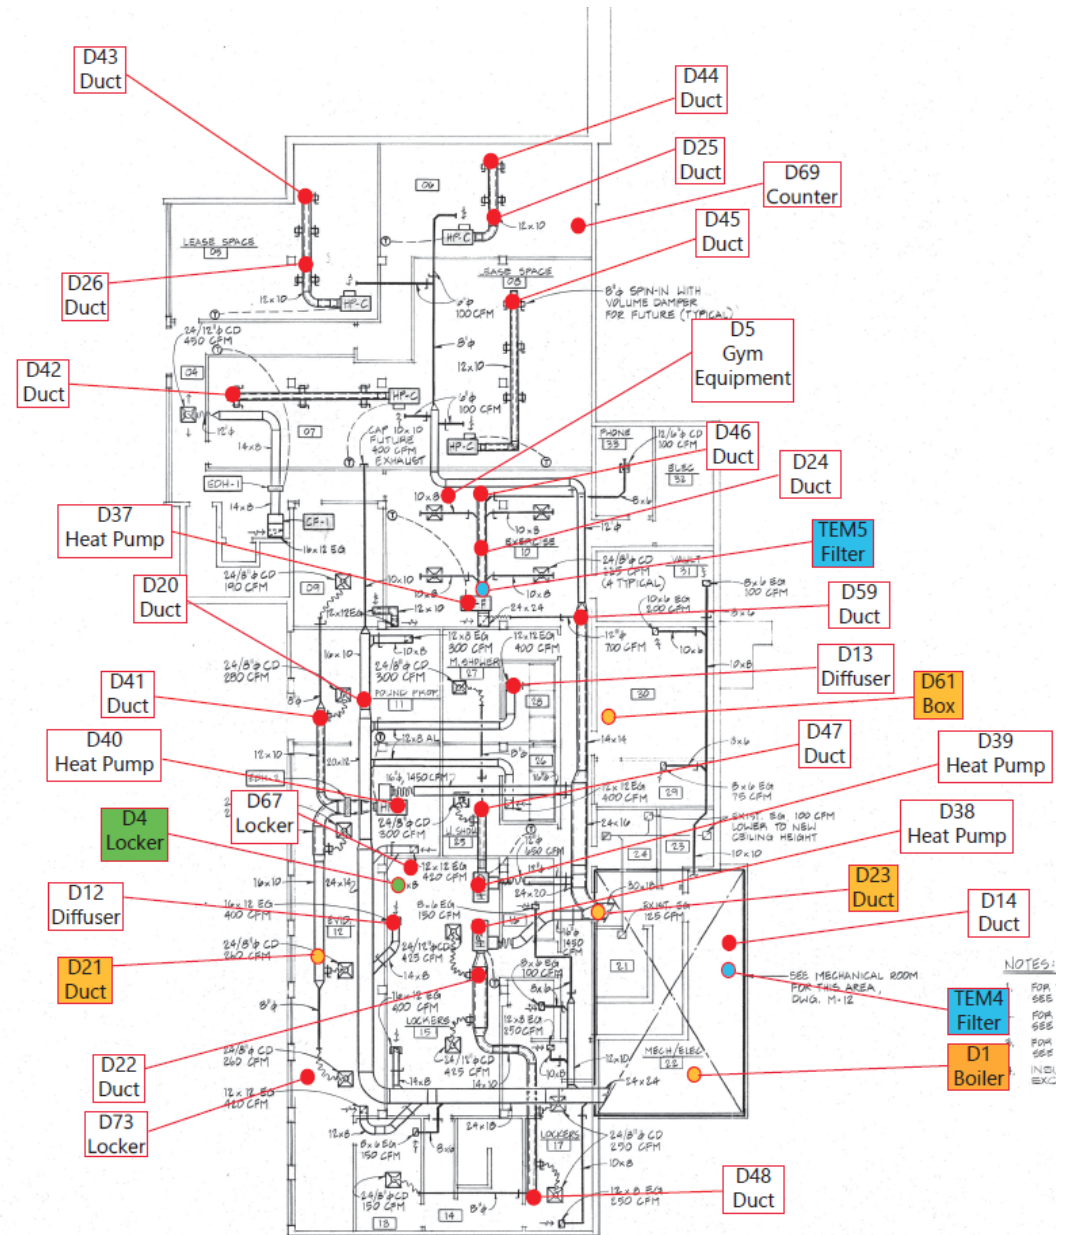
# Sampling Diagrams: Basement

- Exhibit 1 to the AB shows mechanical drawings with dust and bulk sampling results.
- No air samples are recorded on these diagrams.
- Color coding indicates the absence or concentration of detected asbestos.
  - White: No asbestos detected
  - Green: Dust <1,000 s/cm<sup>2</sup>
  - Yellow: Dust <10,000 s/cm<sup>2</sup>
  - Orange: Dust >10,000 s/cm<sup>2</sup>
  - Blue: Bulk sample with a positive detection
- The basement had several positive dust and bulk material tests:

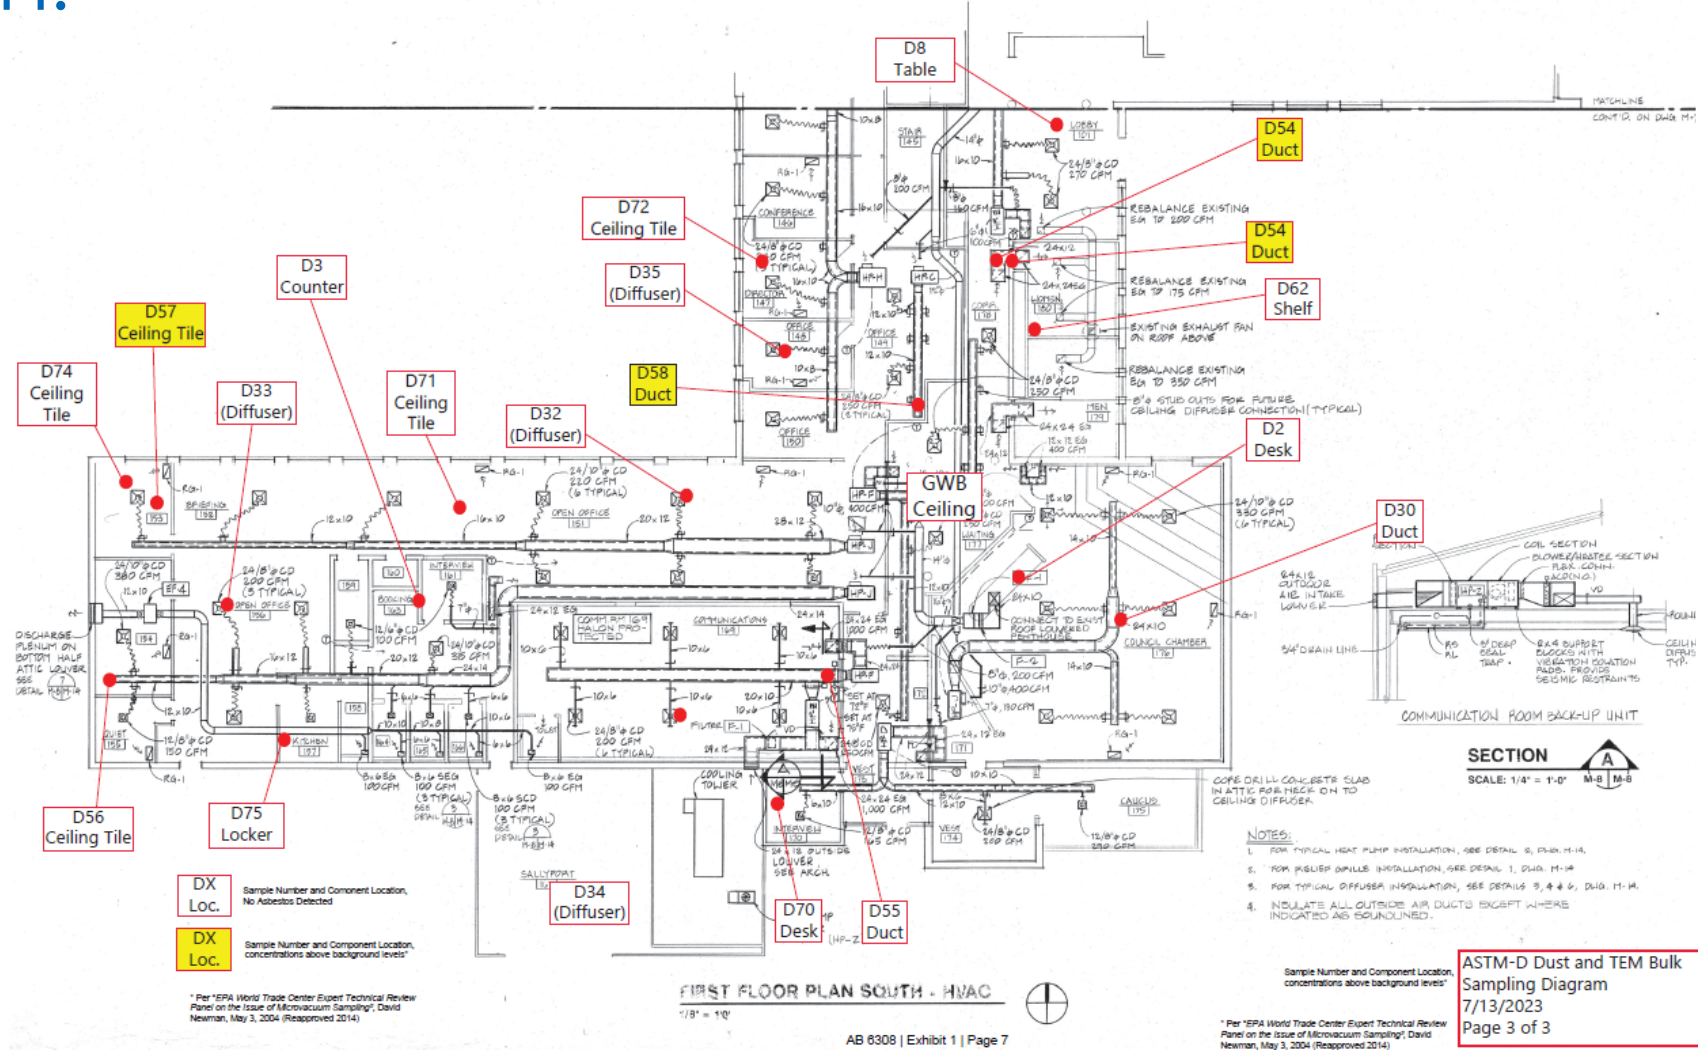
# Sampling Diagram: First Floor, South

- Area includes Police Department and Council Chambers
- Several positive dust samples:
  - White: No asbestos detected
  - Yellow: Dust <math>< 10,000 \text{ s/cm}^2</math>

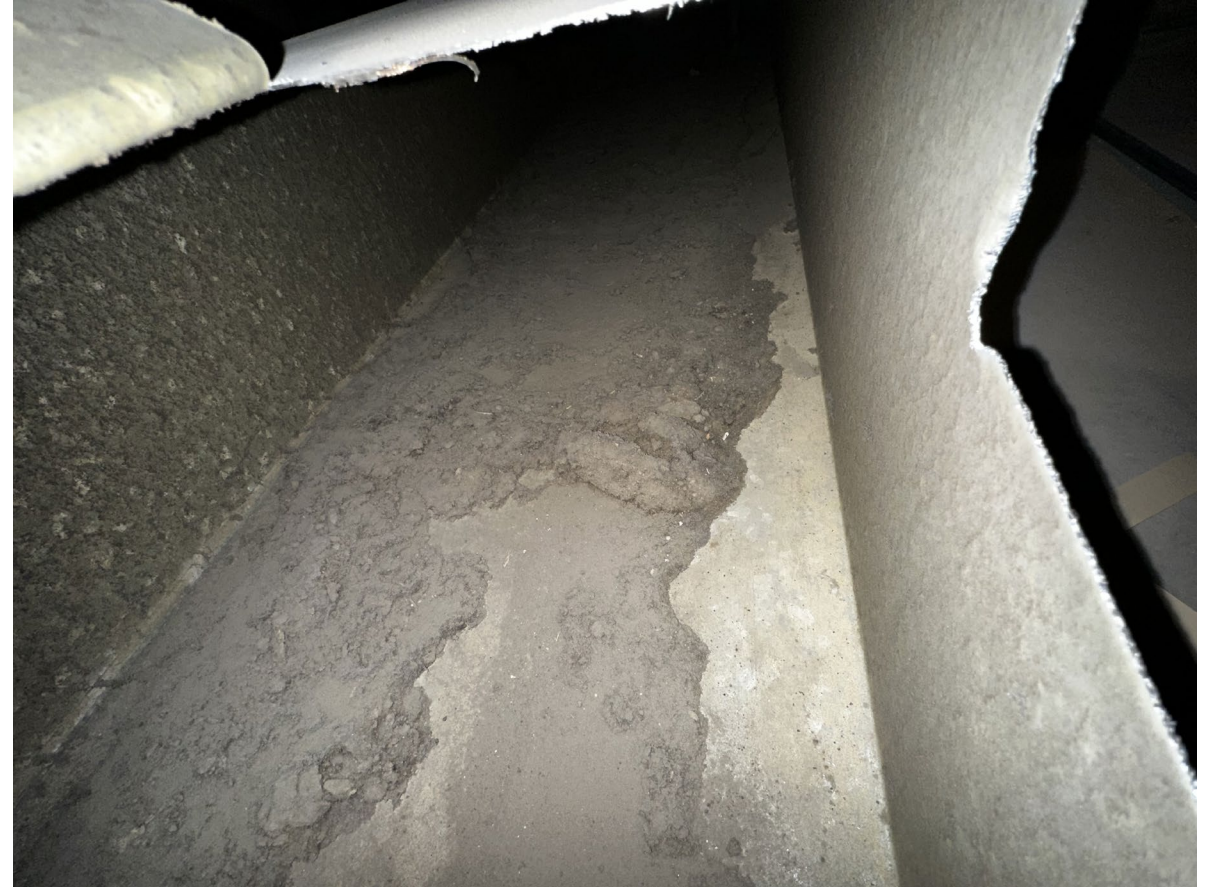
**Picture:** Dust build-up in an unlined duct in the attic mechanical room (sample D53).

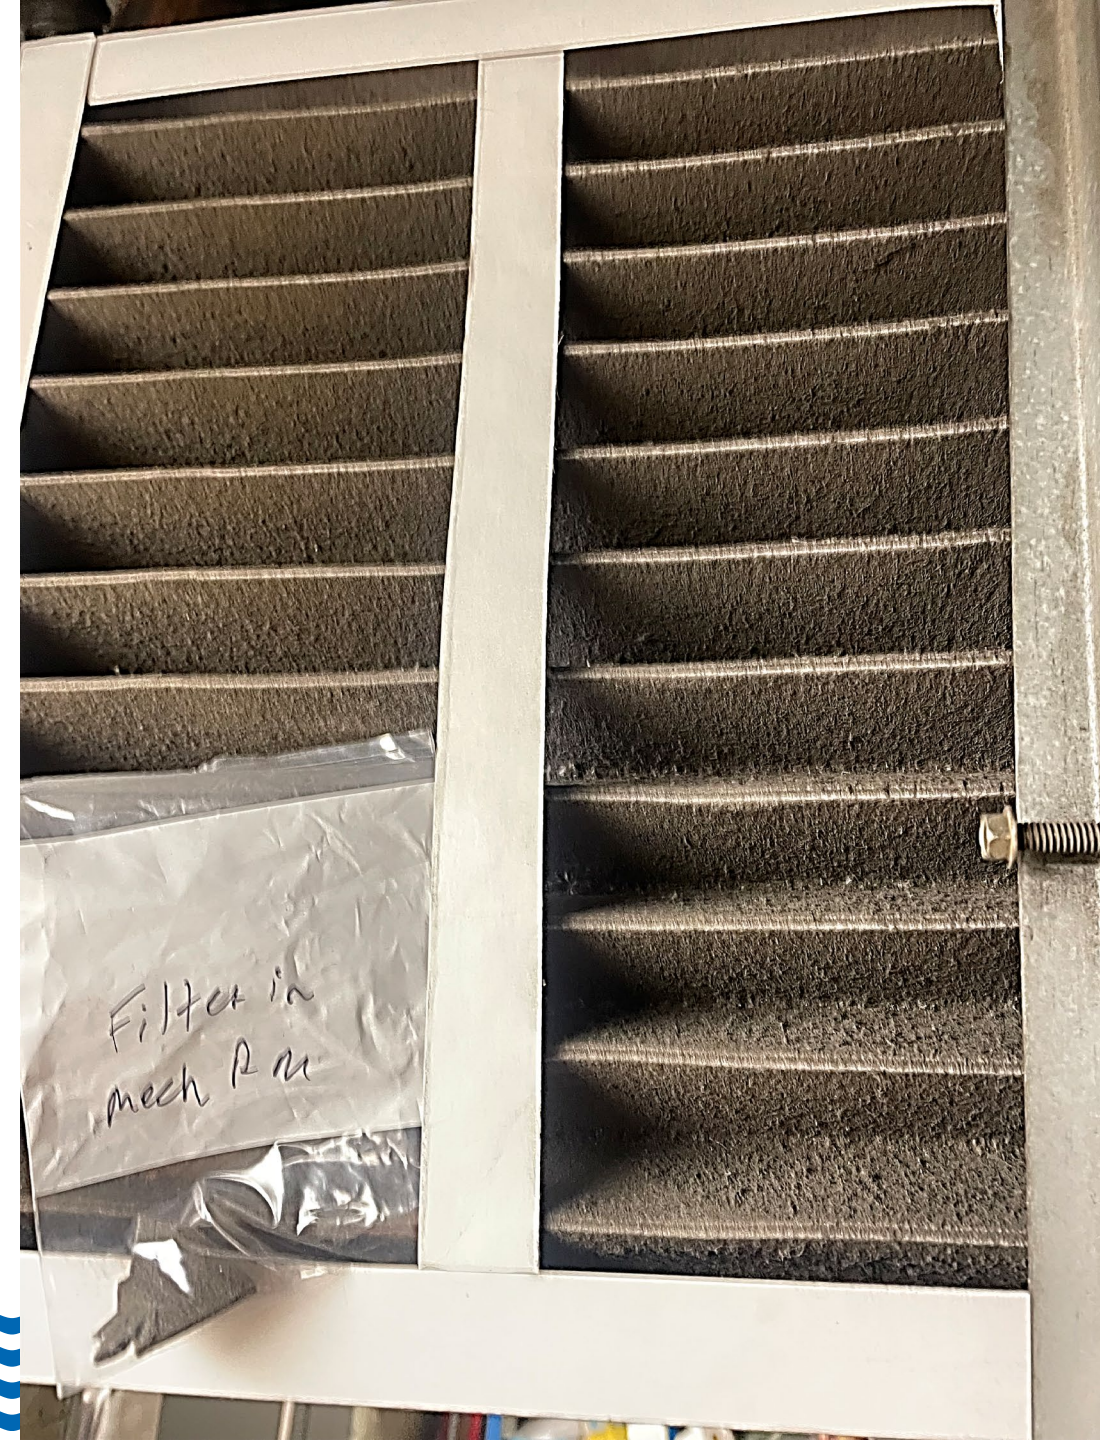
## Results

- Bulk testing identified asbestos in two HVAC system filters and one sample of flooring.
- As previously noted, approx. 10,000 sq ft of asbestos tiles were known to be present throughout City Hall, but most are undisturbed.

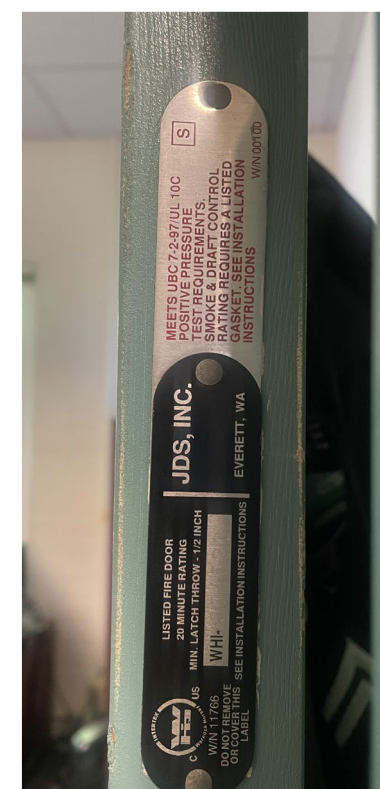
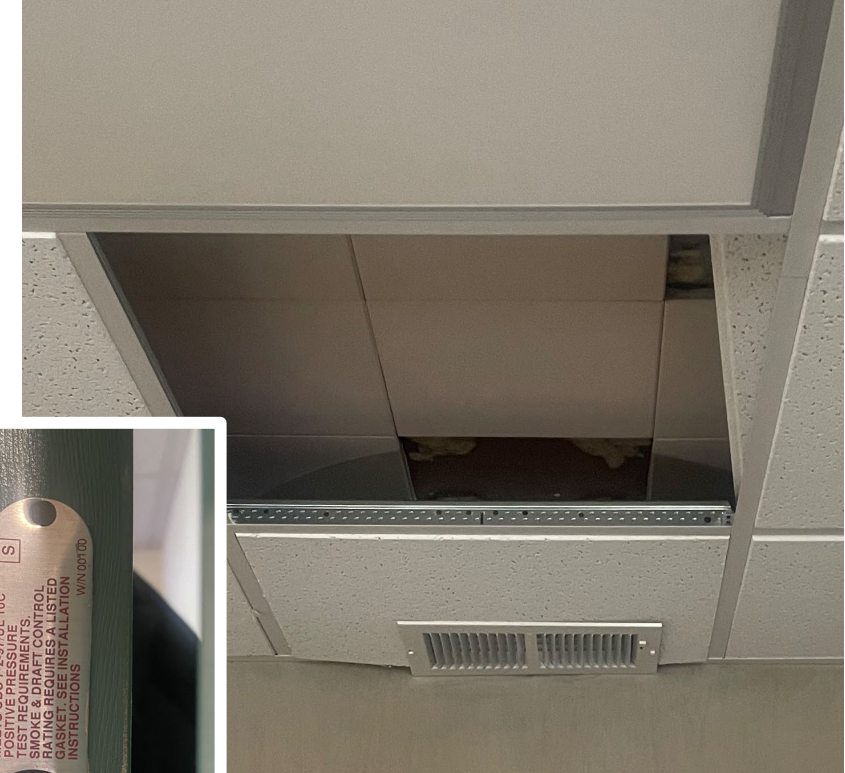
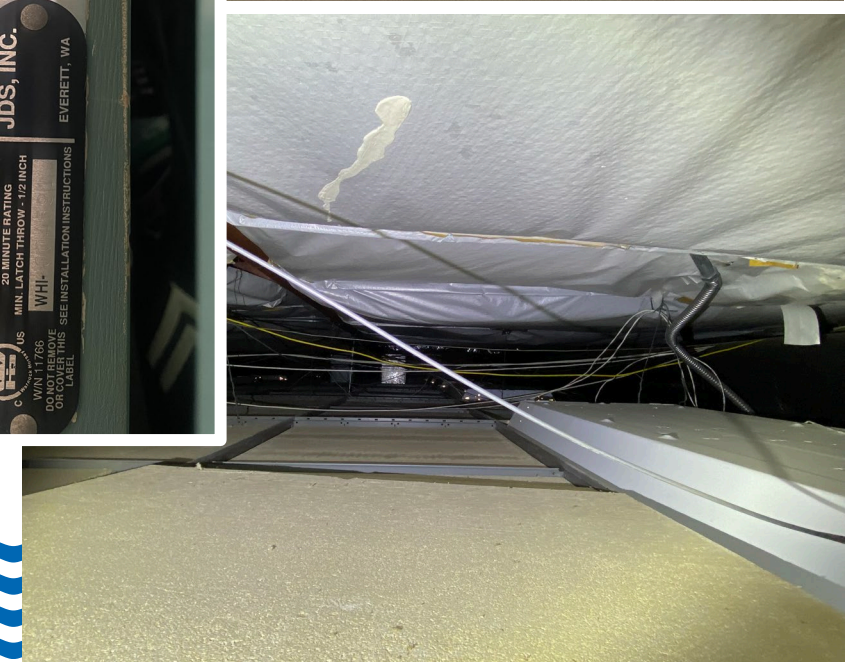
- A Good Faith Inspection surveys all potential asbestos-containing materials in a building.
- The investigation of City Hall was limited by access issues in the ceiling and attic (pictured).
- This work included 77 additional bulk samples.

- 13\* samples were positive, including:
  - Three types of flooring (additional 20,000 sq ft)
  - Flooring adhesive
  - Window putty
- 31 interior fire doors visually identified as asbestos-containing\* (pictured)
