# CONSULTANT FIELD NOTES & OBSERVATIONS OF MERCER ISLAND PARKS SYSTEM

Consultant field visits to all Mercer Island parks, trails and open space areas were completed in 2019 prior to the PROS Plan project being suspended in early 2020. Review of this document is still underway to ensure changes that have occurred since 2019 are accounted for and reflected in the final PROS Plan.

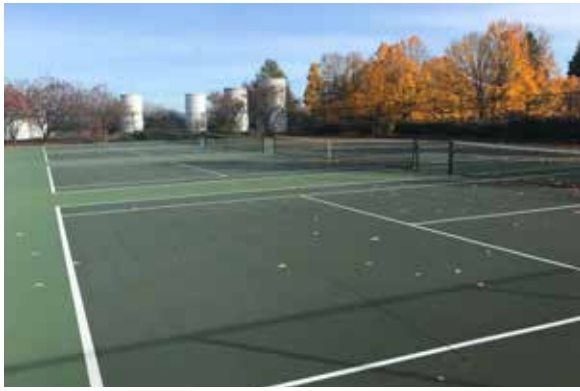
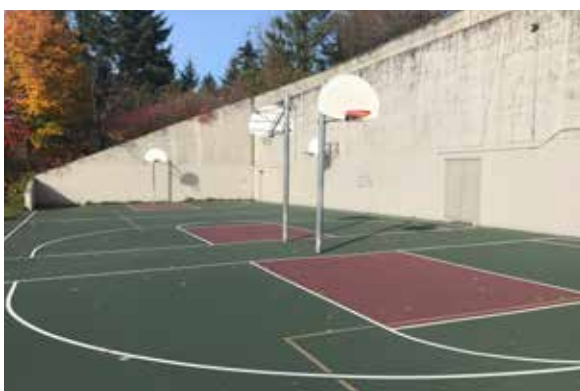
- All natural grass areas look excellent.
- Tennis courts have minor cracks that likely do not affect play yet, but should be monitored.
- A few of the benches at the western most playfield are degraded and should be replaced.

- All of the bike racks are “wheel benders” and should be replaced according to the Master Plan’s recommendations.
- Drainage issues exist where catch basins need to be reset or regraded.

- Irrigation is showing wear and tear. Valve clusters and supply lines fail periodically. Irrigation is not as effective as it could be. Consider a better system for heads that don’t break.

- Pavement heaving and roots are a concern on the trails.
- Pay to park (phone app) at the boat launch is being instituted this year, remove ticket machine.

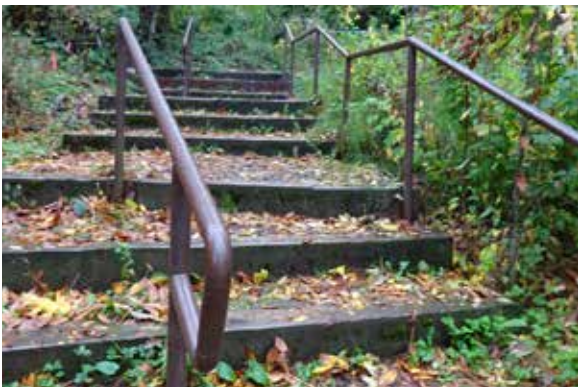
- Install wayfinding sign at base of stairway leading into Mercerdale Open Space to provide directional information.
- Ornamental shrub plantings at base of flagpole are outgrowing their planting bed. Replacement of planting area with new planting design could enhance the sense of place.

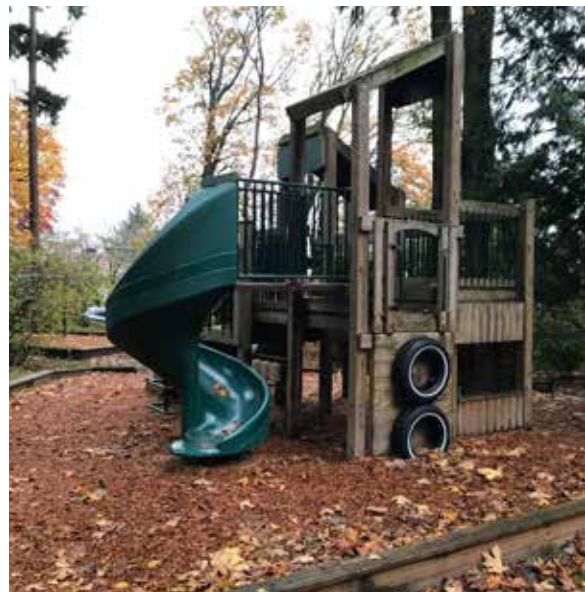
- The top bar on the backstop needs adjusting and the chain link fence is curling at the base.
- The wood headers around the play structure are broken in places.
- The picnic table is not ADA compliant, is rotting and should be replaced.
- The planting around the edges of the park could be thinned and cleaned up.
- Grass is worn under trees and around play structures.
- Douglas fir trees need periodic assessment. Some evidence of latent root disease.
- Big slide needs a stairway and better fall protection, prevent access under slide.
- The rim on the basketball hoop is slightly askew and needs a new net.

- This is a flat site, so ADA access could be improved relatively easily.
- The asphalt surface of the half-court basketball court is mildly wavy and should be replaced.

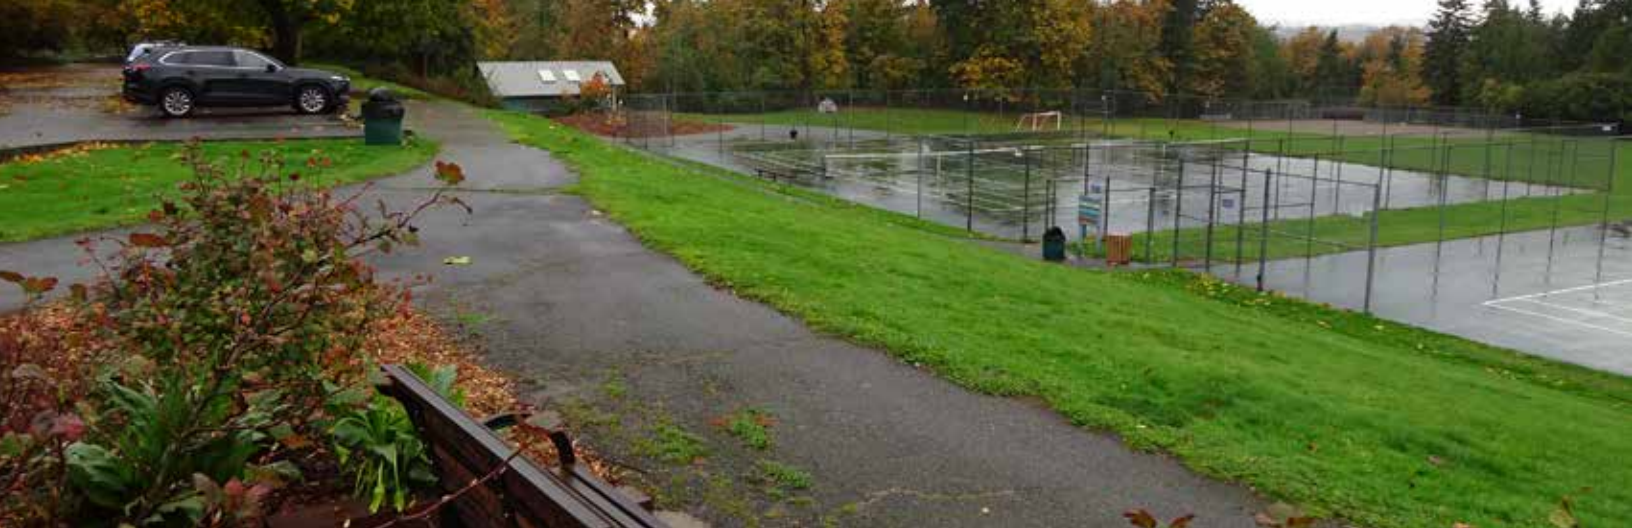
- The two upper picnic tables are in poor condition and should be replaced.
- The chain gate at the top of the asphalt path is closed, forcing foot traffic over a curb and grass area and prohibiting wheeled access. Replace with bollard.
- The sand from the volleyball court has migrated beyond the frame of the court down the bank toward the water, which is not a problem per se but may require more frequent replacement of sand.
- A clay subsurface drainpipe is exposed by the concrete wall at the beach and should be repaired.

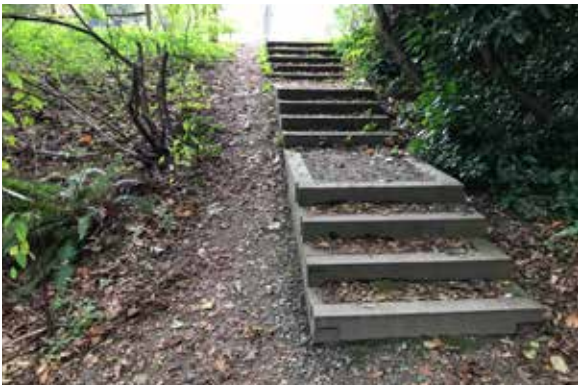
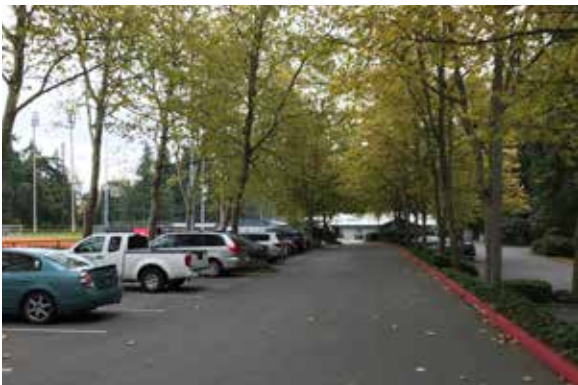
- The low bridge in the walking trail area is in good condition, but one of the railings is leaning moderately. The bridge is also not ADA accessible due to excessive gap width between the planks.
- Vegetation management occurring in the natural areas. Over 30 acres of parkland is managed as open space.

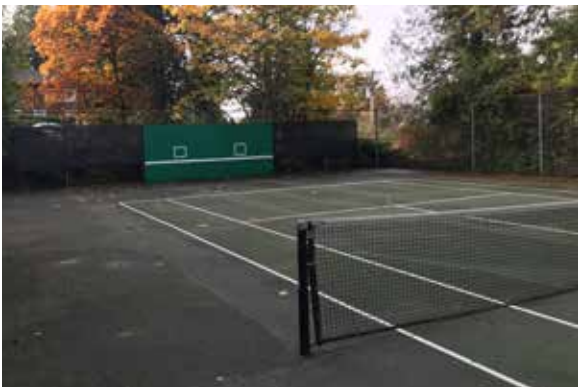
- The wood frames around the play structures are coming apart and leaning outward in places. The playground should be aevaluated for replacement.
- There is no ADA access.

- The tennis court has a lot of cracks, but all are narrow.
- The top tape on the tennis net is frayed needs to be replaced.
- The steps leading to the tennis court are degraded and should be replaced.
- The grass has a few bald spots but is generally fine.

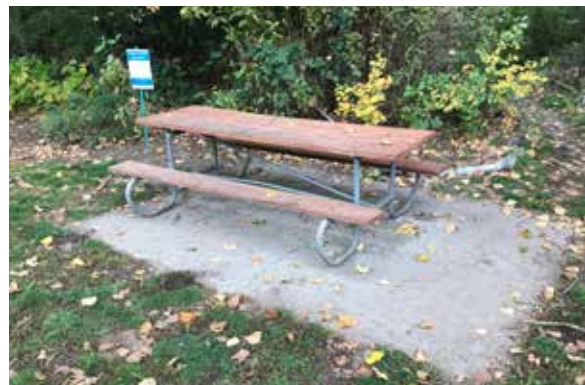
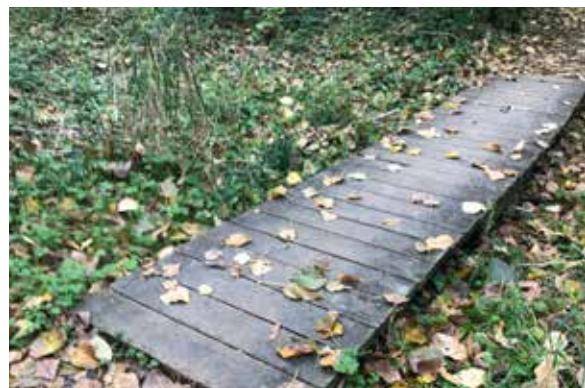
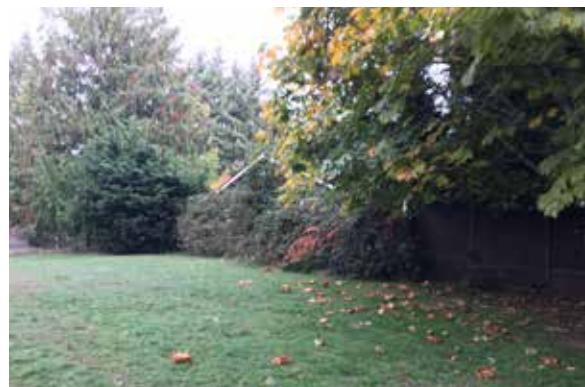
- Grass is spotty by picnic area.
- Evidence of moles digging holes in the grass near the picnic table.
- Short, 30" wide boardwalk is in good condition.
- Lots off-leash dog walking/play/fetching observed (weekday morning).
- All amenities in good condition.
- Soft surface trails are relatively smooth except for a few locations with roots.
- Two trash receptacles, but no recycling.

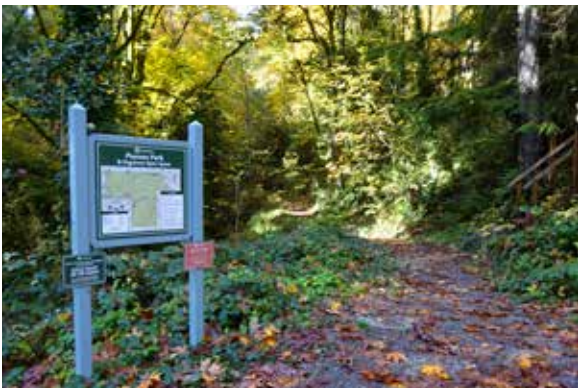
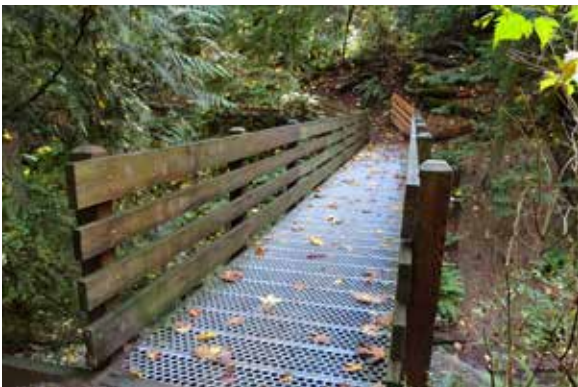
- Timber stairs, retaining walls, bridge, turnpike, and other trail structures require regular monitoring to repair settling, shifting, rotting wood, etc.

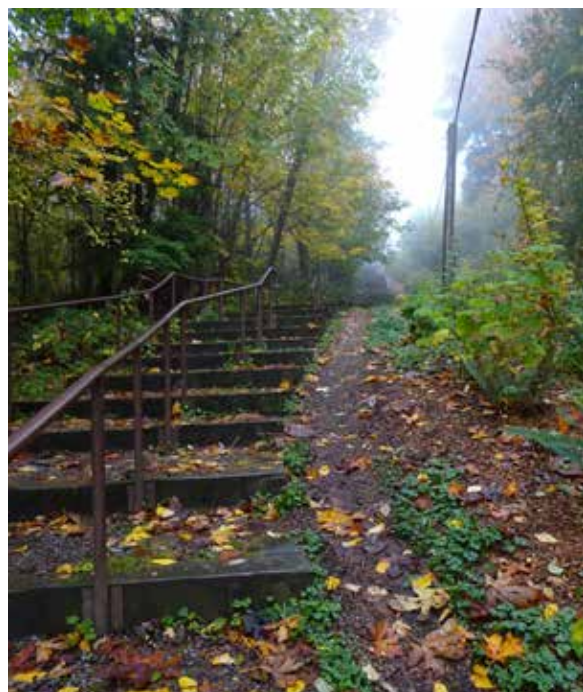
- Extensive sets of timber stairways require regular inspection and monitoring to ensure adequate tread stability. Some stair sections could be evaluated to be unnecessary where trail gradient does not require built steps. Removal of unnecessary stairways could help reduce burden of constant monitoring, repair and replacement. Some timber stairways should have crushed stone tread areas filled to compensate for settling.
- Managed as open space.

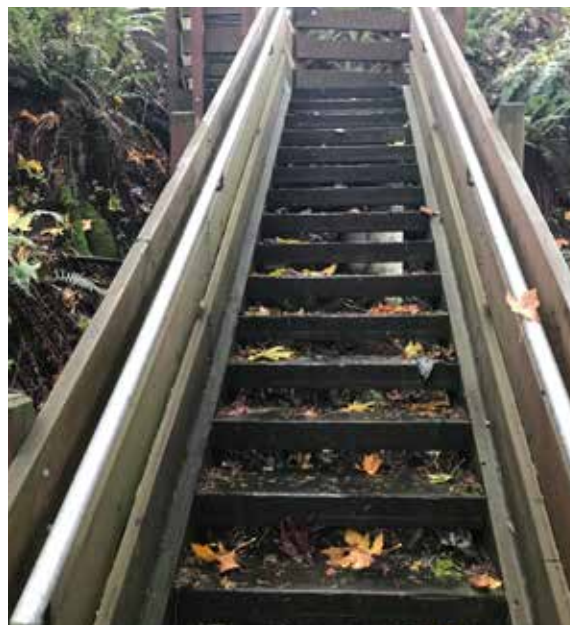
- The northern most dead-end trail is narrow and becomes overgrown near its terminus, making it ambiguous.
- The two dead-end trails present safety concerns.
- Most stairs are in good condition. A few stairs on the south dead-end trail are comprised of round timbers and have excessive riser heights. Transition these stairs to dimensional timbers consistent with the adjacent stairs.
- The 84th Avenue SE trail width and surface are excellent, but the other trail surfaces comprise compacted soil and could use gravel for traction.
- Managed as open space.

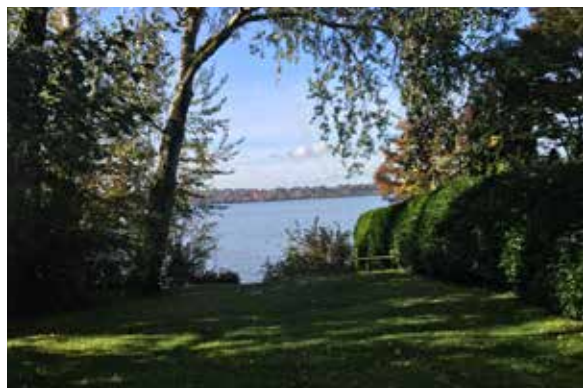
- The bench is weathered, worn and outdated.
- The bank is overgrown with shrubs and constrains access to the beach and water. These shrubs could be removed to some extent to provide better access.
- A “doggydock” (portable mat to create easy dog access to the water) has been placed on the beach and may be a user-placed amenity.
- This site has no parking.
- White poplars are weak wooded, need to be managed for replacement with more reliably sturdy native canopy trees species.
