# Mercer Island 2021 PROS Plan

## Parks Conditions Assessment

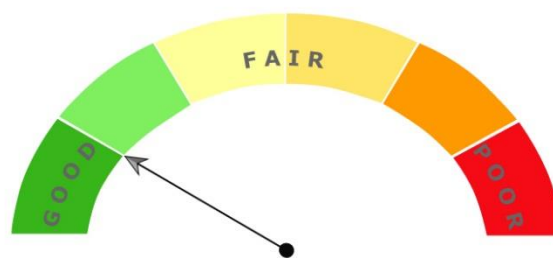
Figure 1: Overall Condition of Regional, Community & Neighborhood Parks

Overall, the condition rating for the Mercer Island parks system is 1.34, with most amenities receiving a “good” rating.

Aging infrastructure, particularly storage buildings, play equipment, restroom buildings, piers and docks, pathway pavement and sport court surfaces are ready for significant repairs and/or replacement and largely rated at “fair” or below.

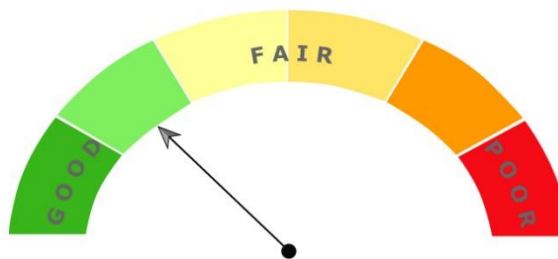
Figure 2: Overall Open Space Conditions

The rating for Mercer Island open space areas and trails is 1.5, halfway between “good” and “fair” and reflects a good condition where publicly accessible, though many are not ADA-compliant.

Most of the trails within open spaces areas are well-maintained, have good surfacing and appear to be structurally sound. While some open spaces have trails with timber steps that are in excellent condition, others have timber steps that are degraded and extremely slippery when wet. Many of the handrails associated with these steps are also degraded and may not meet code.

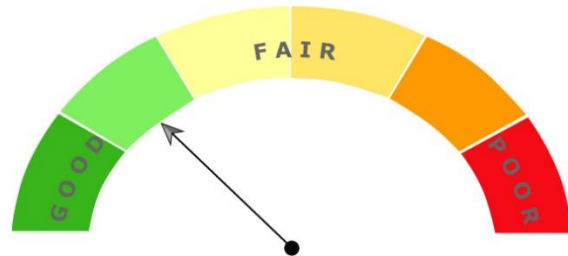
Figure 3: Average Signage Evaluation

The overall rating for park signage is 1.4 to 1.5, halfway between “good” and “fair.” Park signage gaps, particularly at open space areas, landings, and street ends, resulted in a “fair” rating. The trail networks will also benefit from improved signage.

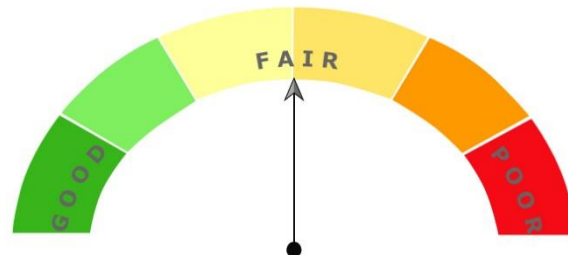
Figure 4: Specific Gaps in Park Signage

With a few exceptions, every park and open space area has at least one primary park name sign that is in good condition. Many of the sites will also benefit from having additional park signs at secondary entries. Currently, most of the secondary park entry points only have "Trail" signs on timber posts, or no signs at all. Identifying parks by name at each entrance will improve the identity of each park and also provide critical information to public safety personnel that may be responding to an emergency.

Most trails and trail intersections within parks are identified with the generic "Trail" signs or not identified at all. Parks with complex trail networks will benefit from signage that identifies the different trails or loops within the park. All trail junctions should provide navigation aids that identify trails and destination options.

Numerous water-oriented parks, street-end parks, and landings are designated as water trailheads. The City should consider park signage that is oriented to the water at these locations for water-based wayfinding. Additional signage should be considered for water trail users to assist them in identifying the route from the water to desired amenities such as park restrooms or parking lots.

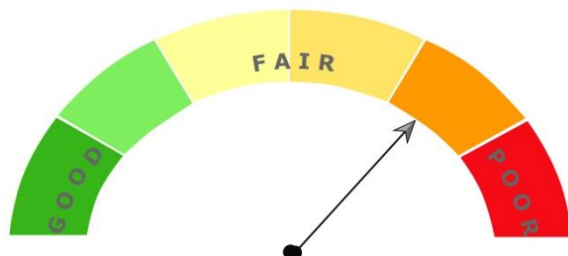
Figure 5: Docks, Piers and Boat Ramp Conditions

Aging docks and swim piers, with an overall rating of 2.25, need significant repair and/or replacement. Some over-water structures should be redesigned and replaced. In some locations over-water structures should be evaluated for removal if they are part of a natural shoreline restoration effort. The redesign and planning for the pier system for Luther Burbank Park is already underway.

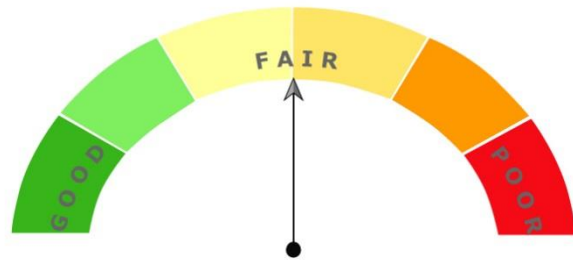
Figure 6: Evaluation of Surface Conditions for Sports Courts

Sports court surfacing at tennis courts and basketball courts show cracks and aging that affects play conditions. Repairs, resurfacing or complete replacement may be called for. As part of this planning process, an evaluation about current use and future trends may warrant converting some court sites into another type of recreational amenity (such as converting tennis to pickleball) to provide broader public recreational value and use.

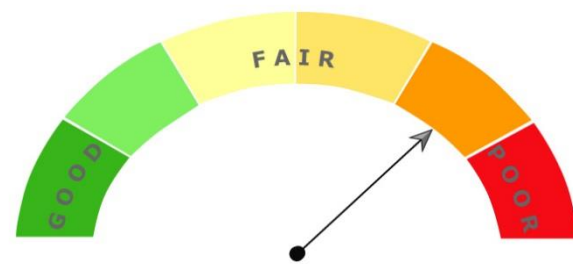
Figure 7: Universal Access and Compliance with the Americans with Disabilities Act

The overall rating for ADA compliance is 2.3, partway between “fair” and “poor.” Numerous minor barriers are present in the parks system where different surfaces meet unevenly. ADA barriers also exist at play areas, exercise stations, and park entries. ADA parking stalls should be adequately signed, travel aisles marked, and tactile warning strips installed.

Most parks are deficient to some degree in compliance with the ADA guidelines. Commonly observed barriers include lack of an accessible route between the parking area and park amenities due to lips, lack of curb ramps, and lack of detectable warnings.

As older parks and amenities are upgraded, renovated, or redeveloped, a focused effort to improve universal access and remove architectural barriers to achieve ADA compliance in park sites is needed.
