**MONACO VILLA
EXTERIOR
REMEDiation**

2929 76th Ave SE, Mercer
Island, WA 98040

01/24/24
DESIGN COMMISSION

**CURRENT
CONDITIONS**

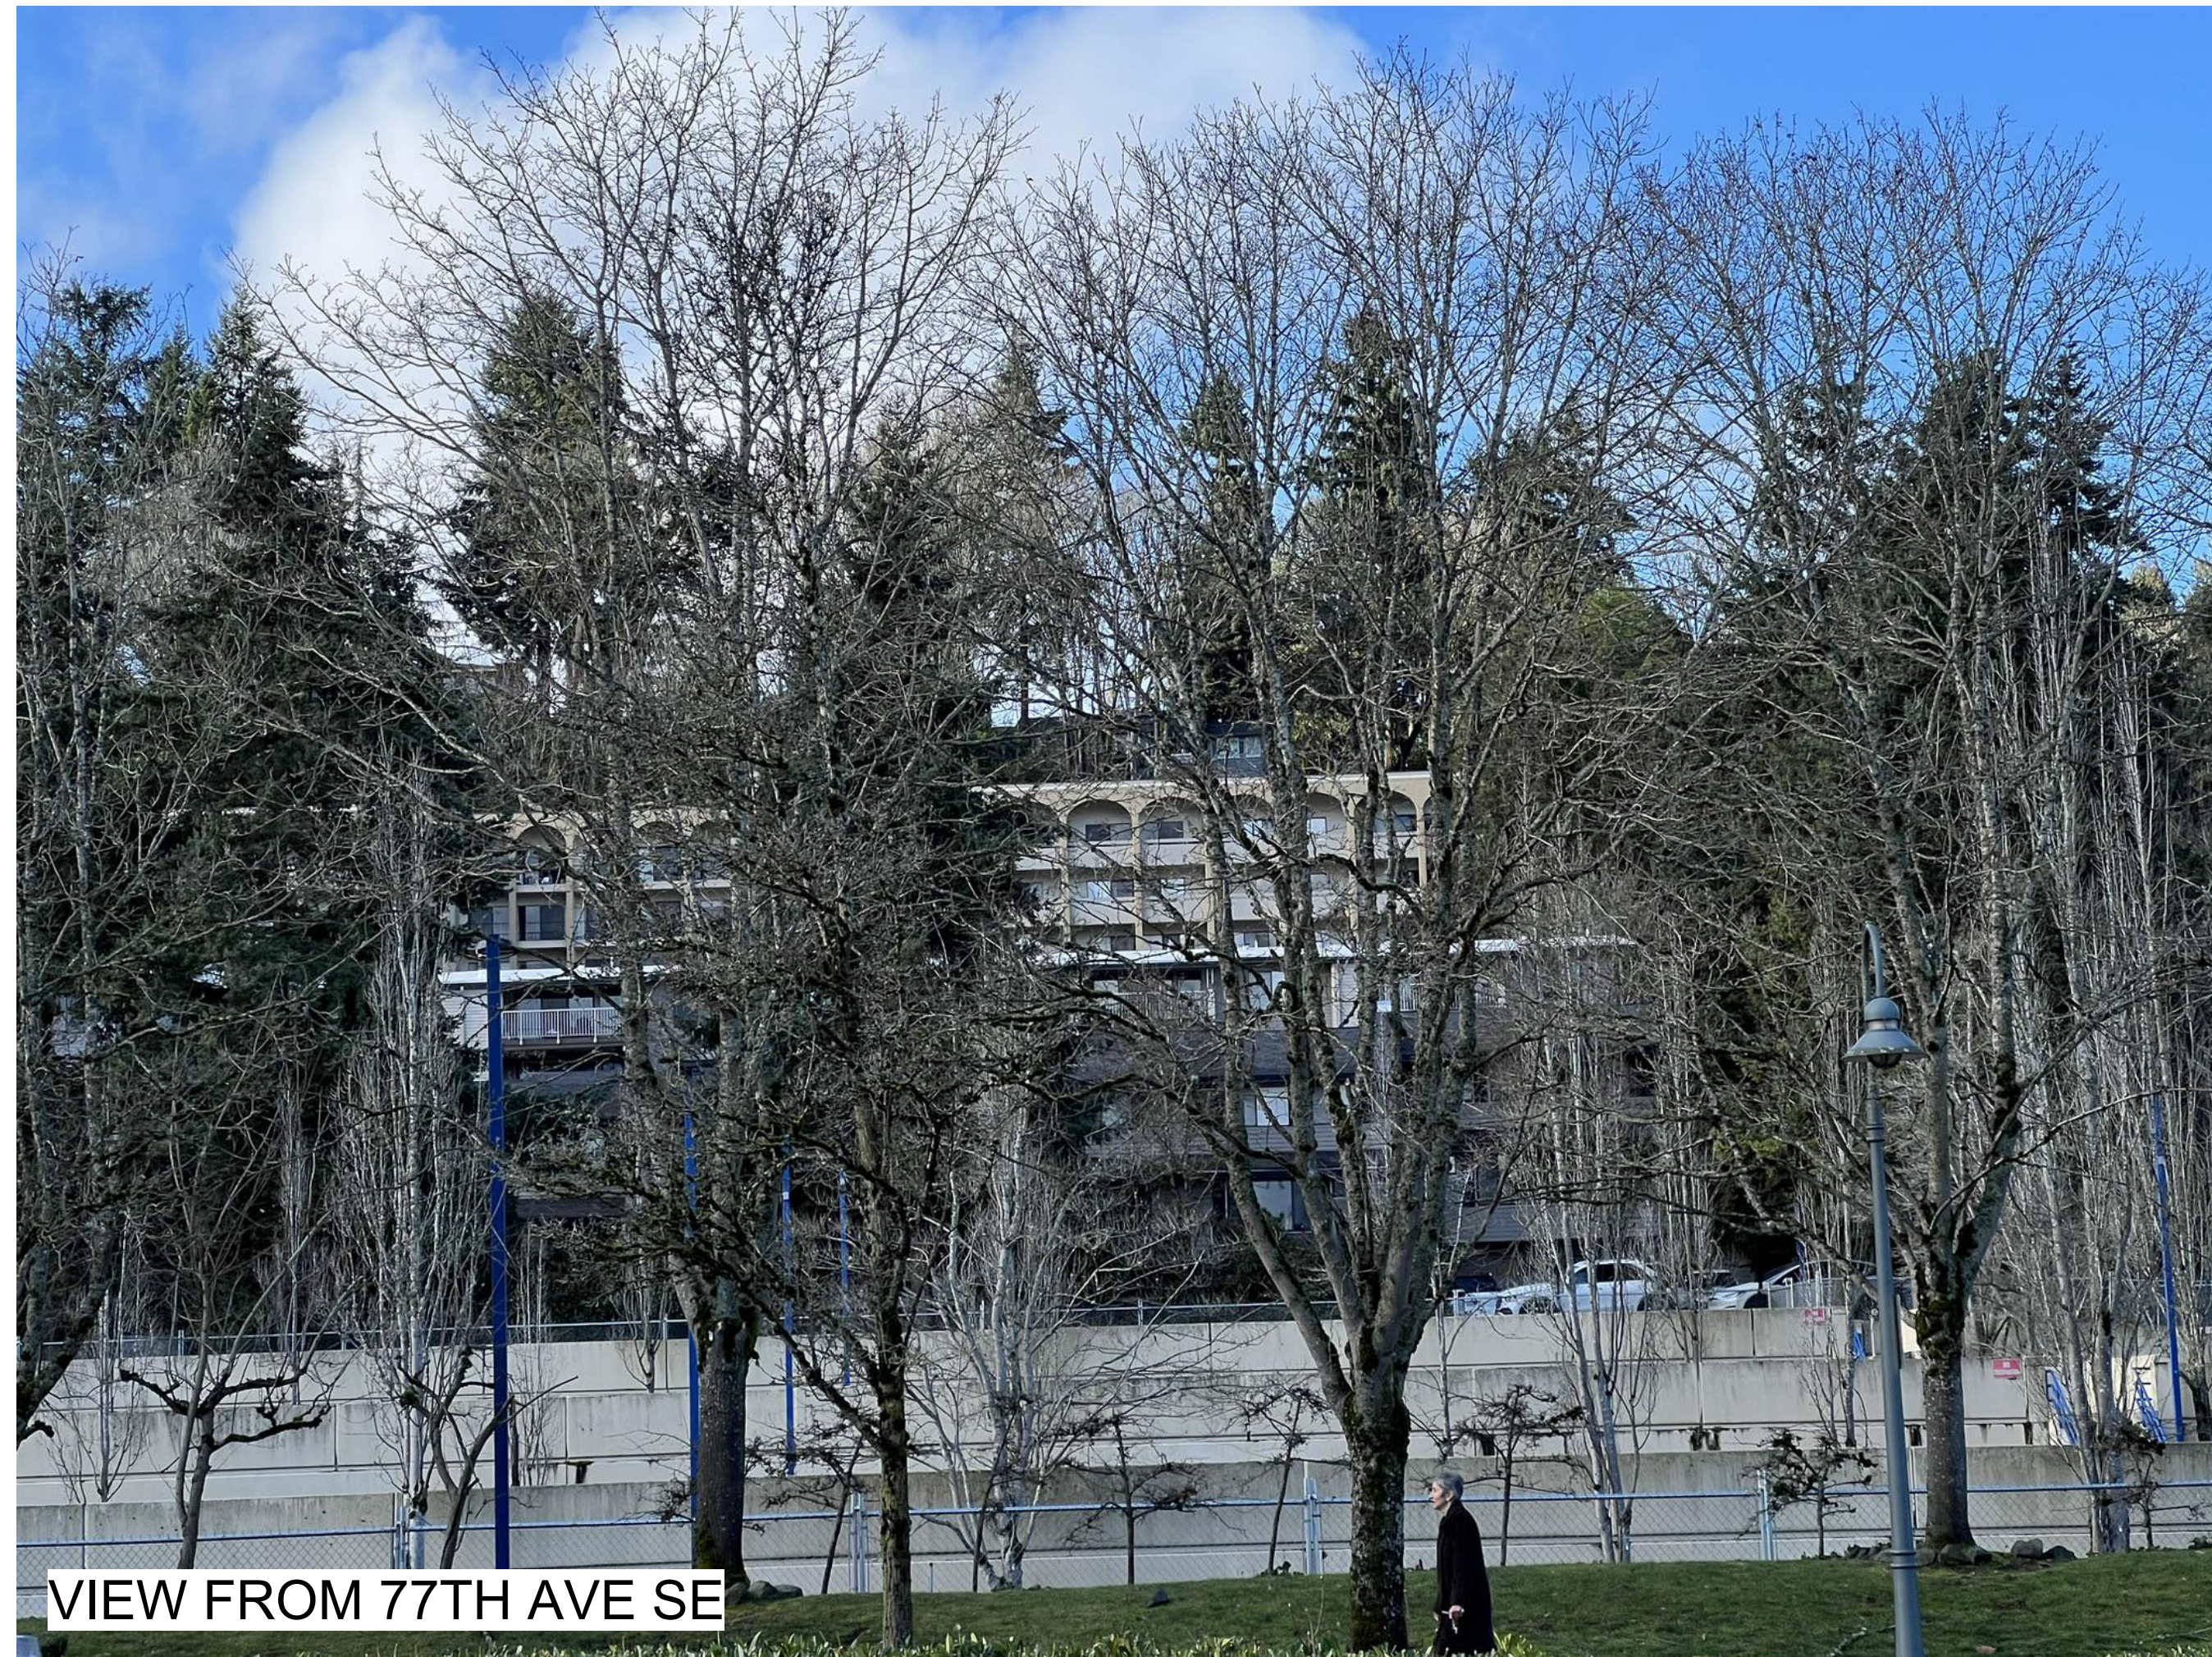
VIEW FROM 77TH AVE SE

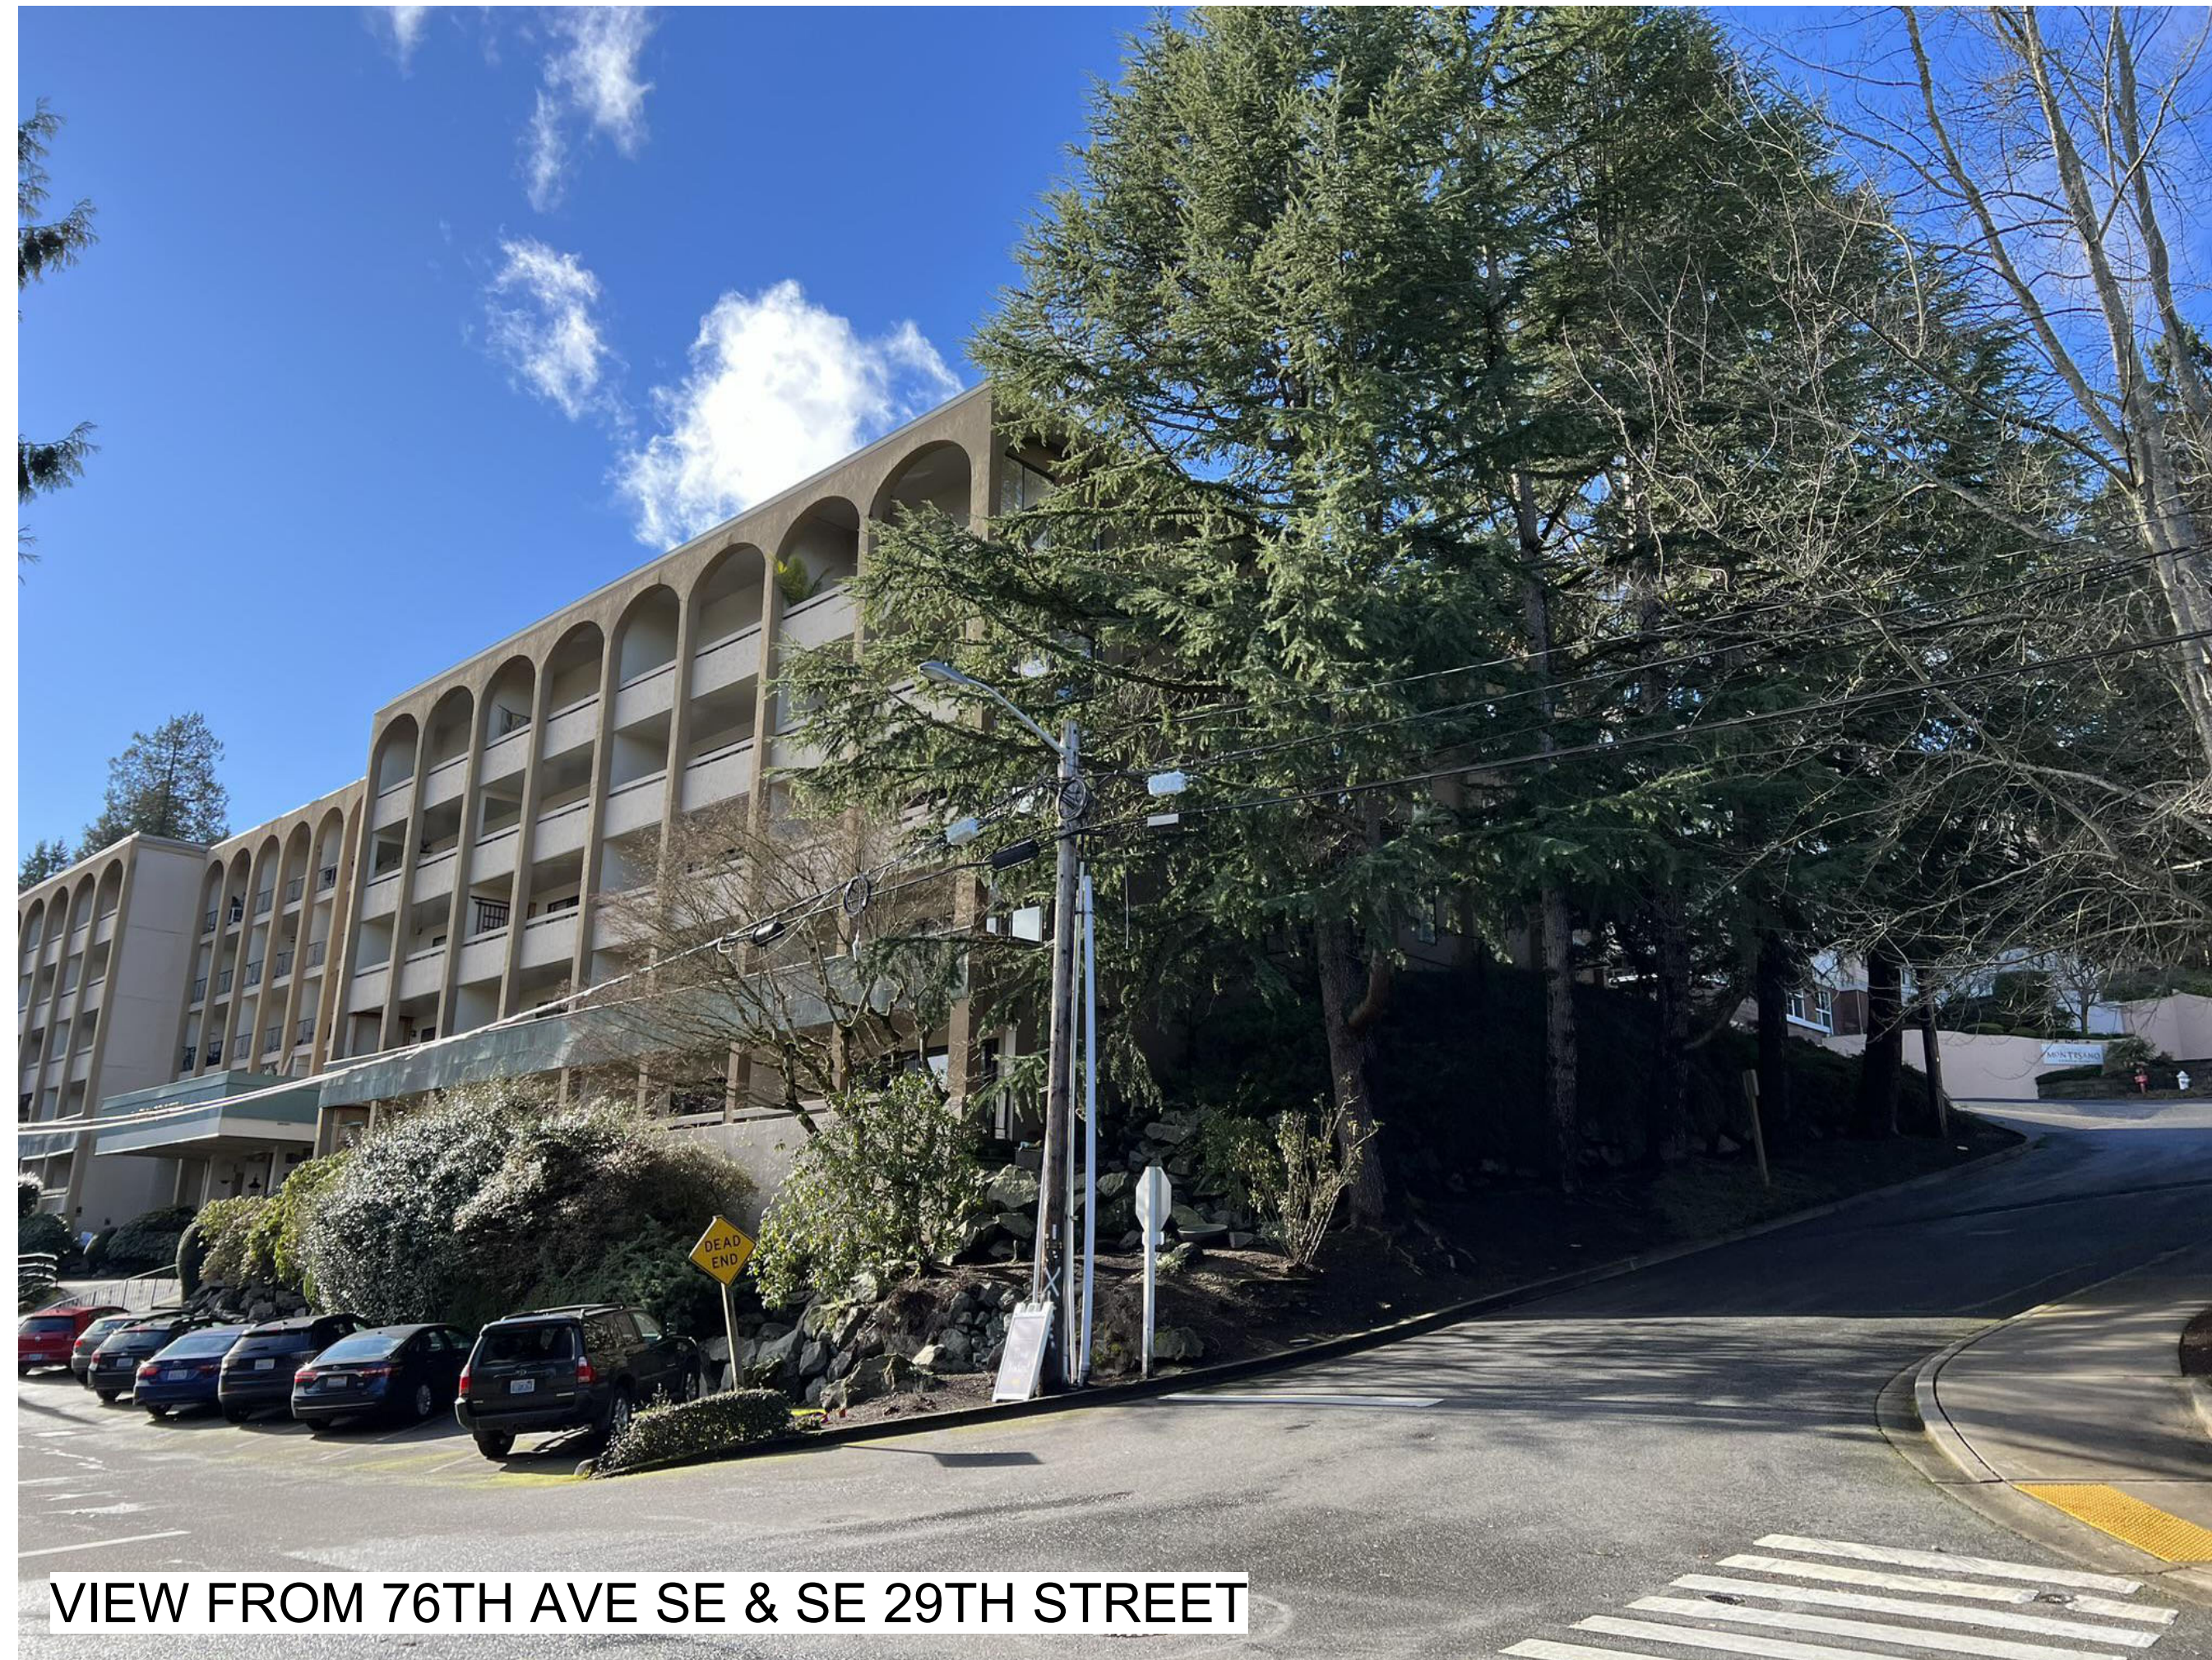
VIEW FROM 76TH AVE SE & SE 29TH STREET

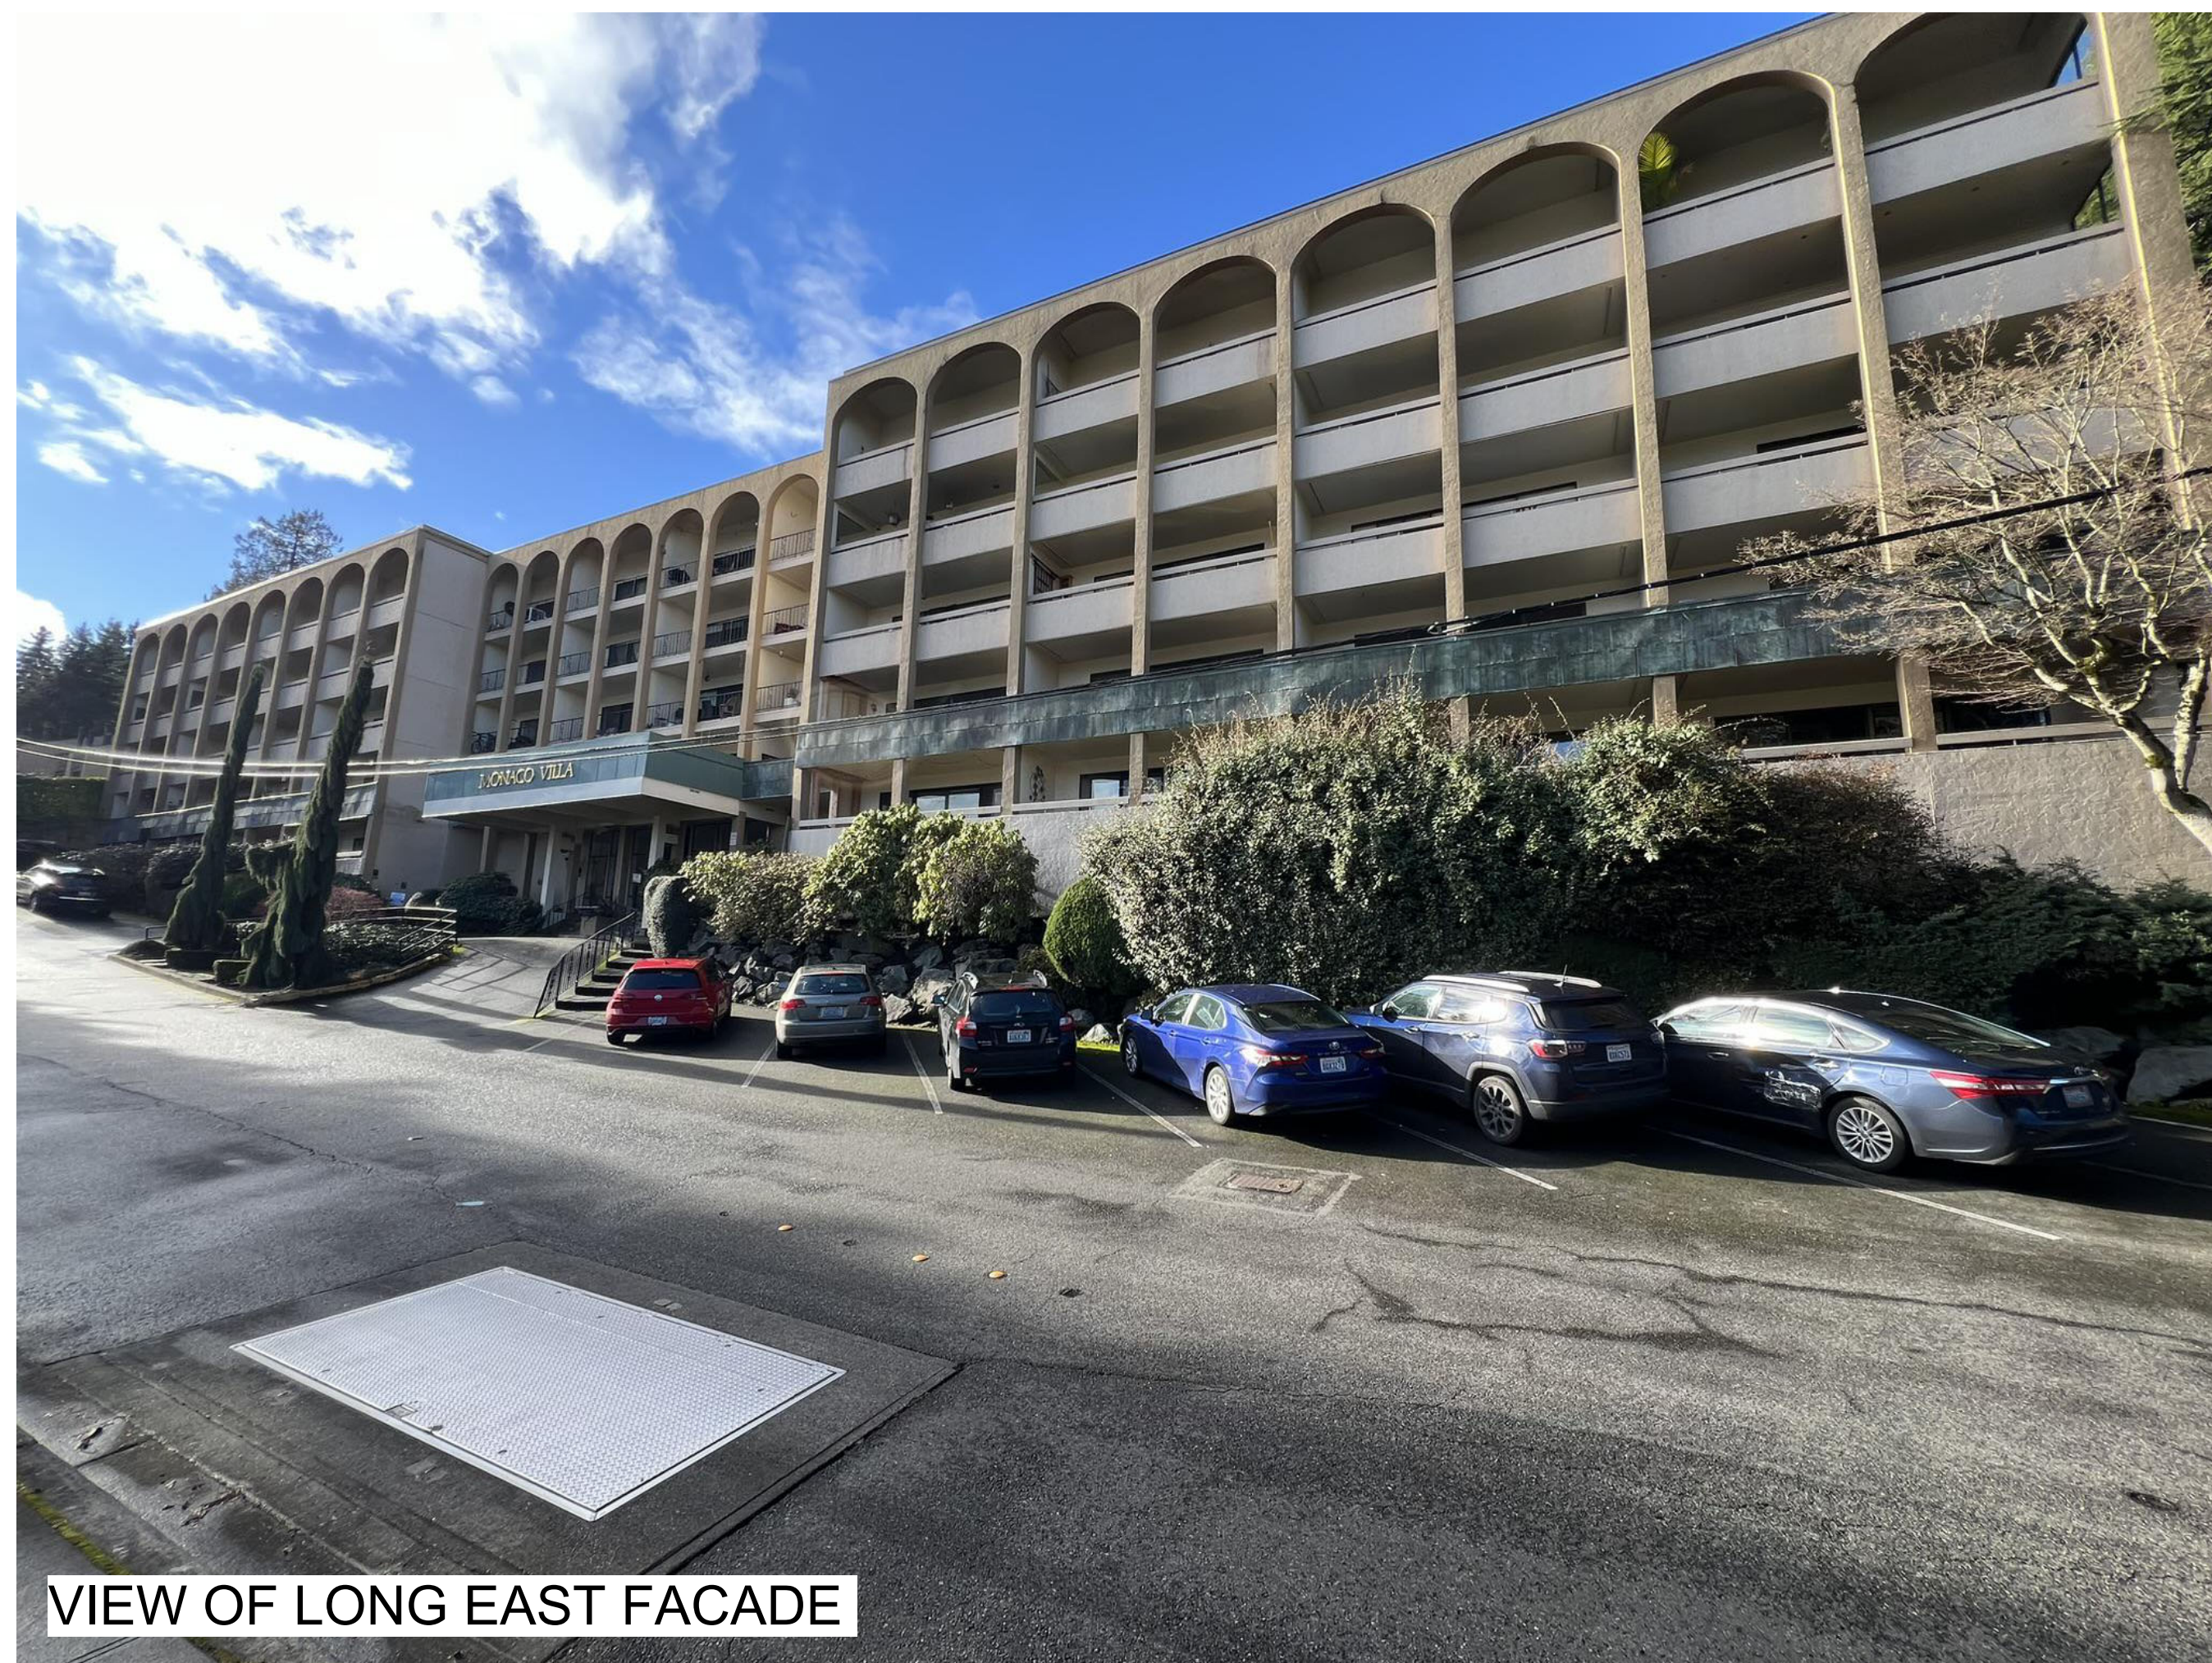
VIEW OF LONG EAST FACADE

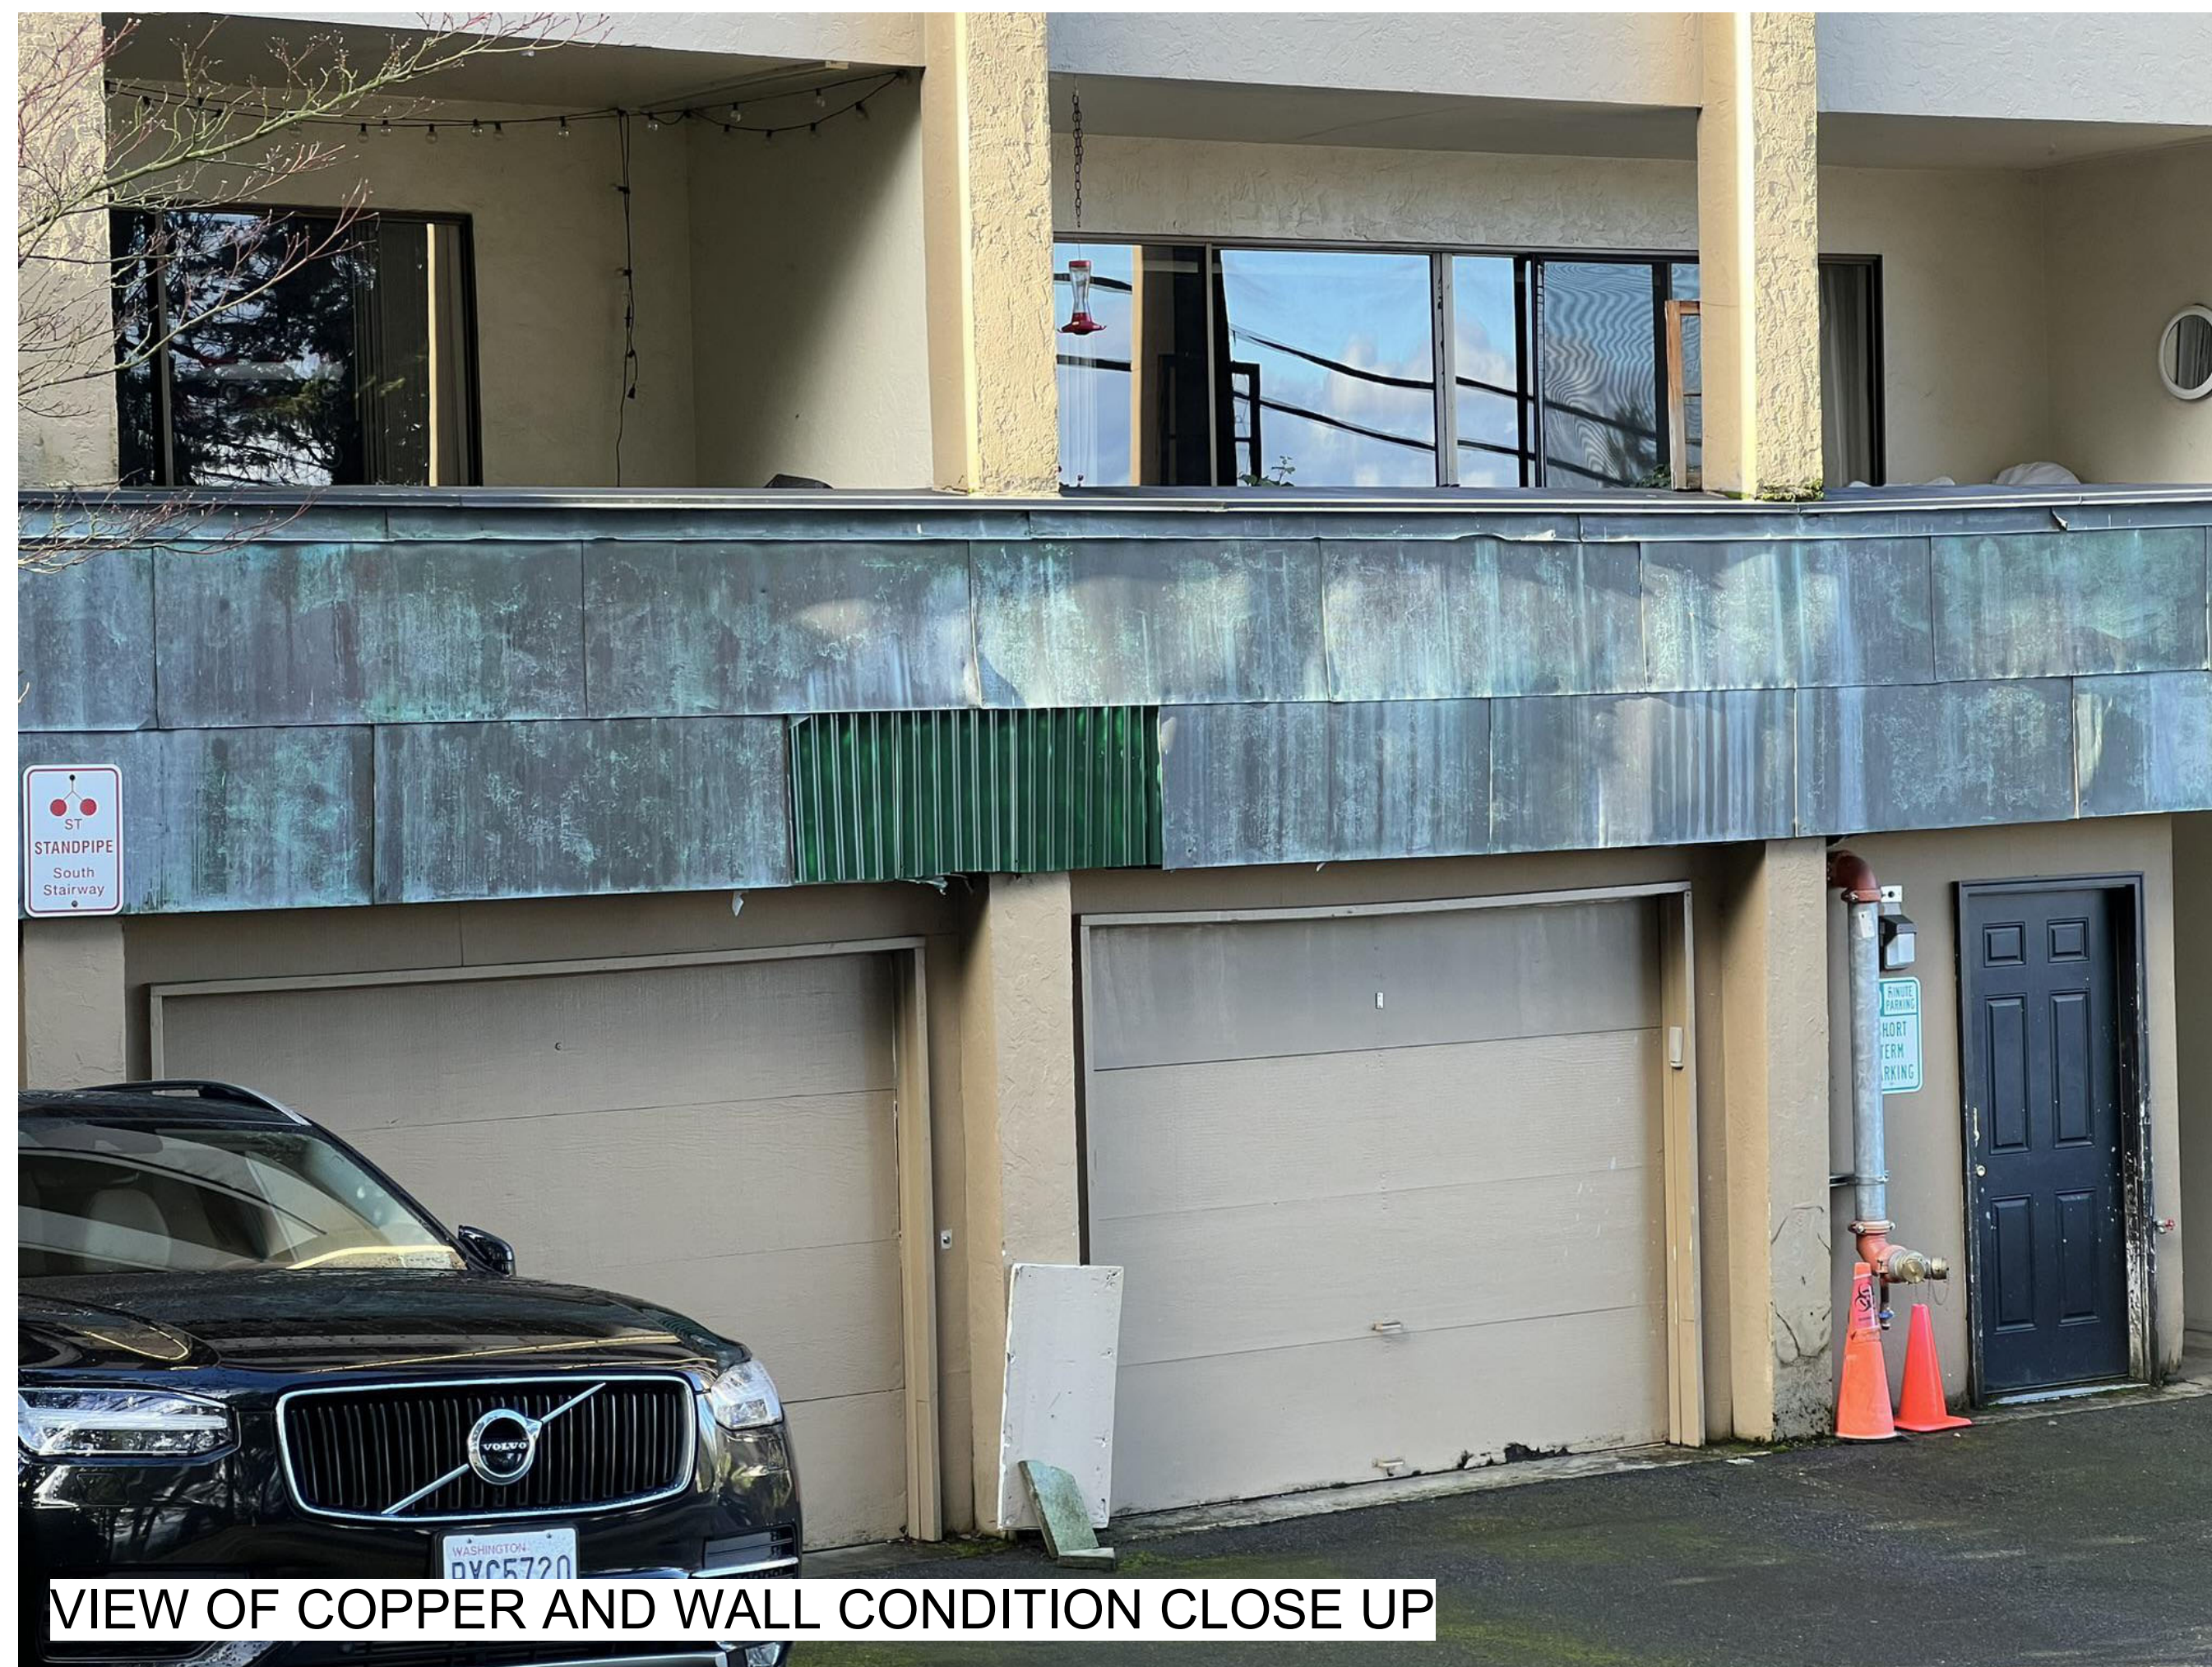
VIEW OF COPPER AND WALL CONDITION CLOSE UP

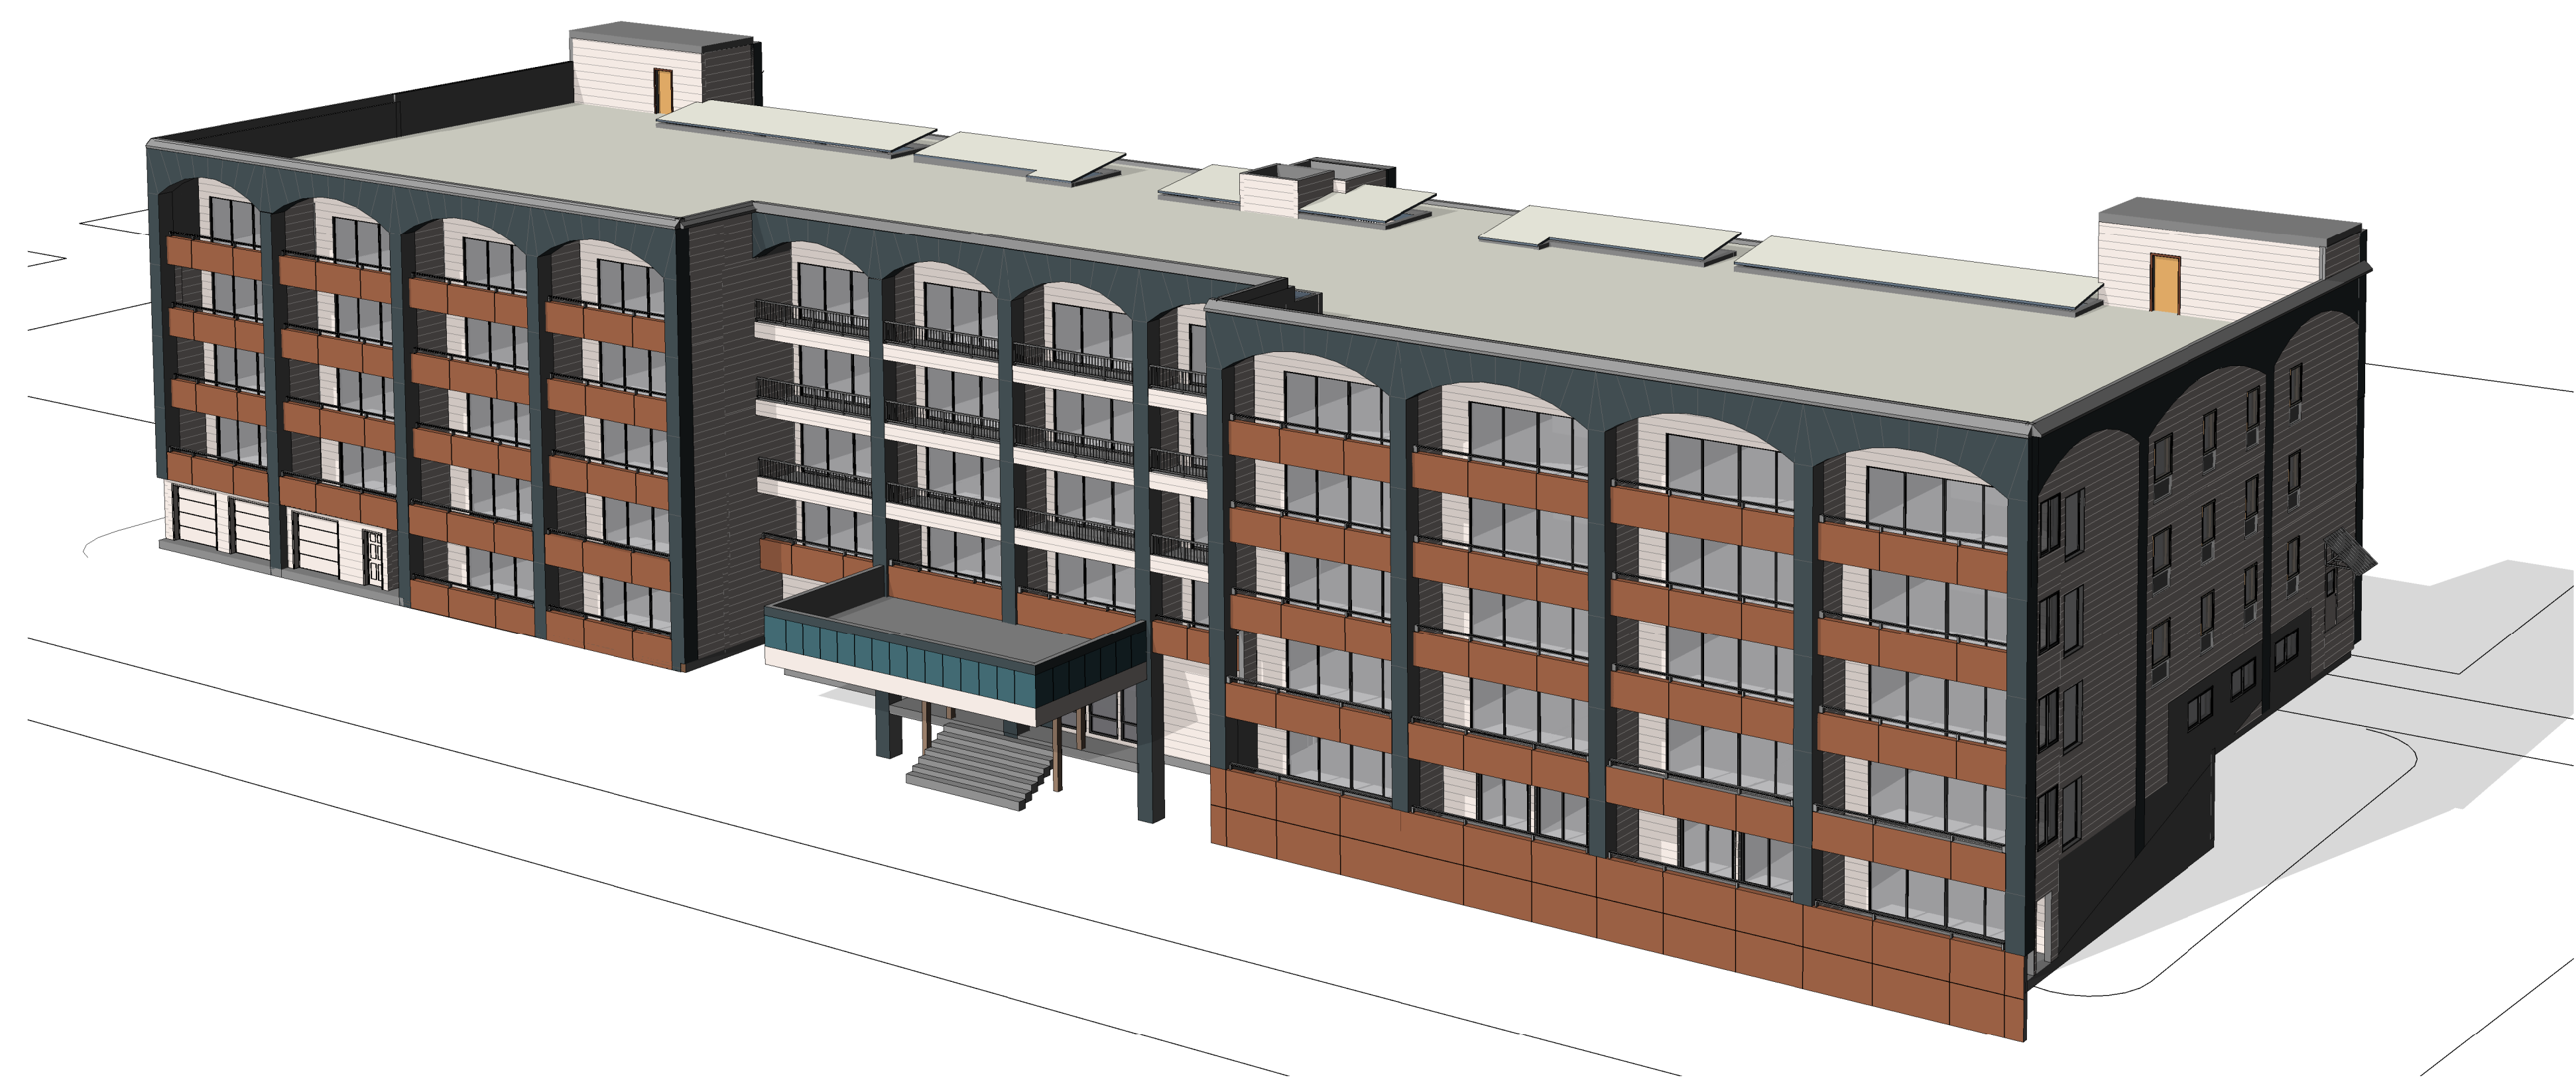
① AERIAL VIEW FROM SOUTHEAST

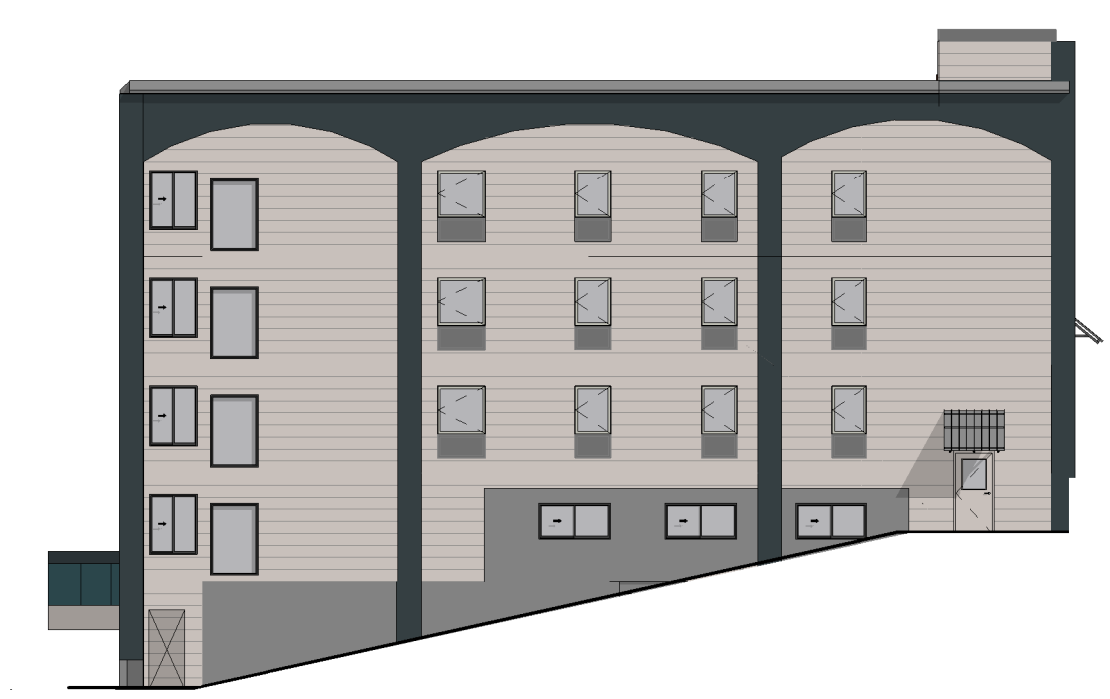
⑤ NORTH ELEVATION VIEW
1/16" = 1'-0"

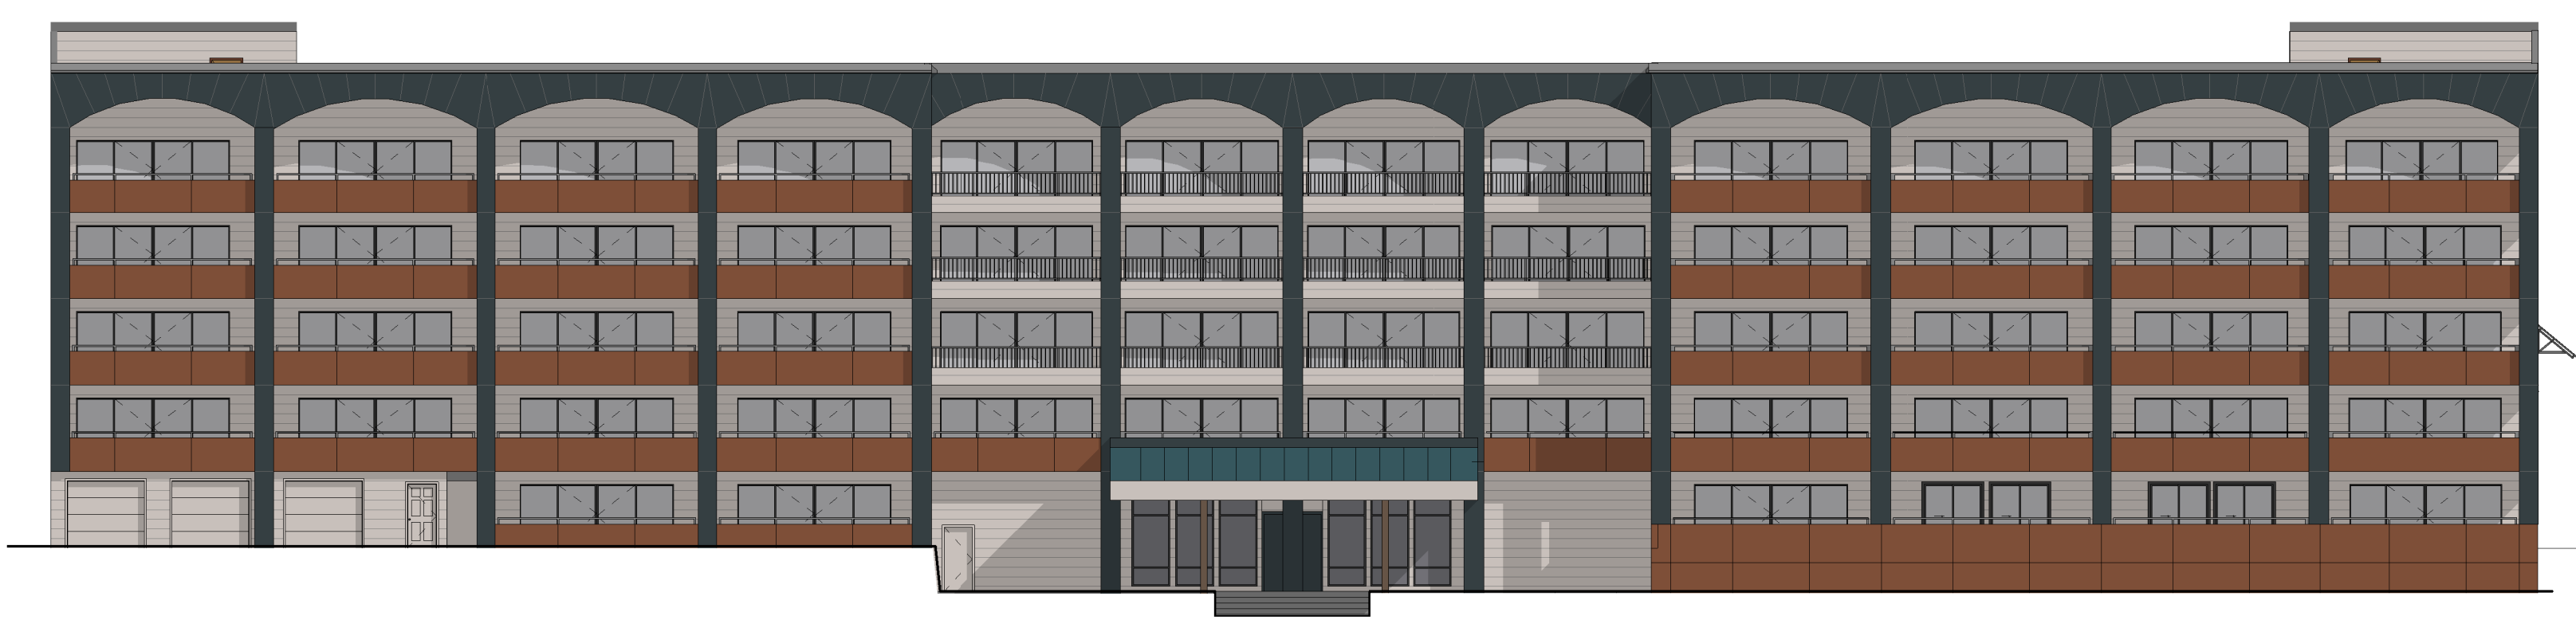
② EAST ELEVATION VIEW
1/16" = 1'-0"

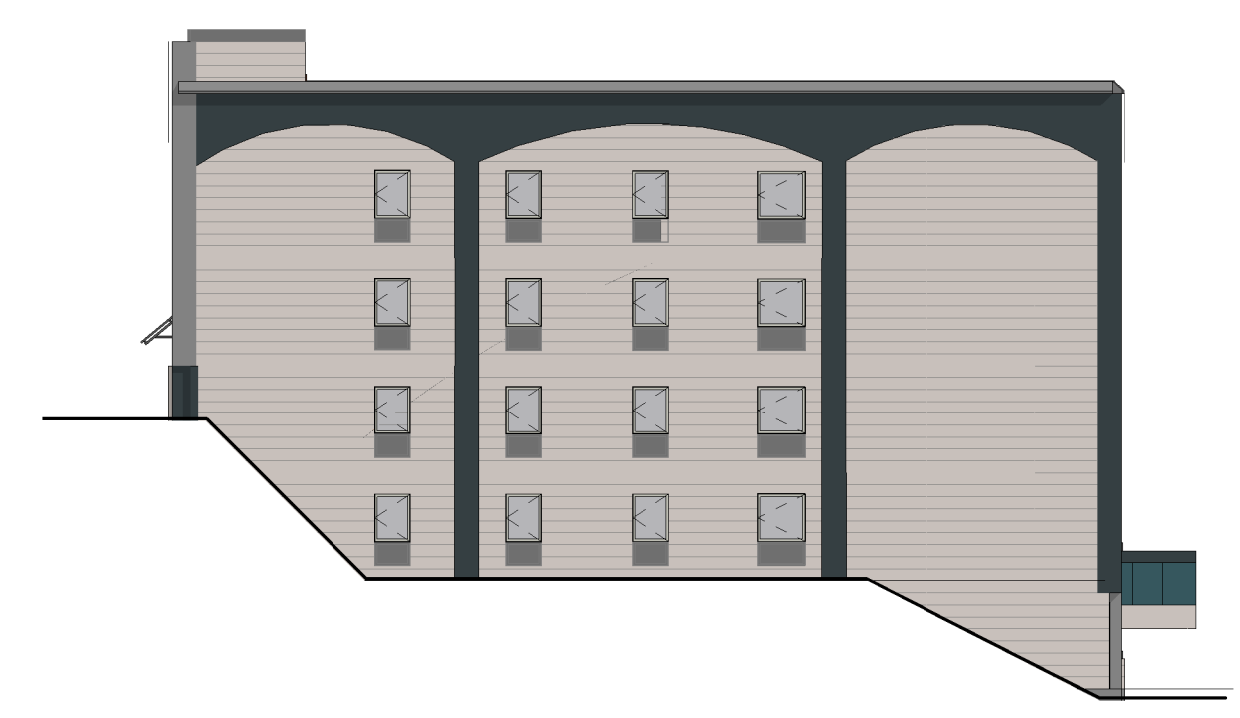
④ SOUTH ELEVATION VIEW
1/16" = 1'-0"

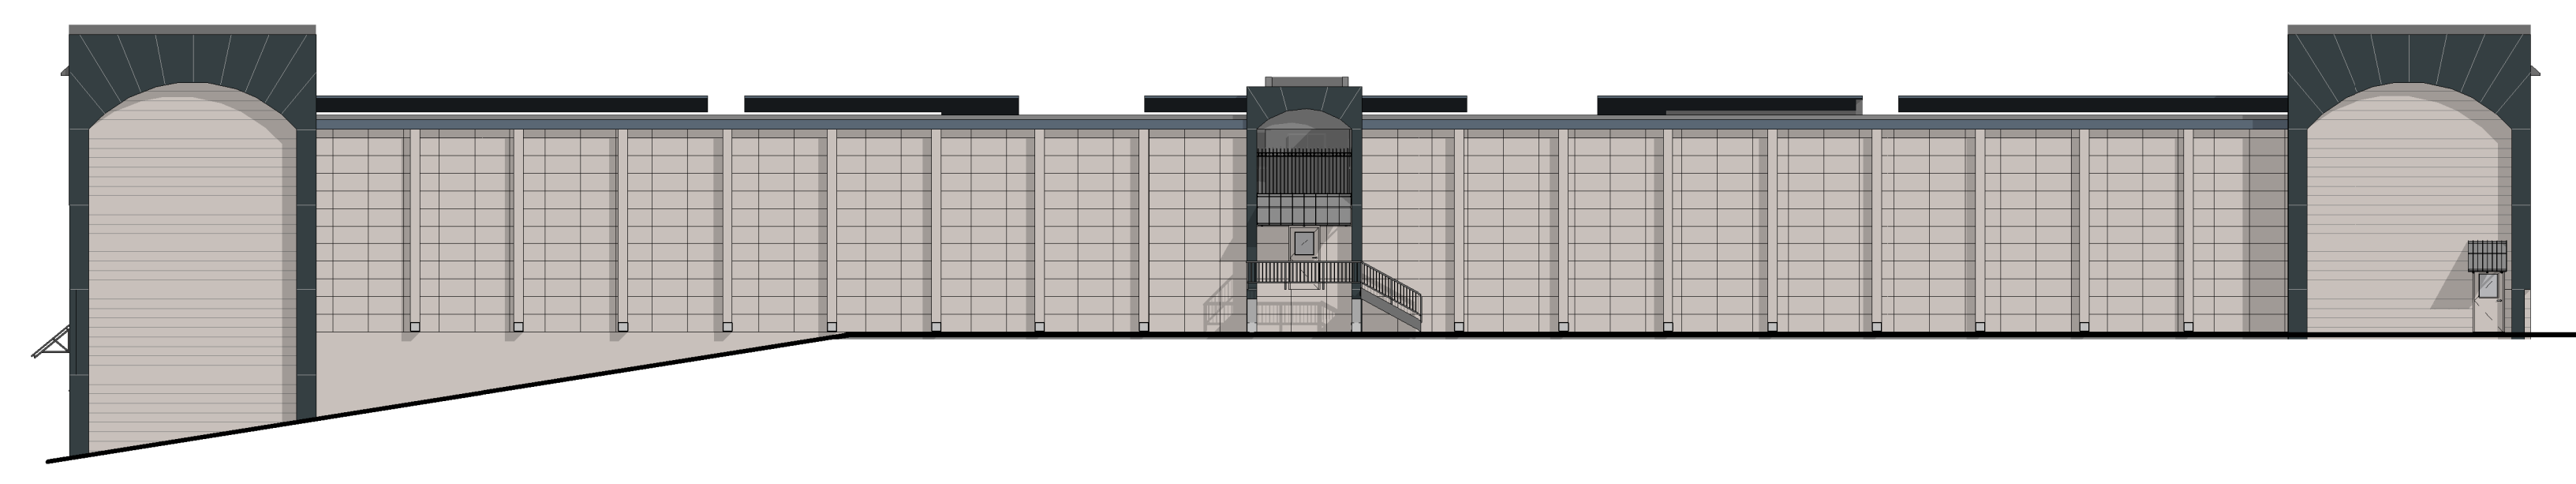
③ WEST ELEVATION VIEW
1/16" = 1'-0"

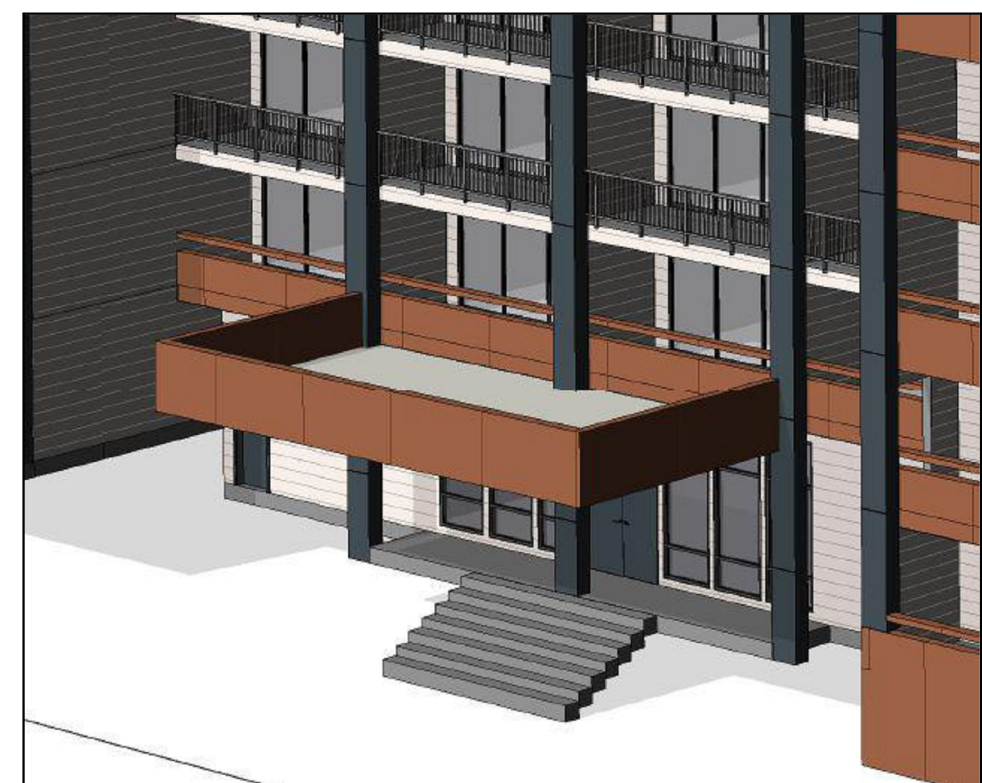
ORIGINAL ENTRY CANOPY WRAPPED IN TRESPA
