**MONACO VILLA
EXTERIOR
REMEDiation**

2929 76th Ave SE, Mercer
Island, WA 98040

01/24/24
DESIGN COMMISSION

**CURRENT
CONDITIONS**

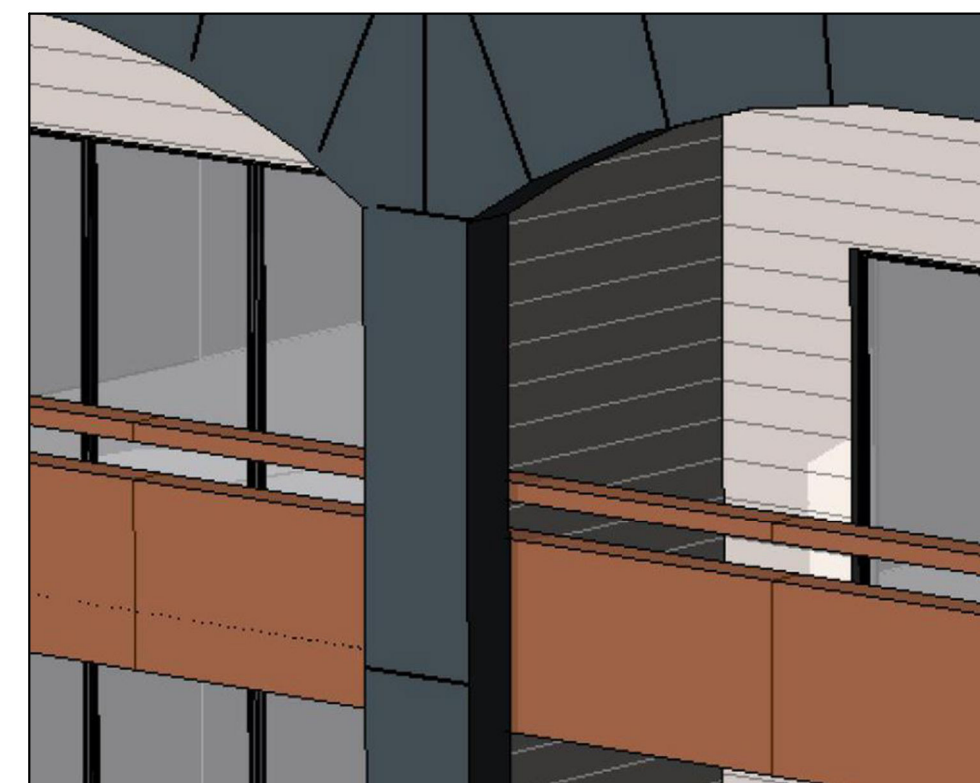
ORIGINAL COLUMN TREATMENT APPEARED SOMEWHAT SHALLOW

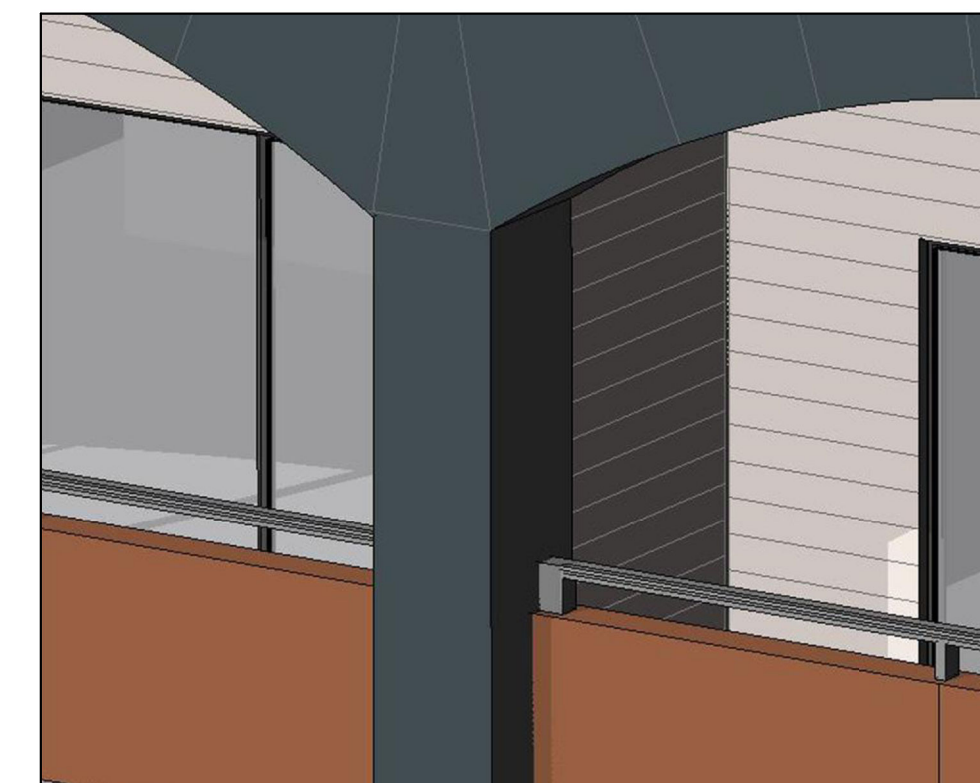
UPDATED COLUMN TREATMENT READS AS MUCH MORE SUBSTANTIAL

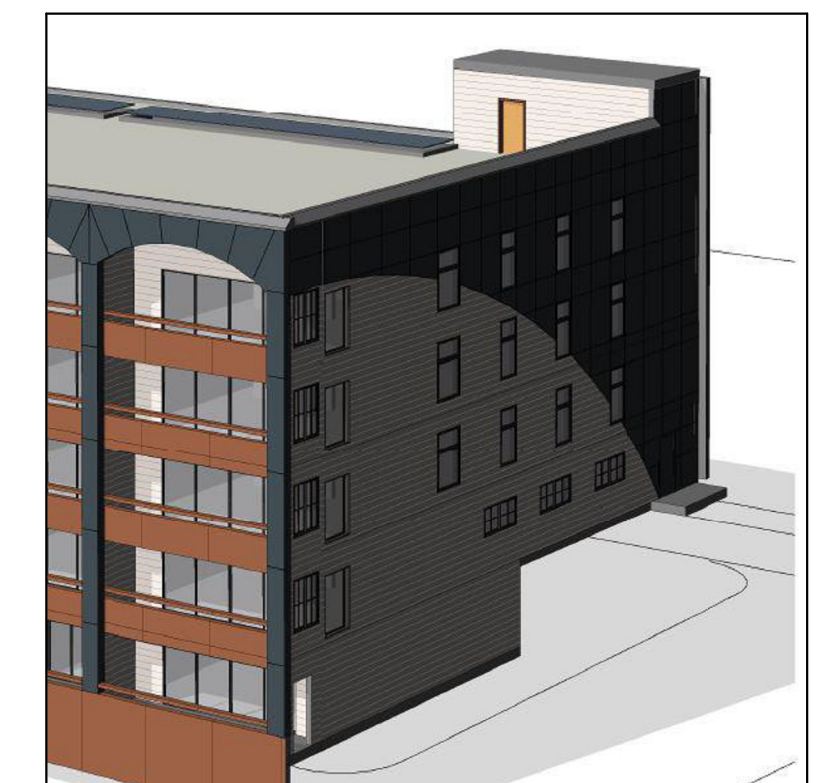
ORIGINAL END FACADES TREATED IN A SUPER GRAPHIC

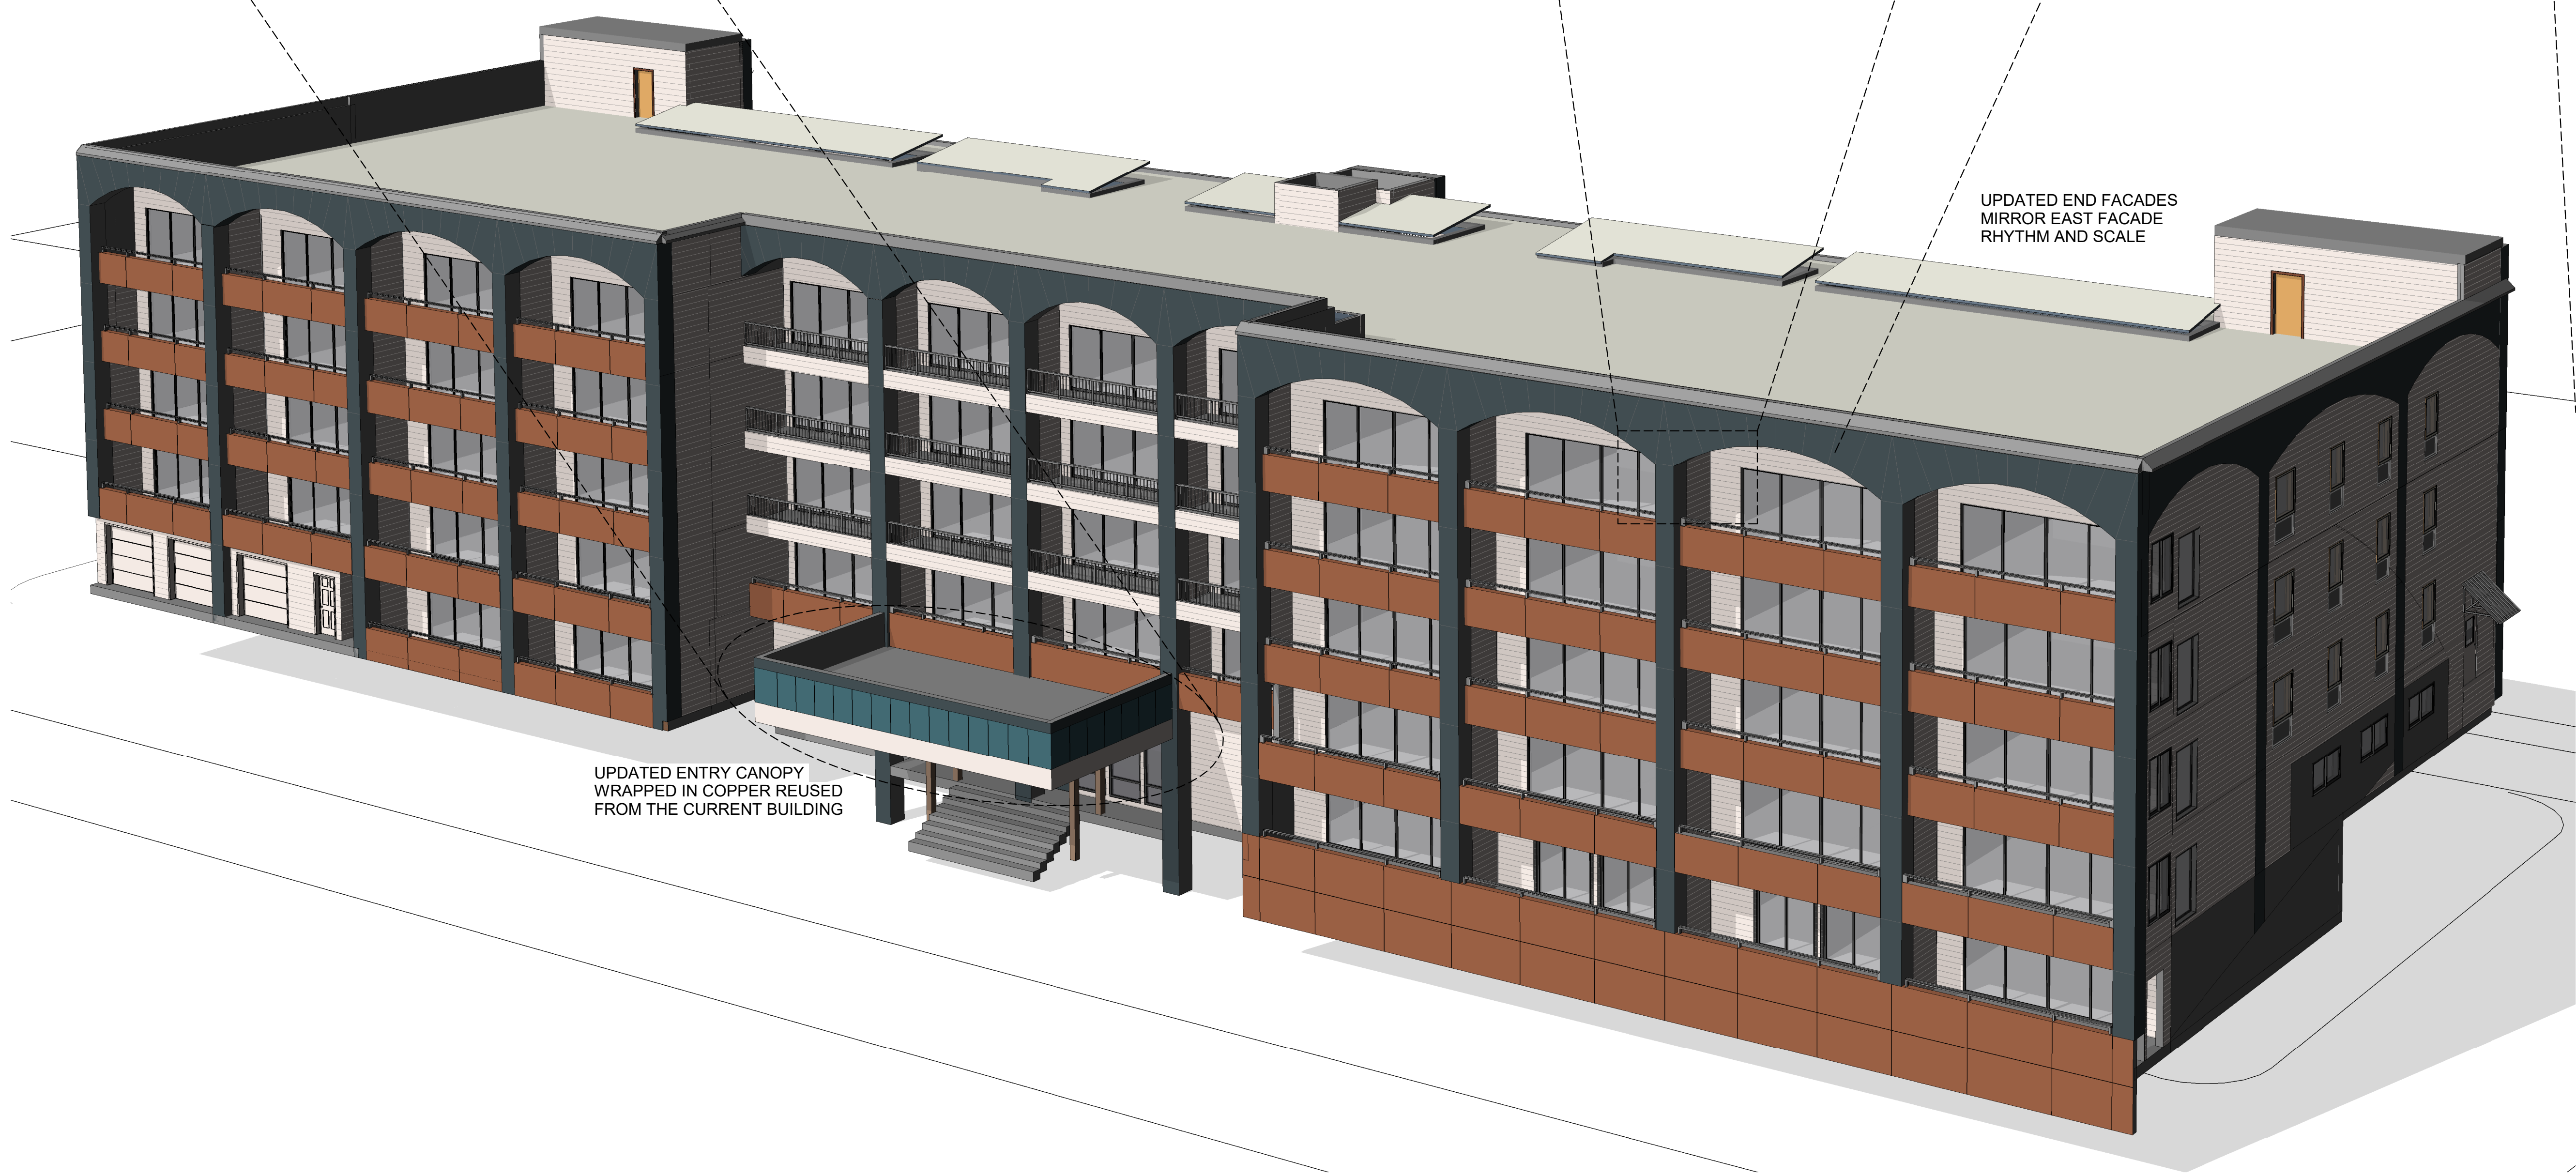
UPDATED ENTRY CANOPY WRAPPED IN COPPER REUSED FROM THE CURRENT BUILDING

UPDATED END FACADES MIRROR EAST FACADE RHYTHM AND SCALE
