# Overview of Clarke and Groveland Beach Parks Joint Infrastructure Plan

PRC 25-05 | May 1, 2025

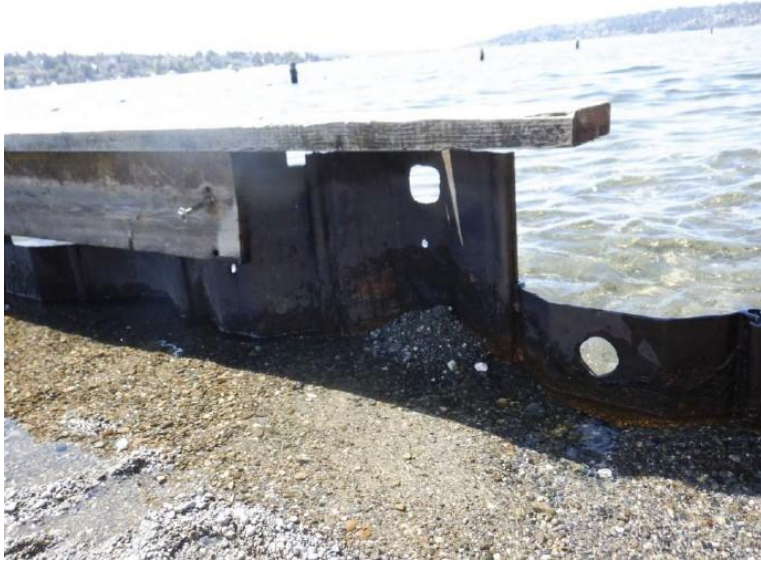
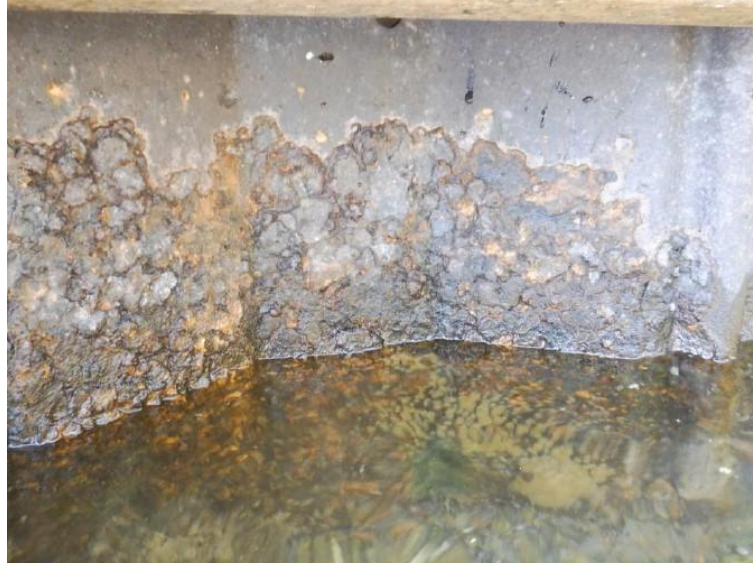
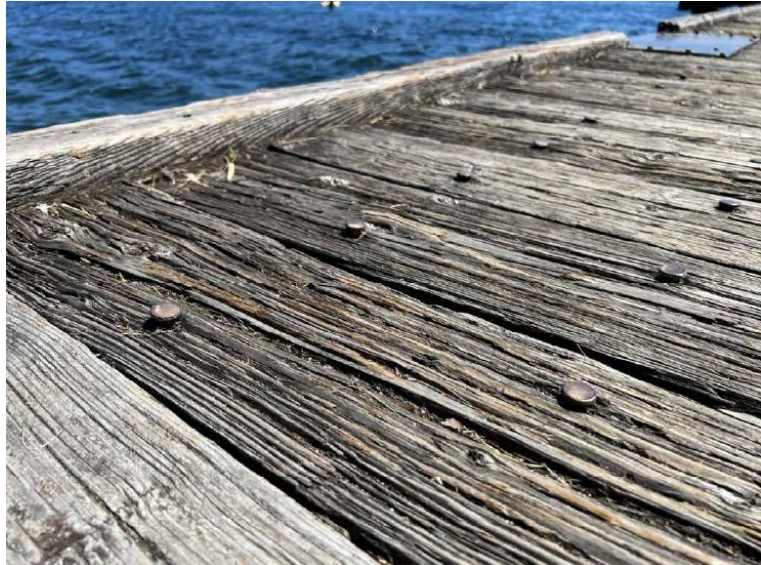
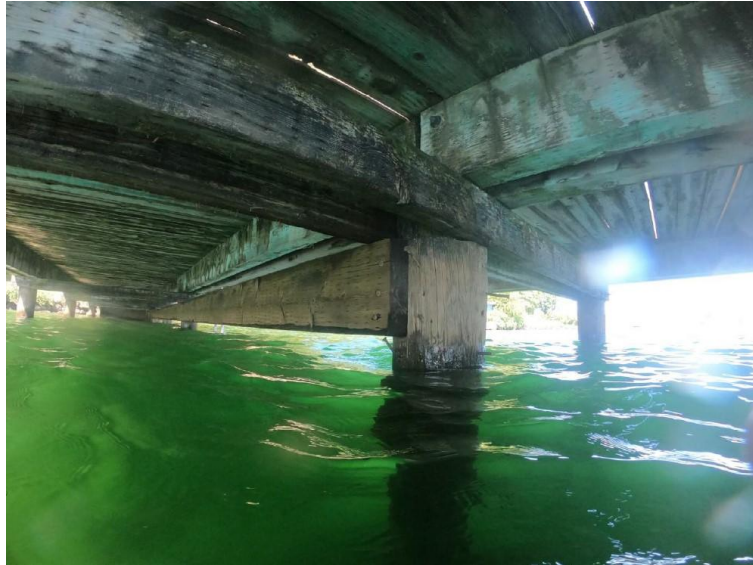
# In-Water Conditions at Clarke Beach

- In-water structures include:
  - Enclosed Swim Area – concrete stairs, concrete and timber pier, sheet pile wall
  - Open Swimming Area – mooring piles for buoy line, timber pier, concrete stairs
- Structures have reached the end of their useful life, including degradation of the concrete stairs, timber piles, and sheet pile wall.
  - Timber: fungal decay and degradation
  - Concrete: spalling, undermining, and voiding compromise structural integrity
  - Steel components: strength likely impacted by corrosion

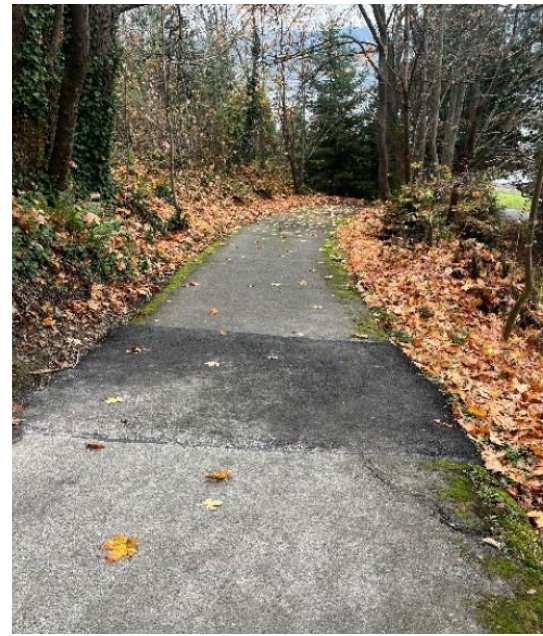
Soil creep throughout steep slopes causes asphalt cracking that must be routinely repaired.

- Primary concerns include:
  - Surficial soil settlement across the slope causes asphalt cracking
  - Waterfront erosion causes asphalt settling and sinkholes
- No wetlands or non-piped watercourses at the site
- Mapped as a hazardous area, which will require additional geotechnical study

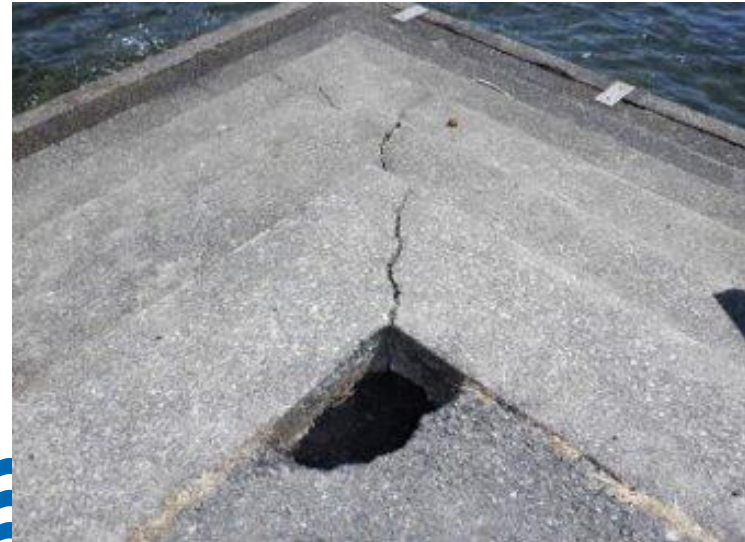
Erosion at the concrete stairs in the Open Swim Area causes significant settling and creates sinkholes.

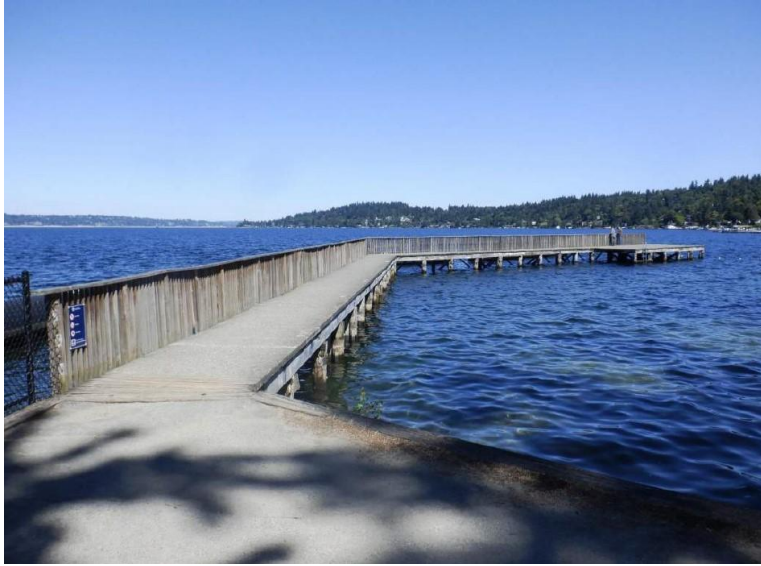
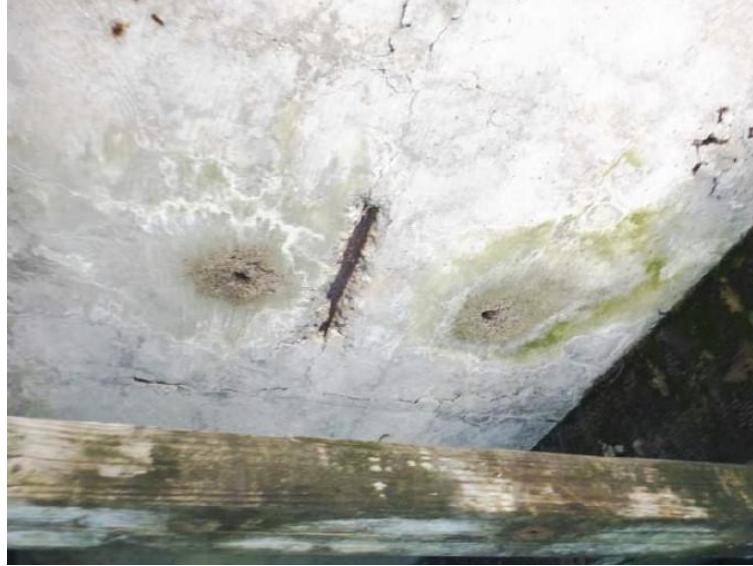
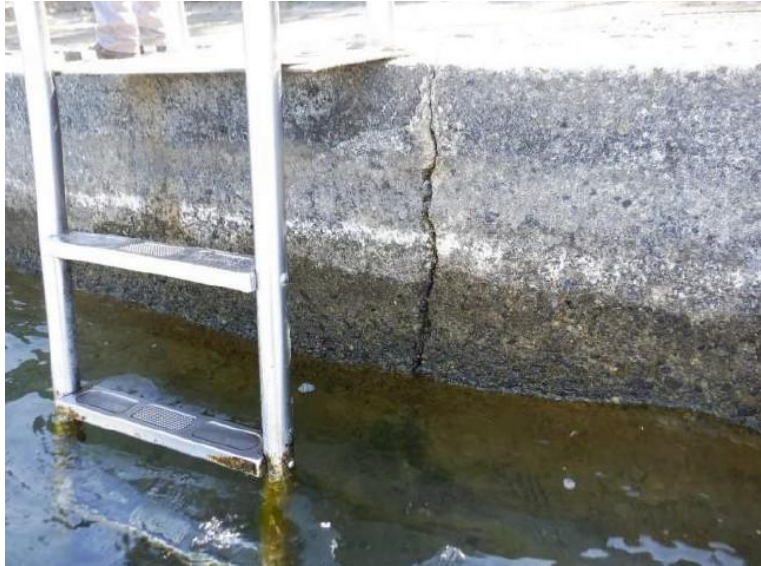
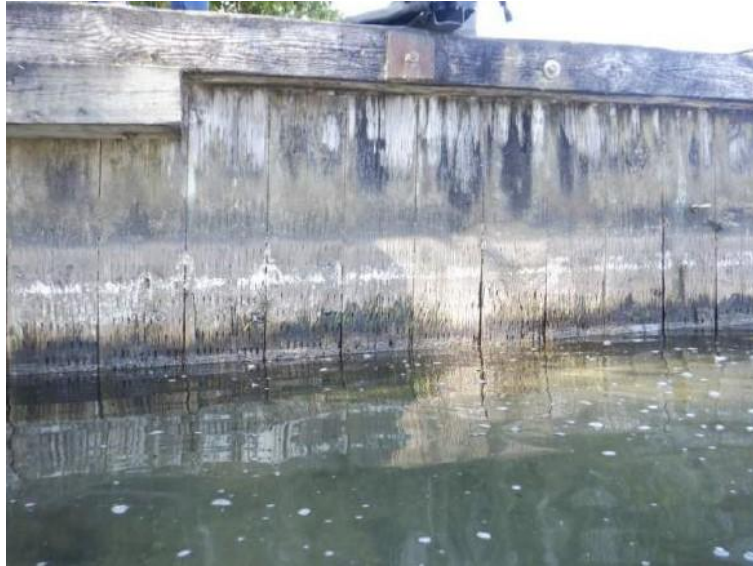
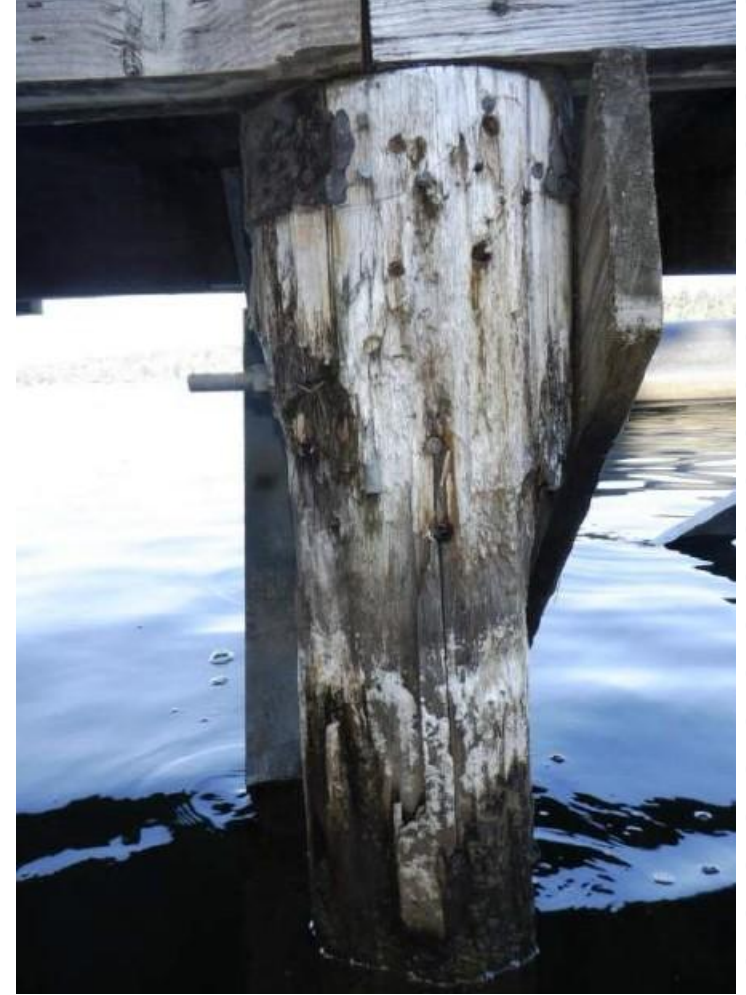
# Groveland In-Water Conditions

- In-water structures include:
  - Timber pier and bulkhead
  - Concrete bulkhead
  - Camel log wave attenuator
- The overall condition of the in-water structures is fair, but degradation is evident and should be monitored/managed to preserve them.
  - Pier: fair to good condition, localized damage to timber piles and deterioration of concrete decking requires attention
  - Timber bulkhead: heavy degradation in curbing and exposed fill behind the wall
  - Concrete bulkhead: cracking, spalling, and undermining

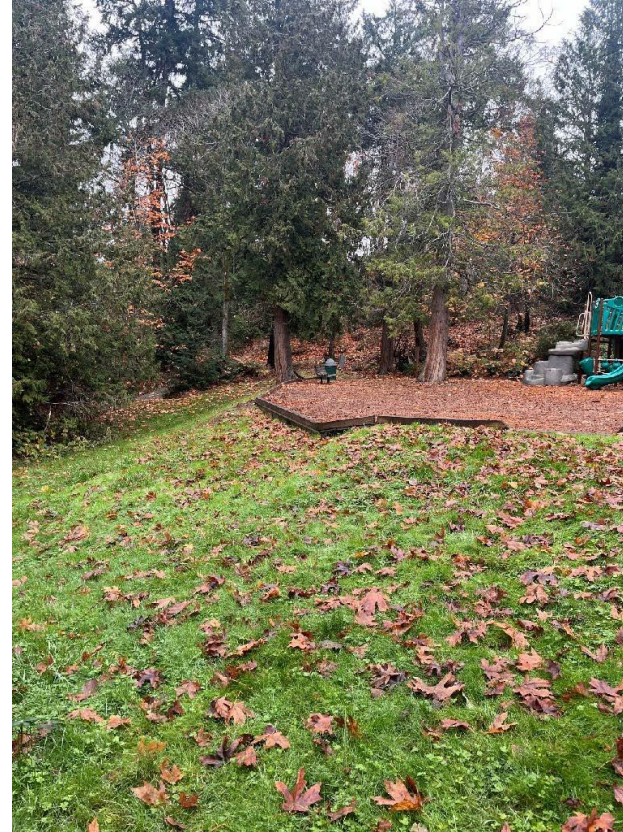
Surficial soil creep along the slope causes the western edge of the playground to settle.

- Primary concerns include:
  - Surficial soil creep along the slope causes asphalt cracking and settling near the playground
  - Beach area settlement causes a stormwater pipe to rupture
- No wetlands or non-piped watercourses at the site
- Mapped as a hazardous area, which will require additional geotechnical study

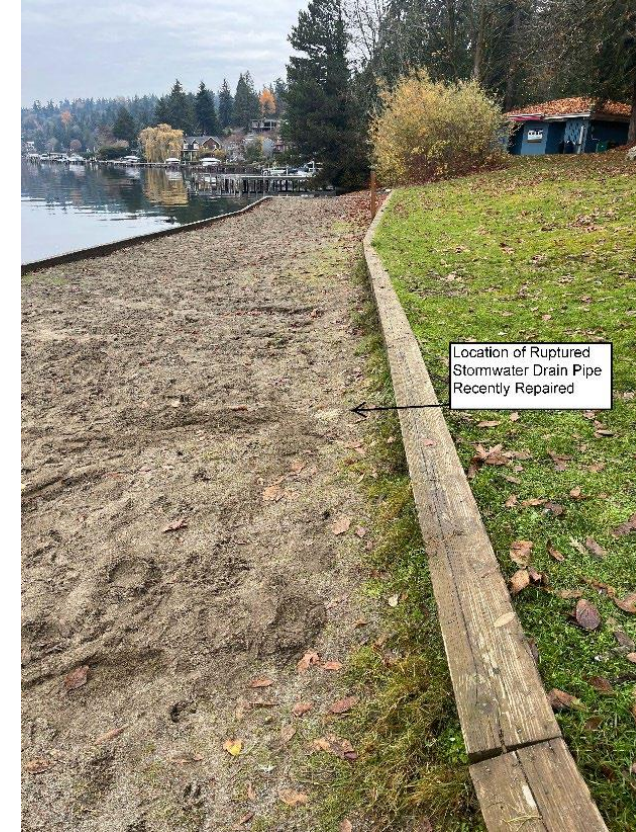
A stormwater pipe located in the beach area has been repaired twice after rupturing due to surface settlement.
