# ISLAND CREST WAY

## SAFETY RECOMMENDATIONS

CITY OF MERCER ISLAND

MARCH 2022

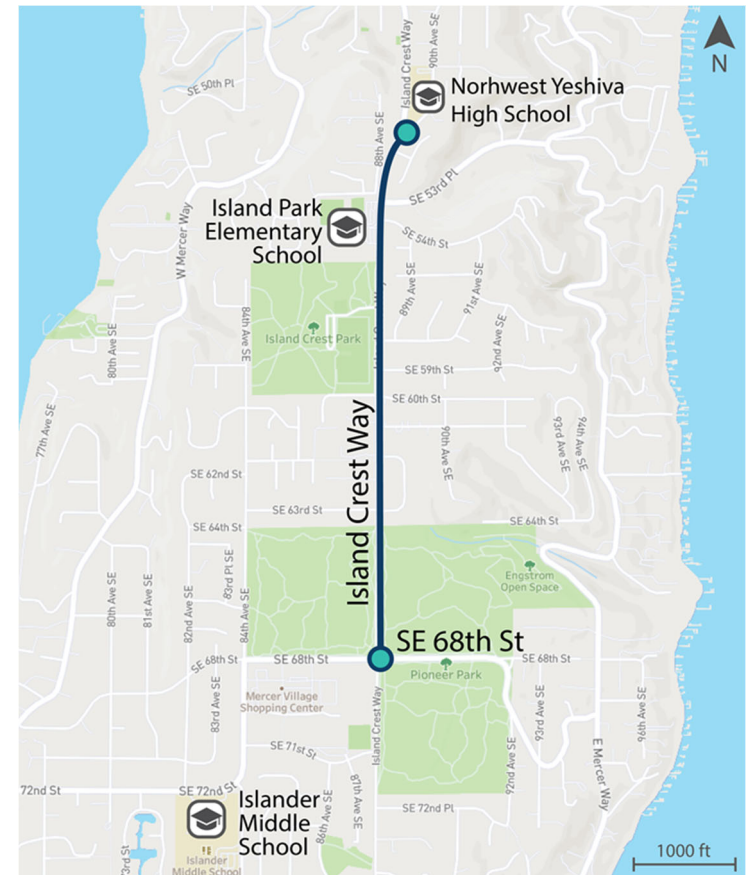
**FIGURE 1. STUDY CORRIDOR MAP**

The study corridor is a two-way undivided road that spans approximately 1 mile from 90th Avenue SE to SE 68th Street, as shown in Figure 1. Through analysis of collision history and traffic operations data, field visits to the site, discussions with school district staff, and data reported from a public survey,<sup>1</sup> the study team identified the following safety needs along Island Crest Way:

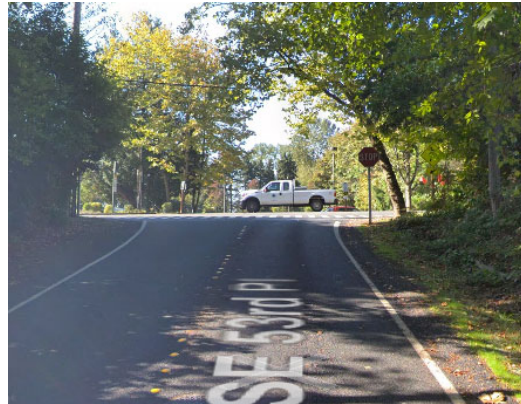
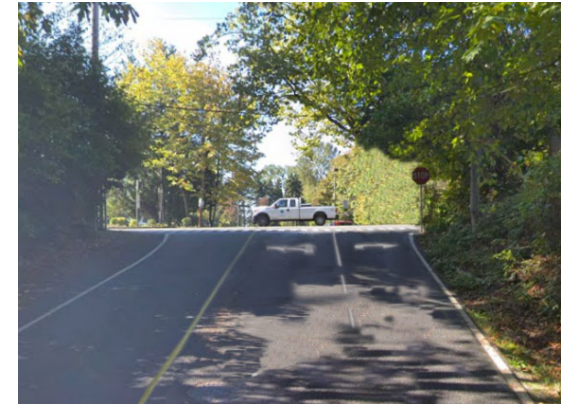
*Add Right Turn Lane at SE 53rd Place*

Before

After

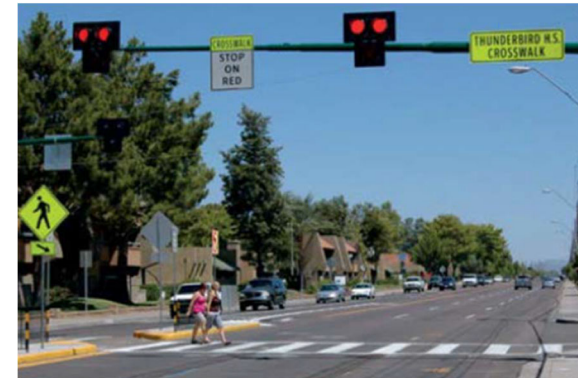
*Pedestrian Hybrid Beacon*

- **Pedestrian Hybrid Beacon.** At the south pedestrian crossing (currently a Rectangular Rapid Flashing Beacon (RRFB)), a Pedestrian Hybrid Beacon could increase pedestrian safety while also providing additional gaps in pedestrian traffic to reduce motor vehicle delay during heavy pedestrian times of day (e.g., before and after school)
- **Long-term Site Planning.** Monitor Island Park Elementary School's future plans for expansion and coordinate student and family transportation safety during the planning stage.

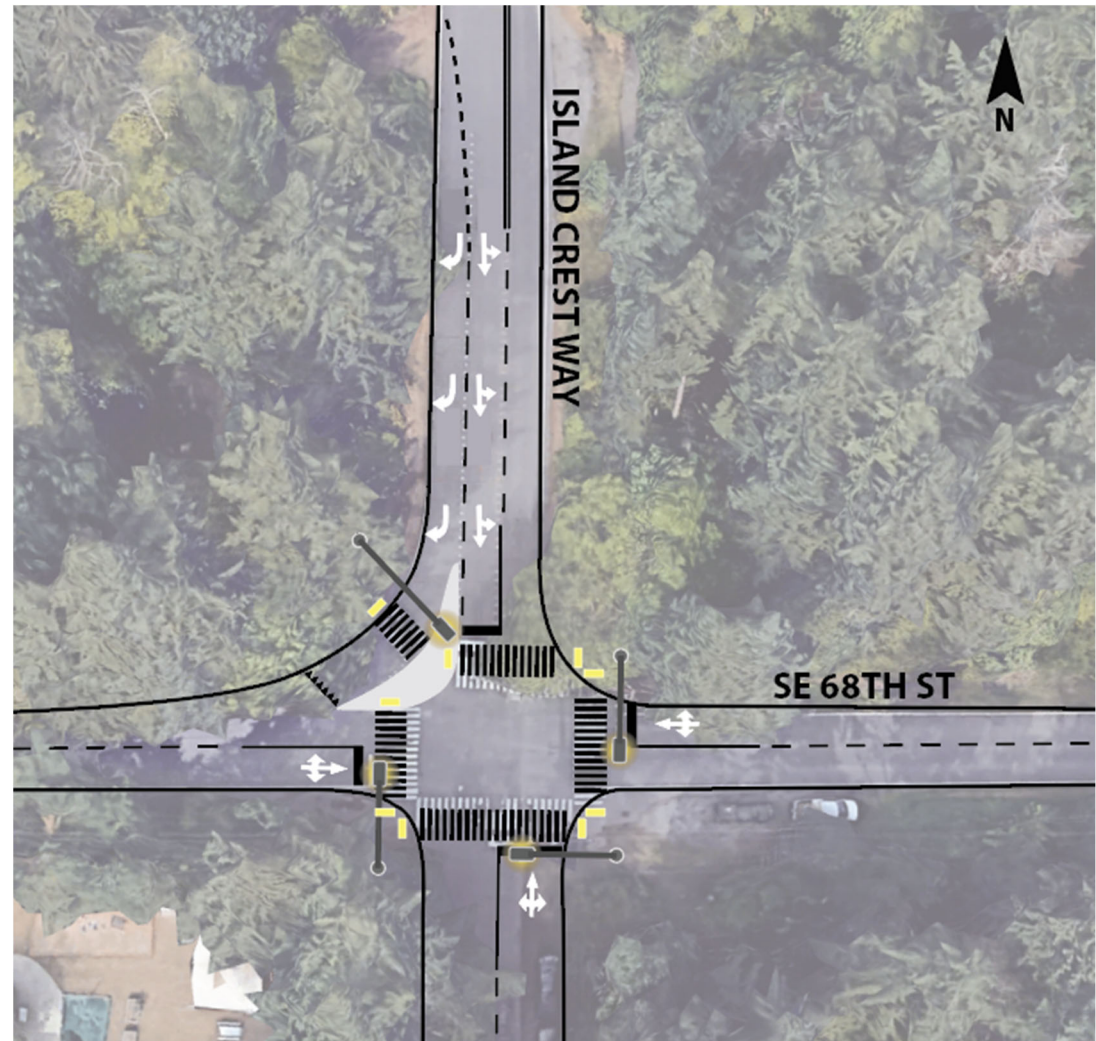
*SE 68th Street: Potential Pavement Marking and Lighting Treatments*

- **Lighting**
  - Upgrade lighting and trim vegetation that blocks lighting from reaching the road surface.

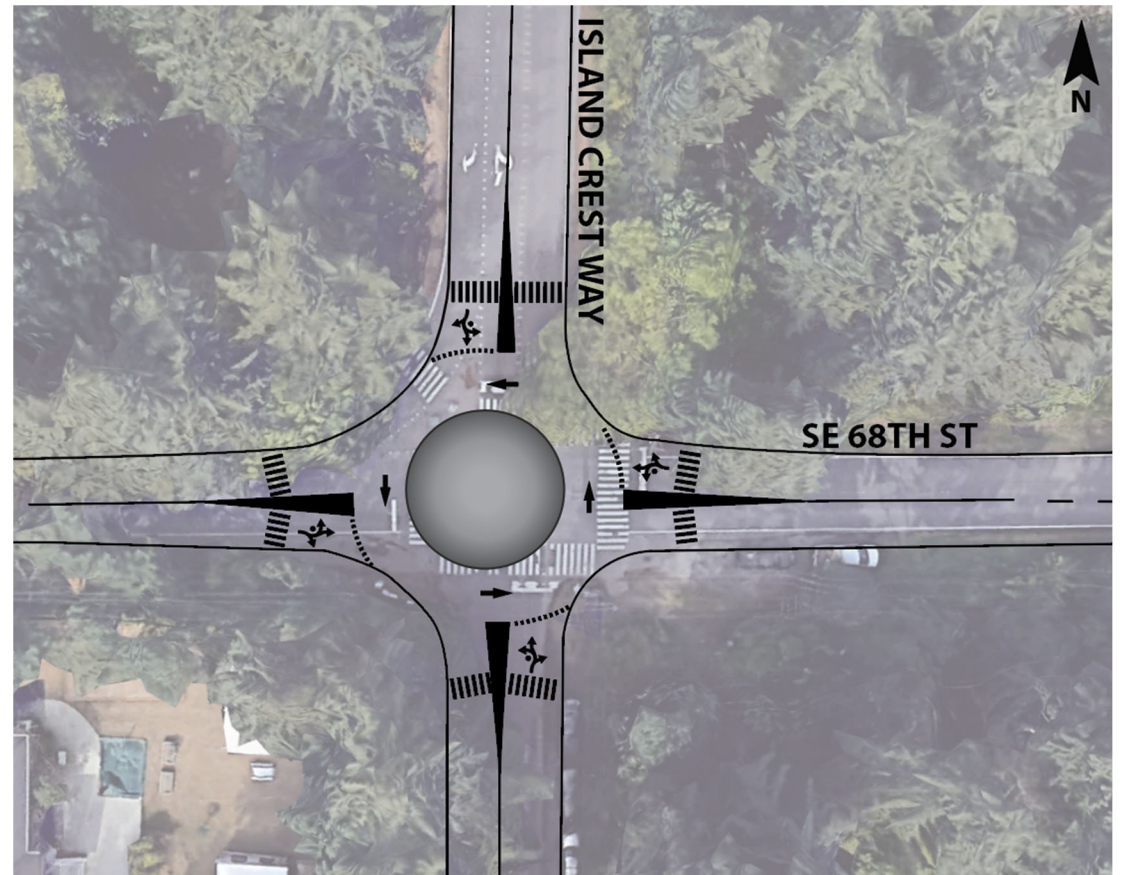
*SE 68th Street: Potential Single-lane Roundabout*

- **Roundabout.** Consider a single-lane roundabout at the intersection to reduce collision frequency, improve traffic operations, and enhance aesthetics.

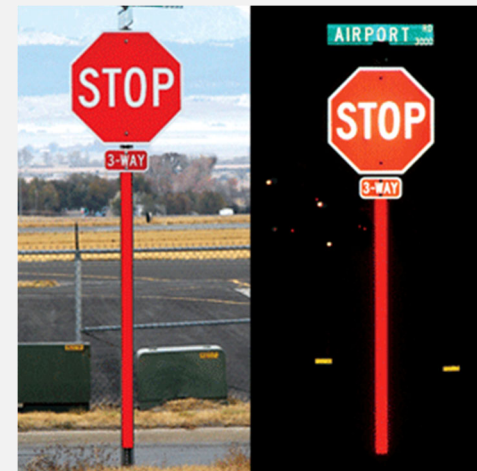
### Retroreflective Strips on Signposts<sup>3,4</sup>

**Description:** Retroreflective strips or sleeves can be added to stop sign posts to draw additional attention to drivers, particularly at night. In addition to providing a warning for approaching motorists on the side street, a wrapped post also indicates an upcoming intersection to mainline drivers.

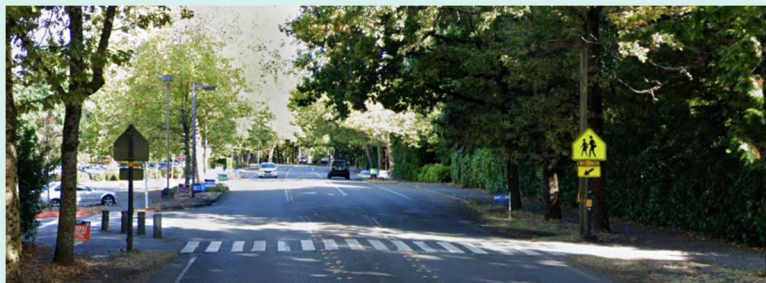
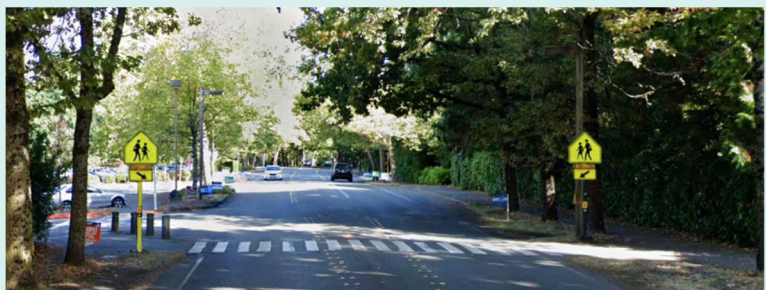
- Post sleeves on each warning sign (advance warning and at the crosswalk)
- Add left-mounted Pedestrian Crossing or School Crossing signs and diagonal down arrow plaques
- Reapply any worn crosswalk pavement marking
- Trim vegetation for improved visibility
- Assess and improve lighting

BEFORE:

AFTER:

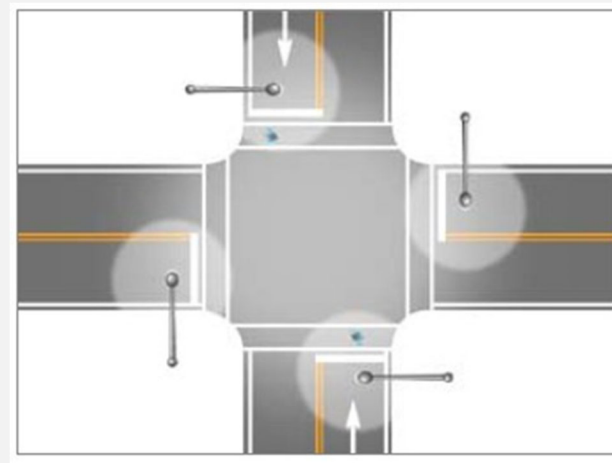
Typical intersection lighting design<sup>5</sup>

**Description:** Installing sufficient intersection lighting can improve the ability for drivers to recognize that an intersection is being approached, navigate turning movements properly and recognize other vehicles and pedestrians in or entering the intersection.

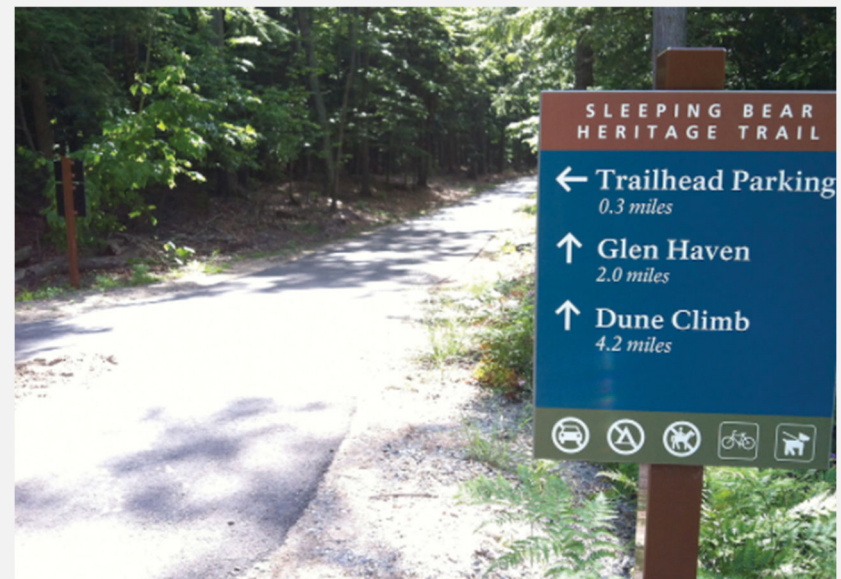
**Description:** A shared use path provides a travel area separate from motorized traffic for bicyclists, pedestrians, skaters, wheelchair users, joggers, and other users. Shared use paths can provide a low-stress experience for a variety of users using the network for transportation or recreation.

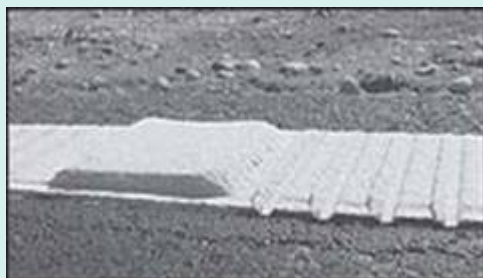
## Profiled Thermoplastic Markings

**Description:** Profiled thermoplastic markings provide enhanced retroreflectivity compared to normal paint strips along with better durability and less maintenance than raised pavement markers.

In addition, the noise and vibration produced by profiled (raised) thermoplastic markings alert drivers when they leave the traveled way.

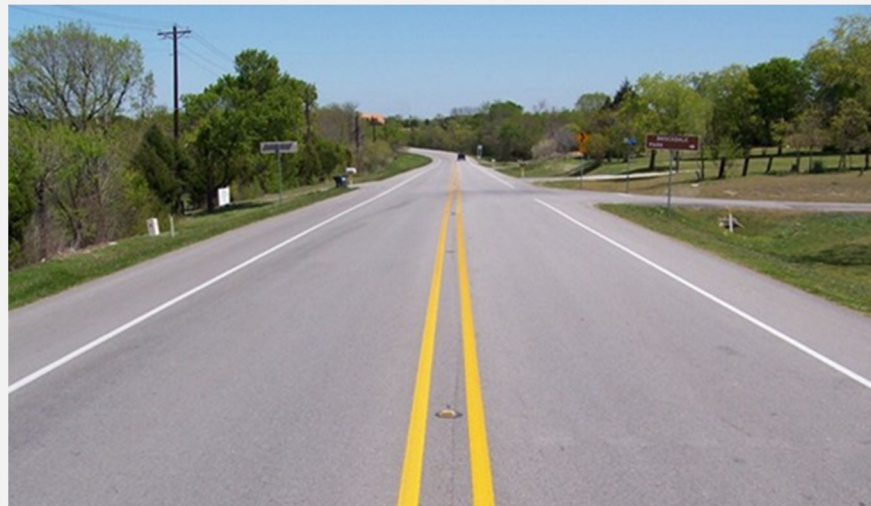
**Description:** Paved shoulders can provide a clear recovery area for drivers who may leave their travel lane.<sup>6</sup> Uniform shoulder width is not required for retrofit installation to provide a safety benefit.

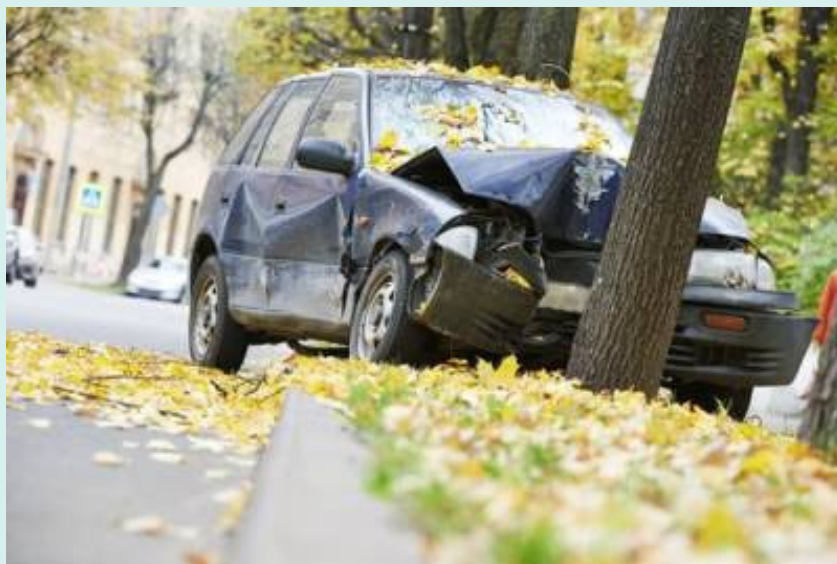
**Description:** The AASHTO Roadside Design Guide provides a hierarchy of countermeasures to deal with roadside fixed objects.

1. Remove the obstacle.
2. Redesign the obstacle so it can be safely traversed.
3. Relocate the obstacle to a point where it is less likely to be struck.
4. Reduce impact severity by using an appropriate breakaway device.
5. Shield the obstacle with a longitudinal traffic barrier designed for redirection or use a crash cushion.
6. Delineate the obstacle if the previous alternatives are not appropriate.

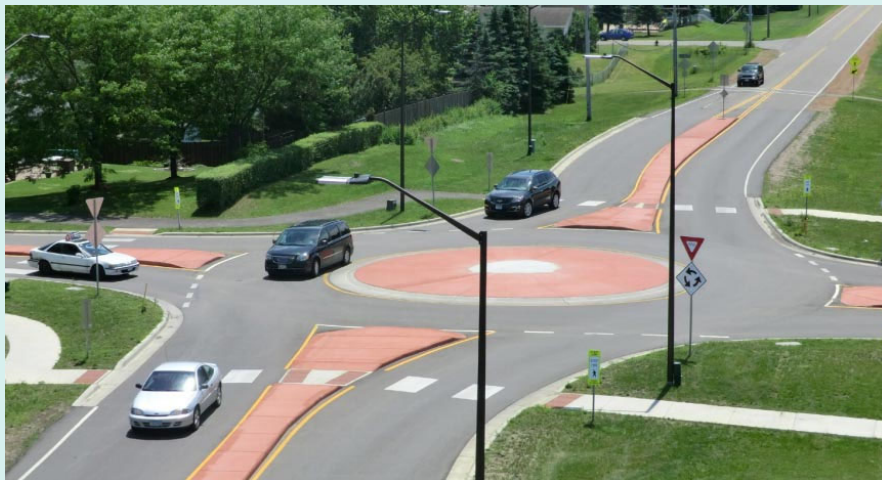
Single-lane roundabout<sup>7</sup>

**Description:** Effective at intersections that have a high frequency of right-angle and left-turn type crashes, primarily at unsignalized intersections with moderate volumes.

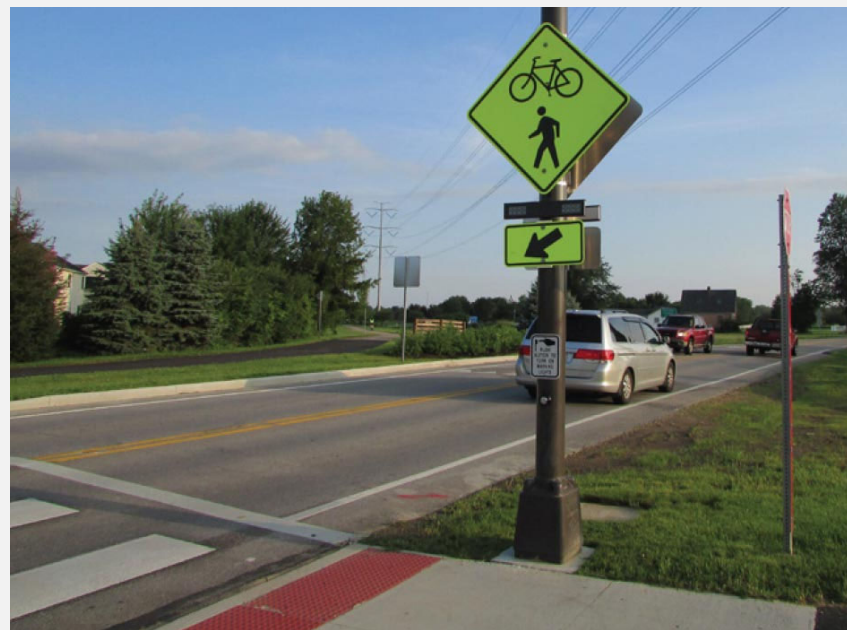
**Description:** RRFBs enhance pedestrian conspicuity and increase driver awareness at uncontrolled, marked crosswalks. It is used to accompany a pedestrian warning sign.

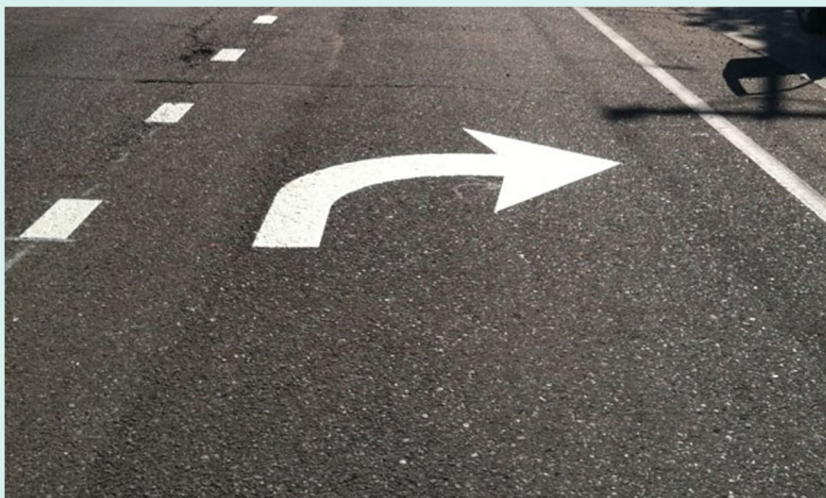
## Install Right Turn Lane

**Description:** While turn lanes provide measurable safety and operational benefits at many types of intersections, they are particularly helpful at two-way stop-controlled intersections. This eliminates delays for right turning vehicles waiting behind vehicles traveling in other directions. Depending on available pavement width, a right turn lane may be striped on the existing roadway, or additional pavement may be needed to accommodate the lane.

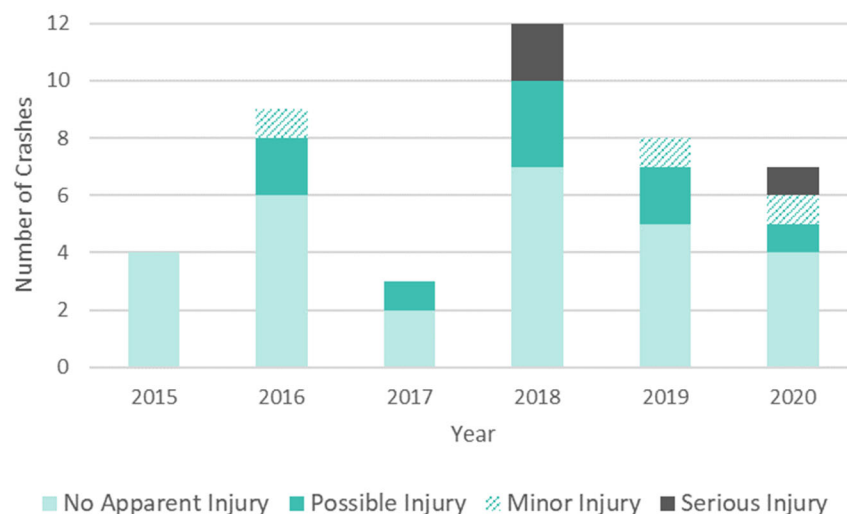
**FIGURE 2. COLLISION FREQUENCY BY SEVERITY AND YEAR, 2015-2020**

The study team retrieved collision data from the Washington State Department of Transportation (WSDOT) collision database from the past six years (2015-2020) along the study corridor (including intersection and non-intersection crashes). The team identified 43 crashes that occurred along the study corridor between 90th Avenue SE and SE 68th Street. Figure 2 presents collision frequency by severity. Overall, the total number of crashes along the study corridor fluctuated over the study period. The first three years averaged five crashes annually, while the final three years of the study averaged nine crashes per year. Regarding severity, two serious injury collisions occurred in 2018 and one serious injury collision occurred in 2020.

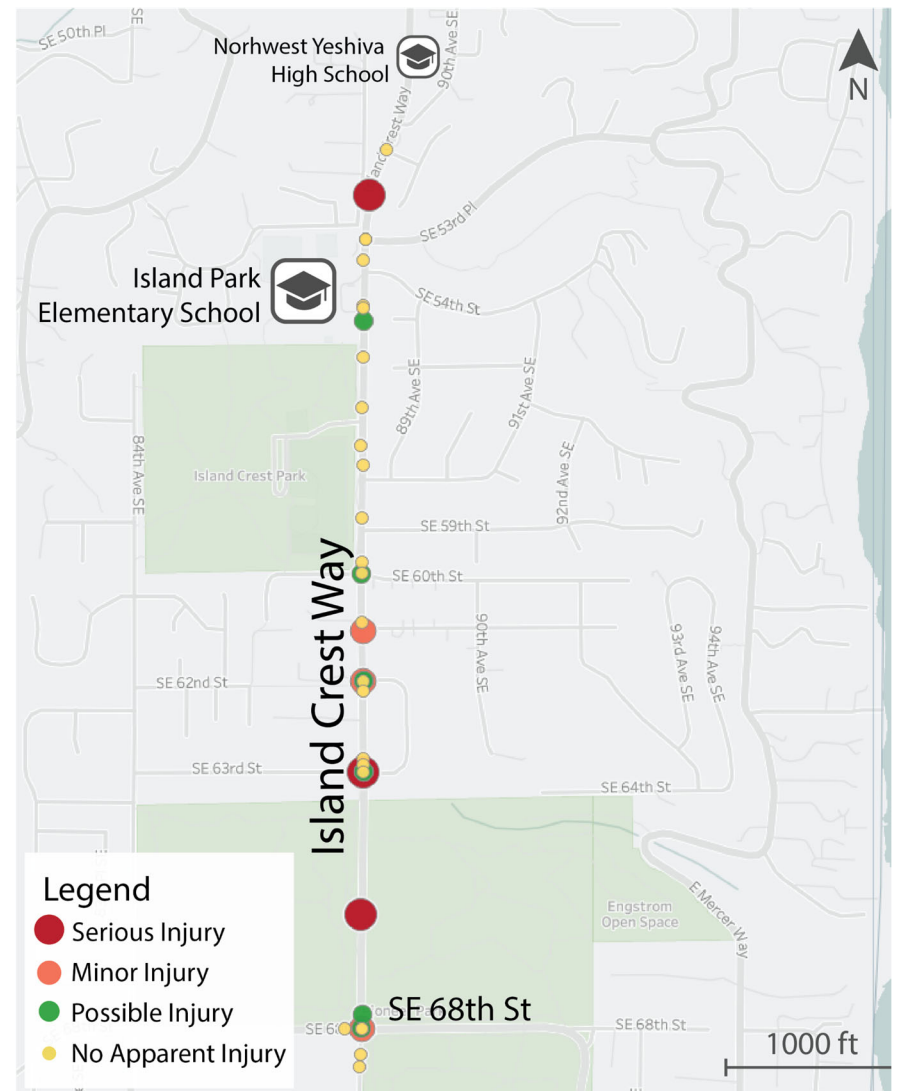
FIGURE 4. CRASH SEVERITY ALONG STUDY CORRIDOR, 2015-2020

Figure 3 presents a heat map of the 43 recorded collisions, showing that corridor crashes tend to cluster around access points. In particular, the access points of SE 62nd Street, SE 63rd Street, and SE 68th Street intersection have experienced a higher frequency of crashes compared to other locations along the corridor. Figure 4 maps all the crashes along the corridor based on crash severity.

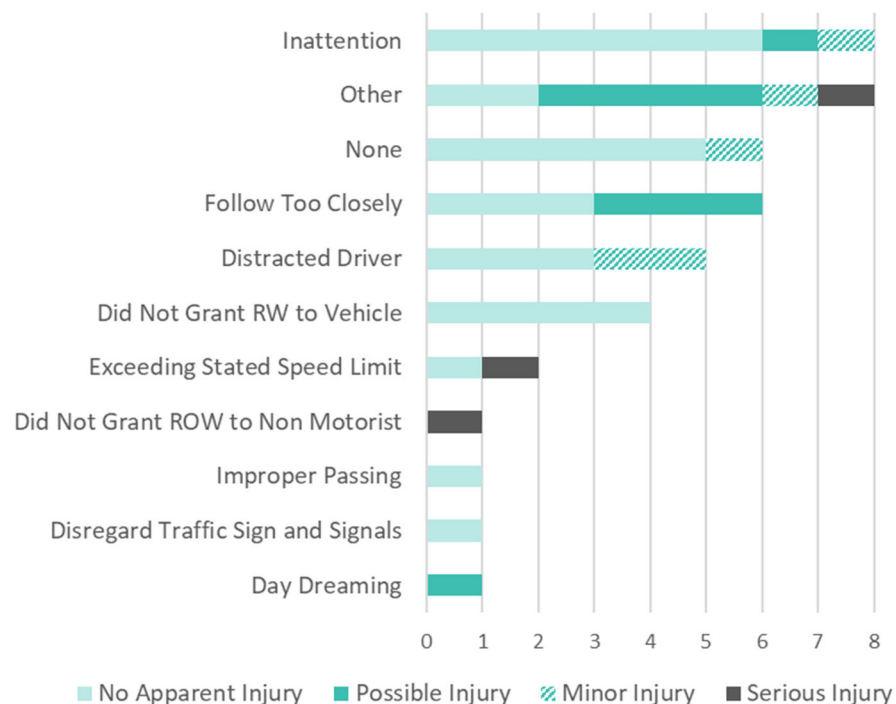
FIGURE 5. CONTRIBUTING CIRCUMSTANCES ALONG THE STUDY CORRIDOR, 2015-2020

As illustrated in Figure 5, the most common contributing circumstance was inattention (18%). As shown in Figure 6, the most common crash types along the study corridor are rear-end crashes (42%), followed by entering at angle<sup>3</sup> (21%) and run off the road crashes (14%).<sup>4</sup>

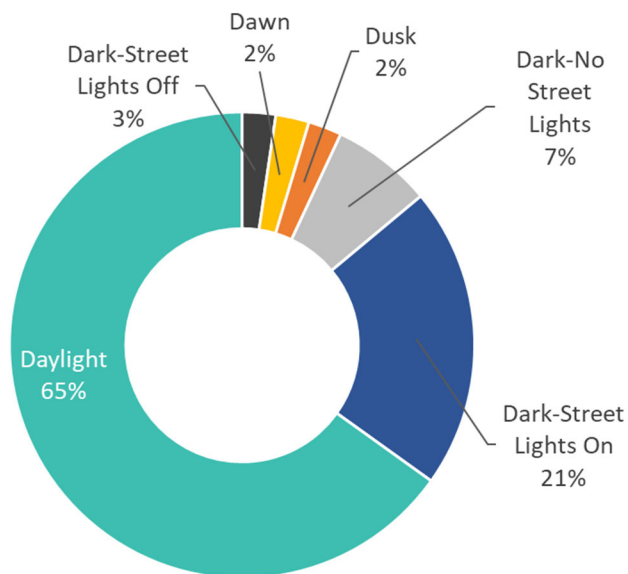
FIGURE 8. CRASH EVENT LIGHTING CONDITIONS, STUDY CORRIDOR, 2015-2020

During the study period, there were 15 crashes that occurred during non-daylight conditions. In particular, 21% of crashes reported dark conditions with street lights on, as shown in Figure 8. During the PM peak field visit, the study team observed the street lighting and noticed that two street lights were not functioning on both sides of SE 58th Street entrance on the east side of Island Crest Way, as shown in Figure 9.

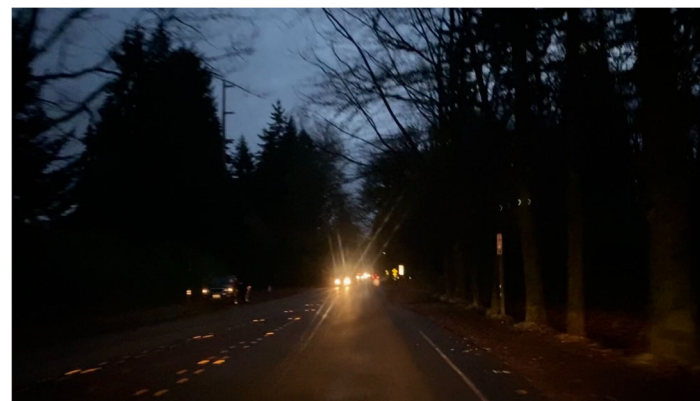
FIGURE 10. ISLAND CREST WAY AT NIGHT.

Once the area gets dark, which is around 5 PM during the winter time, the areas without street lights have limited visibility, as shown in Figure 10. Without daylight, it can be difficult to see the edge line striping (which was not exhibiting retroreflectivity during the field review), centerline reflectors, and trees that border the roadway. As a pedestrian on the sidewalk or a cyclist sharing the road, it can be difficult for drivers to see them in the dark along this corridor.

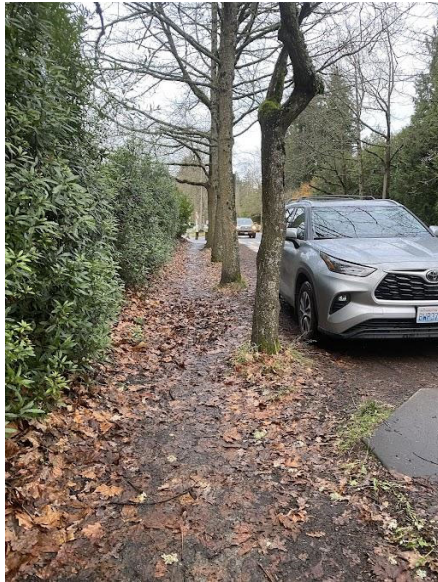
A

Photo A: Informal path on the west side of Island Crest Way, just south of the Island Park Elementary School (facing northbound).

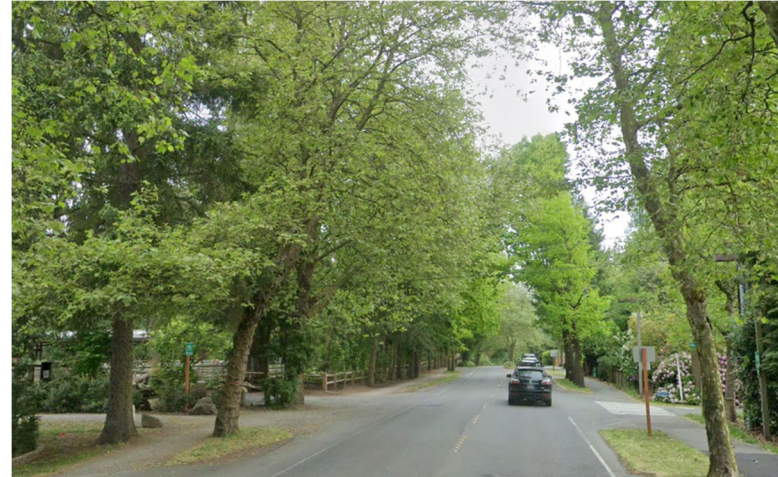
B

Photo B: Bike Route crossing south of SE 62nd Street (facing northbound). Existing street light on the east side. No lighting provided on the west side of Island Crest Way at this crossing.

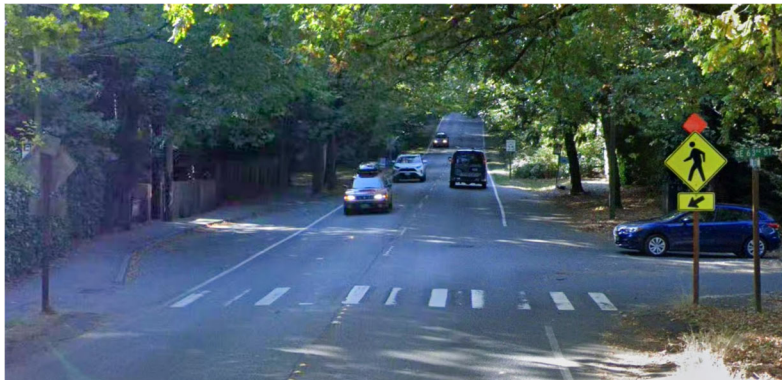
C

Photo C: Marked crossing at SE 63rd Street with signing (facing southbound).

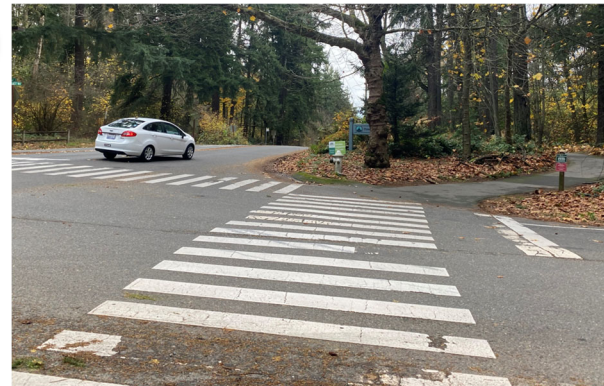
D

Photo D: Marked crossing at SE 68th Street intersection (facing northbound from southeast corner).

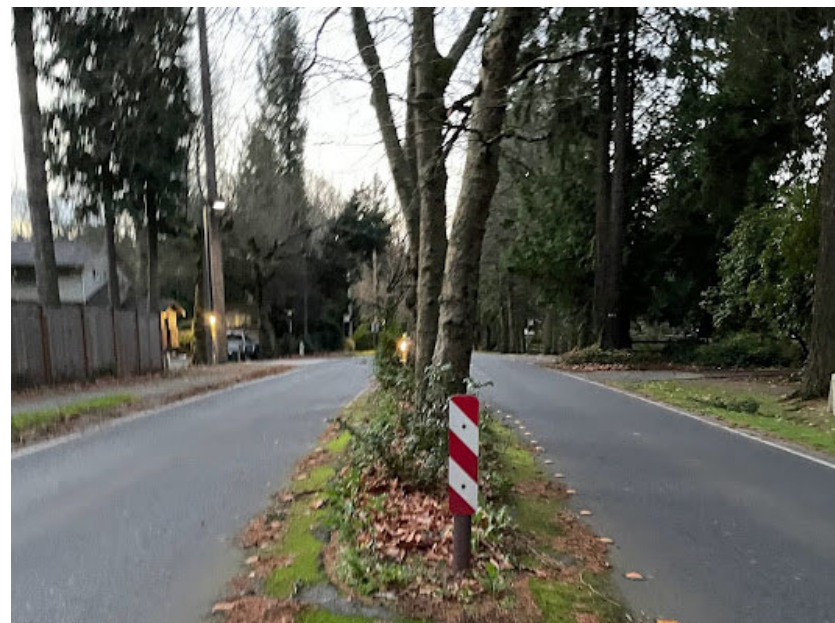
**Median Trees and Signing.** A few locations along the corridor include trees in the median, which introduce fixed object near the traveled way. These same medians have non-standard red-and-white object markers to delineate the presence of trees.

**Pavement Marking.** In general, pavement marking is worn and needs to be re-marked along the edgeline and at crosswalks. Some centerline marking is only raised pavement markers with no striping underneath. When markers are non-reflective or missing, this causes gaps in delineation.

- During nighttime driving, it can be difficult to view the worn out edgeline striping, centerline pavement marking, and faded crosswalk markings.
- There is sign clutter and overhanging tree canopy that can potentially block the southbound approach at SE 68th Street intersection.

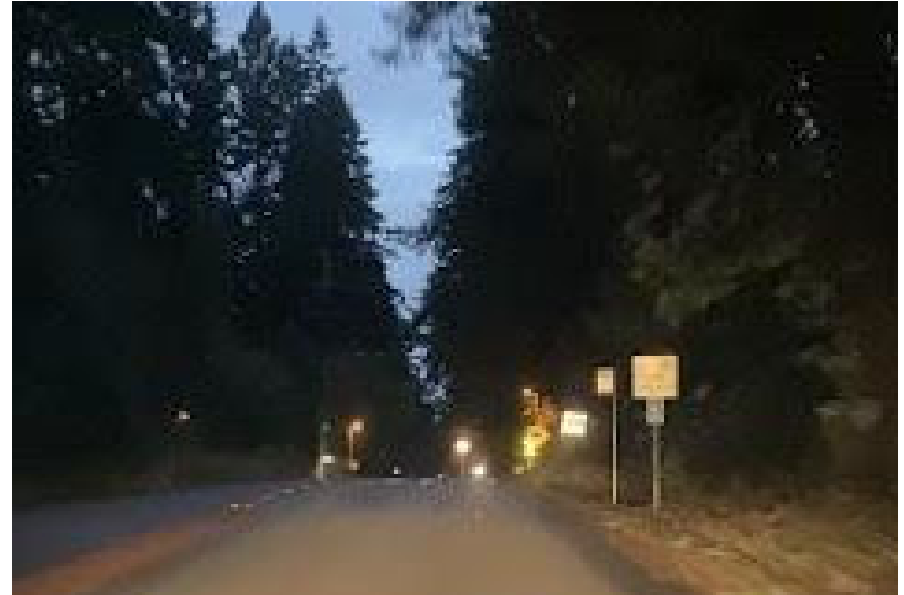
**FIGURE 15: SIGNAGE ON WEST SIDE, APPROACHING SOUTHBOUND OF SE 68TH ST INTERSECTION.**

The southbound approach has a vertical grade approaching the intersection, making it difficult for drivers to know there is an intersection approaching. As shown in Figure 15, leading up to the intersection, there are multiple signs on the west side of the road, which are difficult to read as they are installed in close proximity to one another. Due to approach grade, faded edgeline pavement markings, and absence of curbs, drivers may have limited visibility approaching roadside objects.
