Mosaics at the Luther Burbank Playground  
Maintenance and Repair Proposal – March 4, 2024 (With updates)  
*Prepared by Sandy Glass*

This proposal is a current assessment of necessary maintenance and repairs that need to be completed at this time. There is damage, both caused by natural elements, and vandalism. I've included a detailed explanation of the processes and costs to repair the damage and maintain the mosaics to increase the longevity of the mosaic installations within the playground and above the tennis courts.

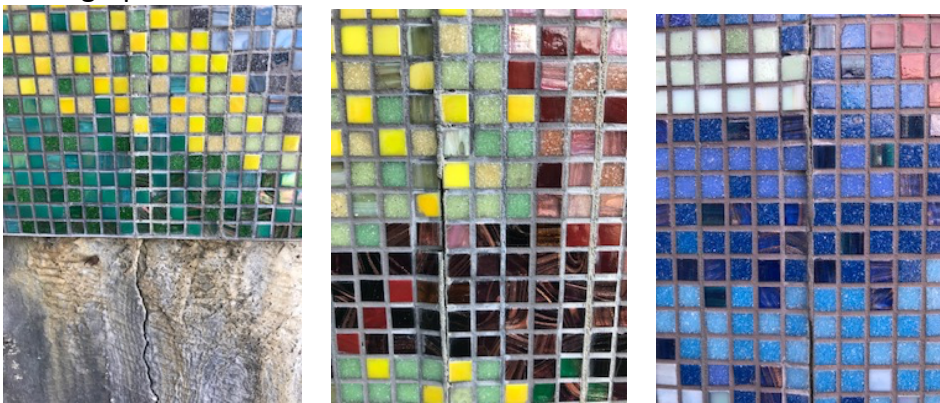
The crack is located about 29.5” from the left side of the mural. There are several caulked expansion joints in a 6” area affected by the existing crack in the concrete. These have been successful in minimizing the affected tiles. The crack is now more pronounced due to shifting and tiles have fallen.

2019 – 2022: Notice how expansion joint shifts along the crack in the wall.

New technology and materials for preparing the cement wall along the existing crack have been made available in the past few years that will increase the mural’s longevity and reduce the impact of the existing crack in the wall. Installing a waterproof membrane in the volatile section is most likely to prevent future damage to the mosaic mural. We’ll remove the tile along the fault line, repair the crack, then reinstall new tile on the membrane and re-caulk the expansion joints. We’ll also need to re-caulk expansion joints in the other parts of the mural. These have been effective.

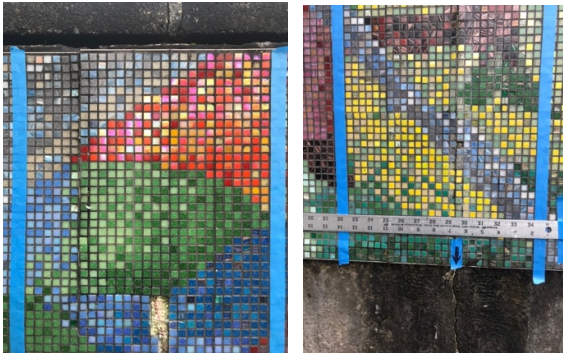
Currently, the tile along the existing crack on the 38’ mosaic mural needs urgent care! Some of the tiles along the crack in the cement wall have been lost and the crack is now visible vertically starting at the bottom. The mural now requires a more extensive and comprehensive fix that includes removing and replacing a vertical strip of tile and using a waterproof membrane to address the crack. I will describe the recommended process to assure the mural’s longevity below.

January 2024: The crack along the existing “fault line” has continued to expand causing more damage to the tilework.

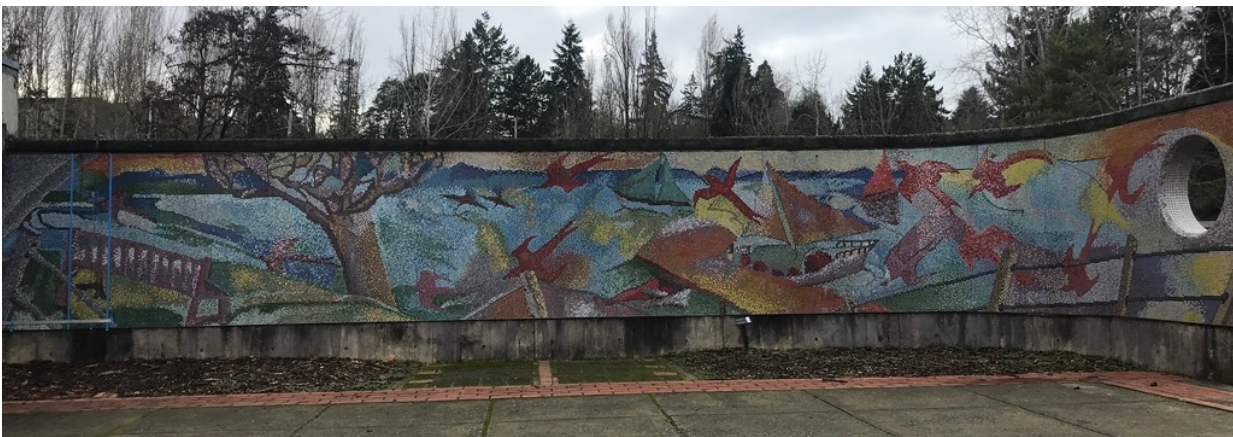
Most of the mural is holding up well because of the expansion joints installed throughout, the use of RedGuard and the integrity of the medium and installation. I’ve taped the area directly affected by the crack in the cement wall for the photograph below. We can best address this “fault line” by removing a 9” to 12” vertical strip and repairing the wall with a waterproof membrane designed for this issue. We’d then, replace the tile over the new substrate. Note: The new tile and new grout in this area may be subtly noticeable but should blend in over time.

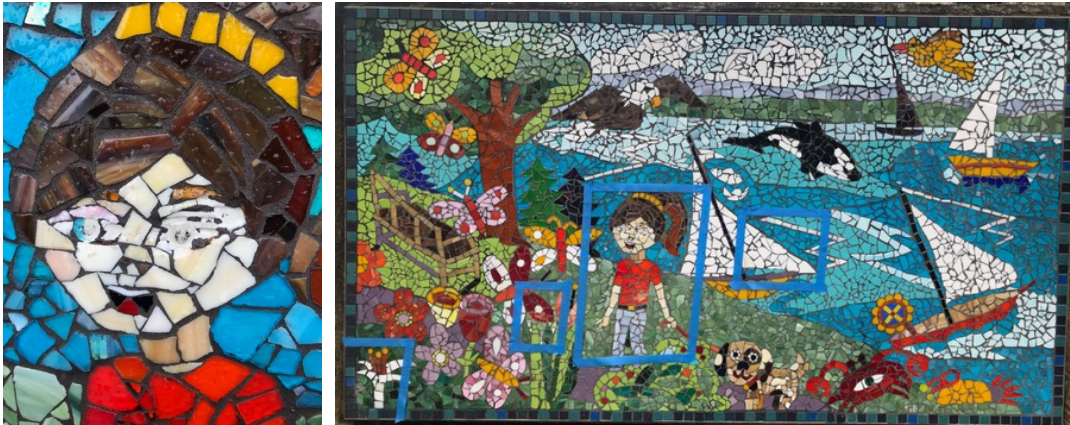
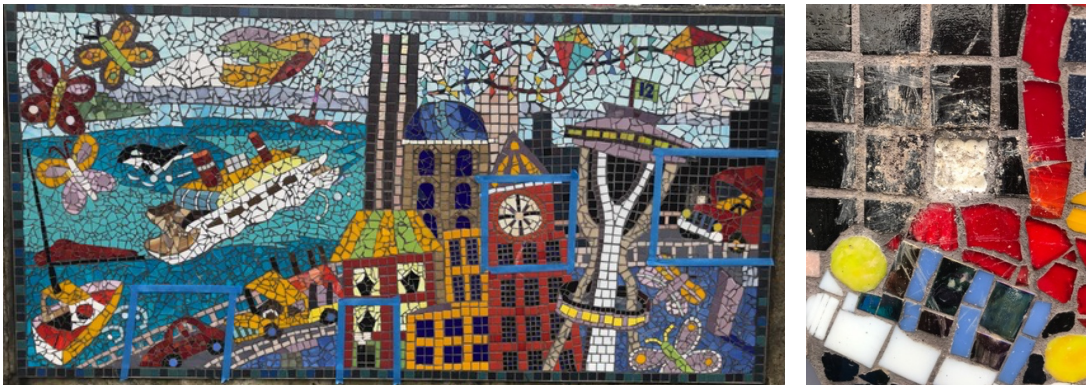
There are three mosaic installations within the playground. On December 2, 2023, I noticed some intentional damage to one of the approximately 6' x 3' mosaics in the playground. It appeared that a rock had been used to smash the face of the girl walking her dog on the mosaic. On my next visit on January 5, 2024, more intentional damage was done to all the mosaics in the playground using a rock or other hammer-like instrument. I filed a police report with Corporal Jira of the Mercer Island Police Department. I am heartbroken. It is important to fix the mosaics to their original condition.

*Dec/2023 and Jan/2024: Intentional damage to the mosaics within the playground.*

The more complicated piece to repair is the girl's face which I will recreate in my home studio and tape so I can reinstall a new face and torso after I chisel away the broken portion and the underlying thin-set and replace the new part. It will then need to dry (without being disturbed) and grouted the next day. Once the grout is set and dry, it will be strong again. Although nothing is impervious to intentional damage.

I believe I can repair the other chips and broken elements on-site, chiseling away the damaged areas, then cutting new recycled glass and/or tiles to fit. These areas will also need to be grouted the following day after the thinset adhesive has set. It will be a painstaking process.
