Next Steps for City Facilities

City Council Study Session
January 16, 2026

AB 6840

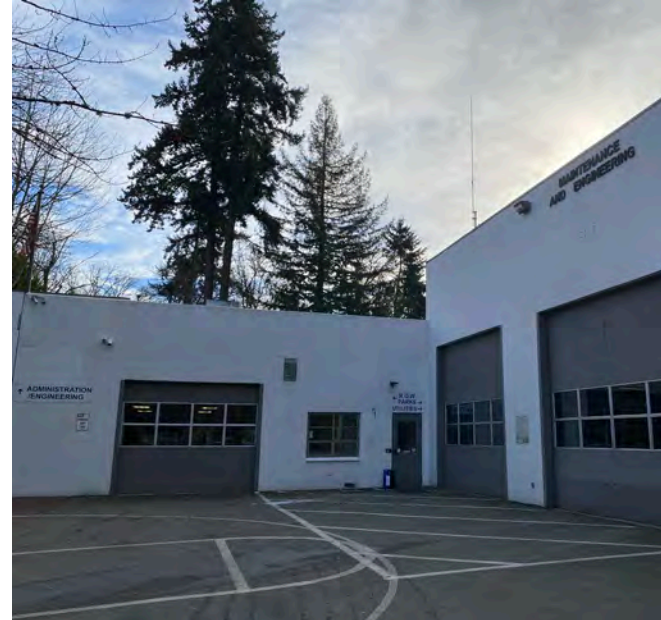
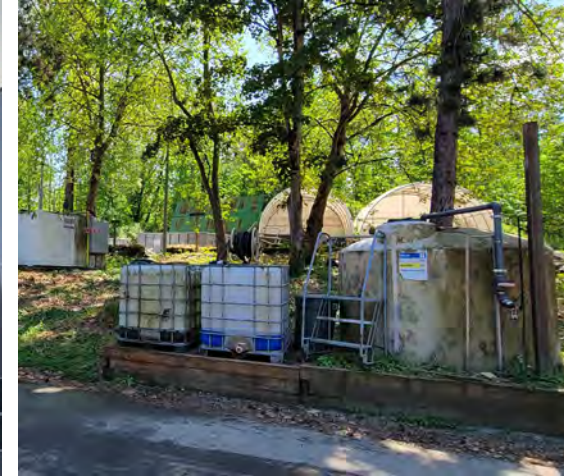
- Constructed in 1980.
- 64 year-round and 15 to 20 seasonal employees.
- Multiple systems are failing or in need of significant repair or investment (i.e. electrical).
- Does not meet certain codes or industry standards.
- Inadequate work areas and support facilities.
- Facility is undersized and poorly laid out.
- City Manager recommended the City Council prioritize the Public Works Building for replacement.

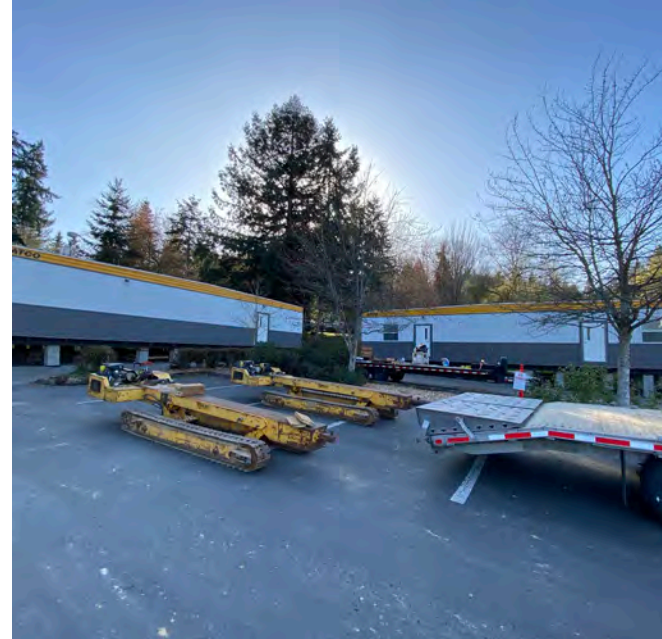
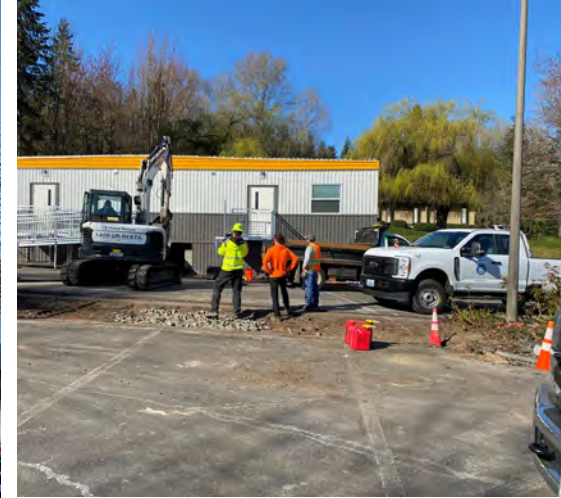
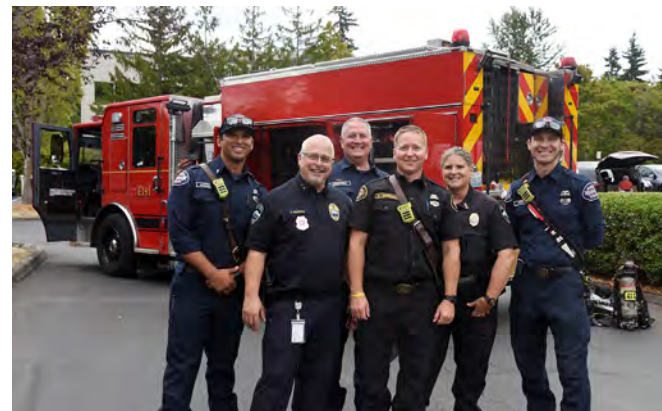
Police Modular Buildings

- Four leased, temporary modular buildings installed in 2024, housing police and emergency management staff.
- Not intended for long-term or permanent use. Does not provide sufficient facilities and capabilities needed for MIPD operations.
- Significant ongoing lease cost to the City.
- Interim solution pending development of a permanent facility.

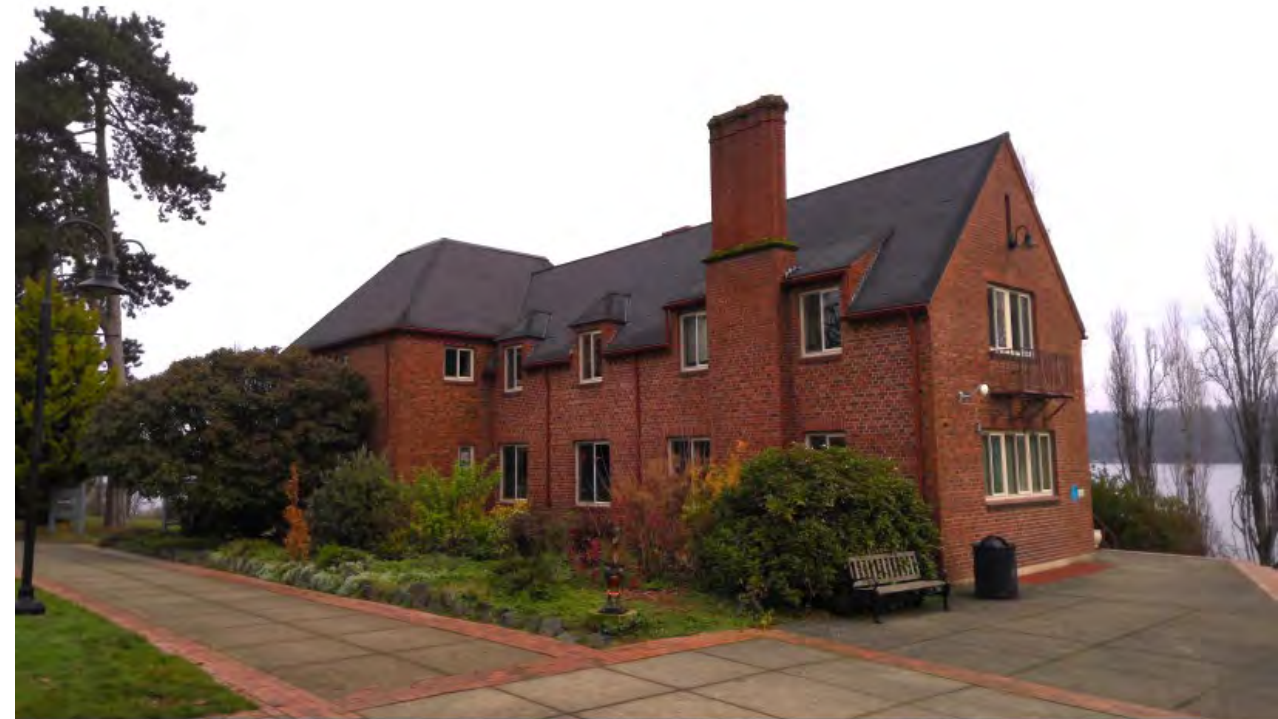
Luther Burbank Administration Building

- Built in 1928.
- Houses and supports Youth and Family Services, providing counseling, family services, and specialized community outreach.
- Has served as temporary workspaces for various city departments, including parks, open-space/natural resources, land-use and permitting, and police functions.
- Aging facility faces issues meeting current accessibility standards and building codes.
- Facility parking is shared with highly active park.

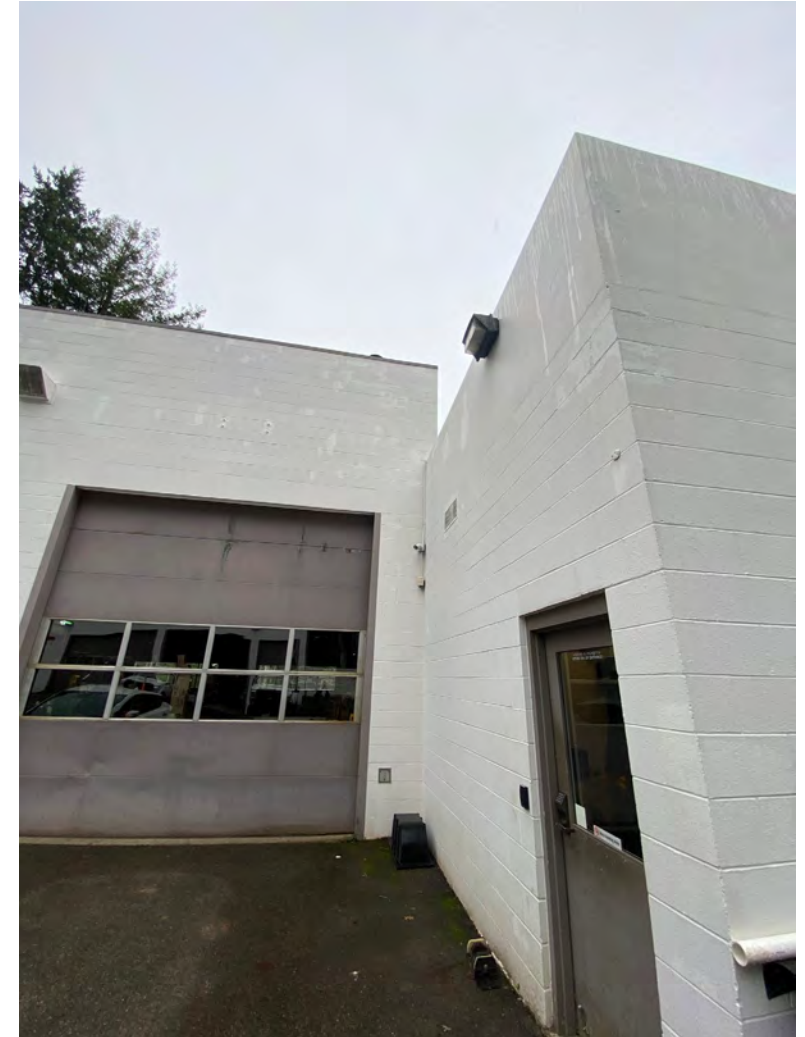
Structural Deficiency Repairs

- The Public Works Building was not designed to meet the seismic demands of the current code or provide seismic resiliency to operate as an essential facility following an earthquake.
- ASCE 41-17 seismic evaluation found that the existing building structure is inadequate to remain operational as a Seismic Risk Category II building.
- A standalone Public Works' operations facility would ideally meet Seismic Risk Category III or preferably Category IV to ensure that it can perform essential functions following a seismic event.

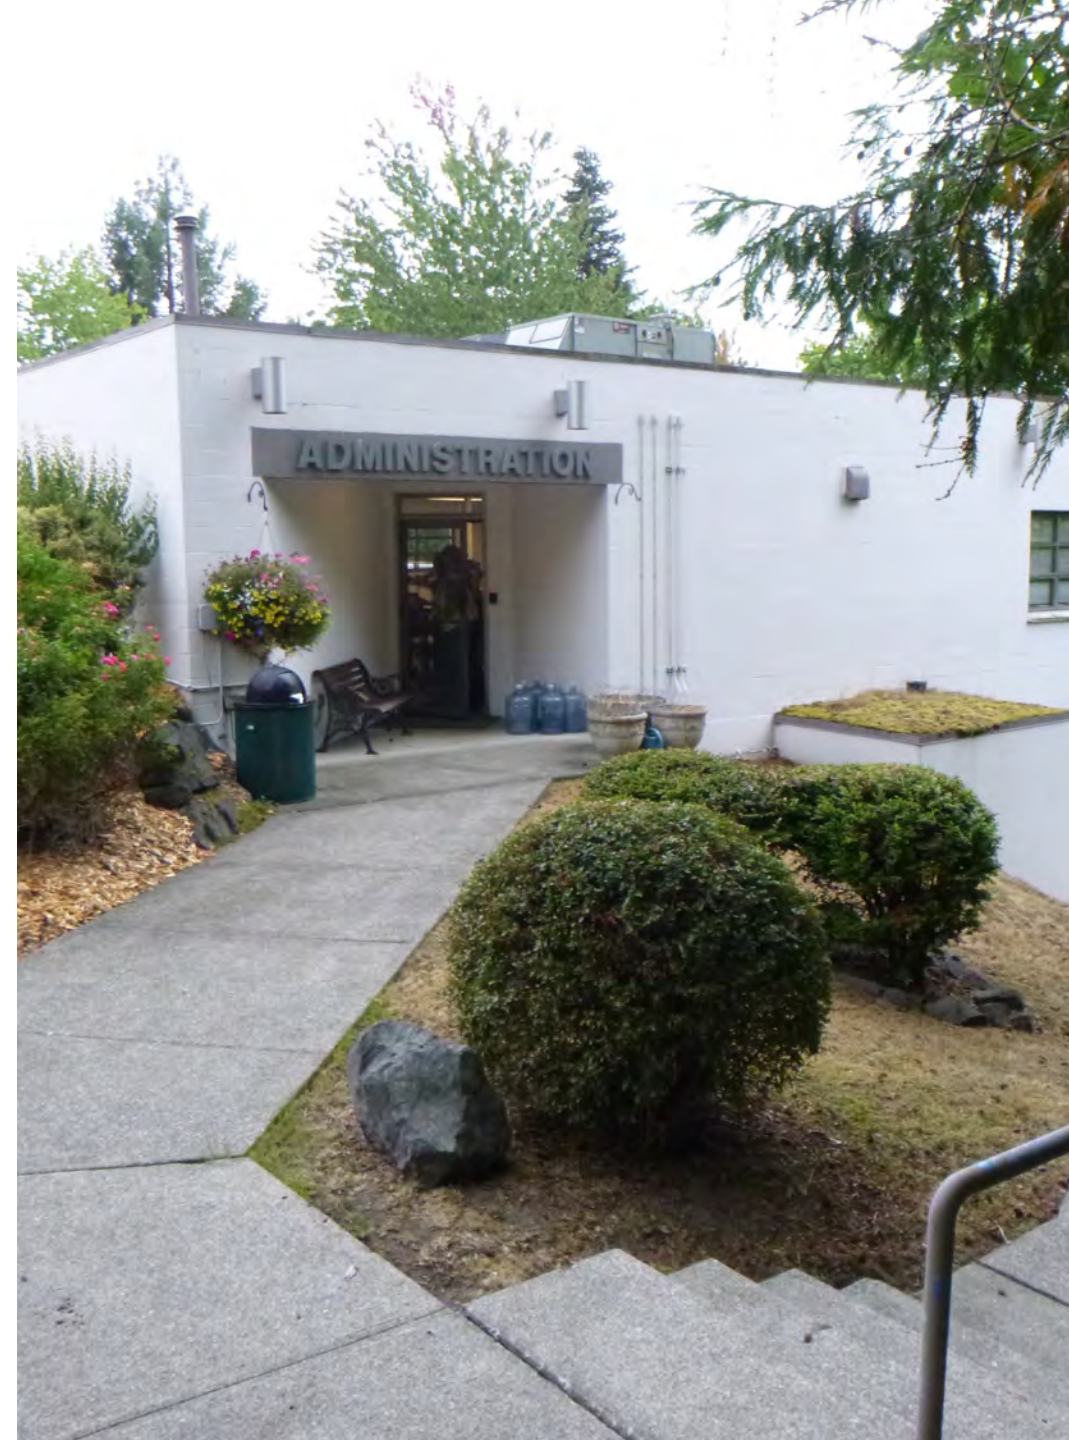
Structural Deficiency Repairs

- Quantum Consulting Engineers conducted a detailed seismic analysis of specific issues identified as priorities from prior structural reports and the building's FCA.
- The evaluation outlined structural system, capacity, and identified the deficiencies relative to current safety standards and code requirements.
- The report included options to retrofit the existing structural system required for the building to meet the minimum seismic performance and allow continued occupancy.

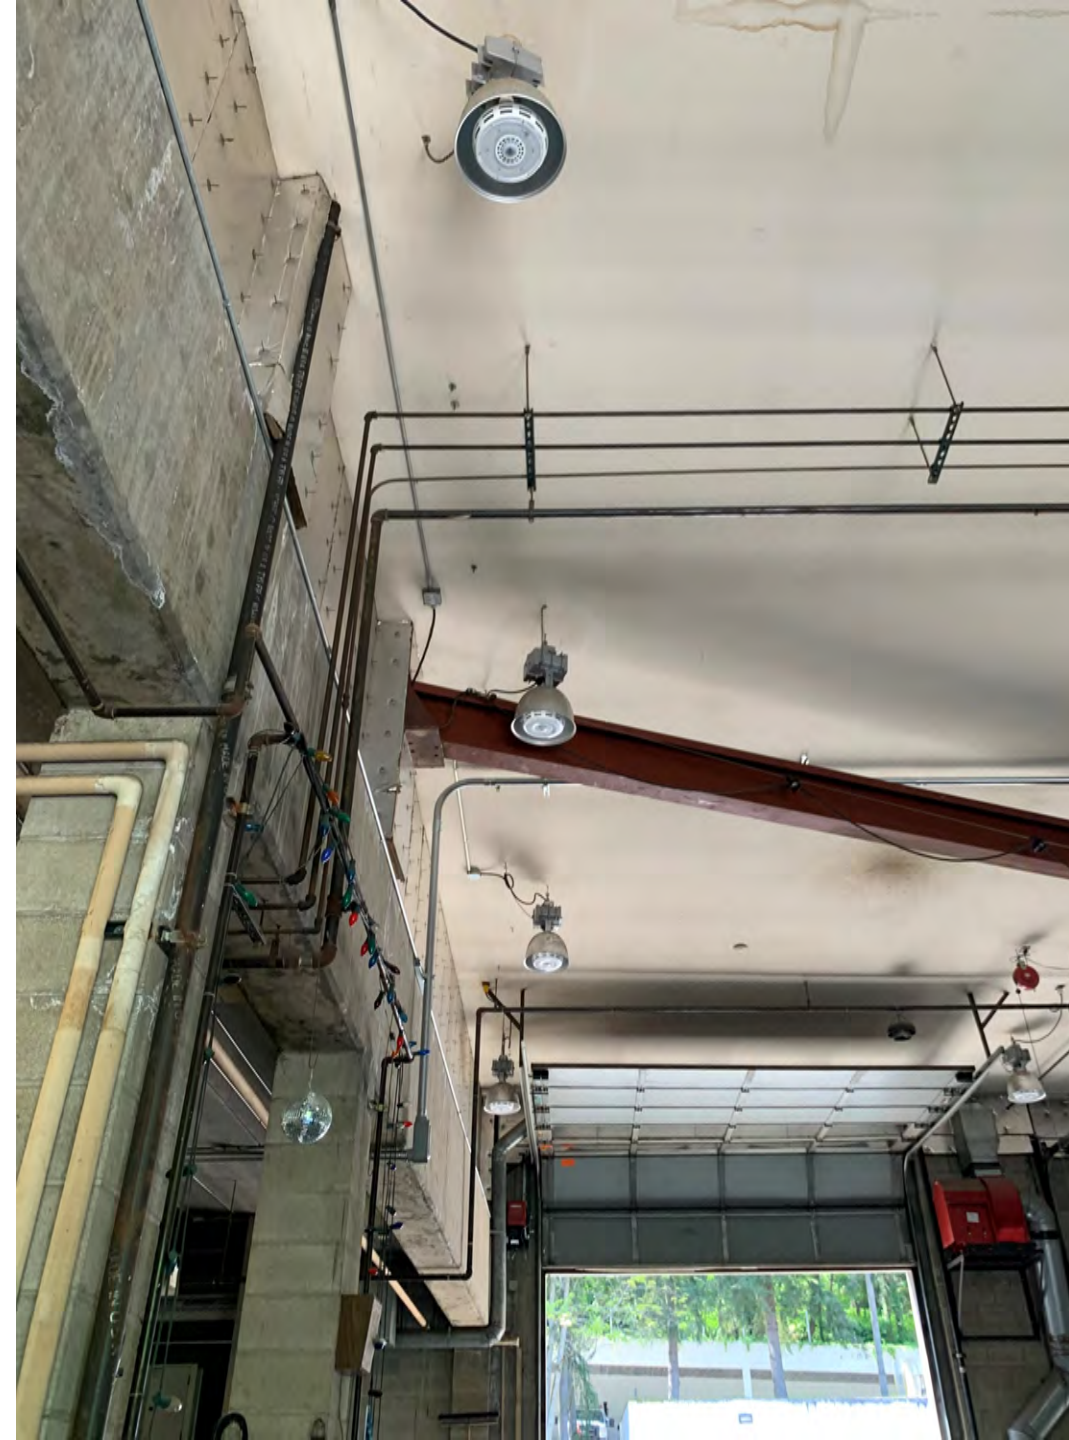
Structural Deficiency Repairs

- **Green roof:** Weight of the green roof's accumulated soil and vegetation is more than existing shear walls were designed to support.
- **Roof-wall connections:** Connections between the wood-framed roofs and the exterior walls inadequate or absent.
- **High-bay garage structure:** Inadequate foundation to support high-bay structure (mechanic's shop).
- **Unbraced interior walls:** Numerous unbraced interior Concrete Masonry Unit (CMU) walls.

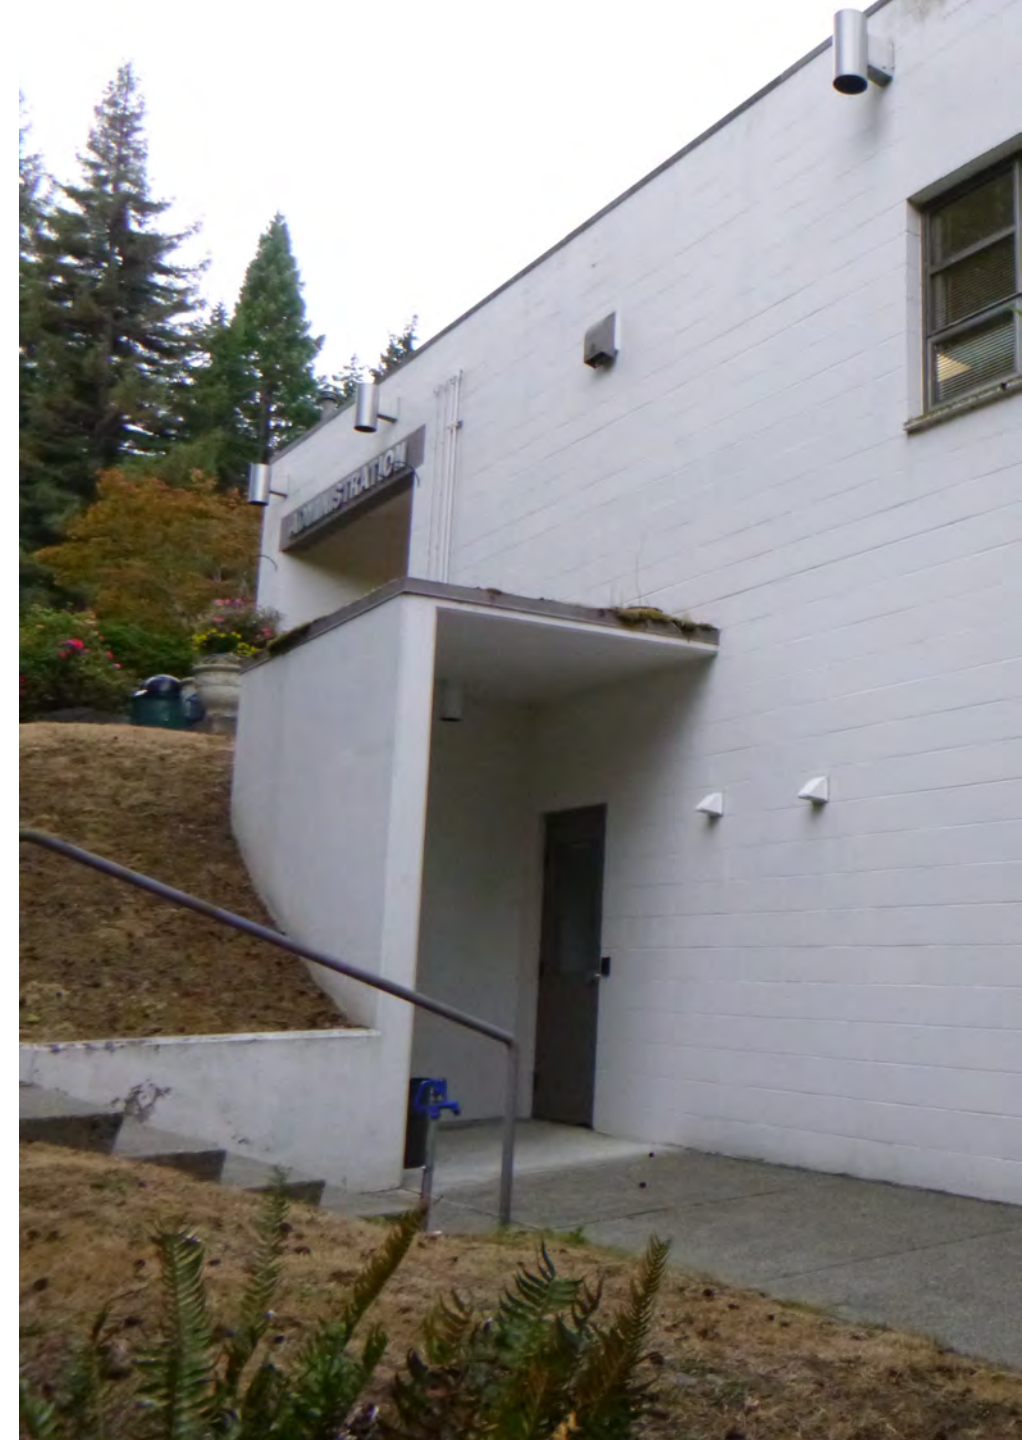
Structural Deficiency Repairs

- City Council directed staff to proceed with seismic repairs in July 2024 (AB 6517).
- In February 2025, \$1.14M was appropriated for the project's construction (AB 6619).
- Construction was completed in summer 2025.
- Seismic retrofit work included:
 - removal of the green roof overburden
 - installation of grade beams on both sides of mechanic's shop
 - construction of numerous wall-roof connections
- Contractor scope also addressed several of the identified non-structural deficiencies.

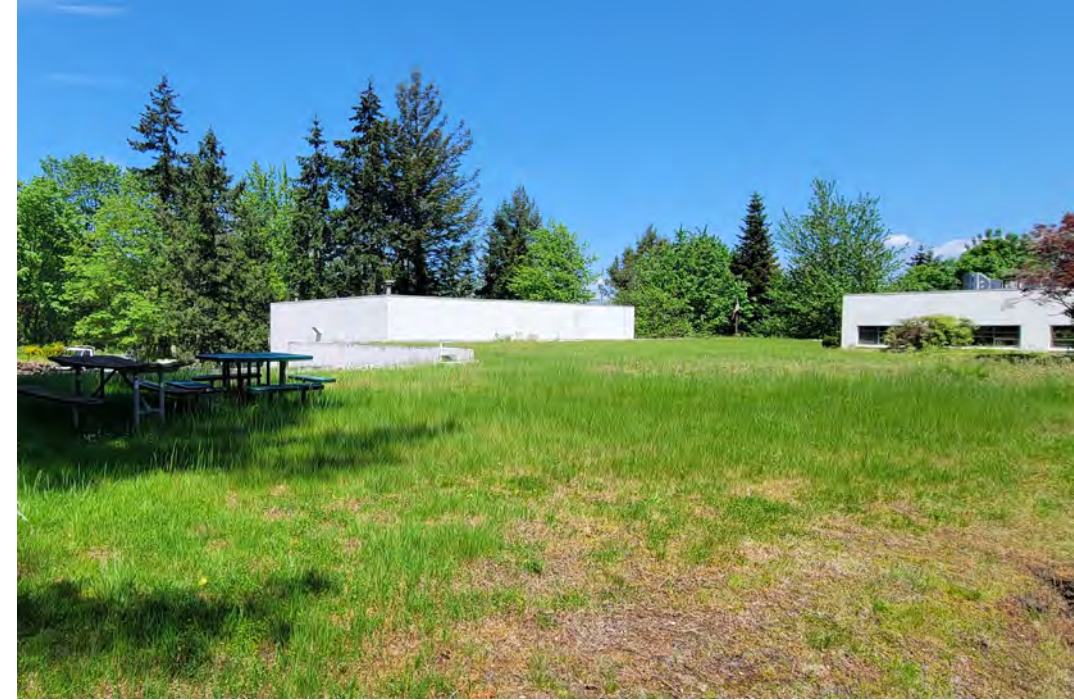
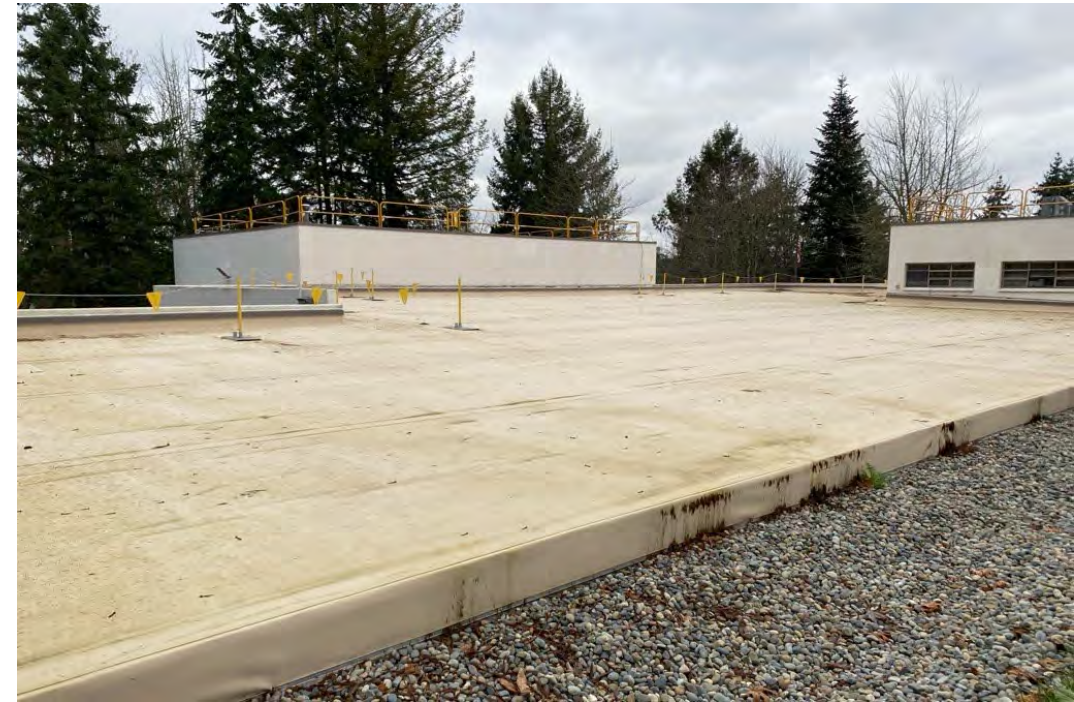
- The roofing membrane over the warehouse and operations spaces was more than 10 years beyond end-of-life and beginning to fail, causing extensive leaking.
- The flat roofs over the administrative offices and the mechanic's shop were not properly sloped, resulting in standing water.
- The existing green roof soil was removed in order to address the roof leaks and structural concerns.
- The membrane beneath the green roof was replaced, and the roofs above the office and mechanic's shop underwent significant repairs.
- New storm drainage was installed to properly direct run-off away from building foundations.

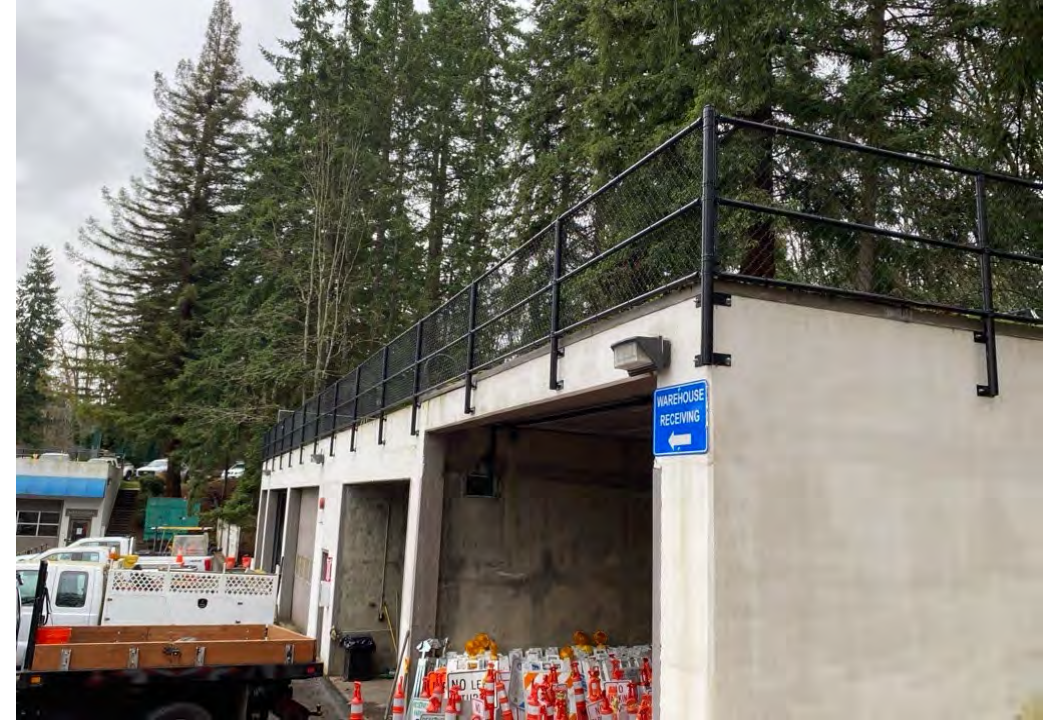
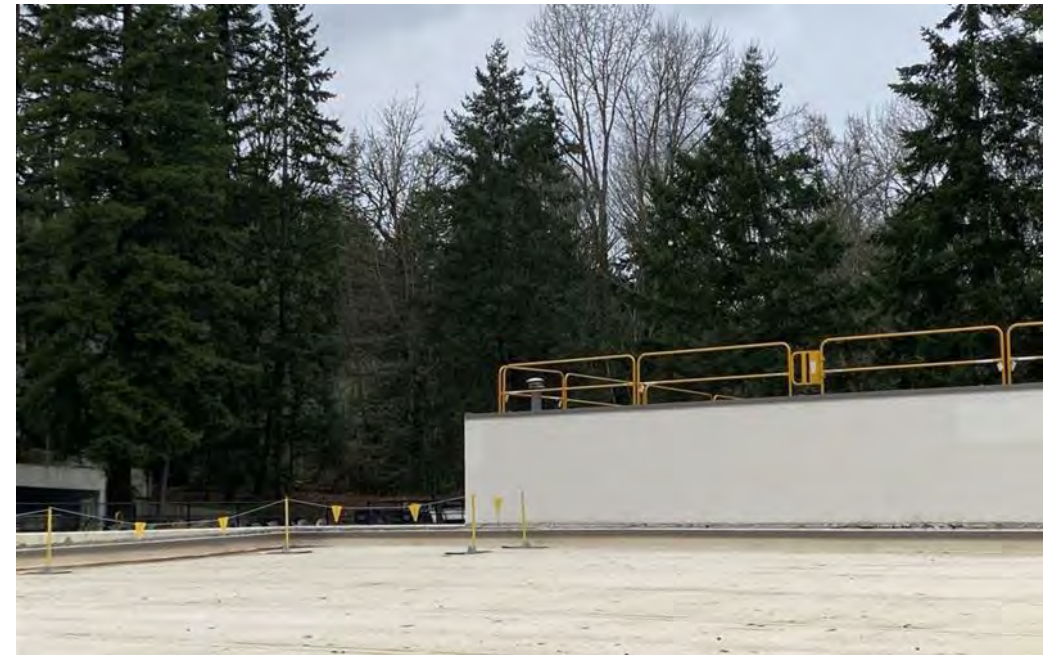
Fall Protection Railings

- Accessible roofs on top of the Public Works Building and outbuildings had no railing system to protect against falls.
- Several of these areas are used for material storage (benches, holiday displays, plants, etc.)
- To meet code requirement, a railing system or other fall prevention system had to be installed on all edges.
- Railings and/or fall protection elements were installed on all accessible roof structures in 2024 and 2025.

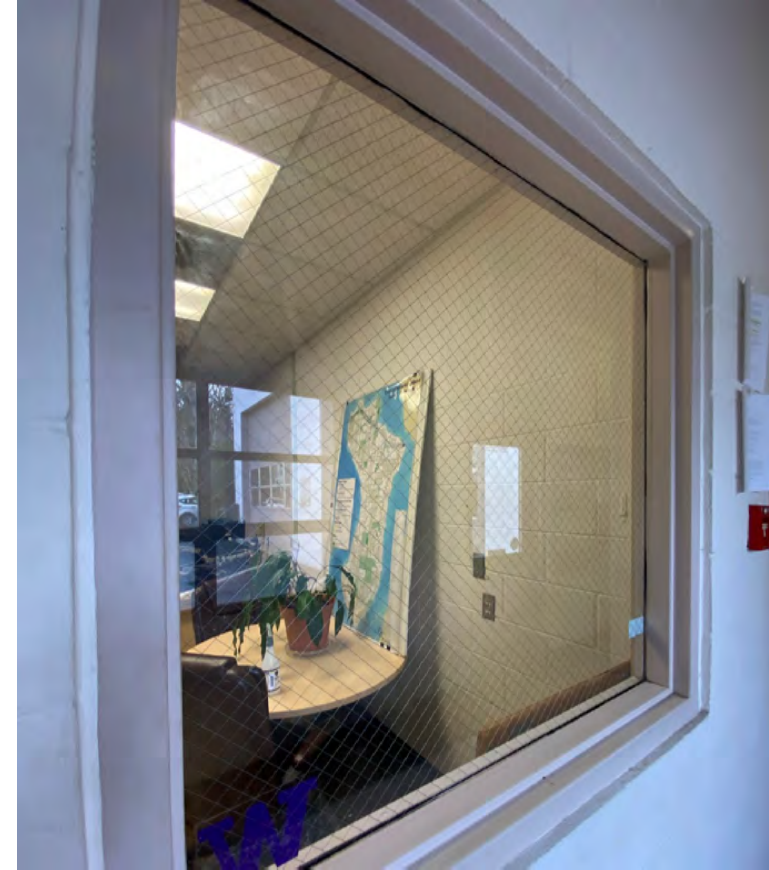
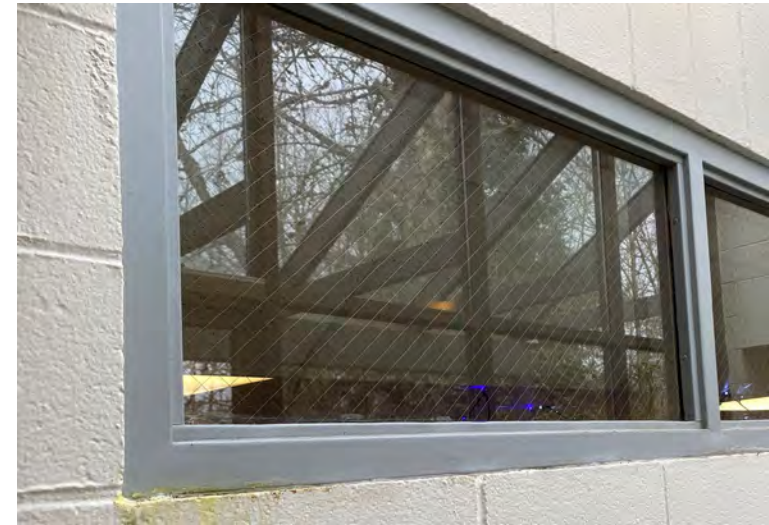
Wired Glass

- The glass originally installed on the interior windows and doors included wired glass, which is now considered a potential safety hazard.
- Wire mesh weakens the glass and creates jagged glass shards when broken.
- In 2024, all wired glass windows were covered with a protective film to contain glass if broken, a cost-effective alternative to full replacement.

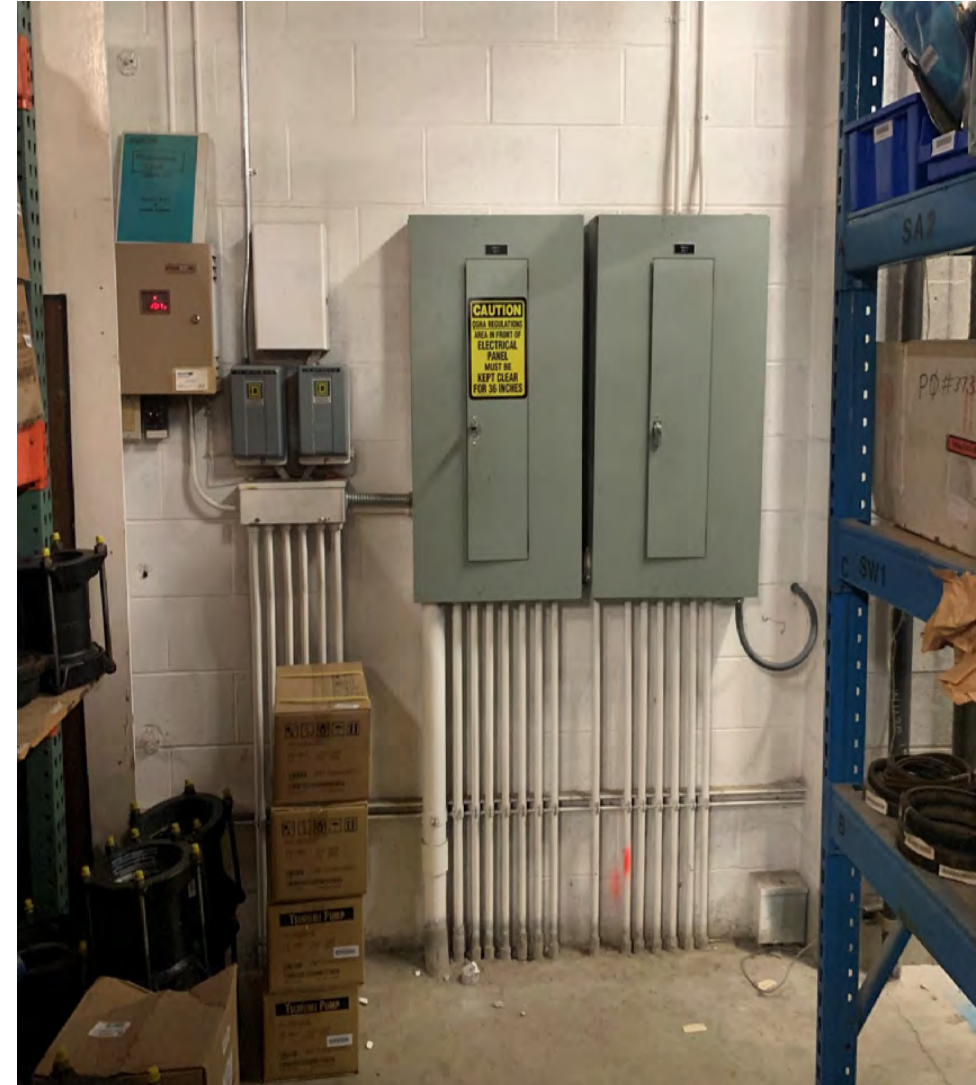
Unresolved Deficiency: Electrical Service & Distribution

- Inadequate electrical capacity, unable to support normal operations with overloading circuits, results in tripping breakers and frequent interruptions.
- The electrical system must be assessed and updated before any modifications can be made to the HVAC or lighting systems.
- The findings of the FCA included a recommendation to engage an electrical contractor to fully review the existing system and develop a work package to address observed deficiencies and code-based upgrades, including replacing electrical panels and distribution system.
- Due to the expected short-term occupancy, the City has not moved forward with this recommendation.

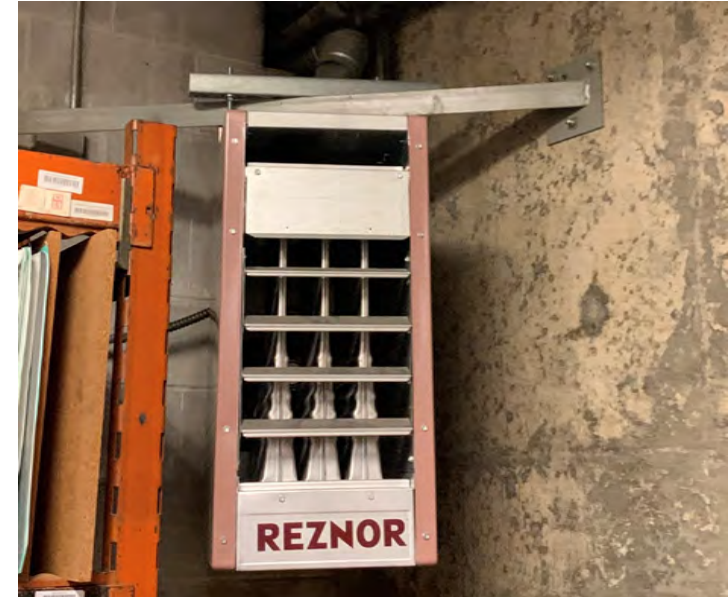
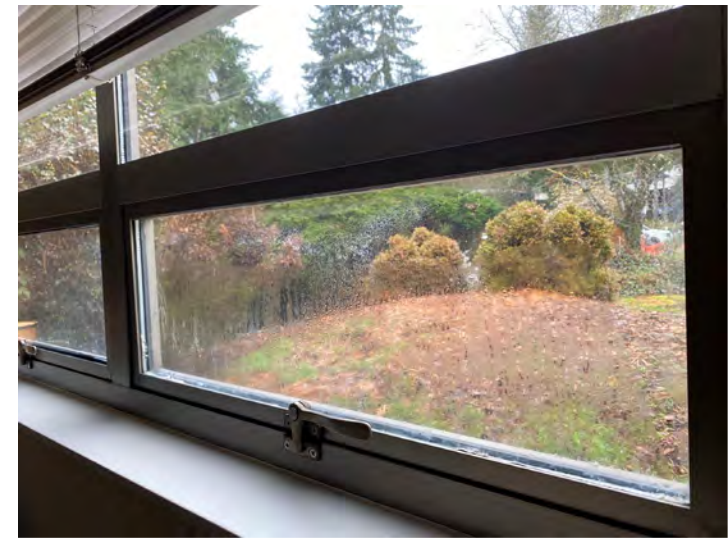
Unresolved Deficiency: Heating, Cooling & Ventilation

- Industrial heating and venting are insufficient for updated use and occupancy. There is no cooling and inadequate venting for staff and operations team in the lower level of the building .
- The HVAC controls system on the upper level is at the end of its useful life, rendering poor performance and high energy use.
- There is a lack of adequate ventilation to address vehicle exhaust, the welding hood, and the fluid storage room.
- The exterior walls are concrete block with minimal insulation value.
- The aluminum-framed windows are not insulated and the double panes are unsealing.
- Extensive updates and modifications required to install a new HVAC system is cost prohibitive given the building's value and expected short-term occupancy.
- The existing HVAC systems will be run to failure and components replaced or repaired if necessary.

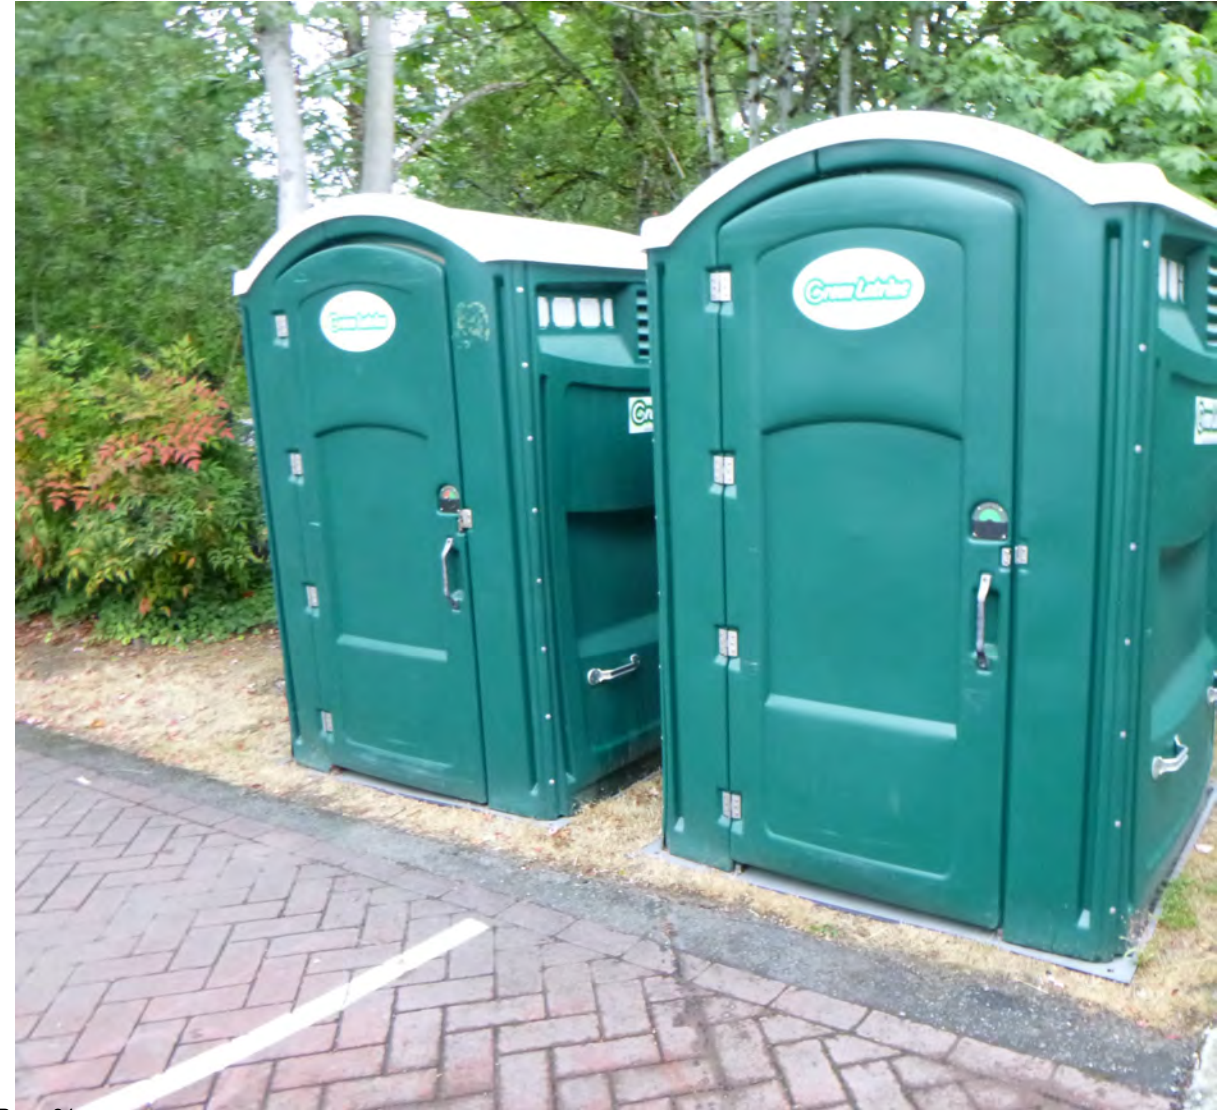
Unresolved Deficiency: Insufficient Restroom Capacity

- The Public Works Building only has 5 restroom stalls, which is insufficient for current staffing needs as determined per WAC 296-800-23020.
- Two portable toilets are currently on-site to satisfy minimum requirements.
- There are no restrooms on the second floor of the building.
- Staff will continue to provide on-site portable restrooms to address the capacity needs for the current workforce.

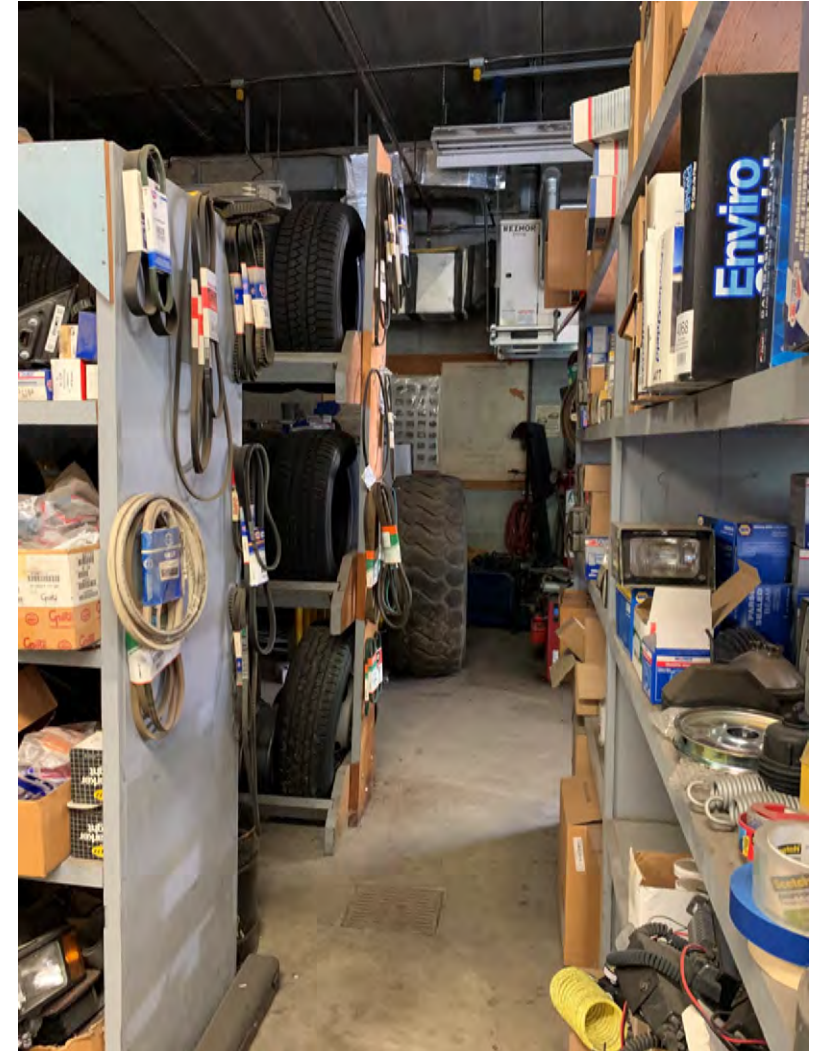
Unresolved Deficiency: Fire Suppression System

- The building does not have a fire suppression system installed and is comprised of fire/heat detection only.
- This is of particular concern in the Mechanic's Shop and Warehouse where flammable materials and liquids are stored.
- The existing fire suppression system meets the code requirements for this building.
- Additional fire extinguishers have been procured for the facility.
- No further work is planned to install a fire suppression system due to the significant cost of this scope of work.

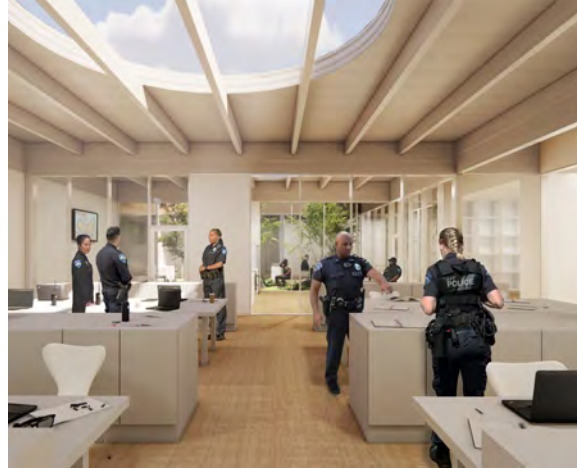
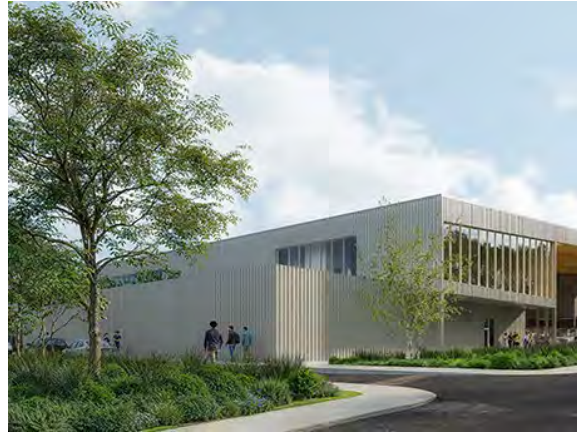
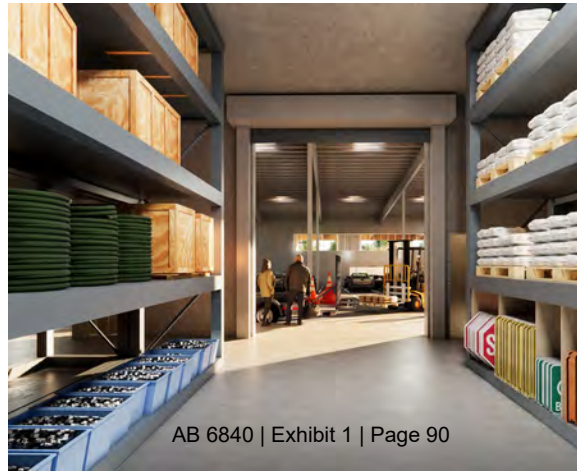
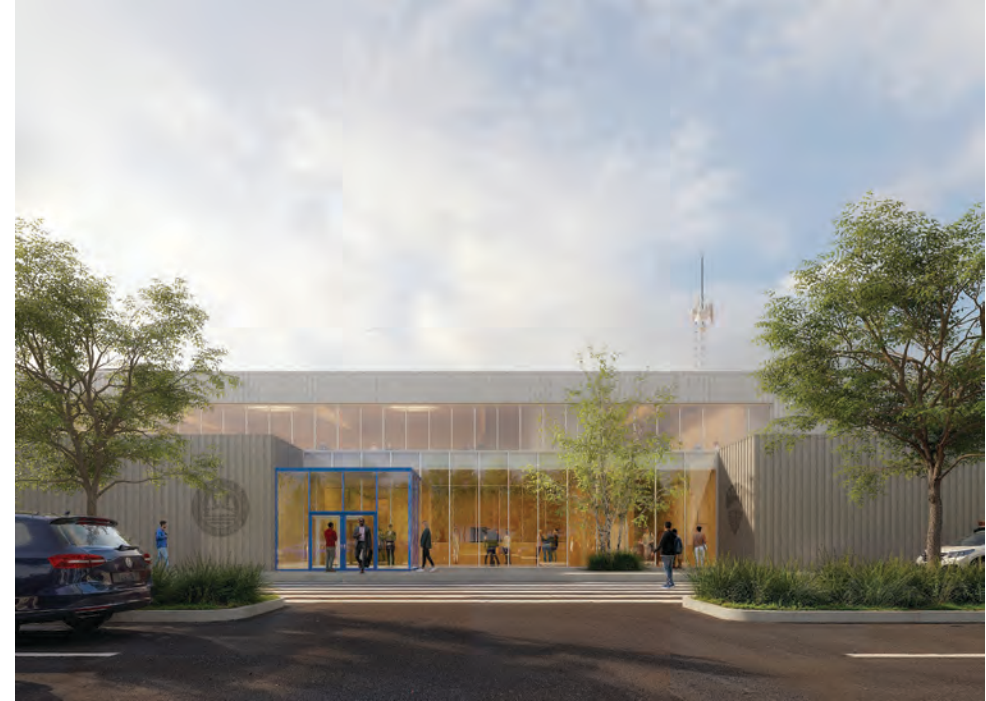
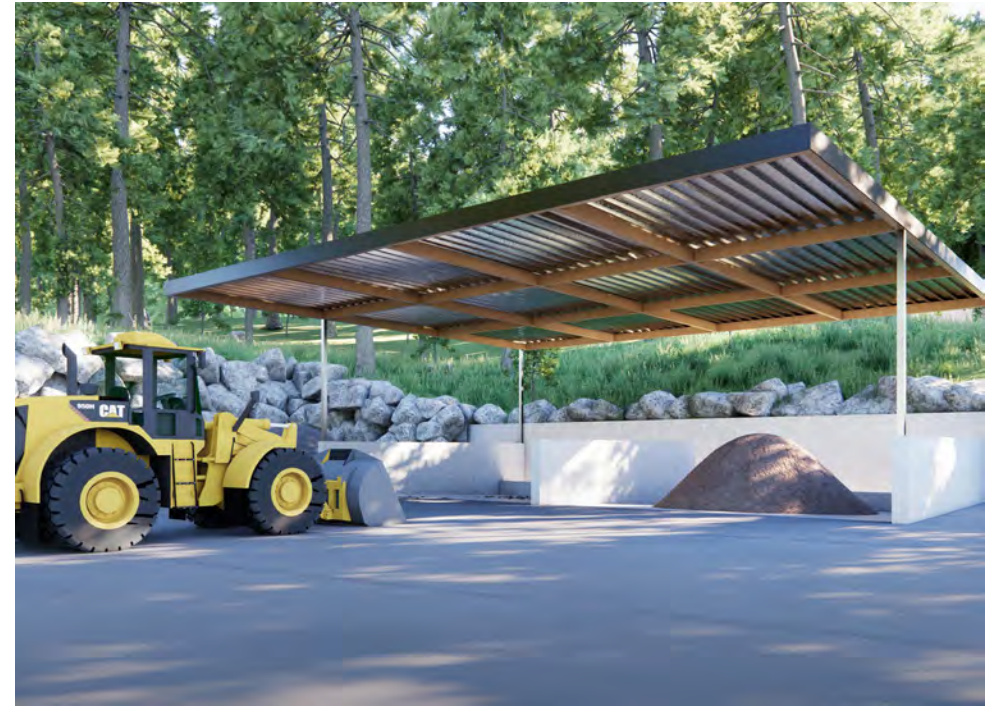
Schematic Design PSM Facility

Facility tours, programming meetings, and design strategies informed the proposed schematic design of the PSM facility, which was subsequently included in the November 4 ballot measure.
