City Council Study Session  
January 3, 2023  
AB 6199

# PAVEMENT CONDITION RATINGS

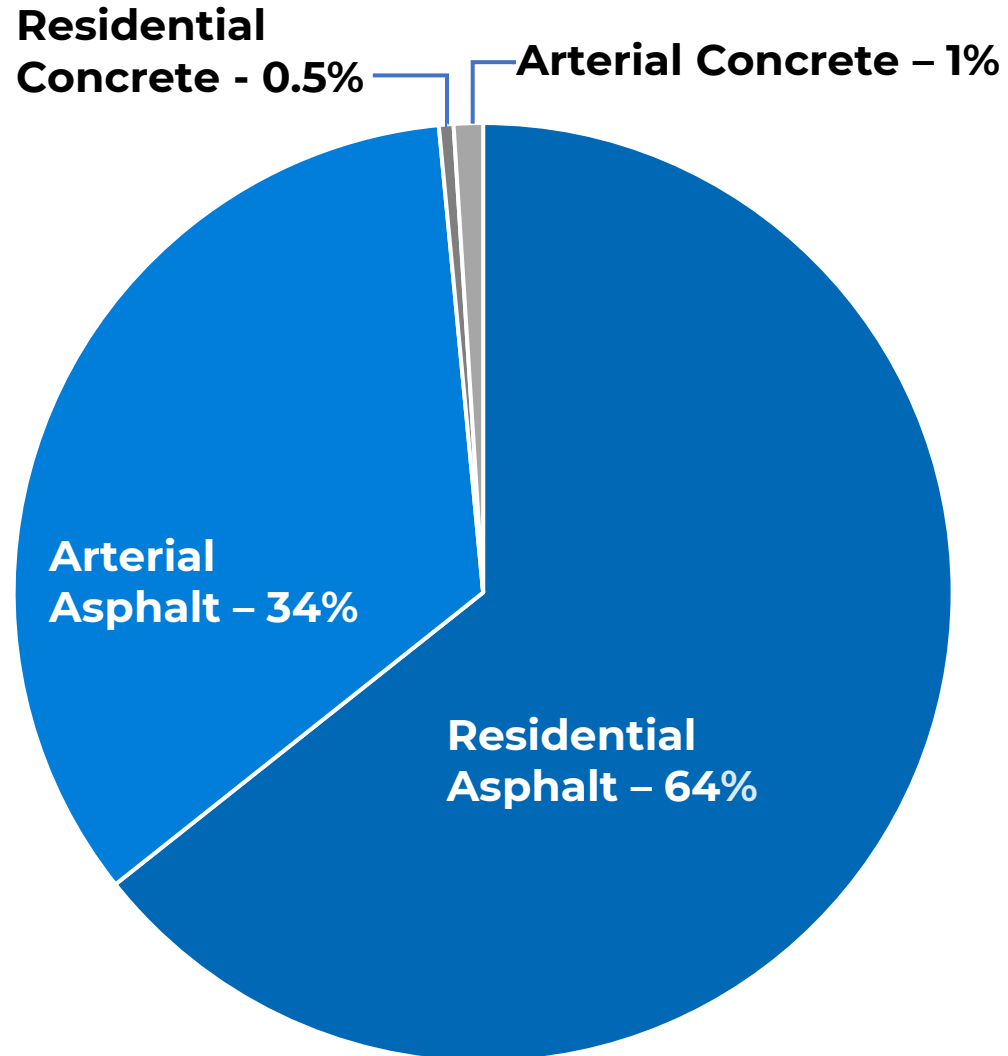
Mercer Island Pavement Type by Area

- Network Centerline Miles
  - Arterial: 25.3
  - Residential: 58.3
  - **Total: 83.6**
- Over 250 acres of pavement
- **99%** of the network is **asphalt**
- Paved at different times, so many different ages
- How do we **prioritize the repair & rehab** of network segments?

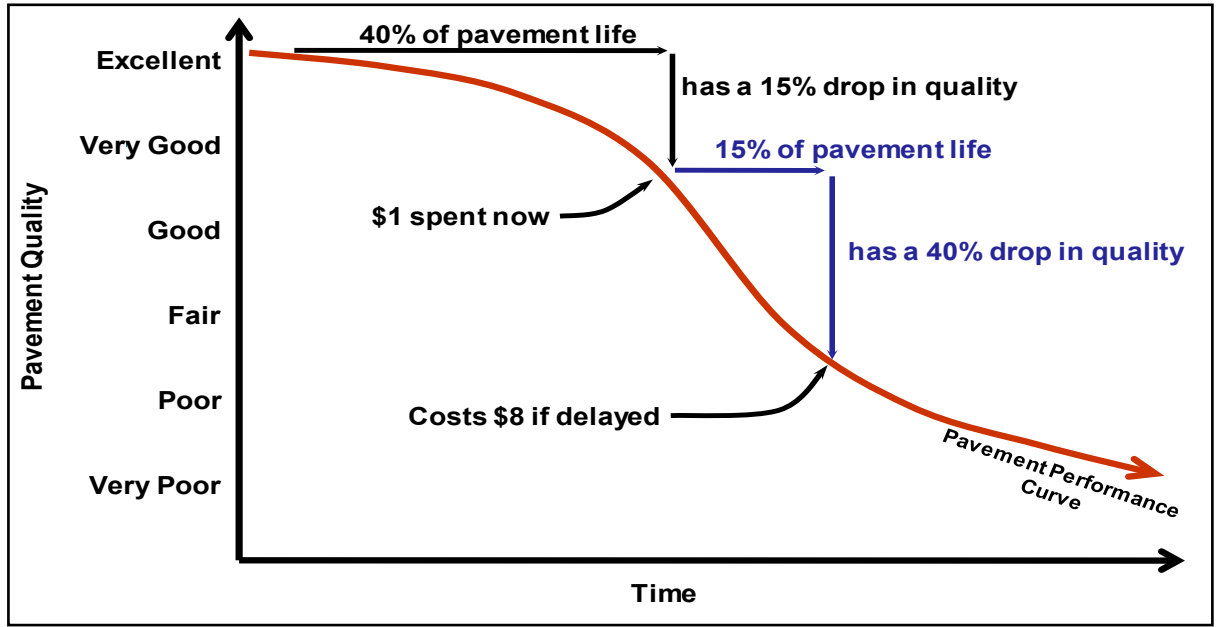
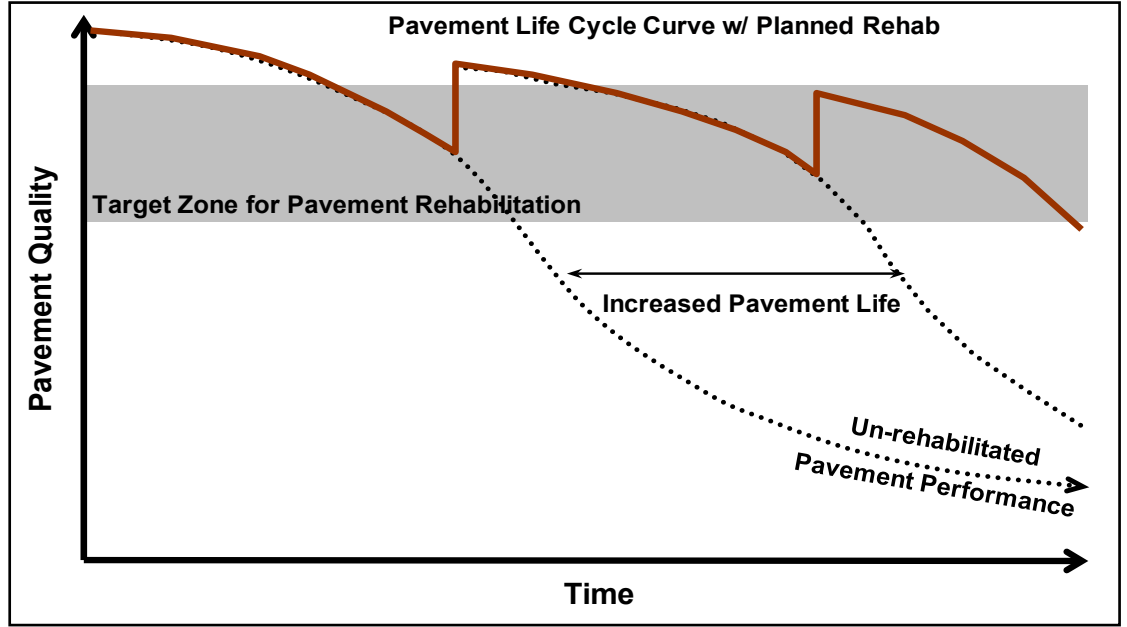
TYPICAL PAVEMENT LIFE CYCLE CURVE

Pavement conditions degrade over time.

It is **much less expensive** to keep a road in good condition than to rebuild it after its condition becomes poor.

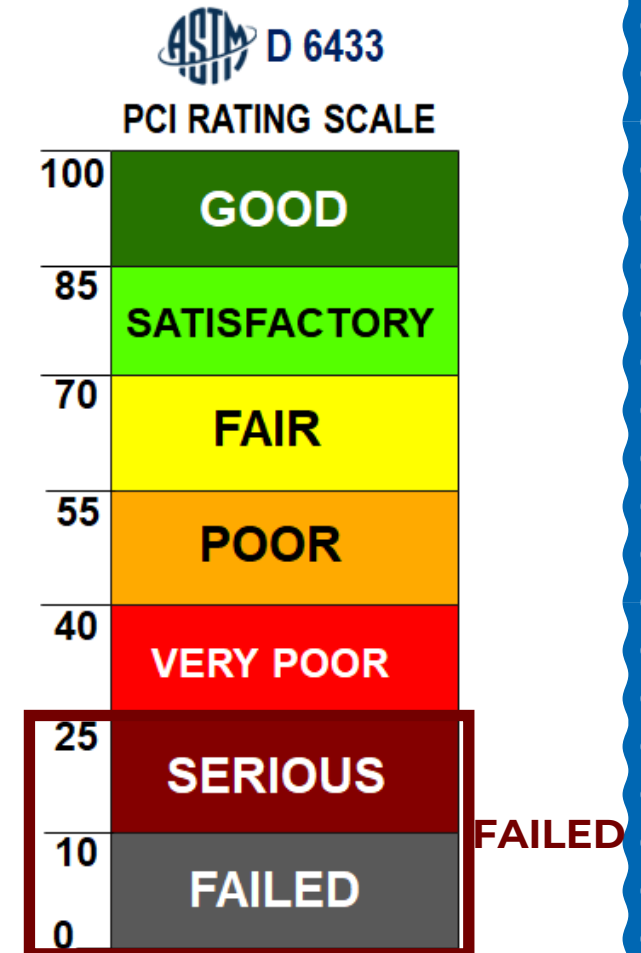
- ASTM D6433 “Standard Procedure for Roads and Parking Lots Pavement Condition Index Surveys”
- Developed by US Army Corps of Engineers
- A numerical indicator from 0-100 that rates the surface condition of the pavement
- An area-based measurement of 19 different visual distresses observed on the surface
- A rational and objective basis for determining maintenance and repair needs and priorities

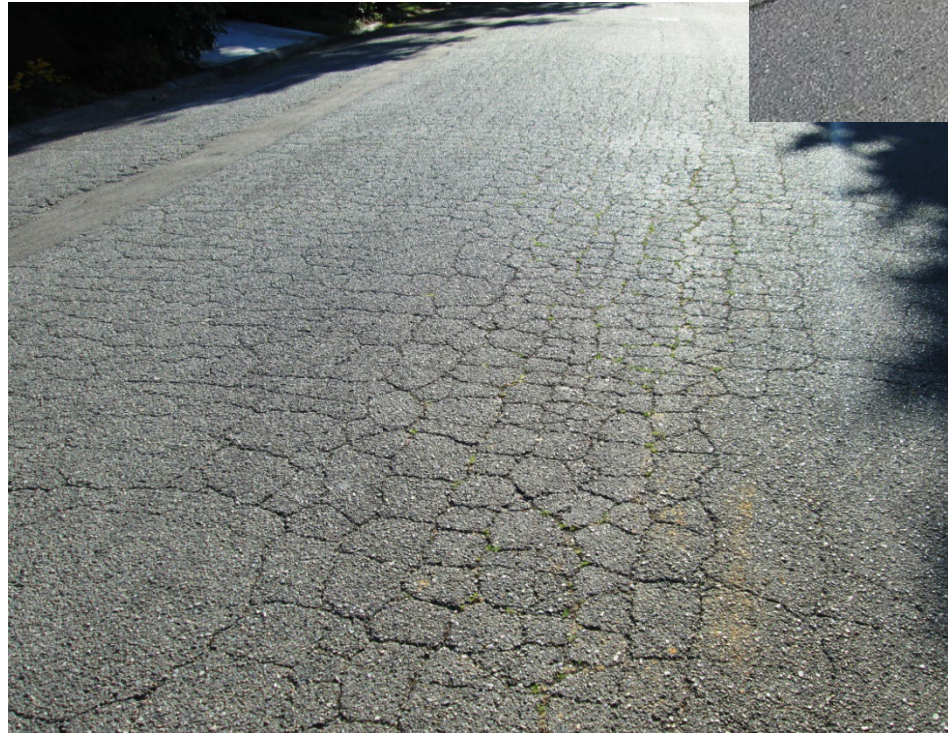
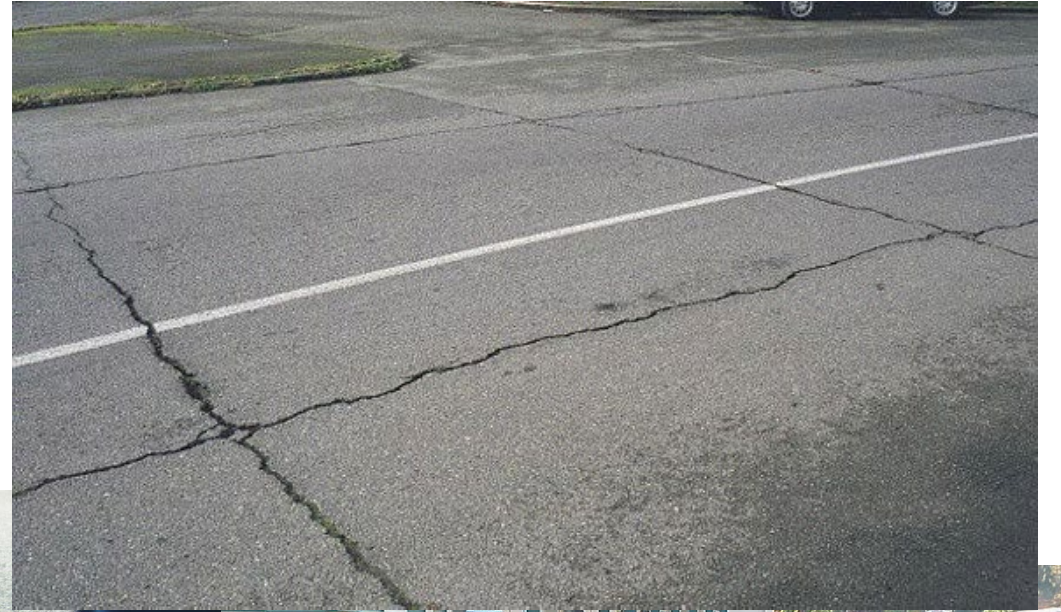
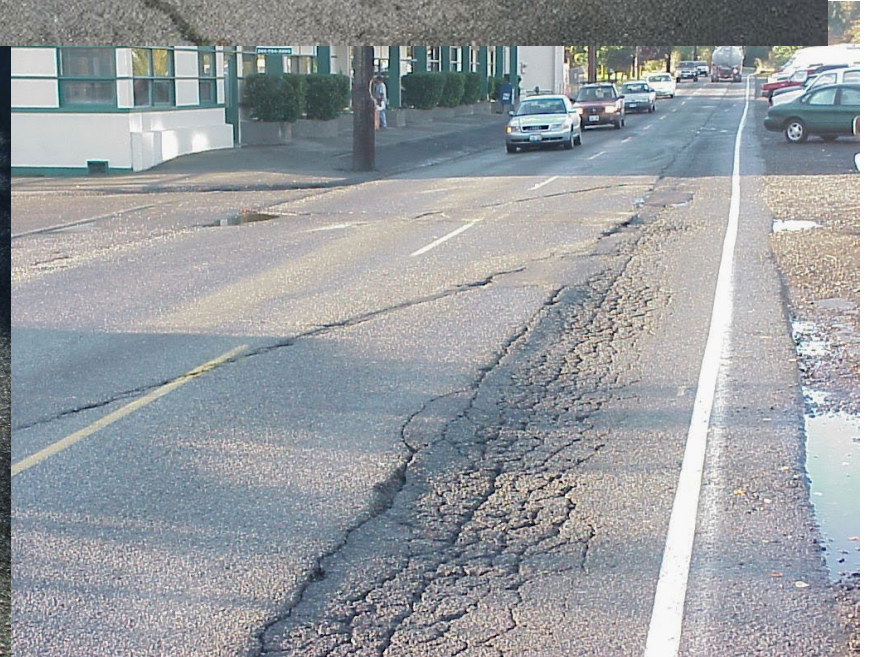
## Cracking

- Longitudinal
- Transverse
- Block
- Reflective
- Alligator

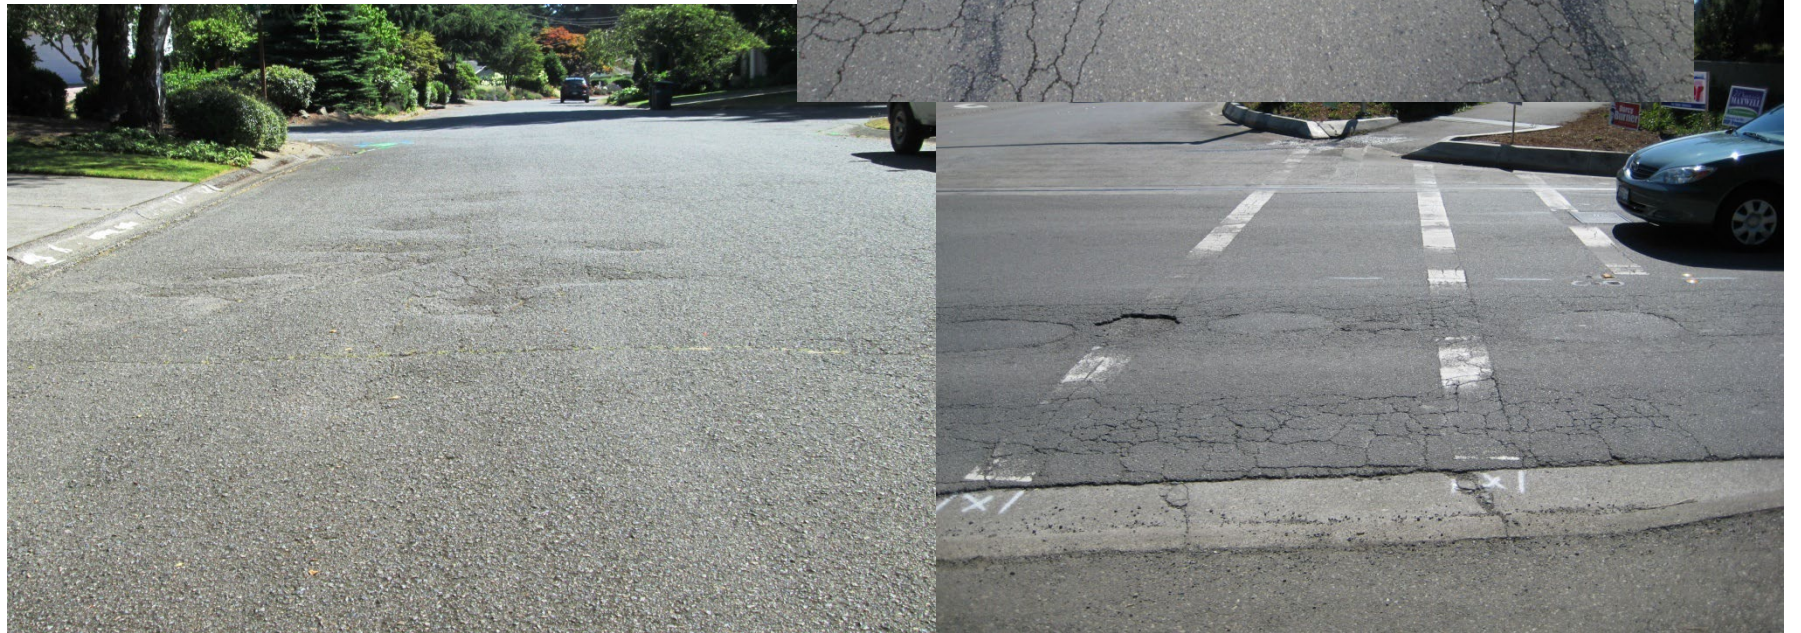
## Distortions

- Bumps and sags
- Depressions
- Patches
- Potholes

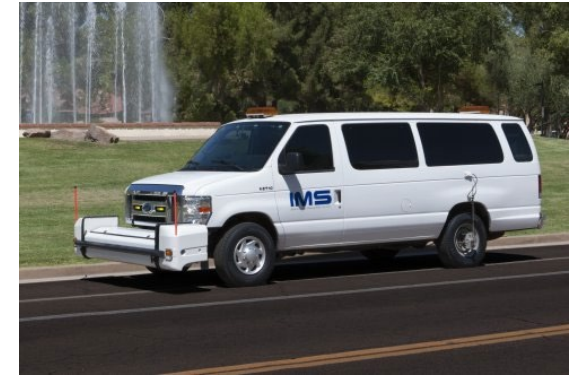
- Imaging and laser instrument can detect cracks even in difficult conditions (like shade)
- Extent and severity of distresses are logged by area
- Some human QA/QC is required

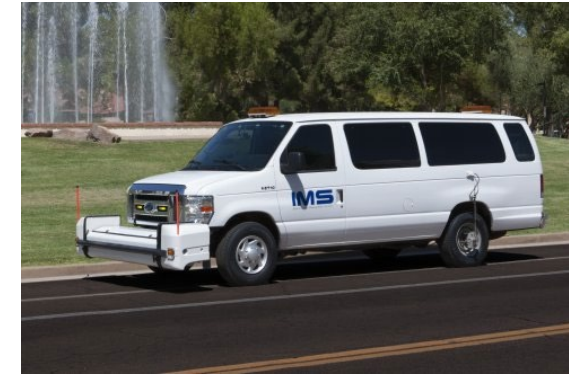
- Algorithm will flag and remove
- Pavement markings
  - Utility castings
  - Raised pavement markers

These do not affect the score

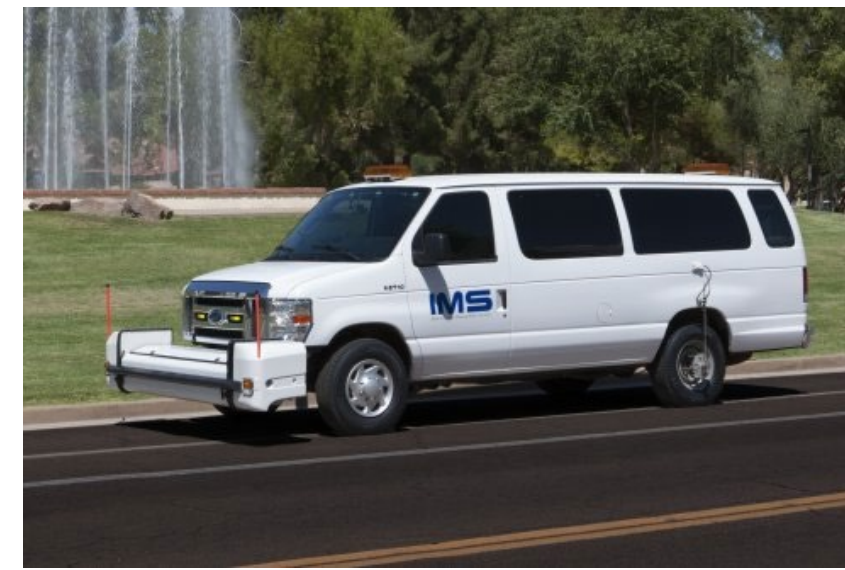
Deflection Testing

60% Surface Distress

40% Structural (for Arterials and High-Volume Residentials)

Pavement Condition Index (PCI)  
0 to 100 Score

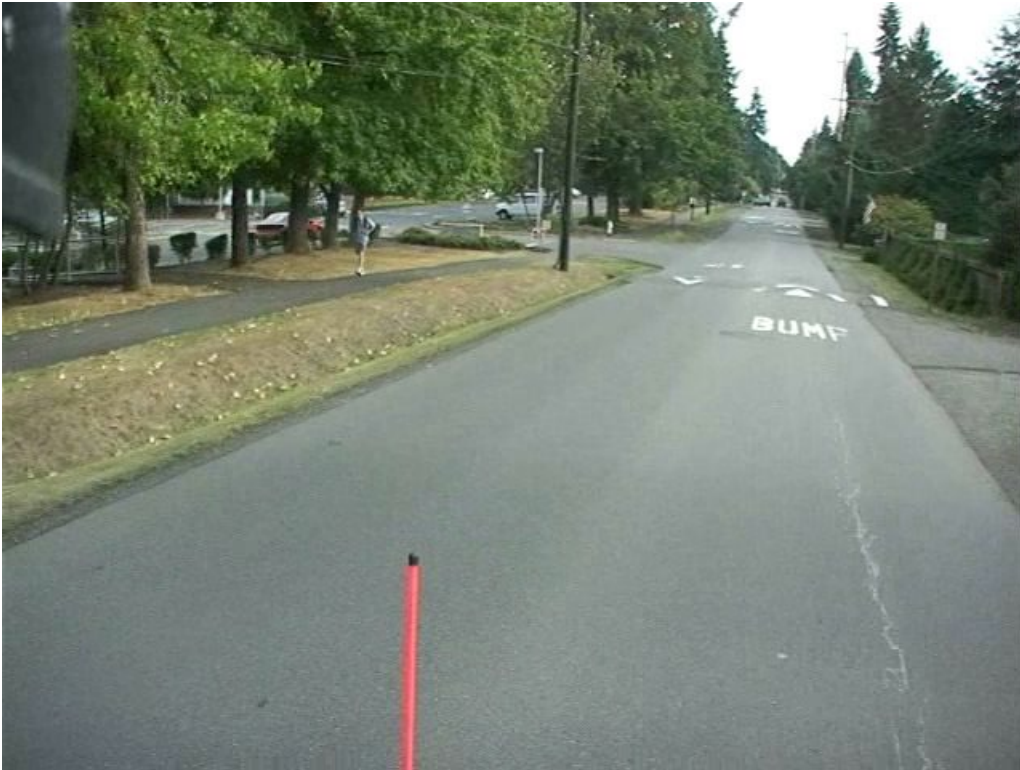
88-86<sup>th</sup> A

## **GOOD (100-86)**

Like new condition

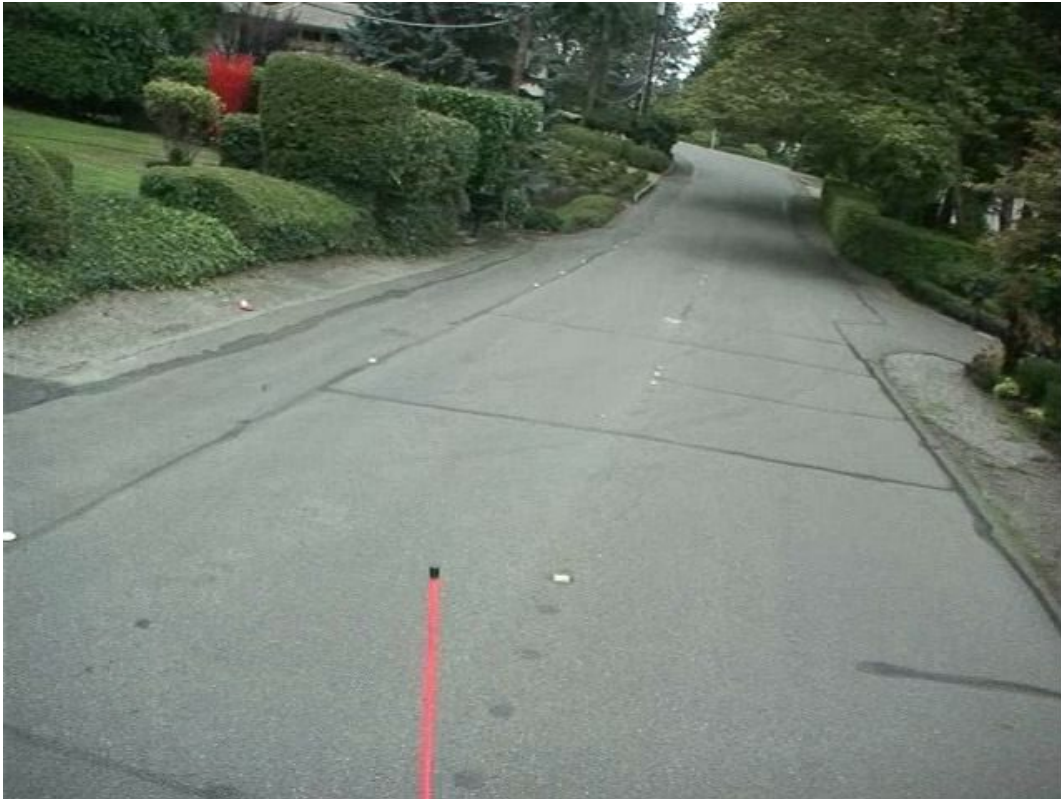
71-NMW

## **SATISFACTORY (85-71)**

- Few distresses overall
- Some cracking (longitudinal and transverse)
- Might contain a few patches

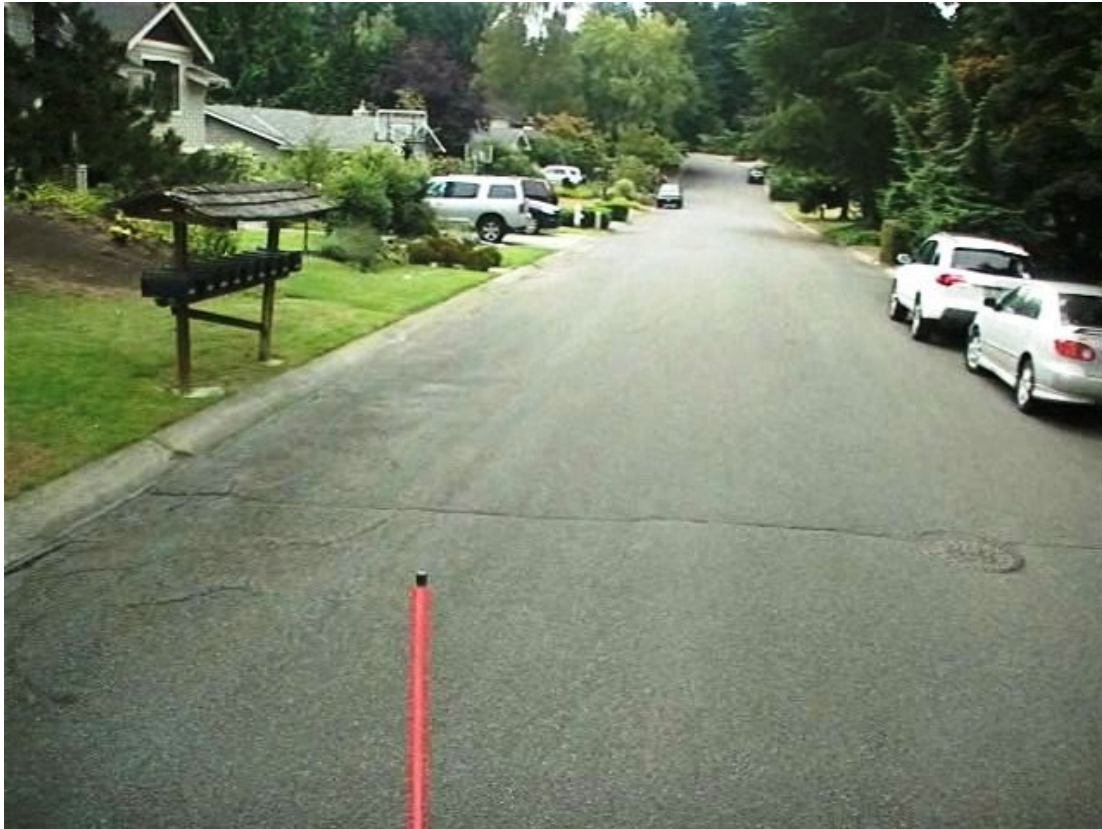
62-85<sup>th</sup> A

# Understanding the PCI **FAIR (70-56)**

Localized distresses such as:

- Alligator cracking
- Block cracking
- Patches
- Distortions

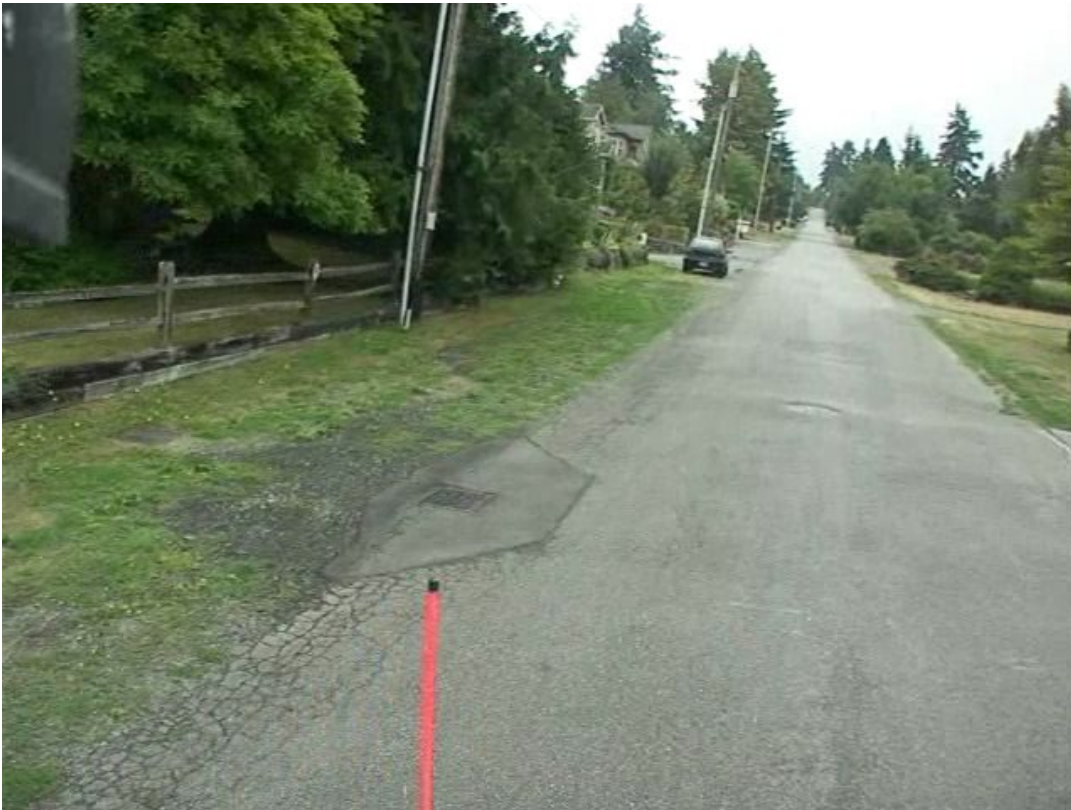
52-70<sup>th</sup> A

## **POOR (55-41)**

- Much larger distress areas
- More severe cracking (alligator)
- Minor base failures

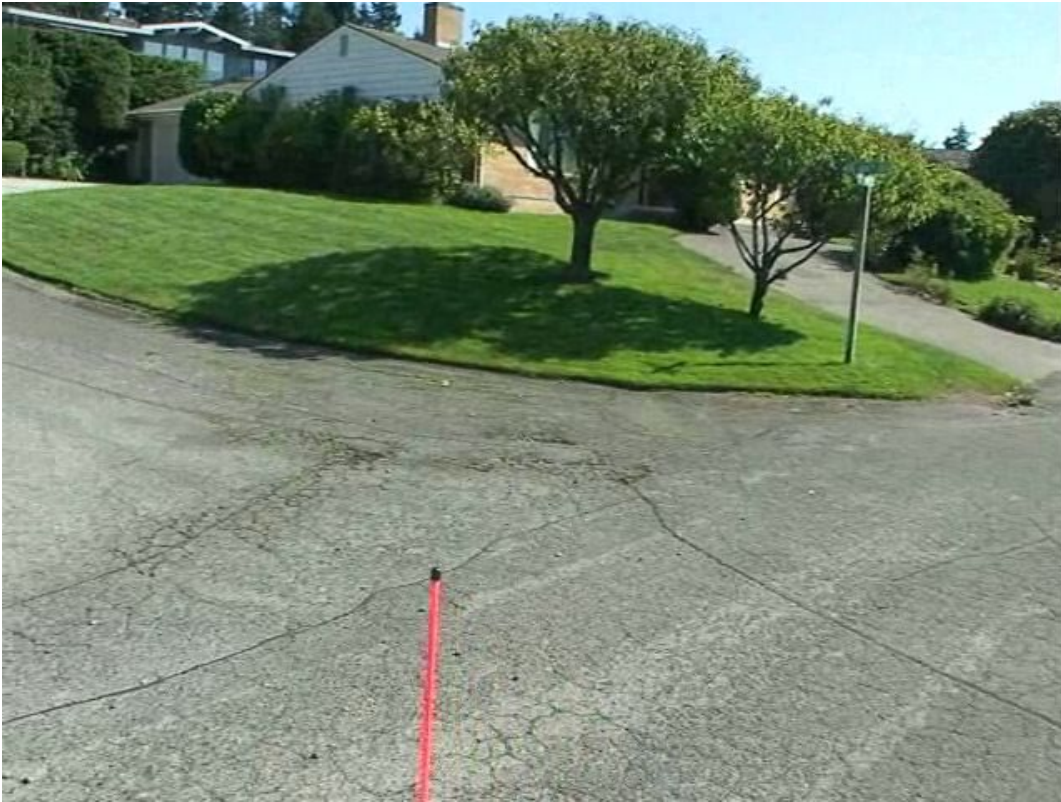
43-82<sup>nd</sup> A

## **VERY POOR (40-26)**

- Extensive alligator cracking and/or patching
- Visible rutting and distortion
- Some base failure
- Likely need to remove and replace large areas of pavement

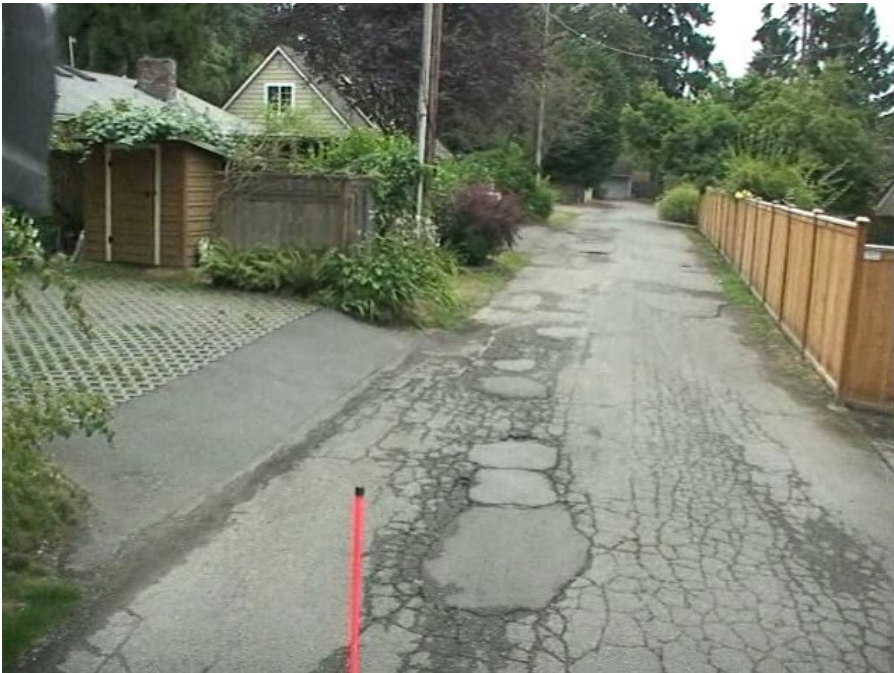
7-73<sup>rd</sup> A

## **FAILED (25-0)**

- Extensive high severity cracking
- Rutting
- Base failures

- Past point of overlay
- Requires total reconstruction
  - Remove existing pavement
  - Regrading and base repair
  - Repave
- **Most costly** to repair

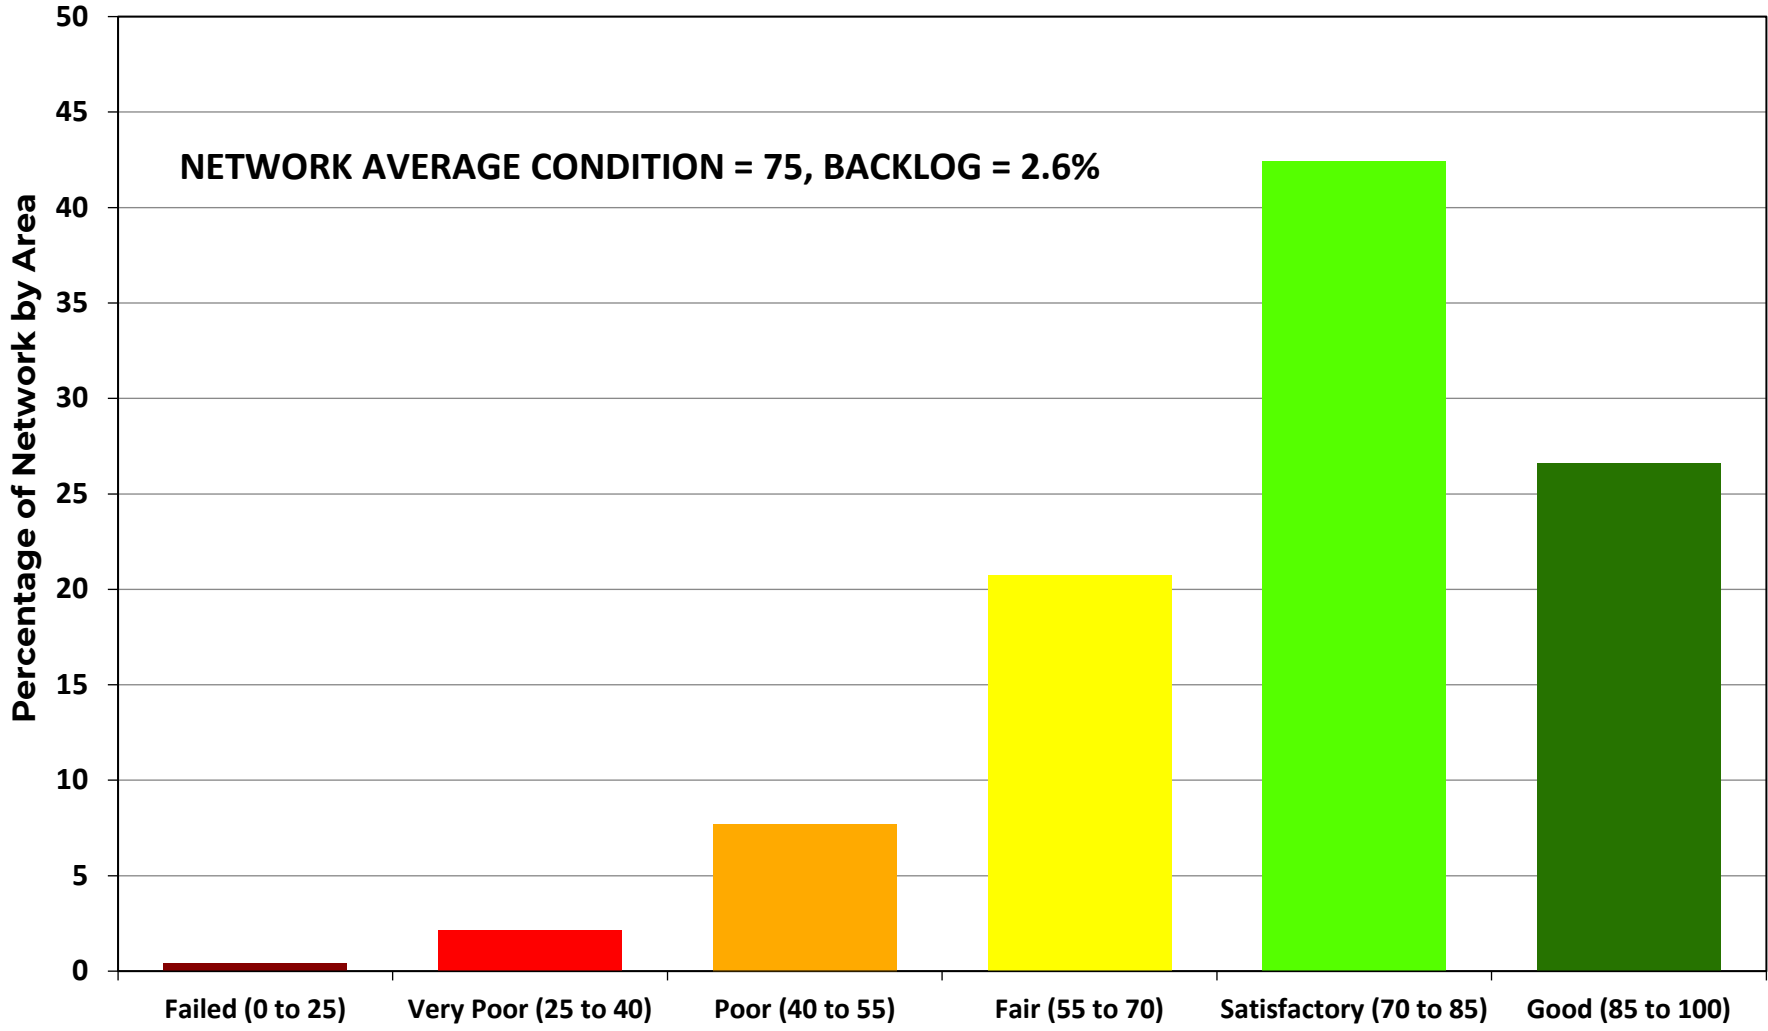
# Mercer Island PCI Distribution 2022

## Pavement Condition Comparison Using Descriptive Terms

- Overall network pavement health is **SATISFACTORY**
- Amount of pavement in each PCI range has remained relatively **consistent since 2013**
- Current pace of repaving and rehab is **matching** the rate of deterioration
- Focus on **Fair and Poor** categories for future rehab
- PCI data will be **used in upcoming TIP** to help plan repair and resurfacing priorities
- Next PCI data collection planned for **2025**

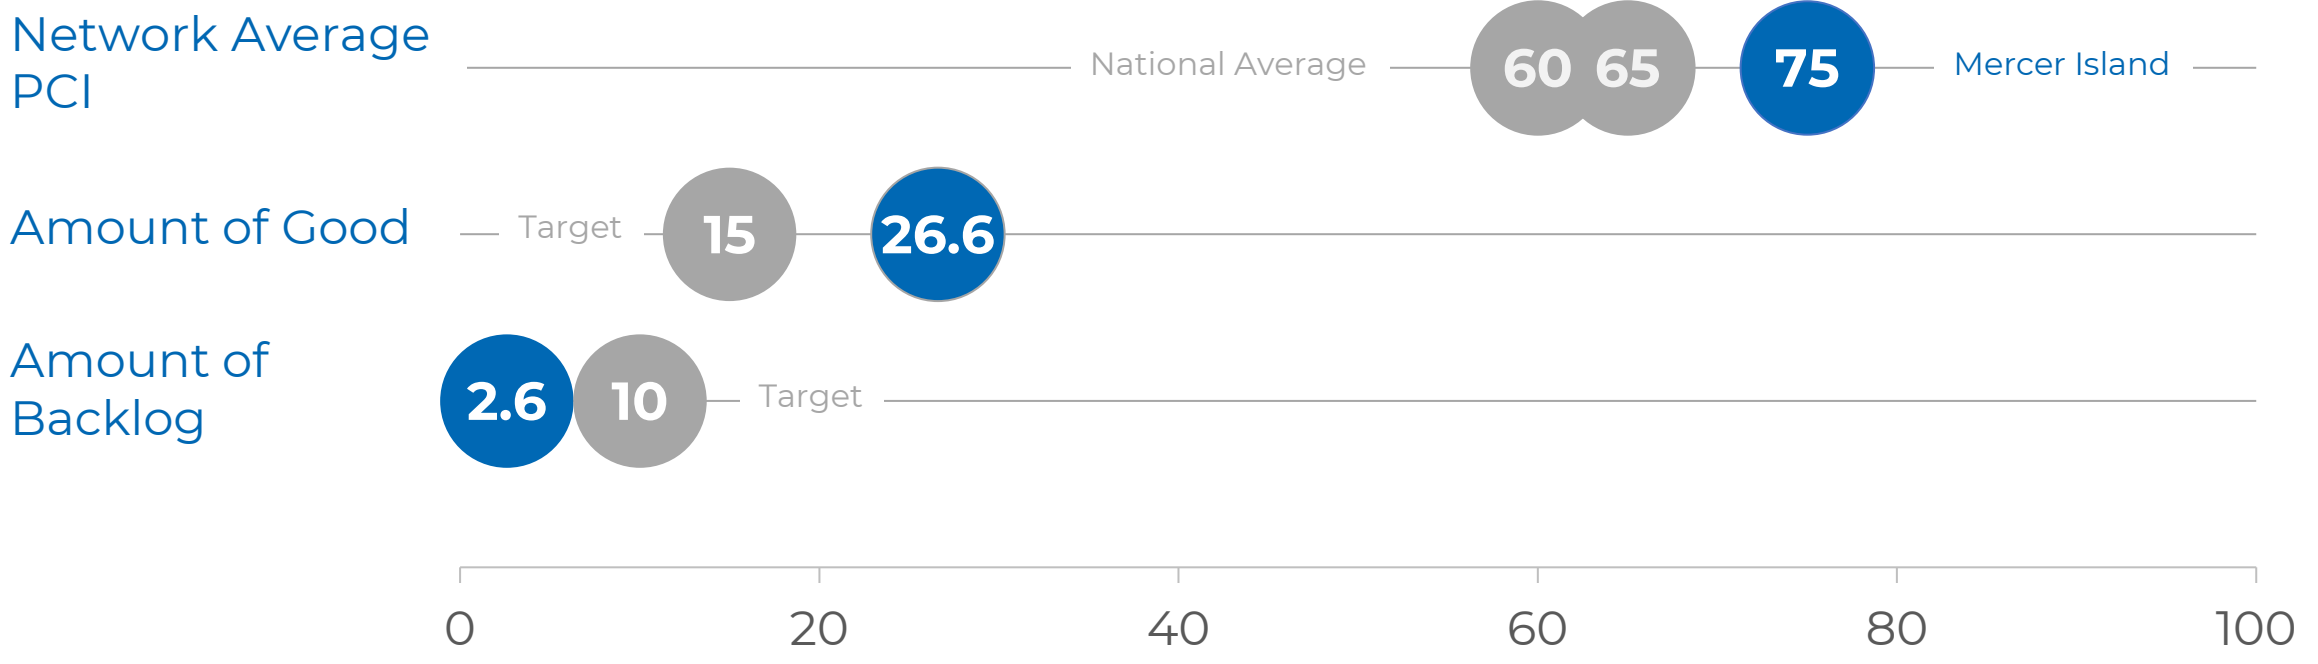
# PCI Report Card - 2022

- Primary indicators of network health
  - Network average PCI
  - Amount of Good (PCI over 85)
  - Amount of Backlog (PCI below 40)

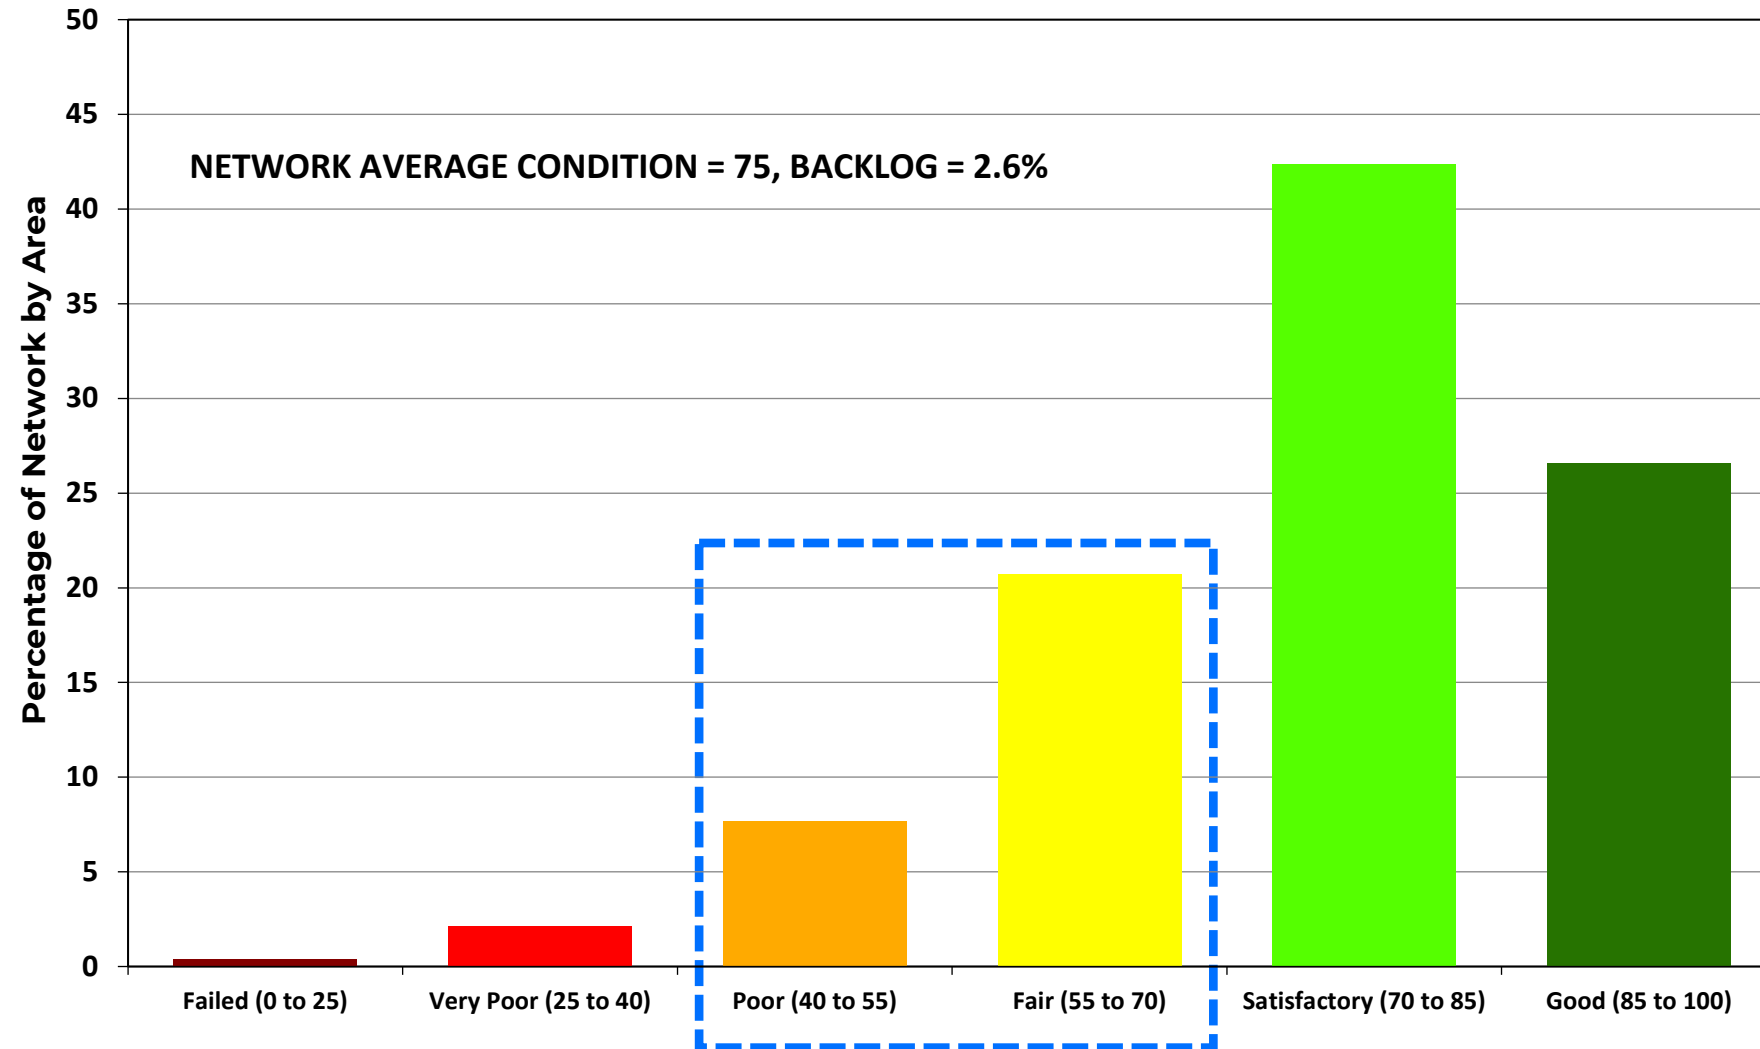
# Pavement Preservation & PCI

## Pavement Condition Comparison Using Descriptive Terms
