**Design Review Board**

**STAFF REPORT**

**Request:** To demolish existing house.

Demolition Plan Review – 12595 Broadwell Road  
Prepared by the Community Development Department for the  
Design Review Board Meeting on May 7, 2024

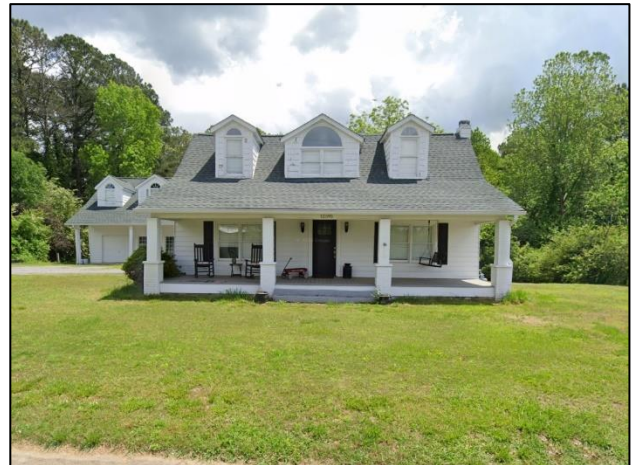
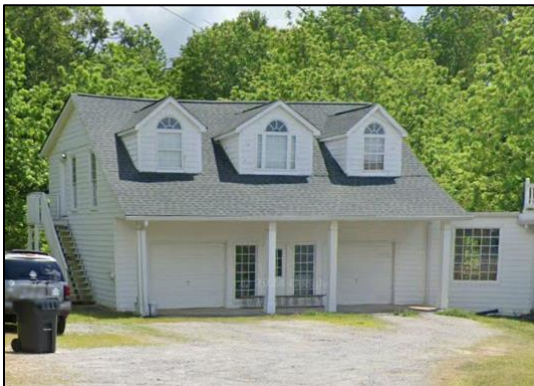
Georgia Historic Resources Survey identified the one-story frame conventional craftsman house as a historic structure due to its architecture. According to the survey, the house was built between circa 1920 and 1929 (see Exhibit 1). During the period from about 1905 until the early 1920s, the Craftsman architecture style was the dominant style for small houses built throughout the country. Features of the structure on the property include the following:

- Low-pitched, gabled roof with wide, unenclosed eave overhang
- One story high
- Gable dormers
- Side-oriented gable roof
- Porch is contained under the main roof.

Per the GA Historic Resources Survey, the garage located at the rear of the house was added in ca. 1995. This structure has not been identified as historic.

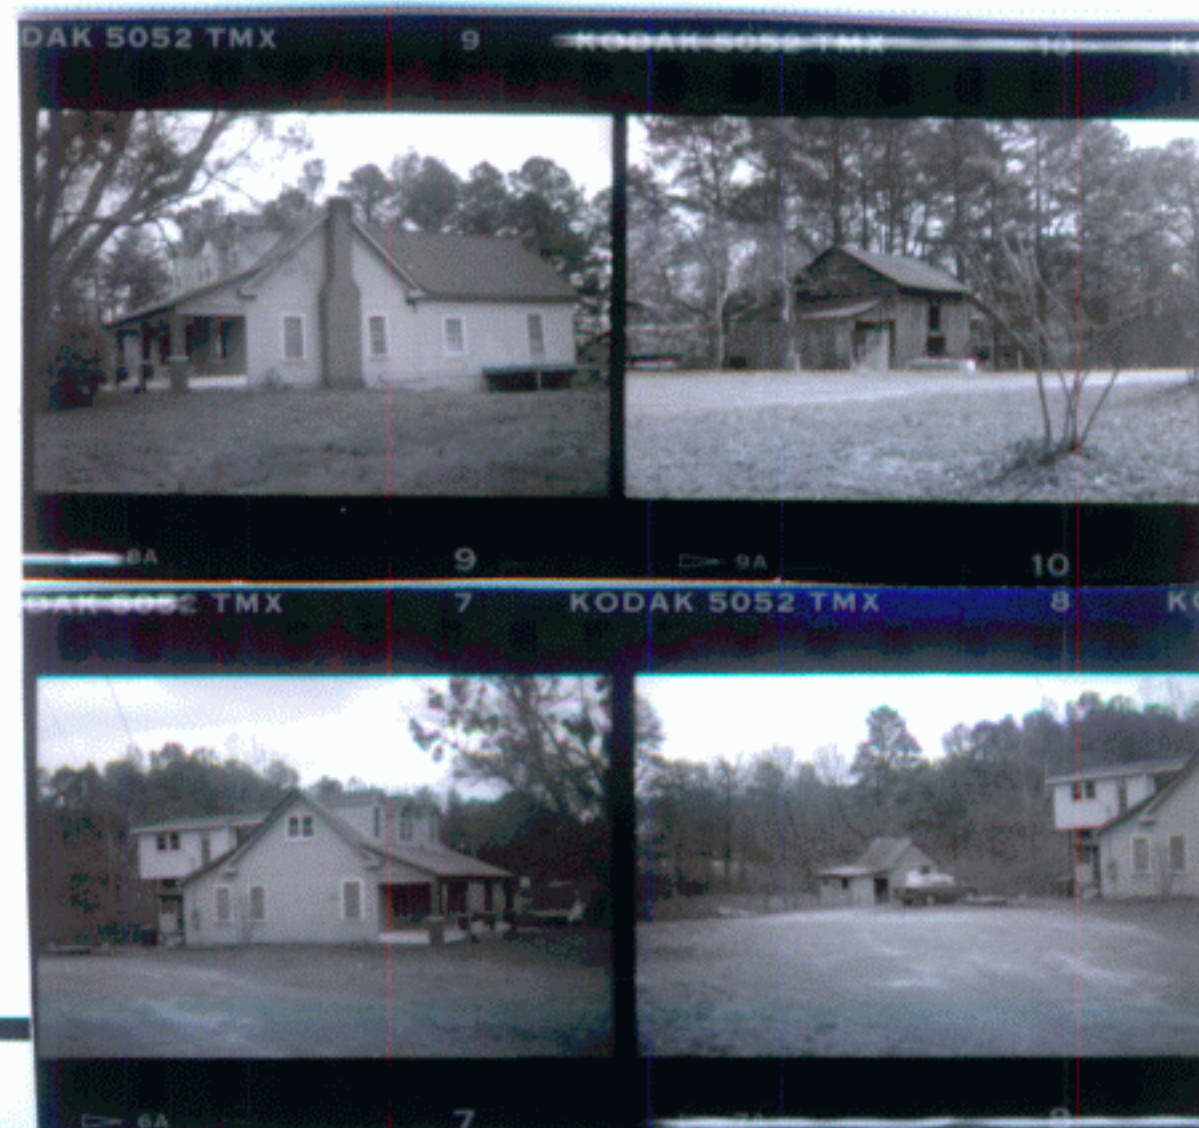
*Wood panel front door with large light. Gable returns, exposed rafter ends, brick columns on brick piers support porch. Obtrusive rear addition. Three gable dormers.**Condition: fair**Addition - Ca. 1995 - Rear addition and front dormers**Altered - Ca. 1960 - asbestos siding installed*26 Negatives: roll # *14*frames # *7-10*

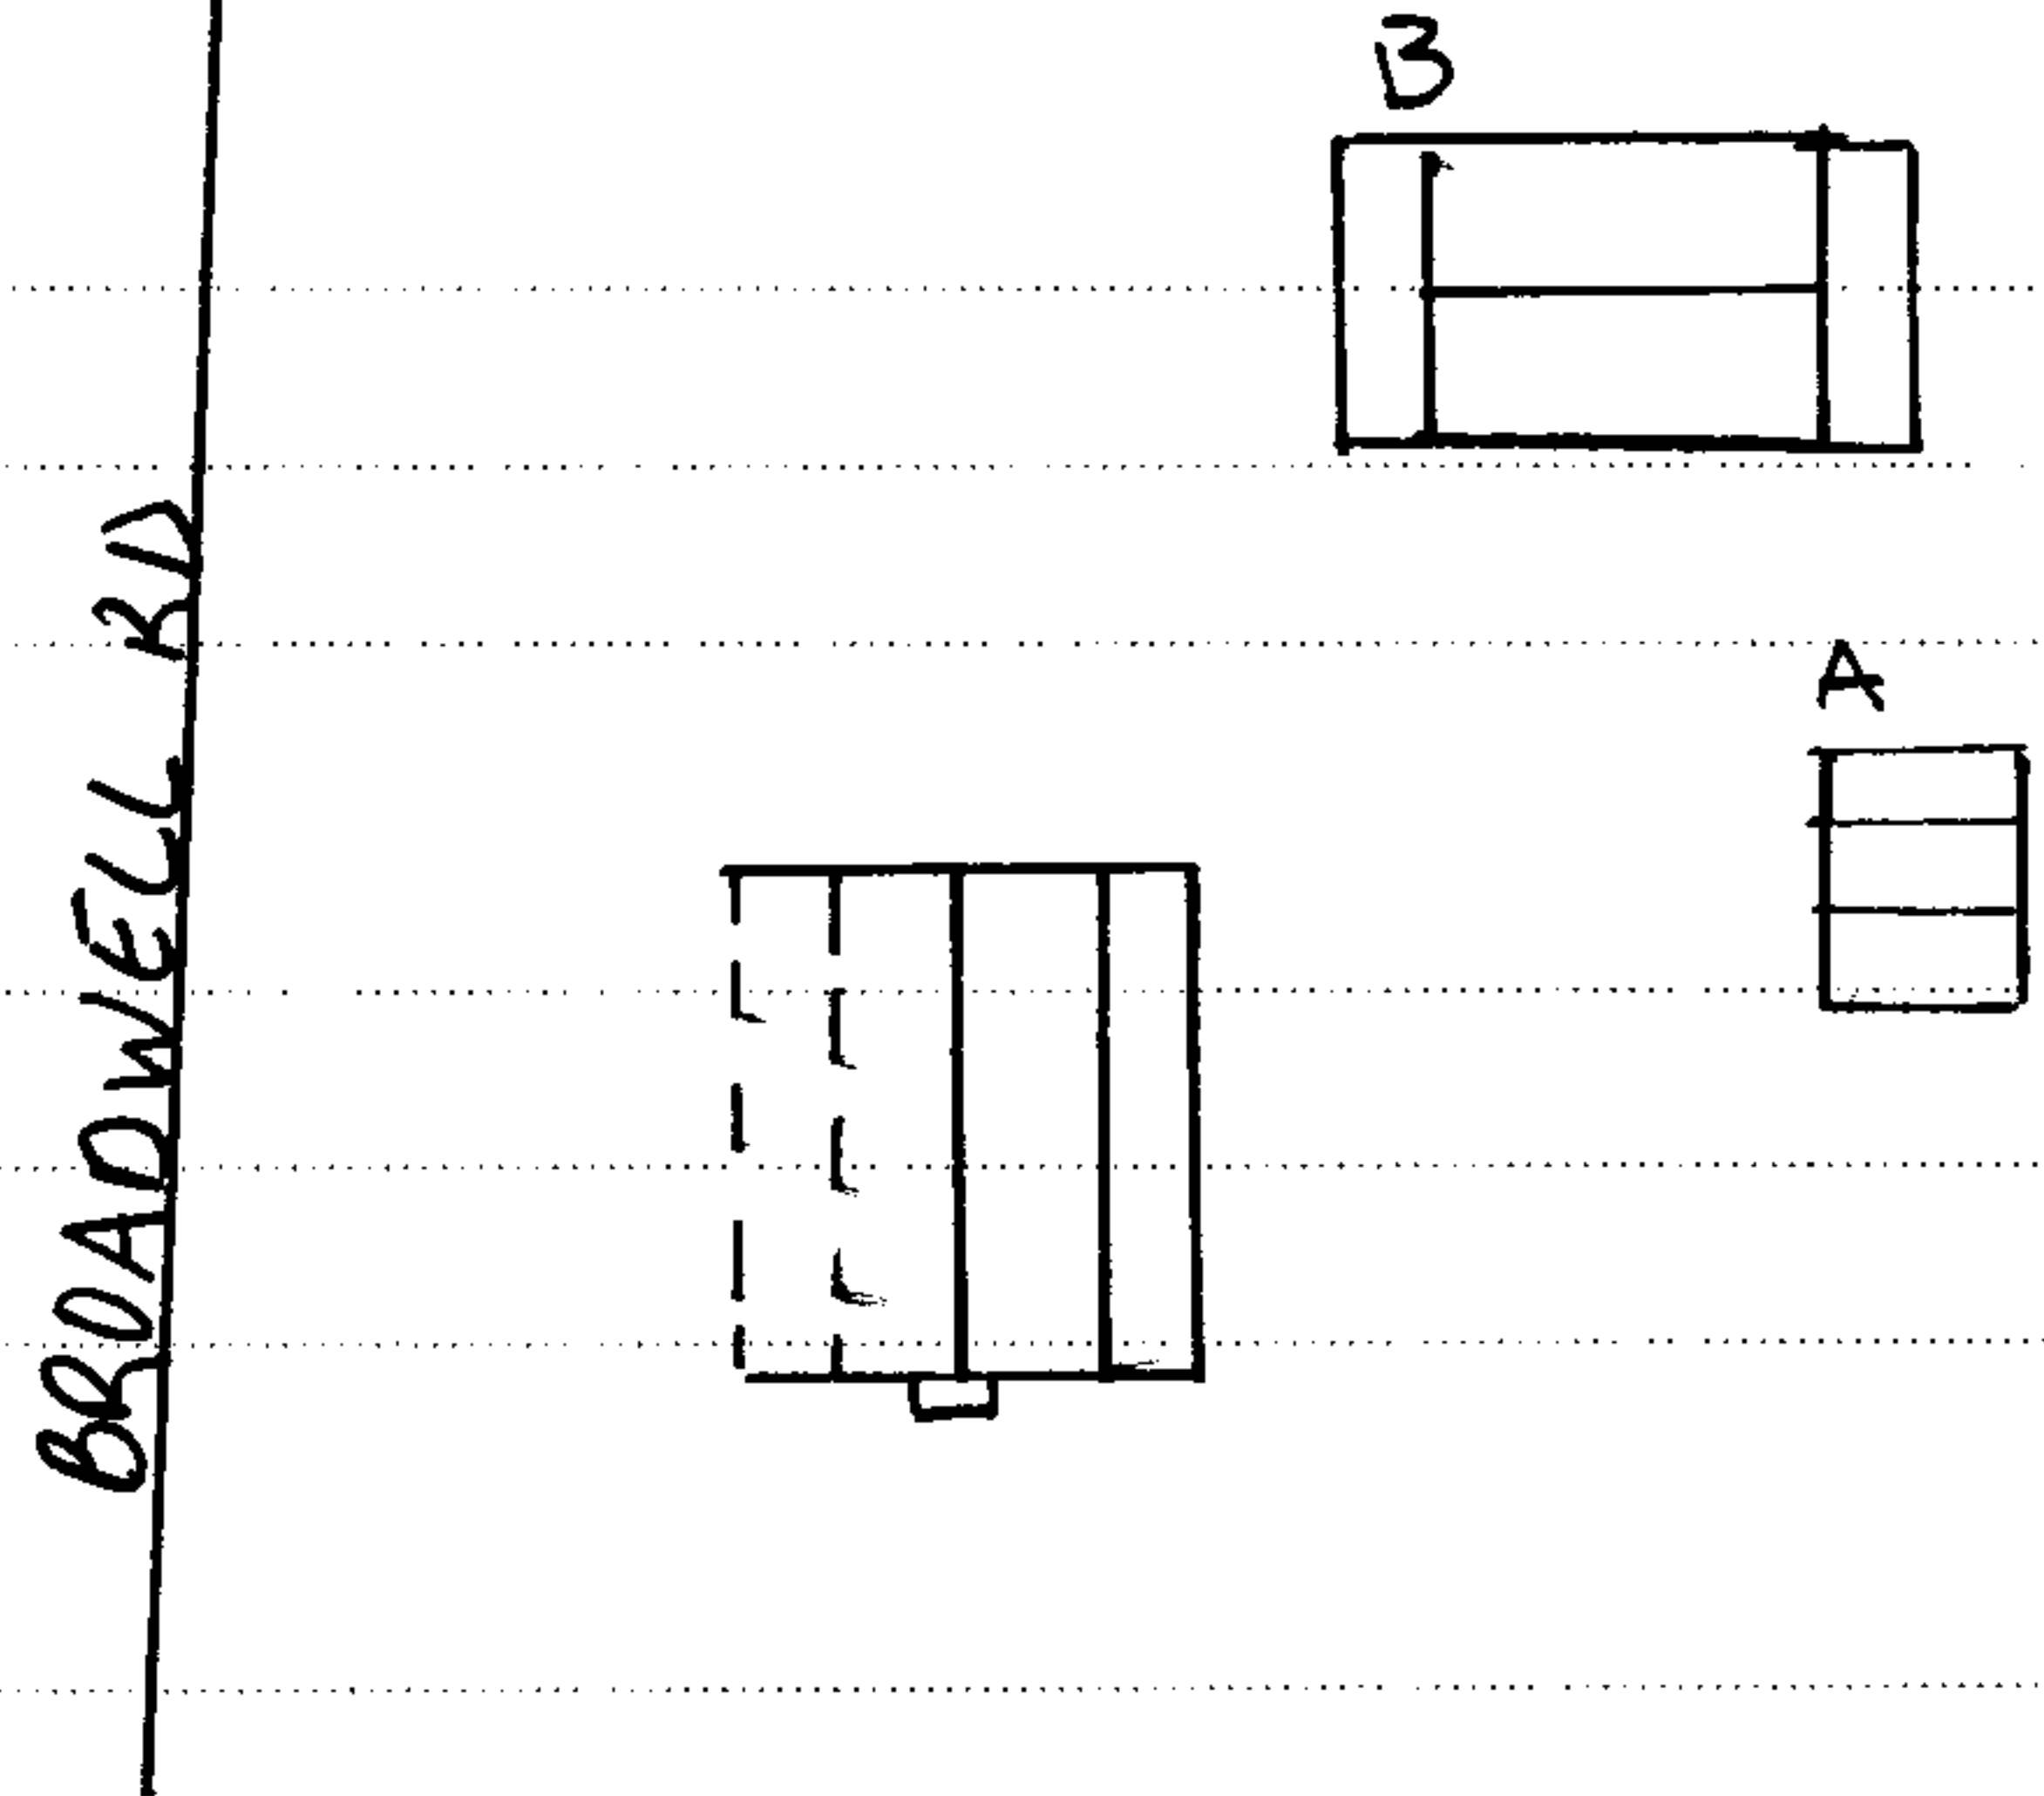
**28 Site plan with North at top**

*storage shed - A: Wood-frame, weatherboard storage shed with side shed, corrugated metal roof, wood-plank door, 6-light fixed-sash window (c.1930).*

*barn/shed - B: Wood-frame, weatherboard, 1-bay barn with side sheds, corrugated metal roof (c.1920).*
