# Town of Minturn, CO

Tank No. 2 Review and Construction  
Alternatives

April 11, 2025

TECHNICAL MEMORANDUM  
PREPARED FOR THE  
TOWN OF MINTURN, CO

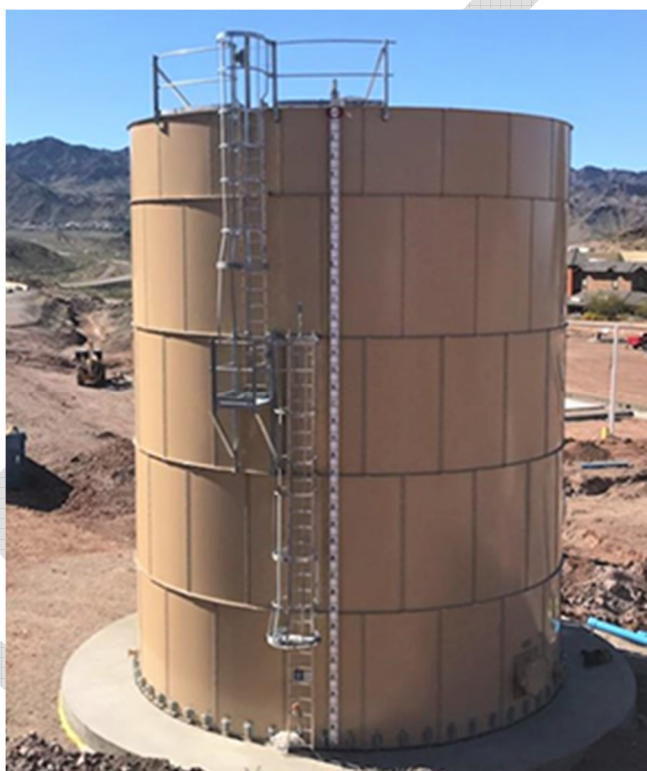
**Figure 1. Chime Panel Bolted Tank**

HDR is working with the Town of Minturn to review rehabilitation alternatives for Tank number 2. Tank 2, a “chime” style bolted tank, was constructed in 1996 with a capacity of 600,000 gallons. Approximately 1/3 (8 ft) of the tank is below grade and constructed out of concrete as a part of the tank stem wall foundation and ring wall. The remaining 2/3 (16 ft) of the tank is the bolted steel portion and is above grade. The tanks diameter is approximately 66’ with a 24’ overall tank height or 16’ from ground level. **Figure 1** shows an example of a chime style tank. The horizontal flange seams can be seen at each stacked panel and are the weakest spots of the tank that often result in leaking, as is the case with Minturn’s Tank 2.

A flat panel over a chime panel tank (existing Tank 2 type) is recommended for a new bolted tank construction. The horizontal flanges where tank panels connect on the exterior of the tank is what differentiates a bolted chime tank and a flat panel bolted steel tank. A standard or flat panel bolted tank has no flanges at panel connections and the panels are overlapped, sealed and bolted together.

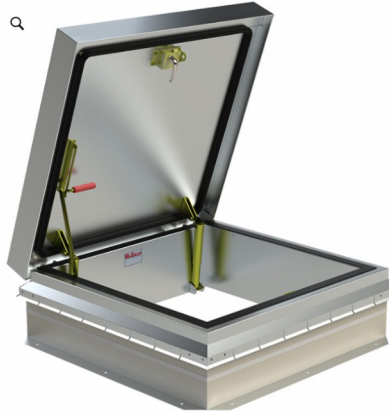
**Figure 2. Premanufactured Bilco Hatch Example**

The hatch is also relatively easy to fix and there are many options to choose from. A Bilco style hatch (example provided in Figure 2) is recommended, and may be required, if any tank rehabilitation work is conducted. These are premanufactured hatches that are affordable and easy to implement into existing tanks. To modify the tank for a new hatch, a flange would be cut and welded into the tank roof and made to accept the manufactured hatch. The height of the flange would be minimum height per CDPHE requirements. These hatches can be furnished with pad locks. If a new tank were to be constructed, a Bilco style hatch is recommended versus a custom fabricated hatch.

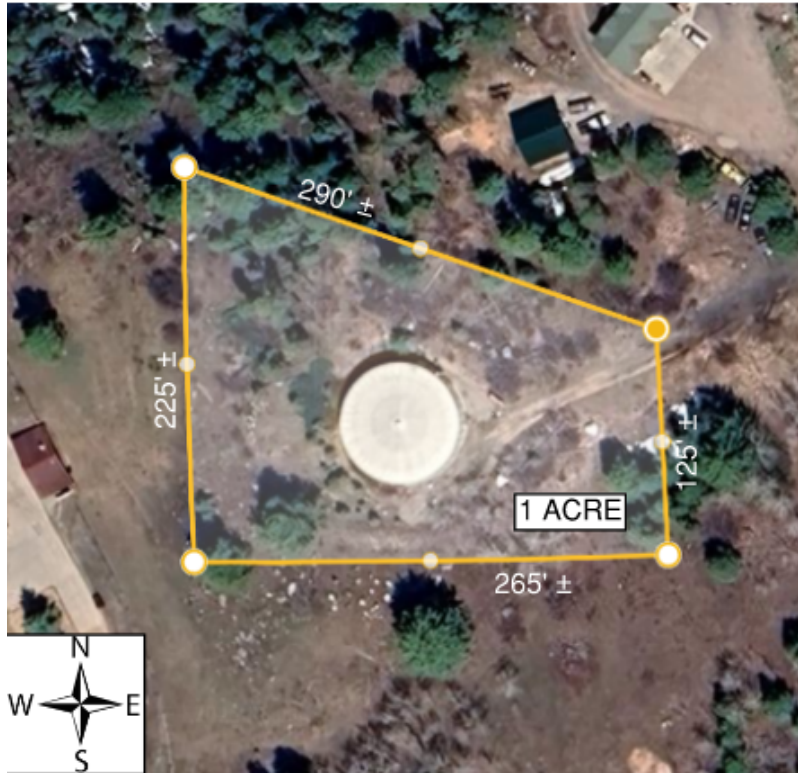
**Figure 3. 1 Acre Space Reference Around Tank Site**

Existing tank construction sites where HDR has direct experience were reviewed along with new construction projects to determine the space recommended for rehabilitation alternatives. At least one acre is recommended for a single tank with a diameter of roughly 60 feet. Most of this space allows for a general approach or driveway into the tank site and staging space for parking and storing materials for a full tank rehabilitation. Figure 3 shows a spatial reference of 1 acre around the existing tank site.

If a new tank were to be constructed at the existing Tank 2 site with similar diameter the minimum staging space requirements would be 1.25 acres.

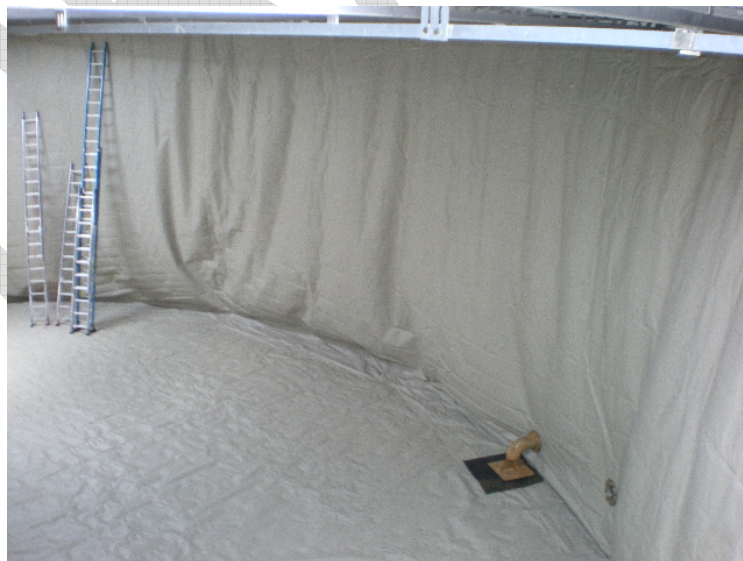
**Figure 4: Tank Liner System**

The Tank Liner alternative includes installing a tank liner or bladder to the inside of the tank as a temporary fix and attempt to extend the usable lifetime of Tank 2. The liner is typically a Flexible Membrane typically made of High-Density Polyethylene (HDPE) or Polyvinyl Chloride

(PVC) as shown in **Figure 4**. The liners material is made specific to potable water system applications and are NSF 61 approved for use in drinking water.

The liner is generally dimensionally custom made and is secured to the side walls above the high-water mark. The method of securing to the tank side wall varies from a rope system, to using the existing tank bolts, self-taping metal screws or drill new holes with new bolts, nuts and washers. It is common for stainless steel hooks to be connected to the liner to then hang on the securing methods mentioned.

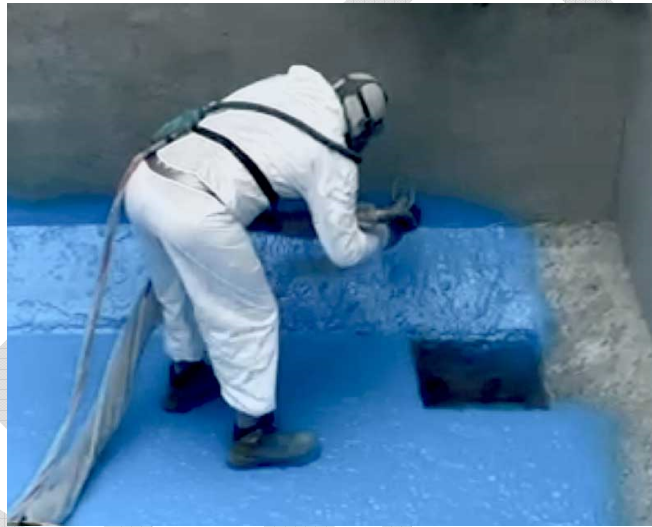
**Figure 5: Plural Component Spray-On Lining System**

This alternative is similar to the liner system previously described but involves a spray or roll-on type of application and is preferred over the liner/bladder system. The spray-on application method can be seen in **Figure 5**. The alternative still requires some prep of all surfaces to be coated and a spray-on poly liner that hardens in place, similar to a pipe relining system. This would require workers to access the tank interior. All the same safety risks occur with this alternative as install a liner and potentially more if the roof interior would be coated.

If no work to the roof would be conducted under this alternative it would be the least invasive method of construction over installing a liner/bladder system. The tank sidewalls and floor could be prepped without needing to drill any new holes, remove any bolts, or tap any screws to hang the liner. Bringing the liner in through the manway will be extremely difficult whereas the plural component alternative is only spray hoses and guns or paint rollers and paint buckets.

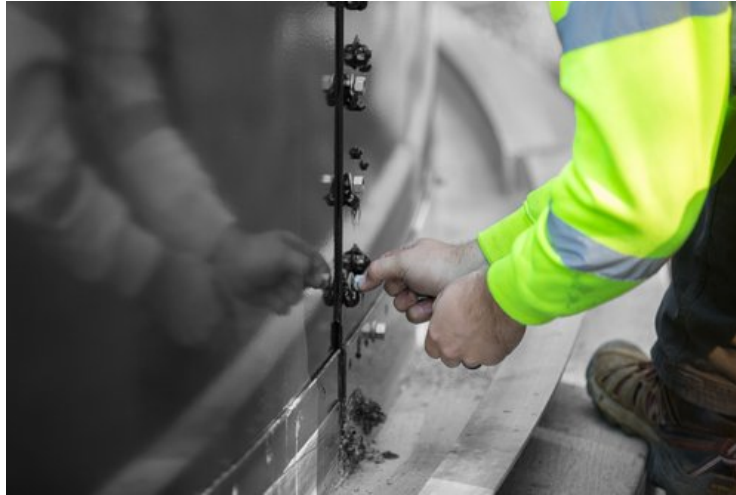
**Figure 6: Bolted Tank Blast, Recoat and Reseal**

**Figure 6** shows the final phases of a tank rehabilitation, applying sealant and tightening bolts.

The tank would be blasted and recoated along with bolts removed and sealant used to reseal all vertical seams. Bolts would be removed and new gaskets installed on horizontal seams. A new epoxy coating or similar would be applied to the interior and exterior of all metal surfaces excluding the ladder. Any issues to the stem wall foundation would be addressed, the overflow modification would be made with a new overflow discharge, a new roof vent, new roof access points and railing, intruder alarms and any other items outstanding on the tank.

**Figure 7** shows a finished welded steel tank and **Figure 6** and **Figure 8** show flat panel bolted tank examples.

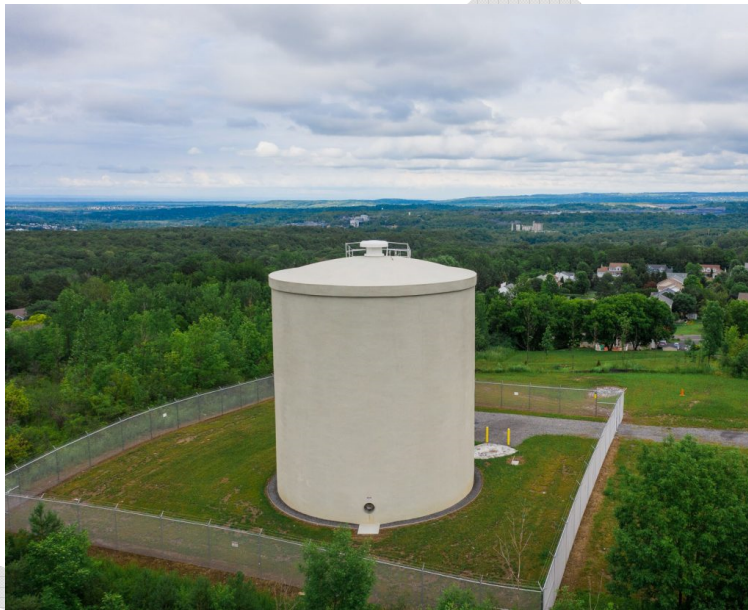
**Figure 8: Finished Concrete Tank**

A new concrete tank alternative is the most expensive of all of alternatives but has the longest life expectancy and least amount of maintenance required. Concrete tanks typically have a 75-year life span versus that of 40 years for a bolted or welded. There are minimal areas for corrosion due to minimal metallic material being used in tank construction. There are no seams in concrete tanks so leaks are less common in wall portions. **Figure 8** shows an example of a finished concrete tank.
