# Greg Roberts Fire Hydrant Repair & Supply LLC

ESTIMATE

Hydrants Needing Repair

Project:	Mt. Pleasant, Tn 2024 Leak Pinpointing				Address:	700 Washington Ave			
Urgency:	Minimal	Surface Material:	Grass	Leak Type:	Fitting	Pipe Size:	6	Pipe Material:	DI
Leak Detection Method:	Sounding		Visible Water:	No	DB level:	64	Person Submitted To:	Mr. Tim Howell	
MC Estimated GPM	Gallons Per Minute:		0.25		Vicinity Map -87.21712232499993 35.536630381000066 Leak				
	Gallons Per Day:		360						
	Gallons Per Month:		10,950

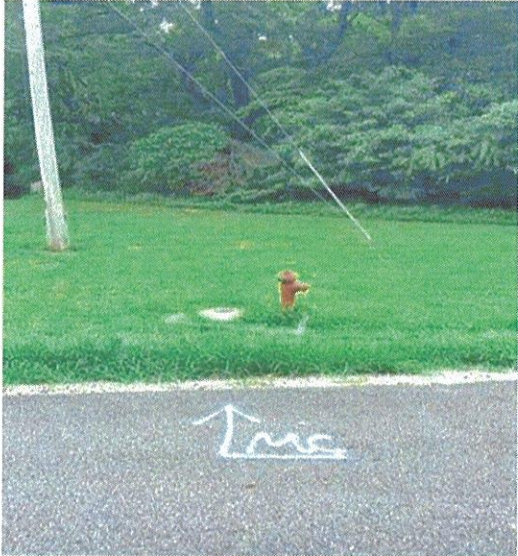
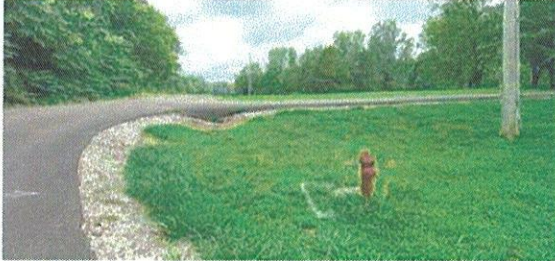
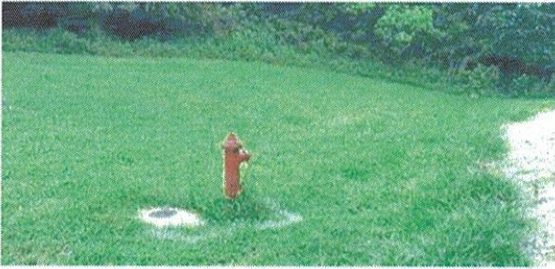
### Leak Card 23

Project:	Mt. Pleasant, Tn 2024 Leak Pinpointing				Address:		End of Mill Pond Rd			
Urgency:	Minimal	Surface Material:	Grass	Leak Type:	Fitting	Pipe Size:	6	Pipe Material:	PVC	
Leak Detection Method:	Sounding		Visible Water:	No	DB level:	99	Person Submitted To:		Mr. Tim Howell	
MC Estimated GPM	Gallons Per Minute:		0.5		Vicinity Map -87.19389047999994 35.53408028100006 Leak					
	Gallons Per Day:		720							
	Gallons Per Month:		21,900							
	Gallons Per Year:		262,800							
Leak Description & Comments:										
Distribution leak detected on blow off valve. Leak can be heard inside valve casing with bare ear.

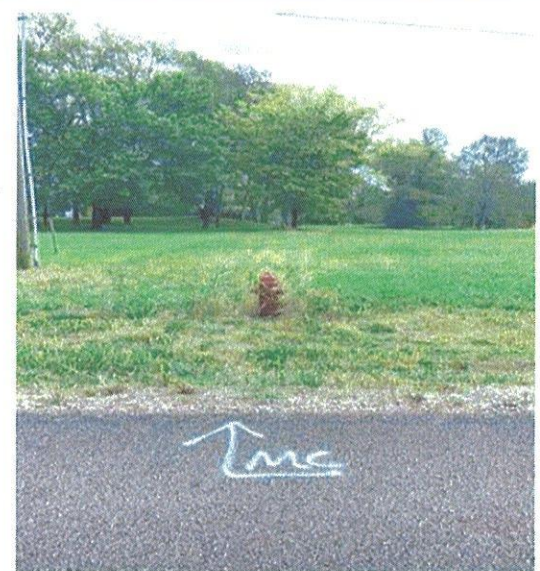
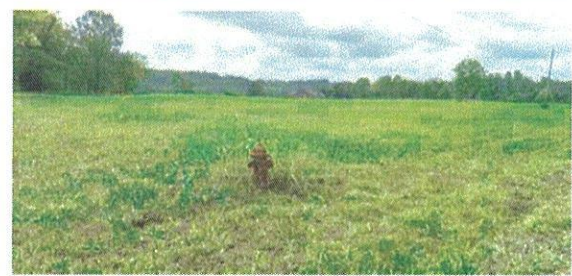
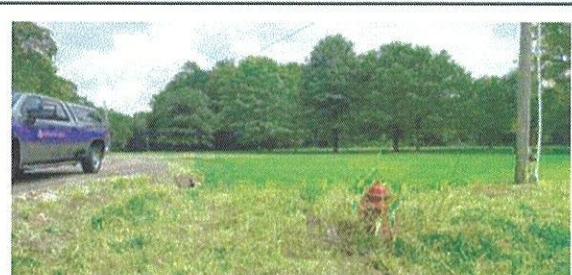
### Leak Card 26

Project:	Mt. Pleasant, Tn 2024 Leak Pinpointing				Address:		1012 Mill Pond Rd			
Urgency:	Minimal	Surface Material:	Grass	Leak Type:	Fitting	Pipe Size:	6	Pipe Material:	DI	
Leak Detection Method:	Sounding		Visible Water:	No	DB level:	74	Person Submitted To:		Mr. Tim Howell	
MC Estimated GPM	Gallons Per Minute:		0.25		Vicinity Map -87.19251944799998 35.53870276600003 Leak					
	Gallons Per Day:		360							
	Gallons Per Month:		10,950							
	Gallons Per Year:		131,400							
Leak Description & Comments:										
Distribution leak detected on fire hydrant 45. Best noise found while probing down the barrels of the hydrant.

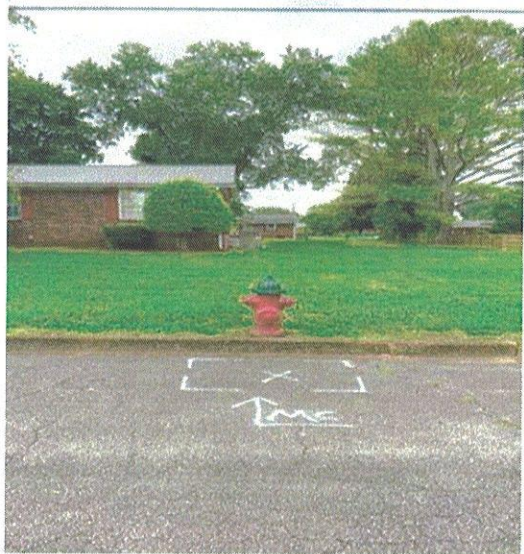
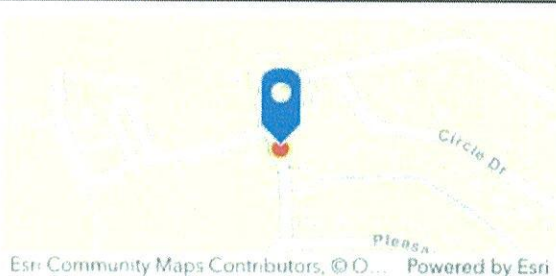
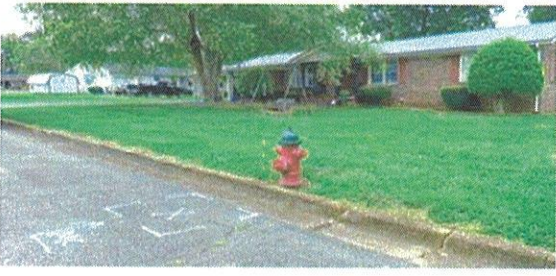
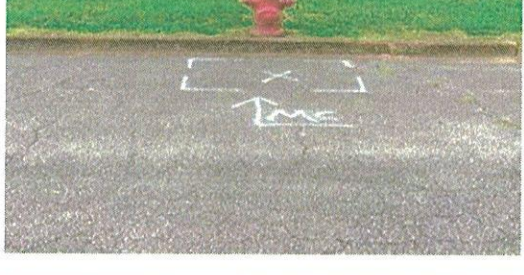
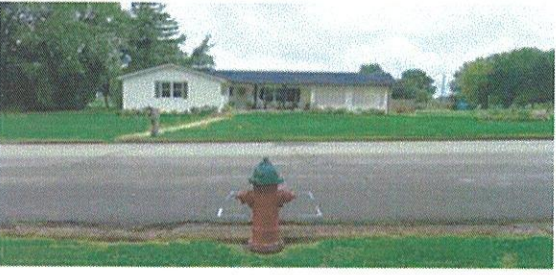
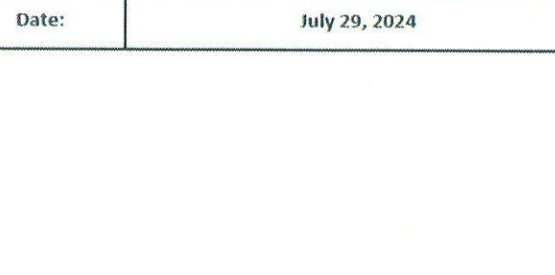
### Leak Card 30

Project:	Mt. Pleasant, Tn 2024 Leak Pinpointing				Address:		705 Meadow Rd			
Urgency:	Minimal	Surface Material:	Asphalt	Leak Type:	Main	Pipe Size:	6	Pipe Material:	Unknown	
Leak Detection Method:	Sounding		Visible Water:	No	DB level:	34	Person Submitted To:		Mr. Tim Howell	
MC Estimated GPM	Gallons Per Minute:		0.5		Vicinity Map -87.21476661099996 35.54464710000008 Leak					
	Gallons Per Day:		720							
	Gallons Per Month:		21,900							
	Gallons Per Year:		262,800							
Leak Description & Comments:  Distribution leak detected on hydrant lead. It is suspected that a possible valve has been asphalted over in front of hydrant and the valve could be leaking. Best noise found 3 feet in front of hydrant.

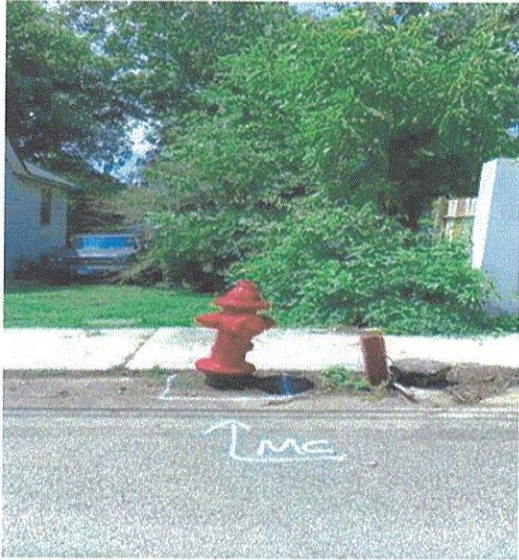
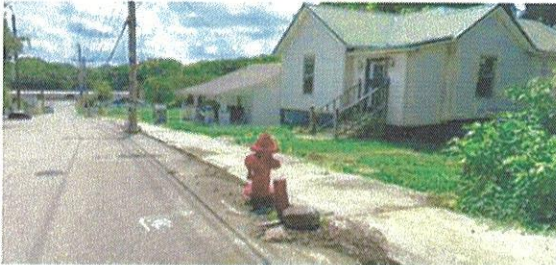
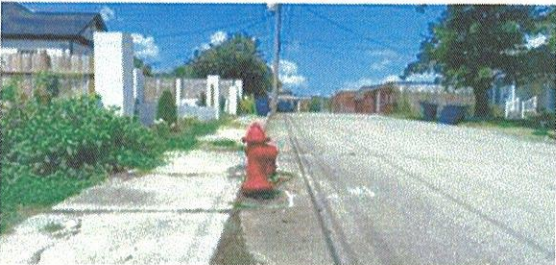
### Leak Card 36

Project:	Mt. Pleasant, Tn 2024 Leak Pinpointing				Address:		114 Jordan Ave			
Urgency:	Minimal	Surface Material:	Asphalt	Leak Type:	Fitting	Pipe Size:	6	Pipe Material:	DI	
Leak Detection Method:	Sounding		Visible Water:	No	DB level:	84	Person Submitted To:		Mr. Tim Howell	
MC Estimated GPM	Gallons Per Minute:		0.25		Vicinity Map -87.20671336799995 35.53225240000006 Leak					
	Gallons Per Day:		360							
	Gallons Per Month:		10,950							
	Gallons Per Year:		131,400							
Leak Description & Comments:										
Distribution leak detected on fire hydrant 32. Hydrant appears to have been hit.

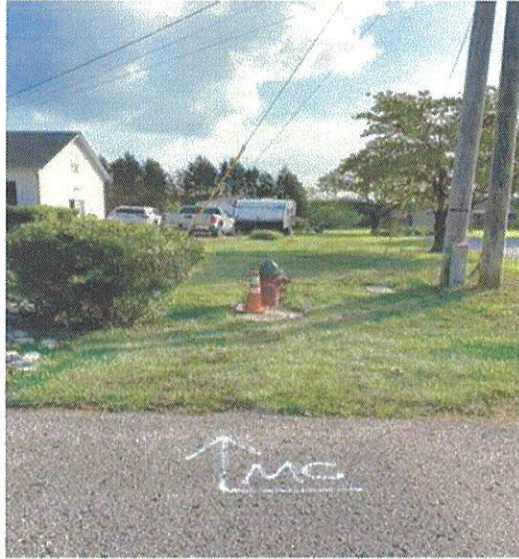
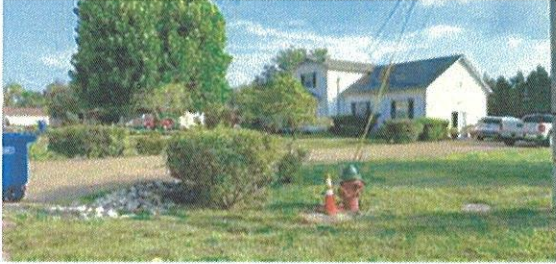
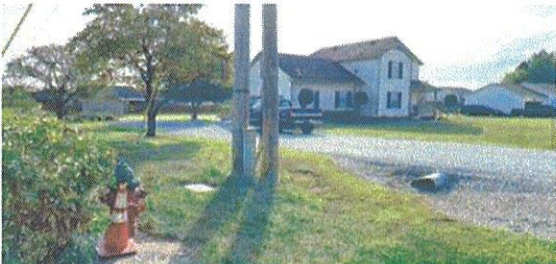
### Leak Card 58

Project:	Mt. Pleasant, Tn 2024 Leak Pinpointing				Address:		506 Mockingbird Dr			
Urgency:	Minimal	Surface Material:	Grass	Leak Type:	Fitting	Pipe Size:	6	Pipe Material:	DI	
Leak Detection Method:	Sounding		Visible Water:	No	DB level:	55	Person Submitted To:		Mr. Tim Howell	
MC Estimated GPM	Gallons Per Minute:		0.25		Vicinity Map -87.20473308499999 35.55158181500008 Leak					
	Gallons Per Day:		360							
	Gallons Per Month:		10,950

Gallons Per Year:		131,400							
Leak Description & Comments:										
Distribution leak detected on fire hydrant 163. Hydrant is suspected to be partially open.

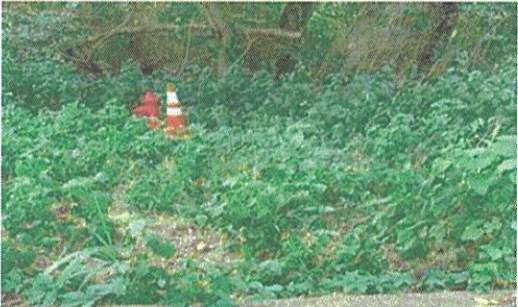
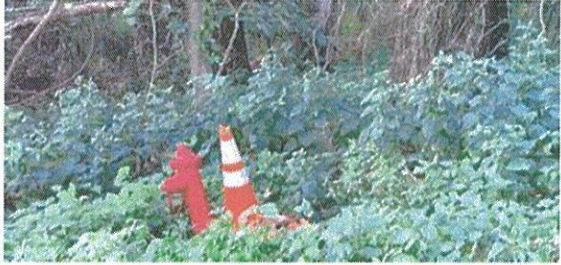
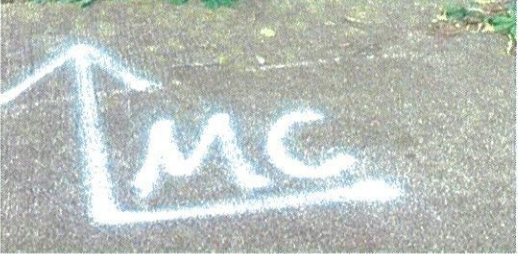
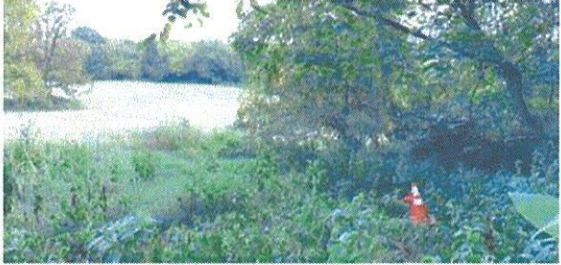
### Leak Card 65

Project:	Mt. Pleasant, Tn 2024 Leak Pinpointing				Address:		End of Trilogy Ln			
Urgency:	Minimal	Surface Material:	Grass	Leak Type:	Fitting	Pipe Size:	2	Pipe Material:	PVC	
Leak Detection Method:	Sounding		Visible Water:	No	DB level:	99	Person Submitted To:	Mr. Tim Howell		
MC Estimated GPM	Gallons Per Minute:		3		Vicinity Map -87.15133054899997 35.55515900600005 Leak					
	Gallons Per Day:		4,320							
	Gallons Per Month:		131,400							
	Gallons Per Year:		1,576,800							
Leak Description & Comments:  Distribution leak detected on 2in Hydrant. Hydrant appears to have been hit. Leak can be heard without sounding equipment on operating nut.

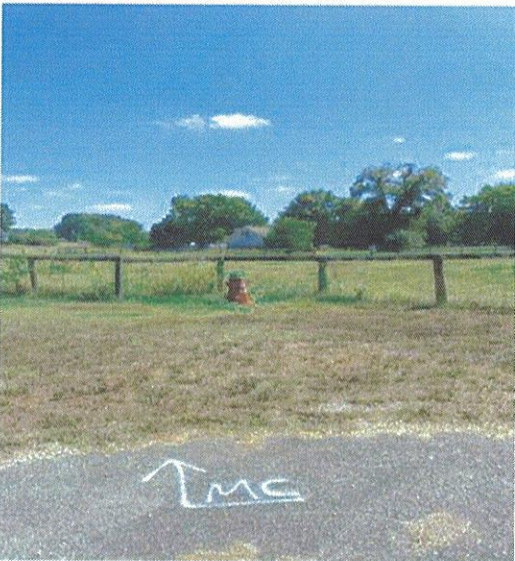
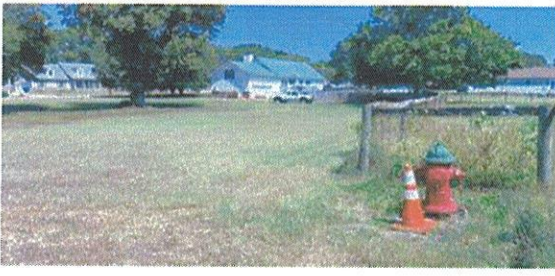
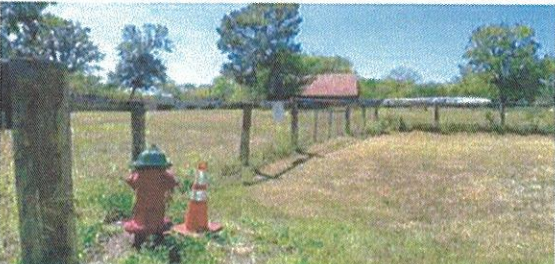
## Leak Card 66

Project:	Mt. Pleasant, Tn 2024 Leak Pinpointing				Address:		639 Watkins Dr			
Urgency:	Minimal	Surface Material:	Grass	Leak Type:	Fitting	Pipe Size:	6	Pipe Material:	DI	
Leak Detection Method:	Sounding		Visible Water:	No	DB level:	52	Person Submitted To:		Mr. Tim Howell	
MC Estimated GPM	Gallons Per Minute:		0.25		Vicinity Map -87.19384189799996 35.565644435000024 Leak					
	Gallons Per Day:		360							
	Gallons Per Month:		10,950

Gallons Per Year:		131,400							
Leak Description & Comments:										
Distribution leak detected on fire hydrant 182. Hydrant is believed to be partially open.

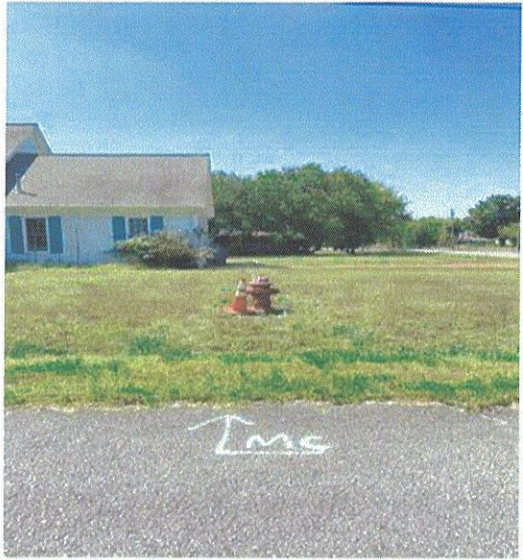
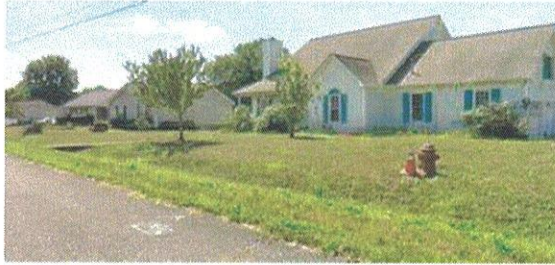
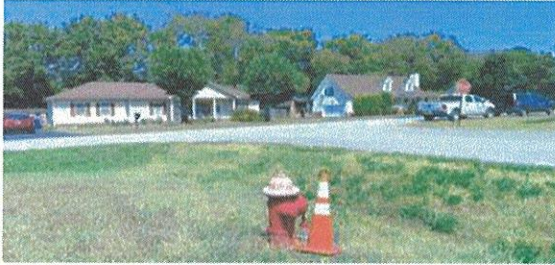
### Leak Card 67

Project:	Mt. Pleasant, Tn 2024 Leak Pinpointing				Address:	700 Sugar Bend Dr				
Urgency:	Minimal	Surface Material:	Grass	Leak Type:	Fitting	Pipe Size:	6	Pipe Material:	DI	
Leak Detection Method:	Sounding		Visible Water:	No	DB level:	64	Person Submitted To:		Mr. Tim Howell	
MC Estimated GPM	Gallons Per Minute:		0.25		Vicinity Map					
	Gallons Per Day:		360		-87.19153692099997 35.56579665400005 Leak					
	Gallons Per Month:		10,950

Gallons Per Year:		131,400							
Leak Description & Comments:										
Distribution leak detected on fire hydrant 185. Hydrant is believed to be partially open.					<small>Esri Community Maps Contributors, © O... Powered by Esri</small>

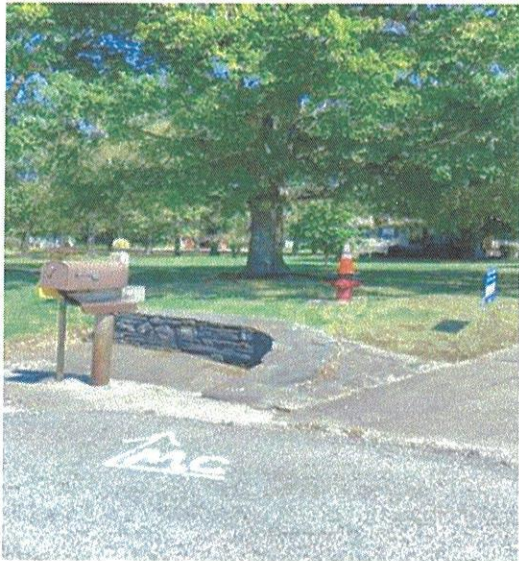
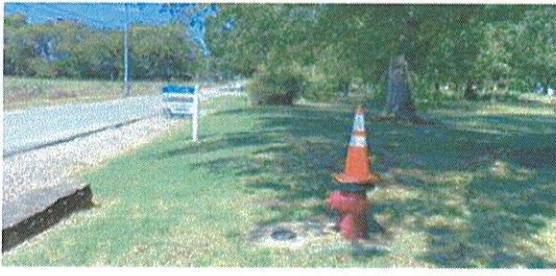
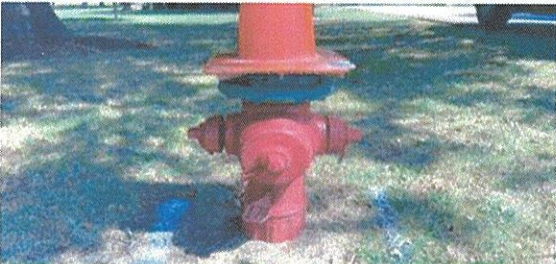
### Leak Card 69

Project:	Mt. Pleasant, Tn 2024 Leak Pinpointing				Address:		330 Cannan Rd			
Urgency:	Minimal	Surface Material:	Grass	Leak Type:	Fitting	Pipe Size:	6	Pipe Material:	DI	
Leak Detection Method:	Sounding		Visible Water:	No	DB level:	66	Person Submitted To:	Mr. Tim Howell		
MC Estimated GPM	Gallons Per Minute:		0.25		Vicinity Map -87.19033301499996 35.56059582000006 Leak					
	Gallons Per Day:		360							
	Gallons Per Month:		10,950

Gallons Per Year:		131,400							
Leak Description & Comments:										
Distribution leak detected on fire hydrant 179. Hydrant is believed to be partially open.

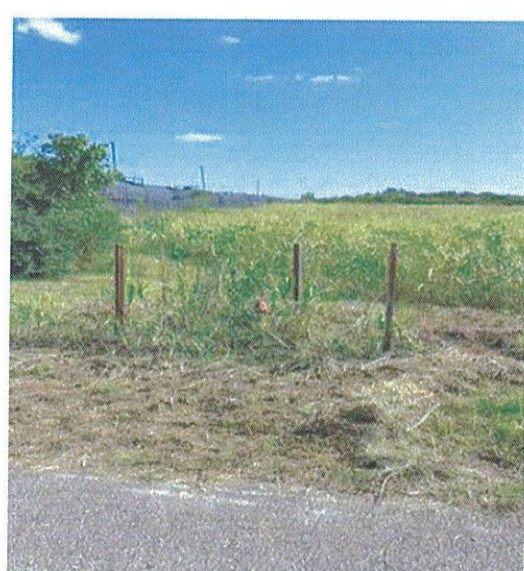
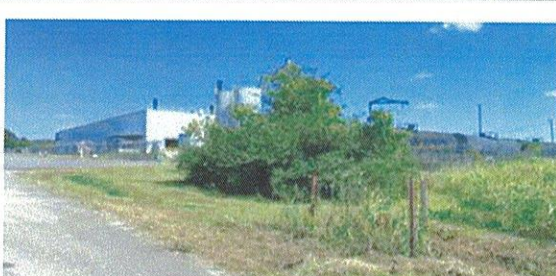
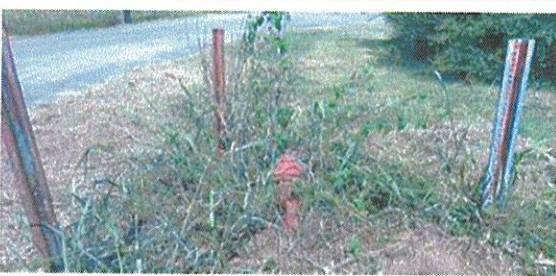
### Leak Card 70

<b>Project:</b>	Mt. Pleasant, Tn 2024 Leak Pinpointing				<b>Address:</b>	350 Magnolia Dr			
<b>Urgency:</b>	Minimal	<b>Surface Material:</b>	Grass	<b>Leak Type:</b>	Fitting	<b>Pipe Size:</b>	2	<b>Pipe Material:</b>	DI
<b>Leak Detection Method:</b>	Sounding		<b>Visible Water:</b>	No	<b>DB level:</b>	99	<b>Person Submitted To:</b>	Mr. Tim Howell	
<b>MC Estimated GPM</b>	<b>Gallons Per Minute:</b>		0.5		<b>Vicinity Map</b> -87.19479809199998 35.554102055000044 Leak

Esri Community Maps Contributors, © O... Powered by Esri				
	<b>Gallons Per Day:</b>		720						
	<b>Gallons Per Month:</b>		21,900						
	<b>Gallons Per Year:</b>		262,800						
<b>Leak Description &amp; Comments:</b>									
Distribution lake detected on 2 inch hydrant. Hydrant is believed to be partially open.

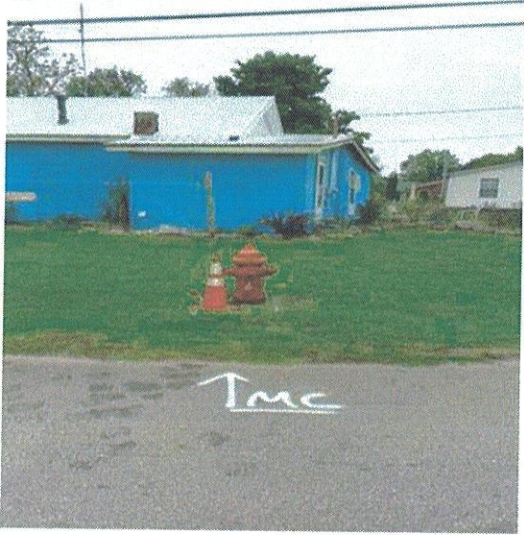
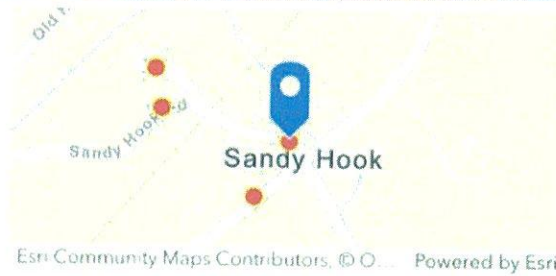
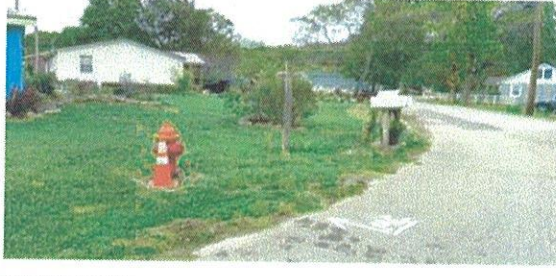
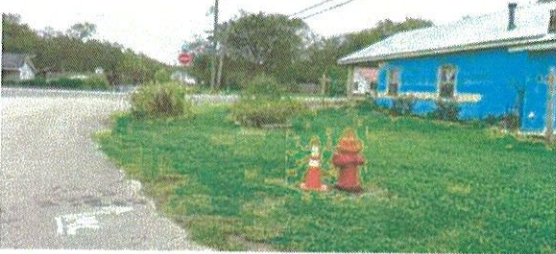
### Leak Card 83

Project:	Mt. Pleasant, Tn 2024 Leak Pinpointing				Address:		8338 Lawrenceburg Hwy			
Urgency:	Minimal	Surface Material:	Grass	Leak Type:	Fitting	Pipe Size:	6	Pipe Material:	DI	
Leak Detection Method:	Sounding		Visible Water:	No	DB level:	66	Person Submitted To:		Mr. Tim Howell	
MC Estimated GPM	Gallons Per Minute:		0.25		Vicinity Map -87.23795093499996 35.483610147000036 Leak					
	Gallons Per Day:		360							
	Gallons Per Month:		10,950							
	Gallons Per Year:		131,400							
Leak Description & Comments:  Distribution leak detected on fire hydrant. Noises isolated to the hydrant. Hydrant is believed to be partially open.
