## Colorado River Basin Regional Water Quality Control Board

**TO:** Discharger File: WDID 7B360110014, City of Needles Wastewater Treatment Plant, Board Order R7-2015-0018

**SUBJECT:** Facility Inspection Report

**FACILITY:** City of Needles, City of Needles Wastewater Treatment Plant, San Bernardino County

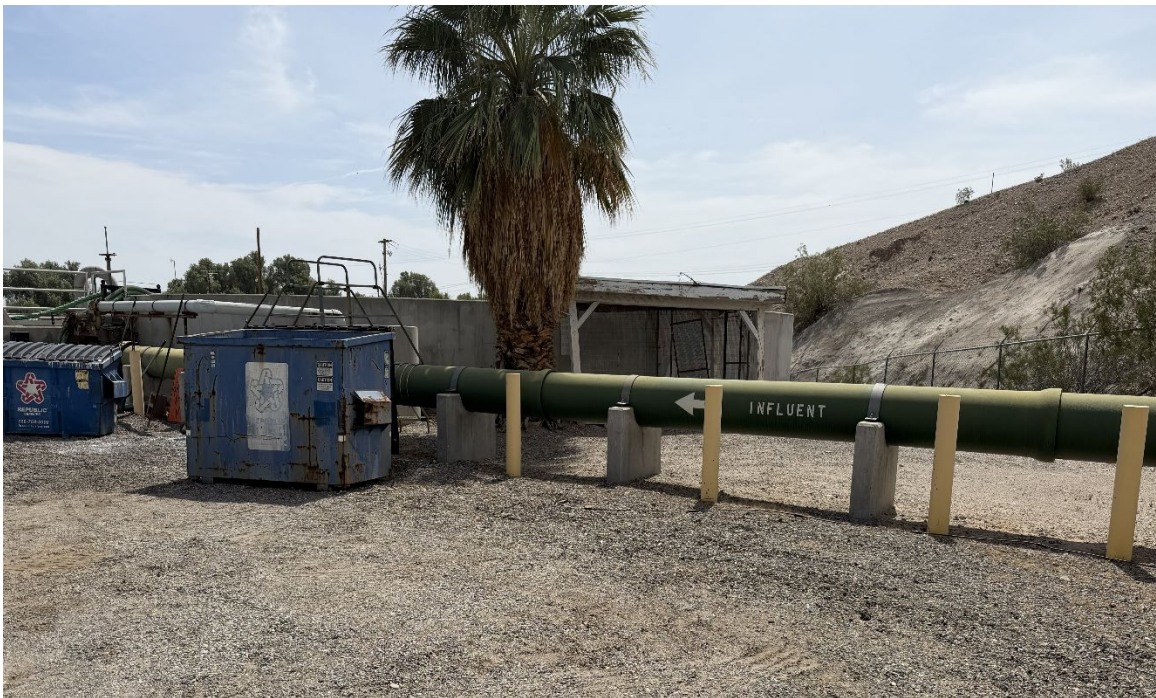
*Figure 2. The influent wastewater pipeline routes wastewater from the sewer collection system to the treatment plant and is clearly labeled. The influent pipeline is located on the east side of the Facility.*

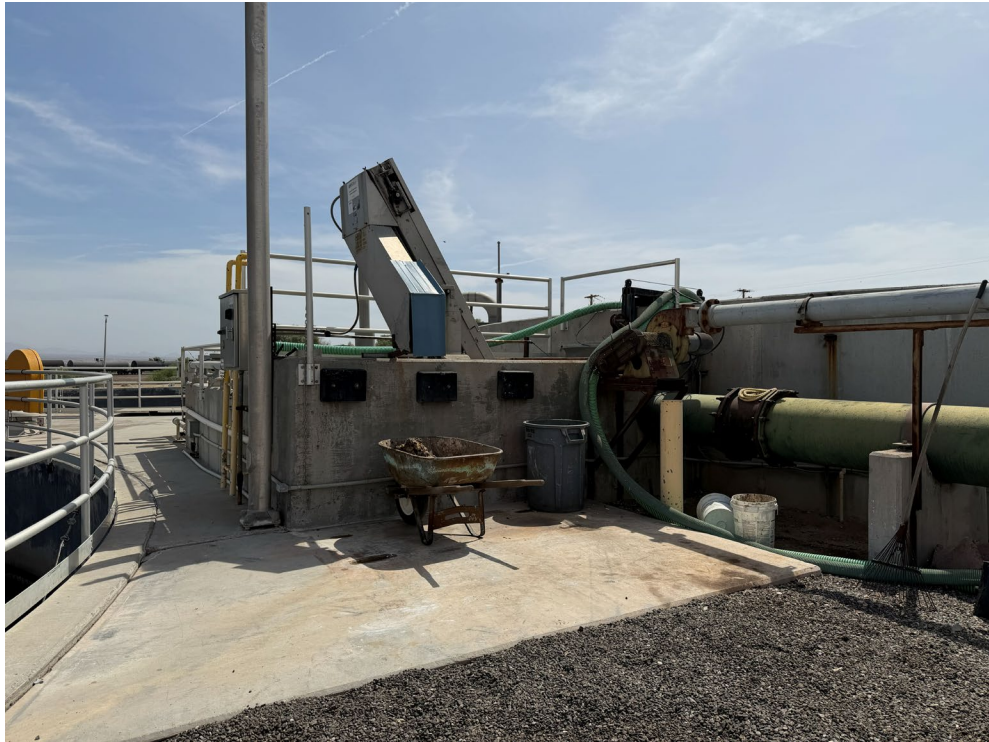
*Figure 3. A mechanical bar screen removes larger solids from the influent wastewater. Solids are collected in the wheelbarrow and hauled.*

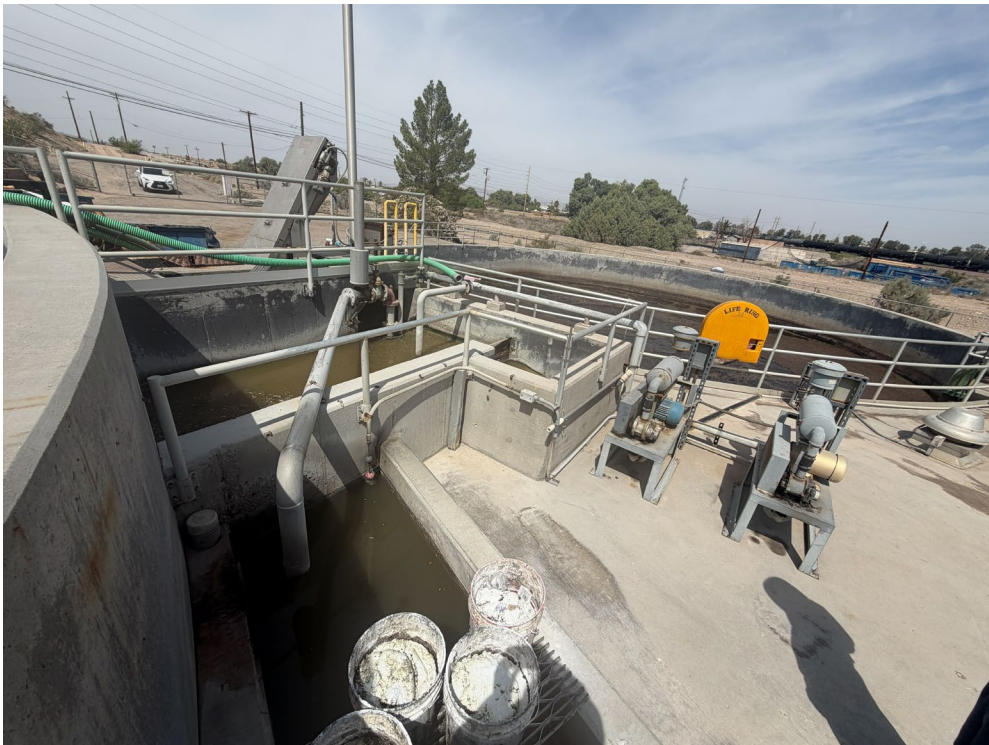
*Figure 4 The aerated grit chamber that utilizes an airlift pump that operates 24 hours a day. Grit is collected in 5-gallon buckets, and lime is placed on top to help limit vectors and odors.*

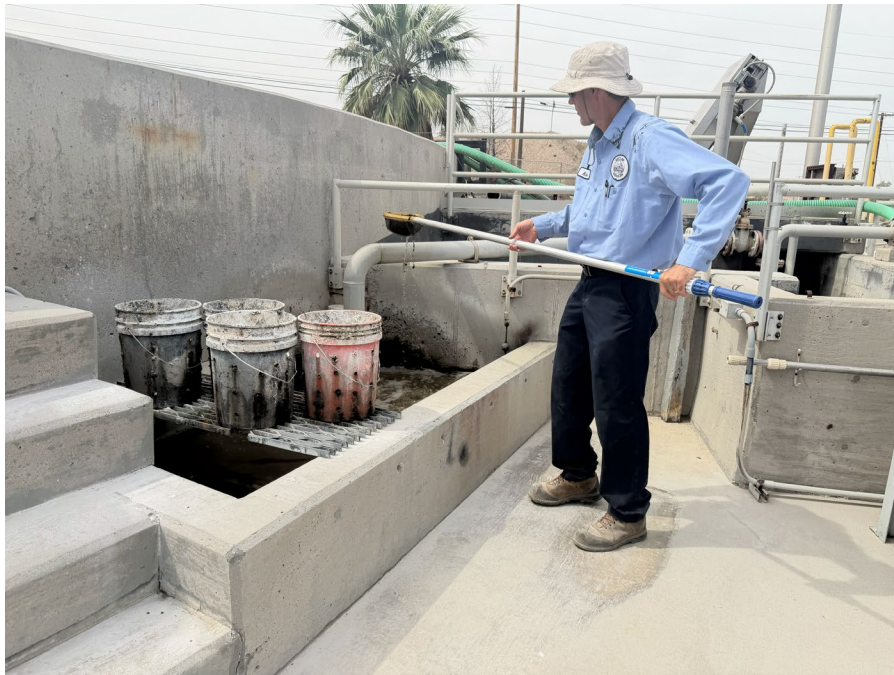
*Figure 5. The airlift pump is in operation, and the operator is scooping out grit from the grit settling zone and placing the collected grit in the five-gallon buckets.*

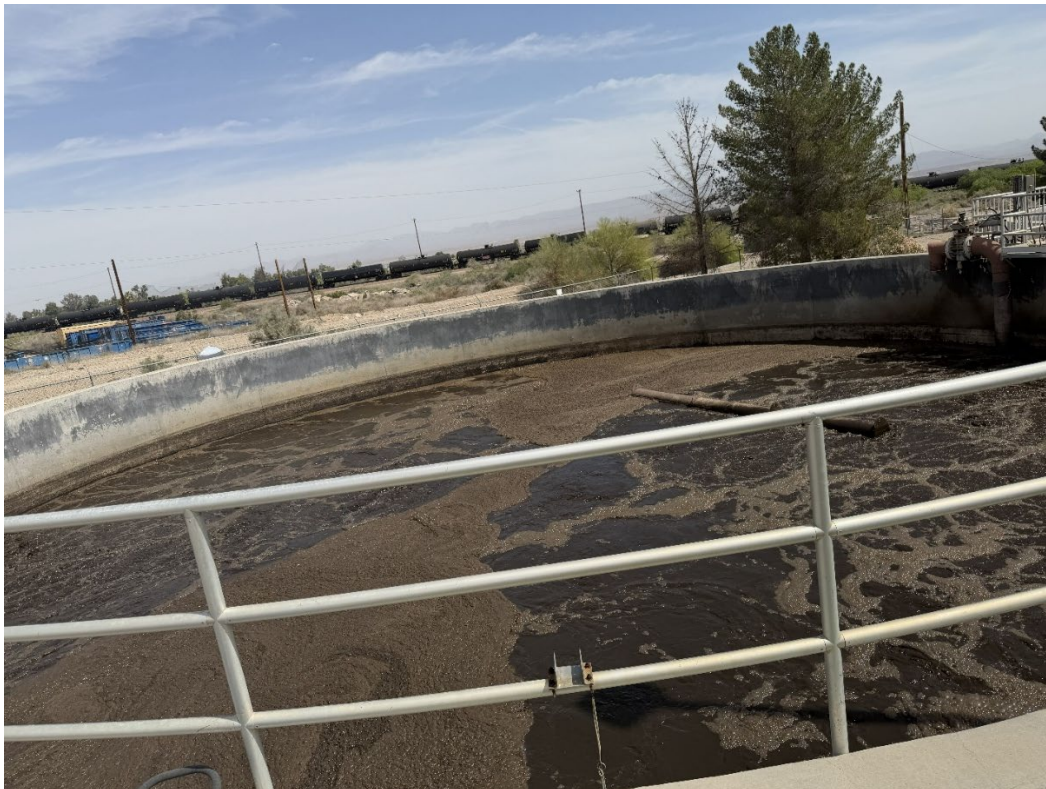
*Figure 6. SBR No. 1 in operation at the time of inspection. Each SBR is designed to treat 600,000 gpd and provides equalization, aeration, and clarification into a single timed sequence in one reactor basin.*

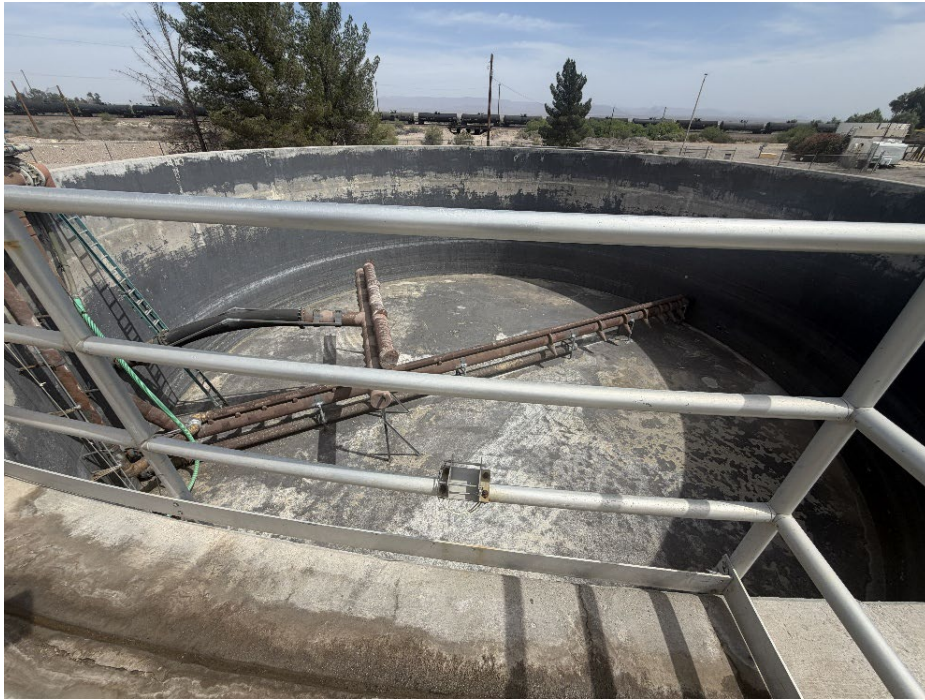
*Figure 7. SBR No. 2 not in operation due to yearly maintenance. Typically, one SBR is in operation at a time.*

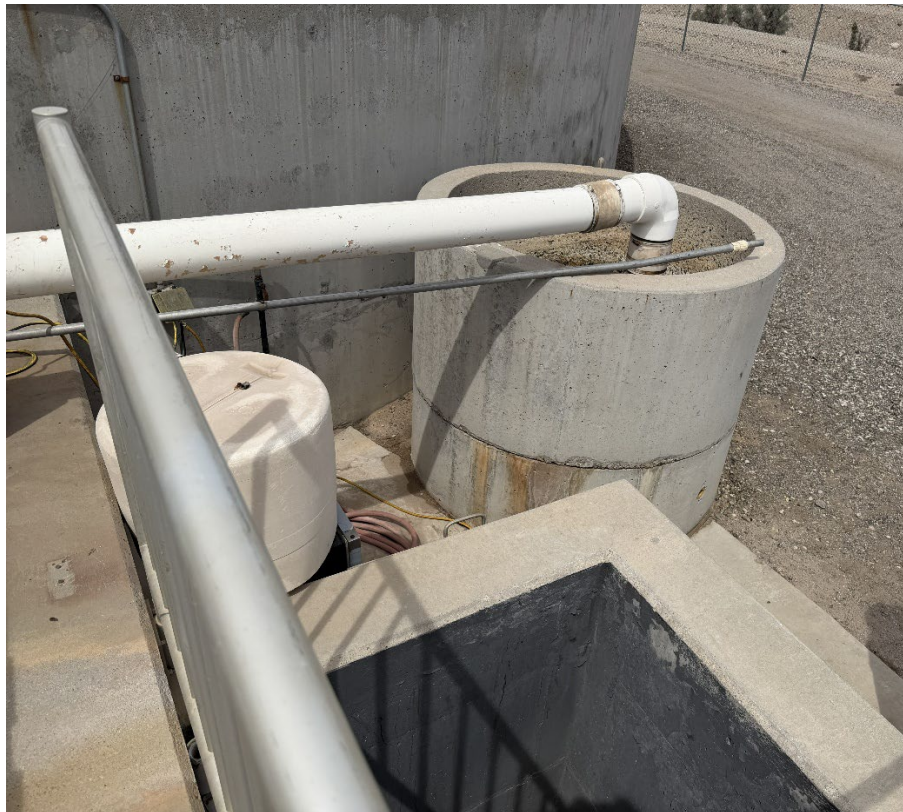
*Figure 8. The effluent wet well shown in the foreground. Effluent samples are taken from the effluent wet well using an automated composite sampler located to the left. In the background a wood chip basin is used for odor control.*

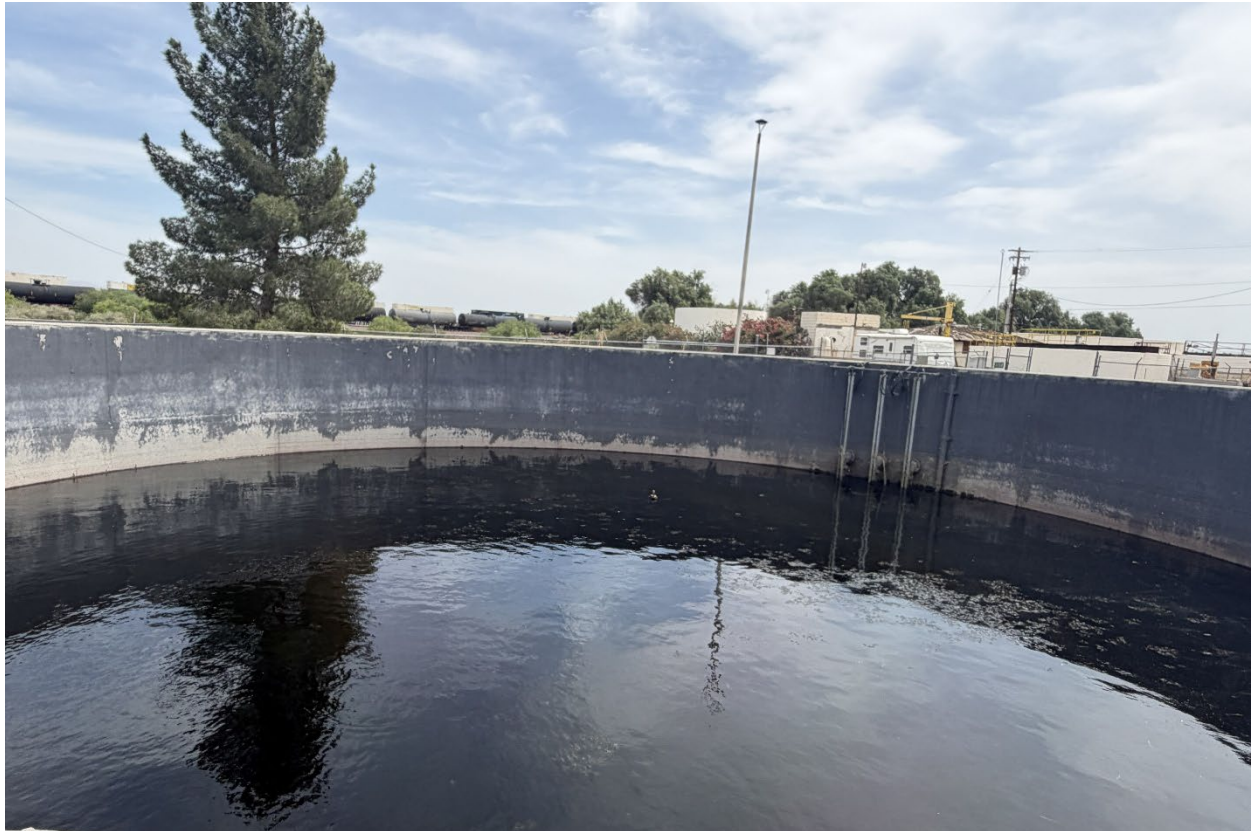
*Figure 9. The effluent equalization basin stores treated wastewater. Treated wastewater from the effluent equalization basin is pumped to the evaporation/percolation ponds.*

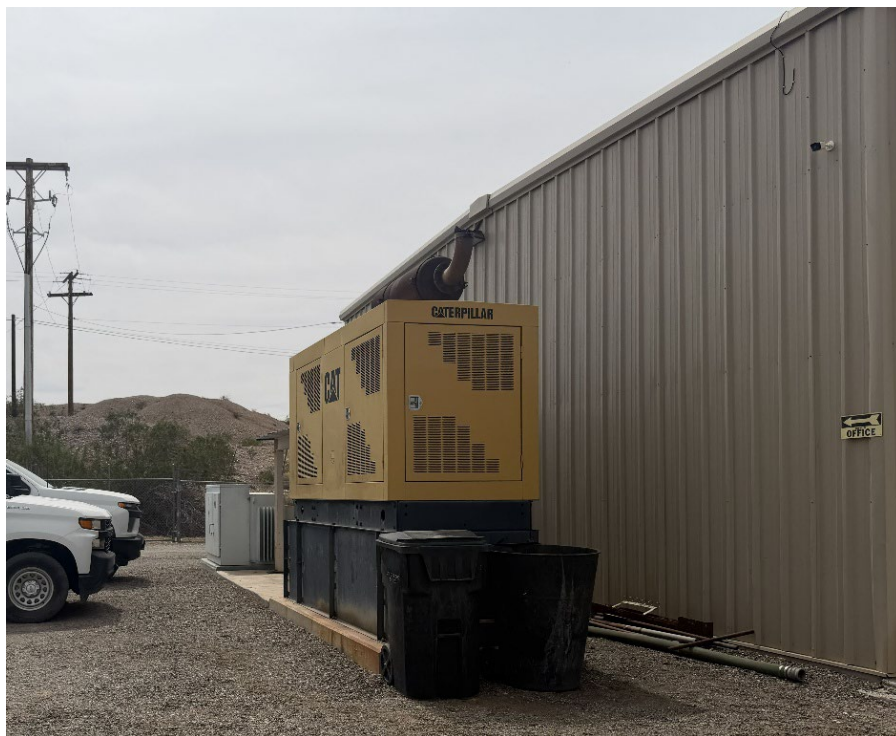
*Figure 10. The emergency generator provides power to run the Facility in the event of a power outage.*

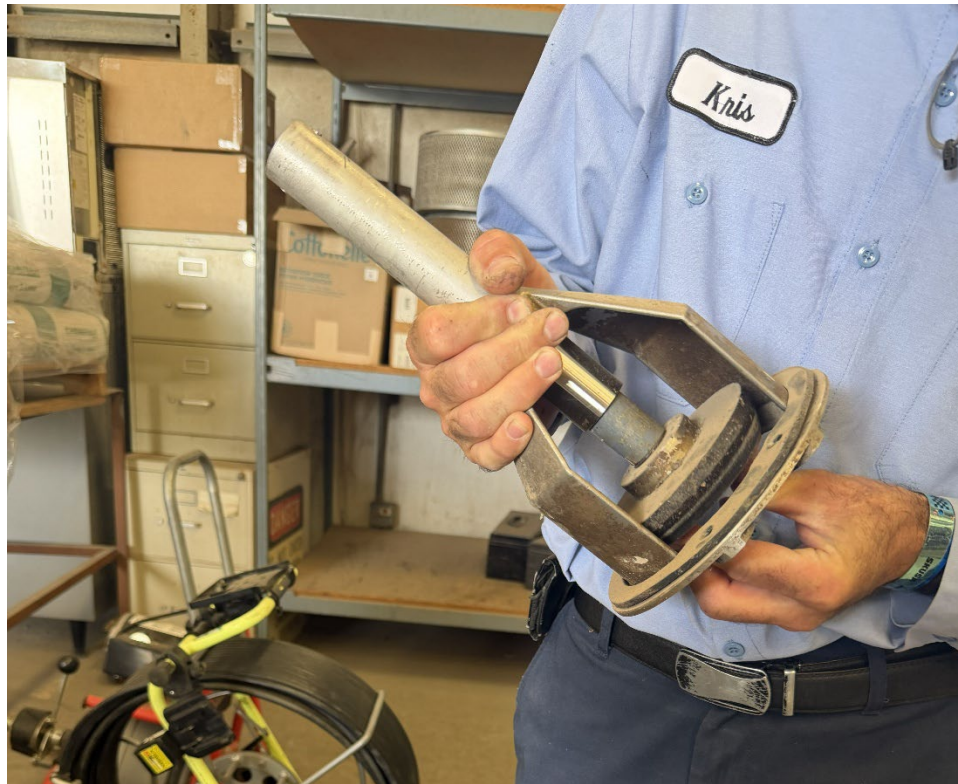
Figure 11. The solids excluding valve, which is controlled by pressure/head loss differential, was shown in the open and closed position.

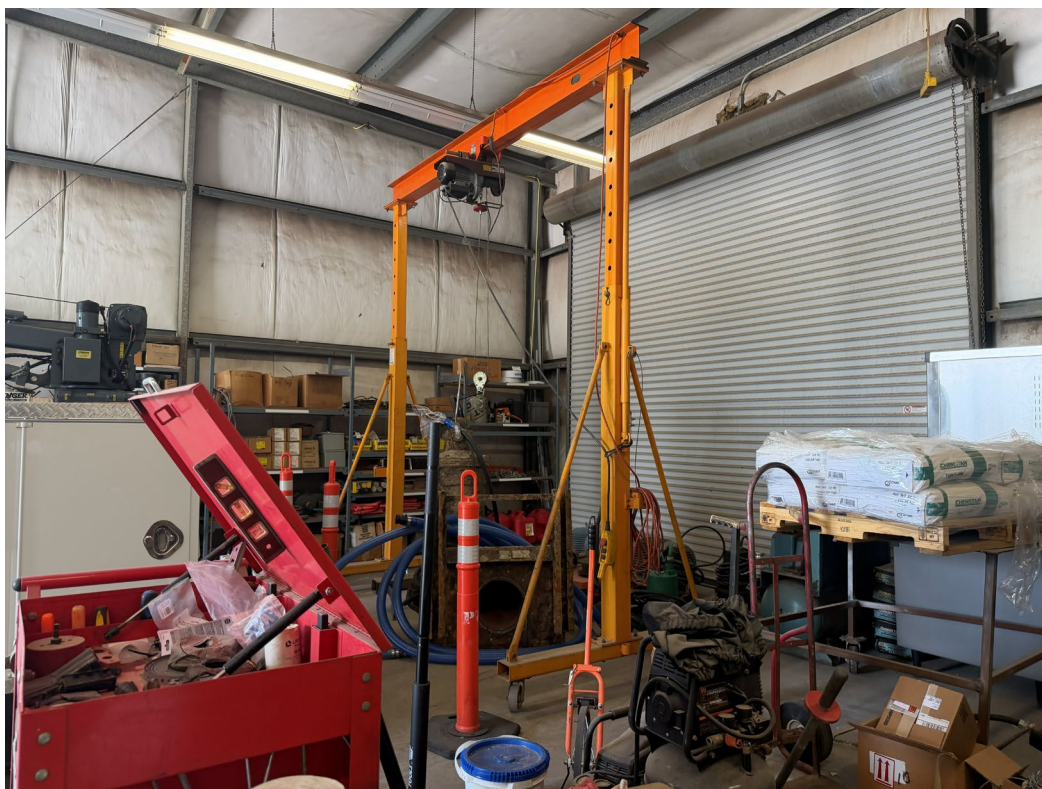
Figure 12. The workshop where spare parts/equipment are stored. A motive pump was observed.

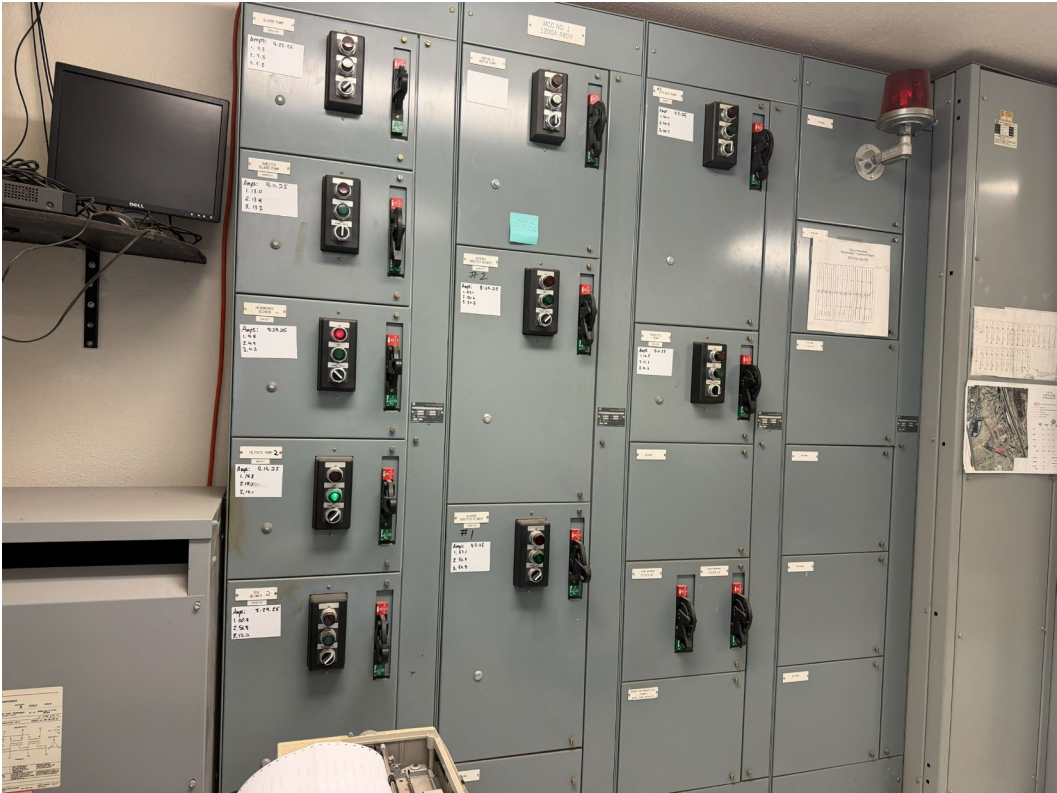
Figure 16 A motor control center located in the main office.

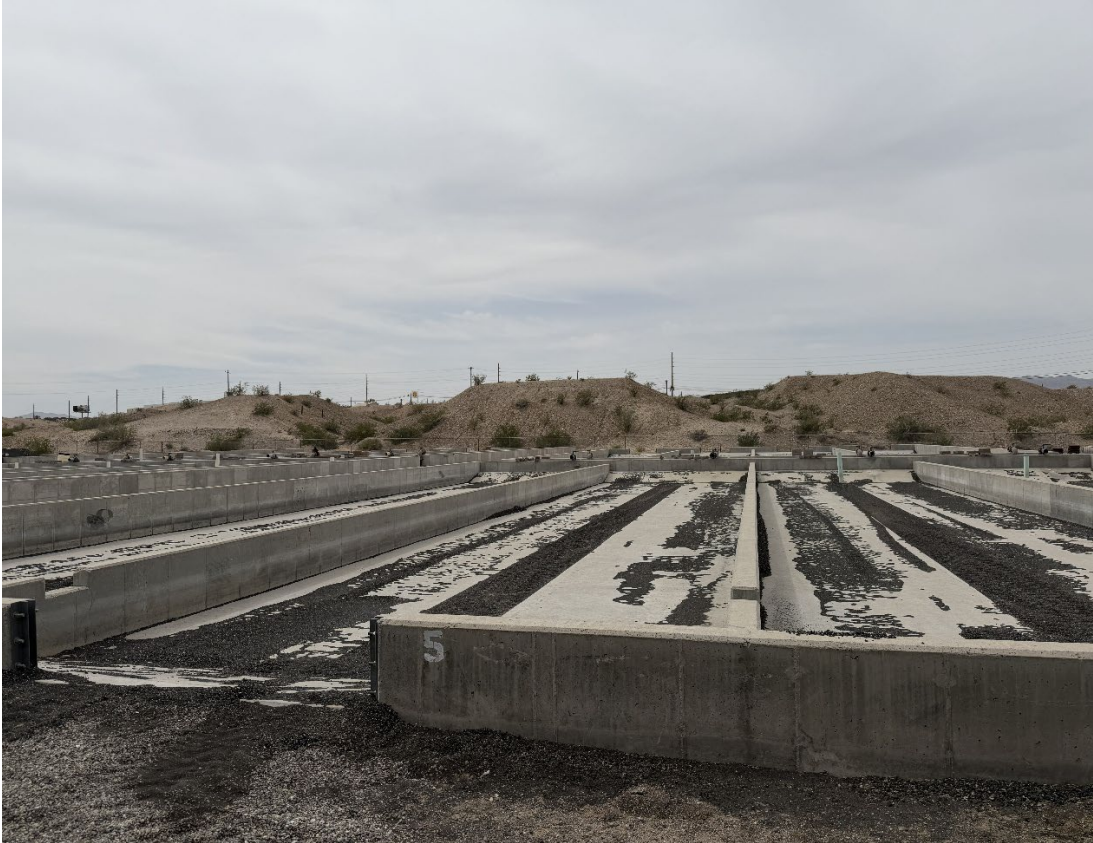
Figure 16. Sludge drying beds. There are a total of twenty-four sludge drying beds onsite.

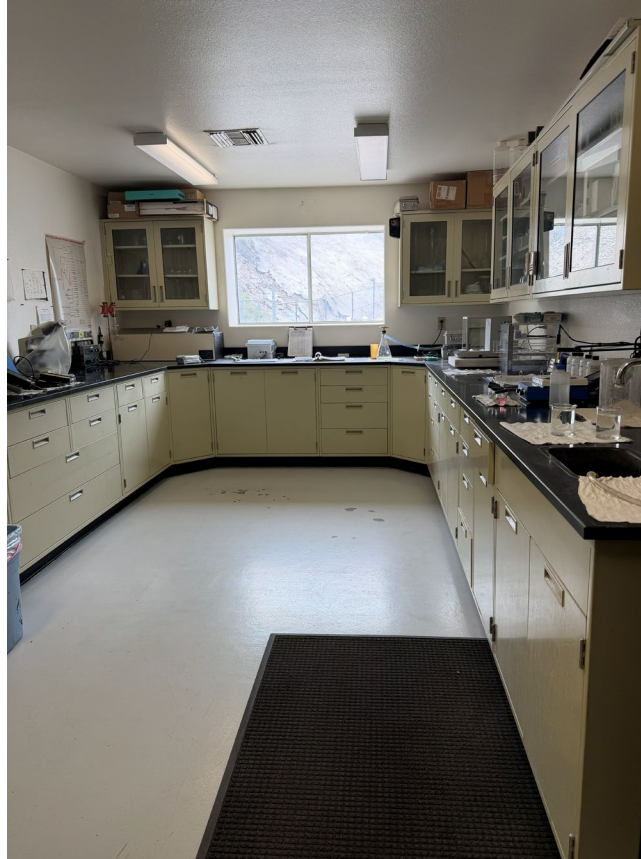
*Figure 17. The onsite laboratory is adjacent to the main office. Laboratory tests are conducted to measure pH, total suspended solids, dissolved oxygen, ammonia, nitrate/nitrite for process control.*

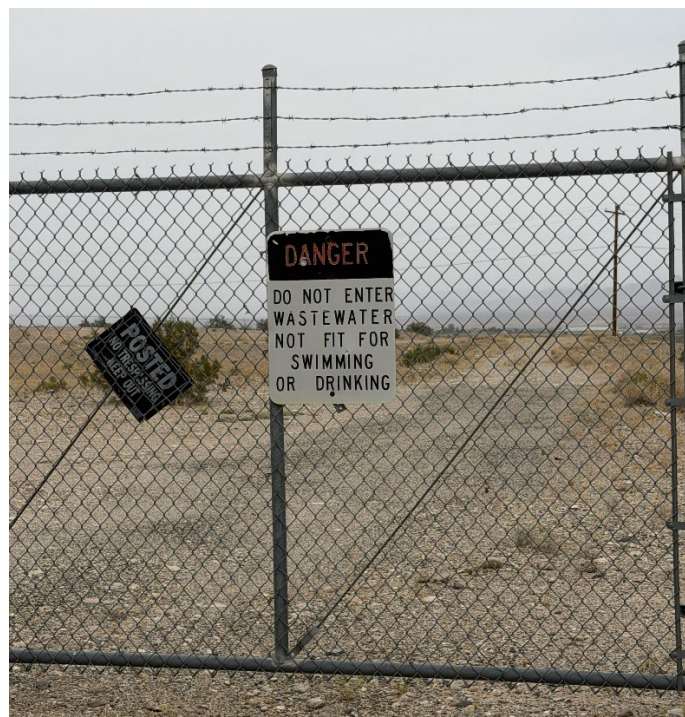
*Figure 18. Evaporation/percolation pond area properly fenced and proper signage observed.*

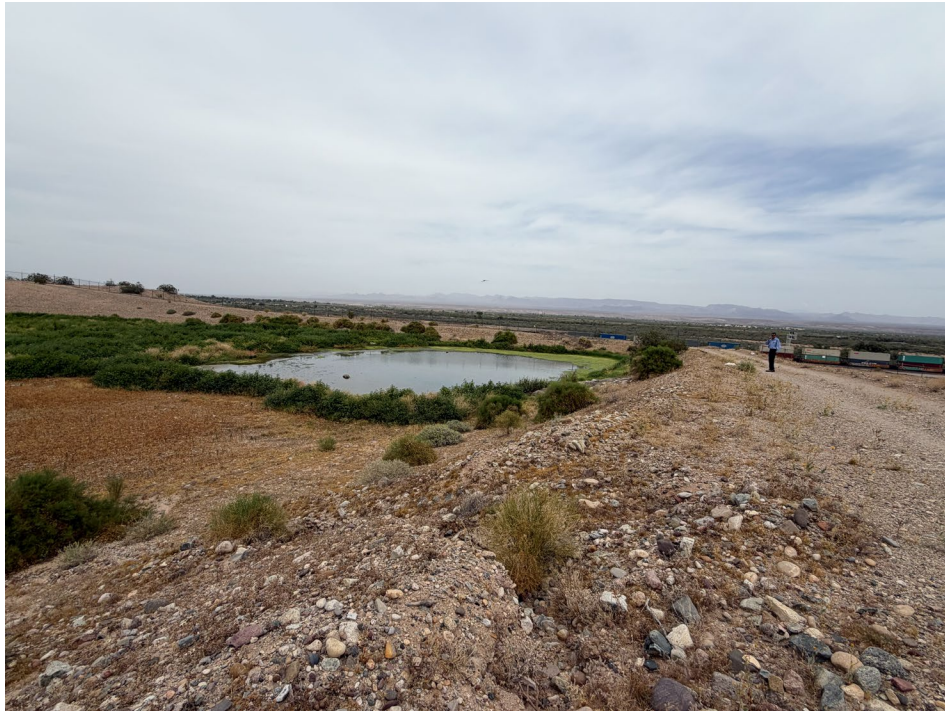
*Figure 19. Evaporation/percolation Pond No. 2 was the only pond receiving treated wastewater flows at the time of inspection. Approximately less than a quarter of the pond was observed to be filled with treated wastewater.*

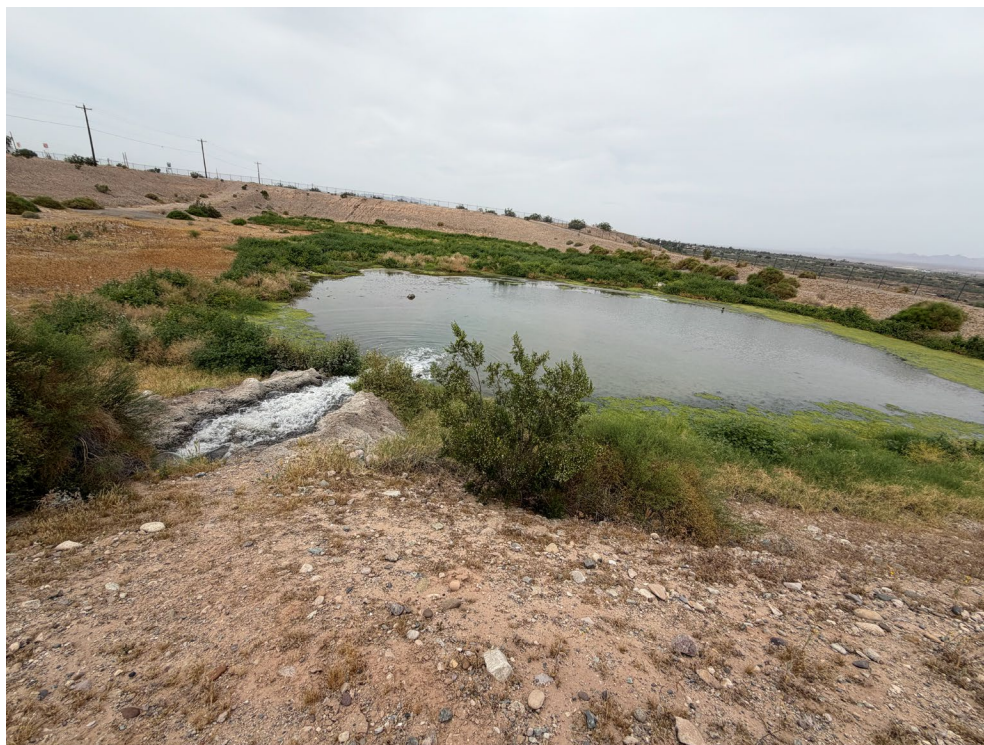
*Figure 20. The influent pipe to Evaporation/percolation Pond No. 2 was observed.*

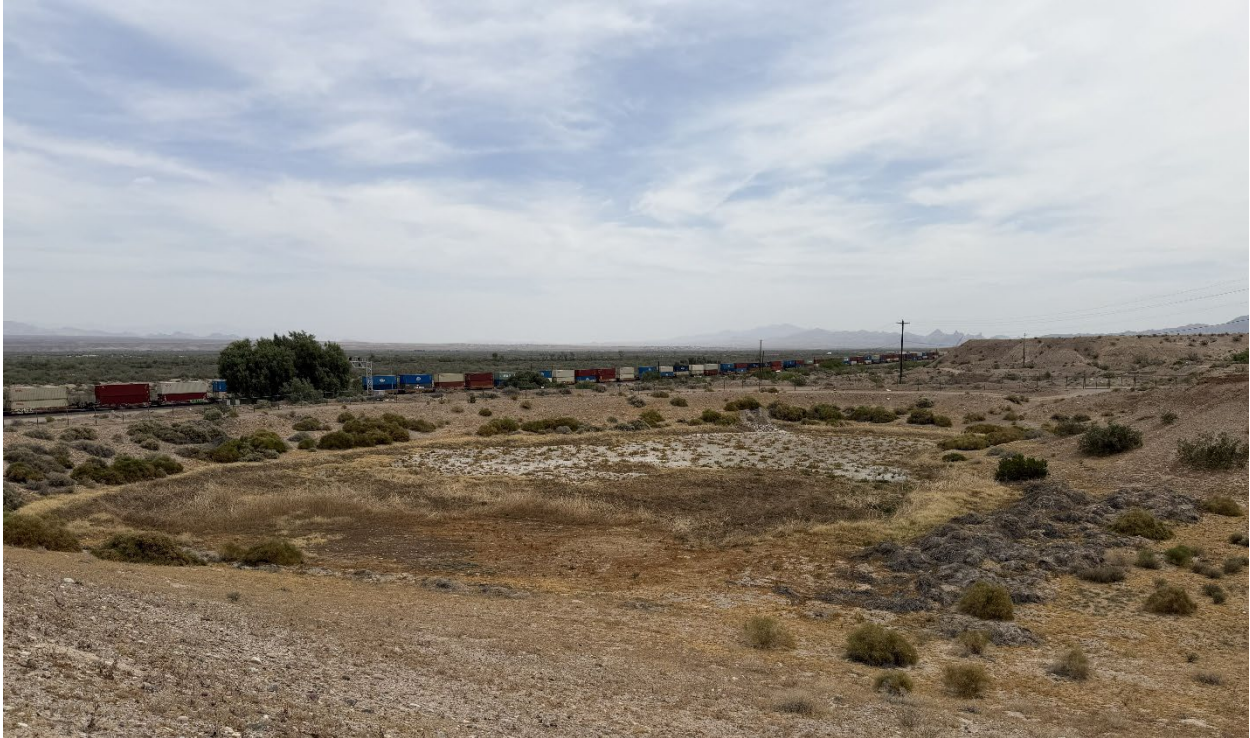
*Figure 21. Evaporation/percolation Pond No.3 not in use at the time of inspection.*
