Roof Service Work Proposal For:
Public Library – Slate to Brick Flashing Repair

Newmarket Town Library
1 Elm St
Newmarket, NH 03857 USA

**Roof Service Work Proposal For:
Public Library – Slate to Brick Flashing Repair**

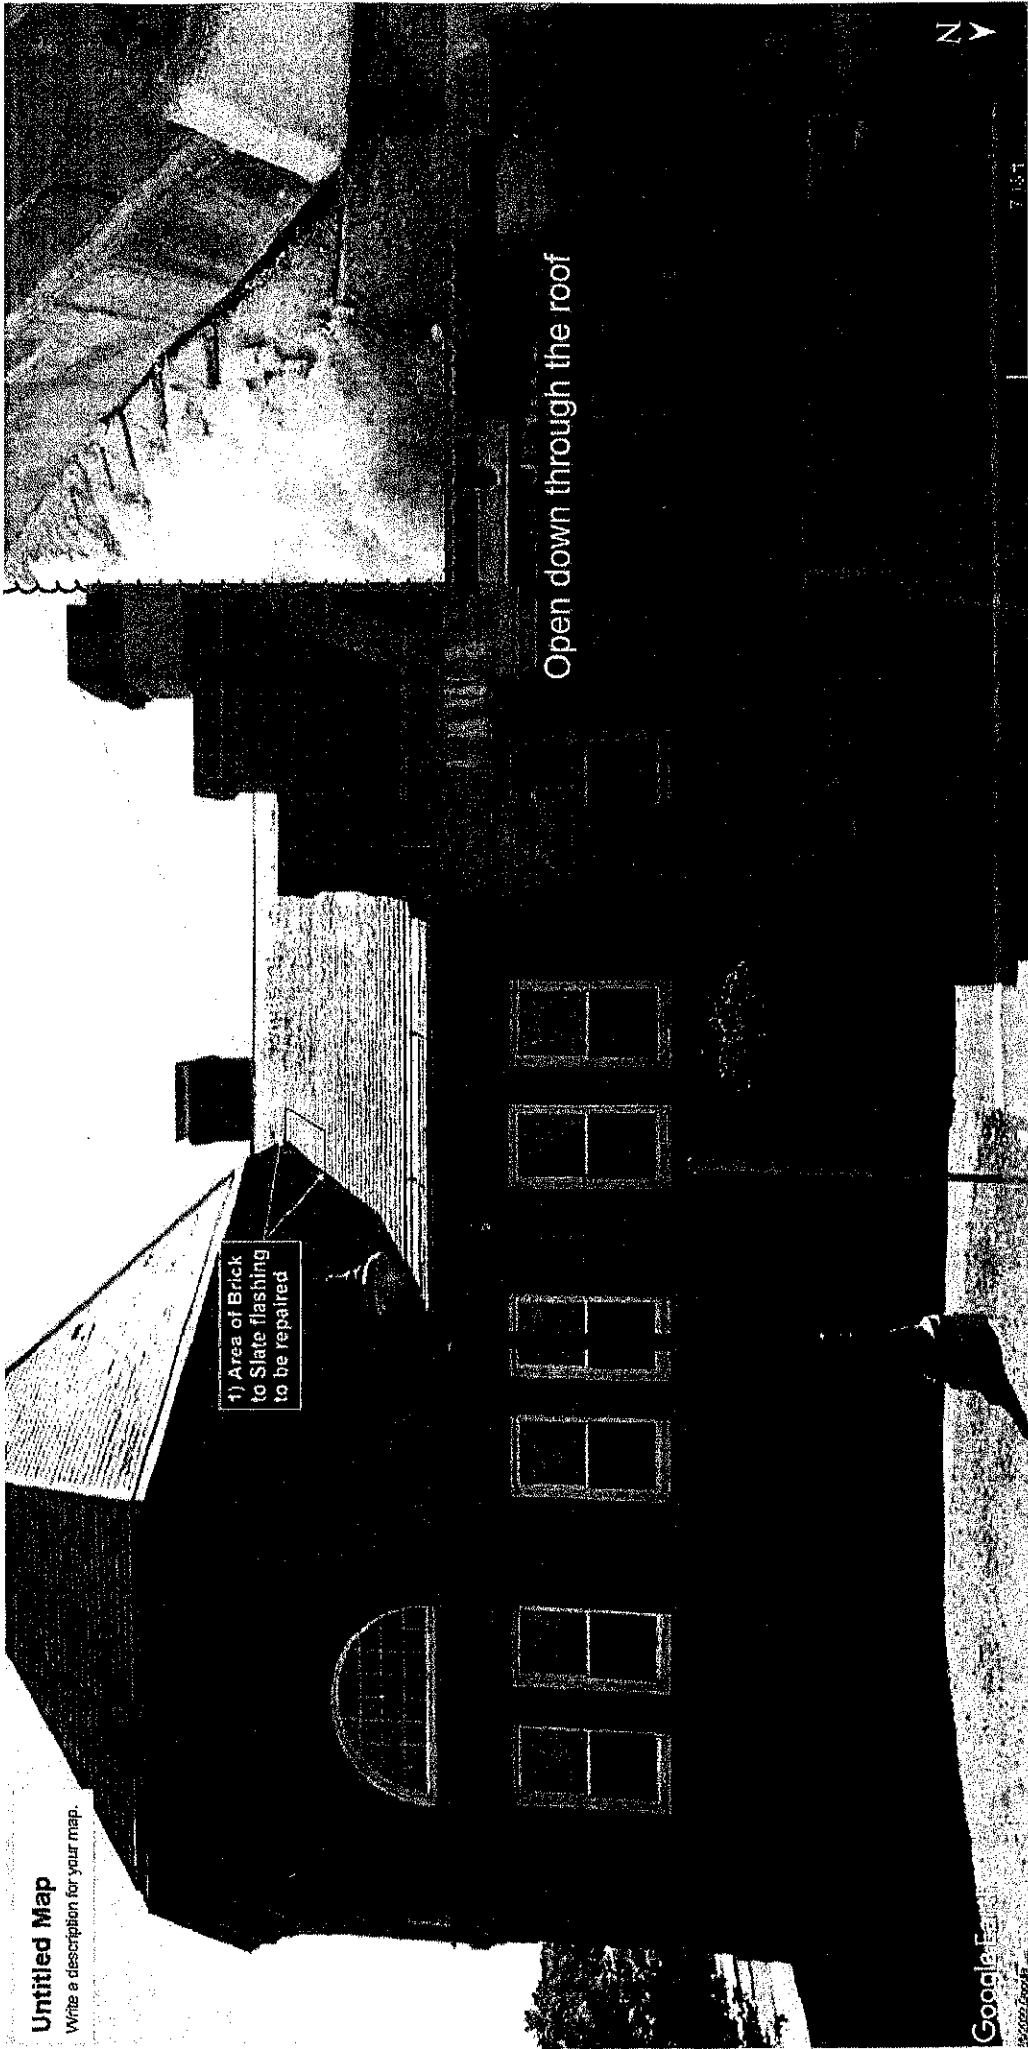
1) Area of Brick
to Slate flashing
to be repaired

Open down through the roof

- [REDACTED]
- Set up Safety Zone in front of work area, this may impact the ADA access ramp and close it for short periods.
 - Remove and preserve (some may break on removal and will be replaced as needed) slate shingles
 - Remove existing brick surface mounted lead coated copper counter flashing
 - Furnish and Install Grace Ultra High Temp Ice/Watershield as a waterproof Selfsealing underlayment for the shingles and brick counter flashing.
 - Furnish and install New Lead Coated Copper Step Flashing in too the brick and under slate
 - Replace original Slate and replace any slate damaged during the removal process.
 - Remove all safety zone set up
- [REDACTED]
