Re: Poor Condition of Locker Rooms at the Nome Recreation Center

Locker Room Pictures

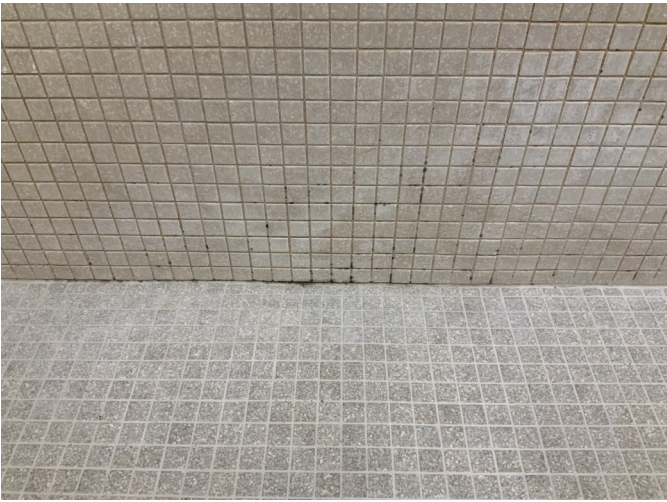
Mold in Grout of Men's Showers: Once mold gets into grout it is impossible to remove. Staff have tried numerous ways to remove it and none have been successful.

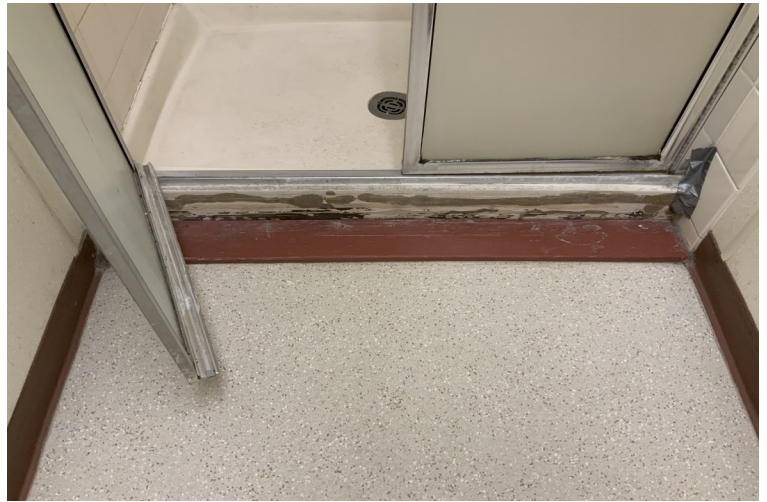
Rotten Flooring and Sub-Flooring: Water has been escaping the shower pan in one of the single showers in the ladies' locker room leading to rotten flooring and unsafe conditions.

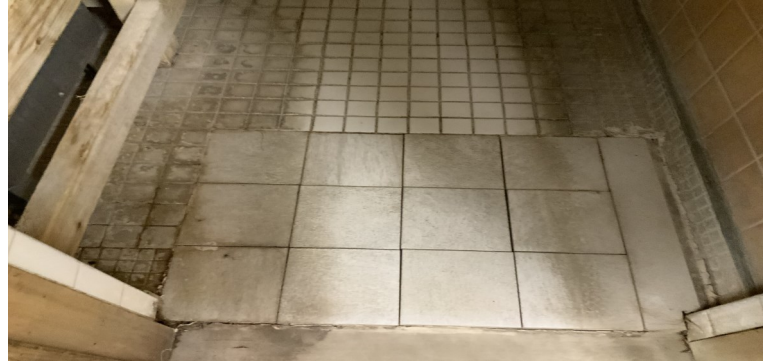
Worn Out from Heavy Usage: The women's sauna is in particularly poor condition. Years of neglect have led to loss of grout and rotten subflooring. Floor has hard water stains throughout.

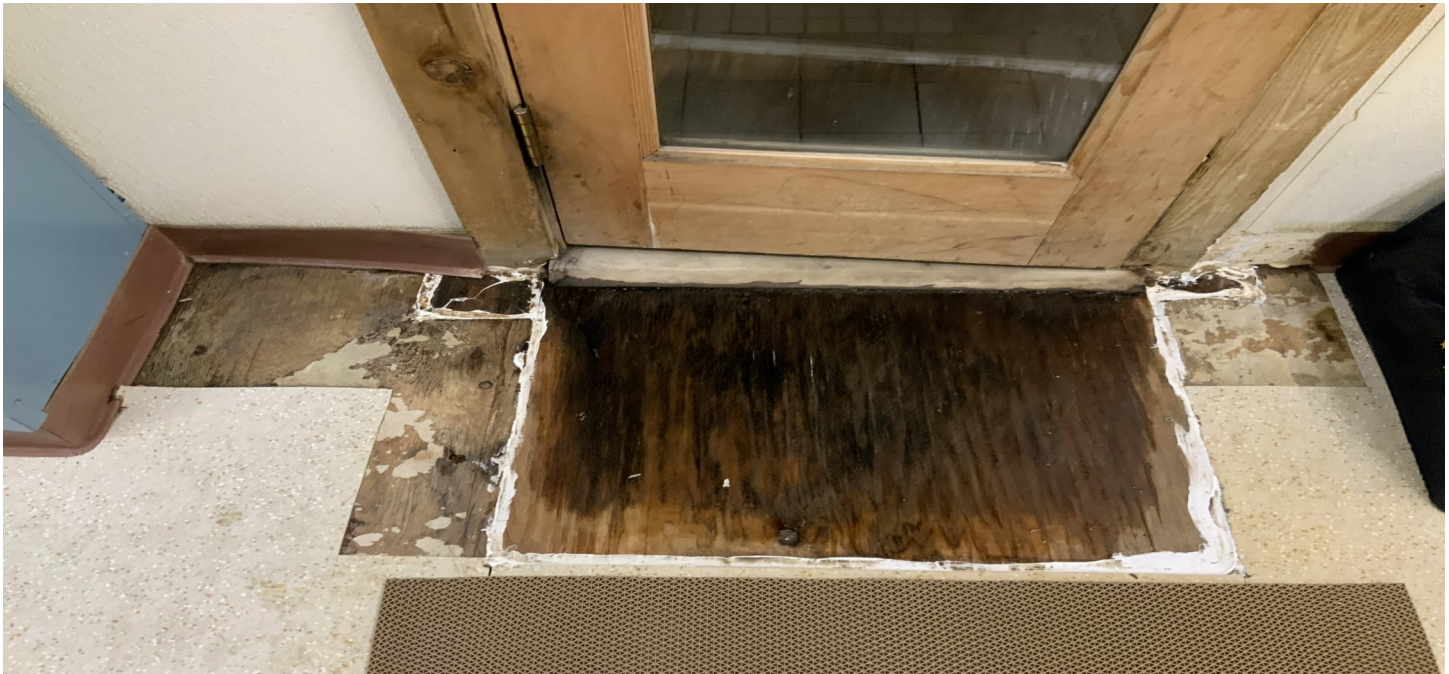
Beyond Repair: Years of water flowing out of the women's sauna has rotted the threshold, flooring and sub-flooring. As patrons need to step on this area to enter the sauna there are major safety concerns regarding the possibility that the floor will collapse causing potential injury to a patron.

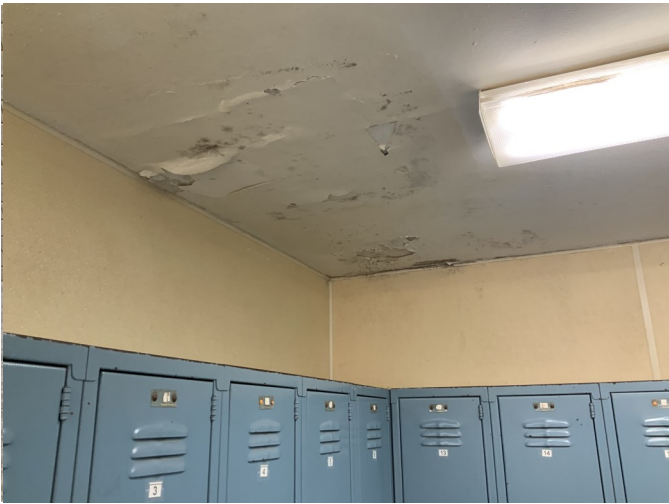
Mold Growing on the Ceiling: Lack of ventilation has led to mold growth on the ceiling of the men's locker room. The build-up of moisture is making the plaster peel.

- **Installation of Ventilation Systems:** Implementing a modern air handling system will improve air quality by facilitating proper airflow and reducing humidity levels. This can help eliminate odors and create a more comfortable environment.
- **Temperature Control:** Advanced HVAC systems can regulate temperatures effectively, ensuring that locker rooms remain comfortable year-round.

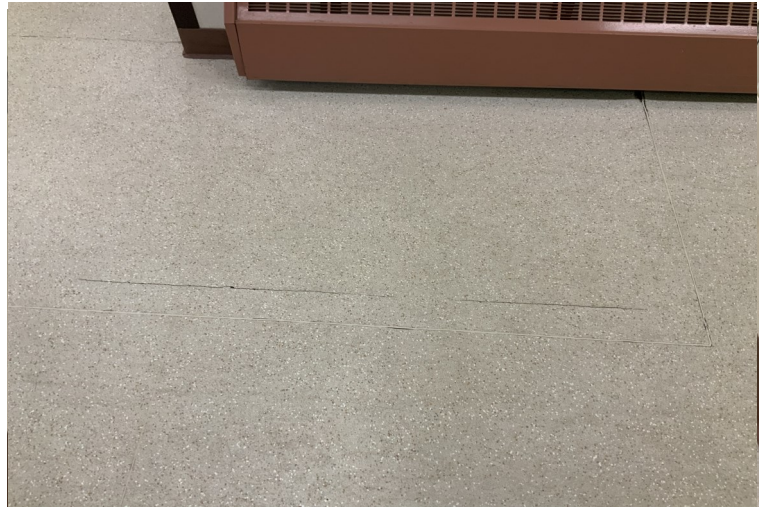
Old Worn Flooring: Heavy traffic and repeated use have led to cracks forming on the floor of the women's locker room. As the degradation continues water will seep down into the subfloor.

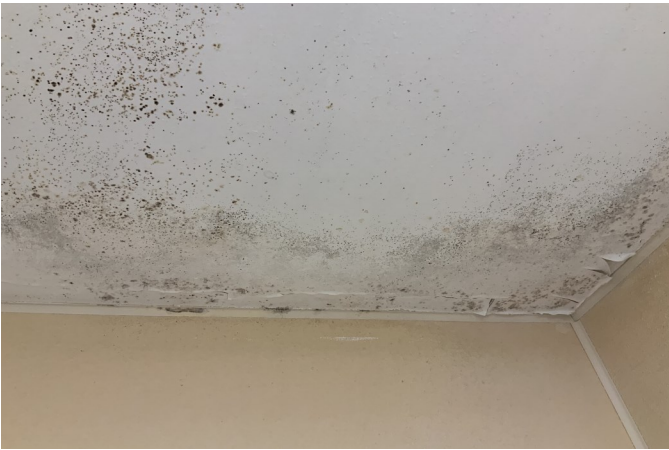
More Mold in the ceilings: The existence of mold is pervasive throughout the ceiling areas of both locker room ceilings.

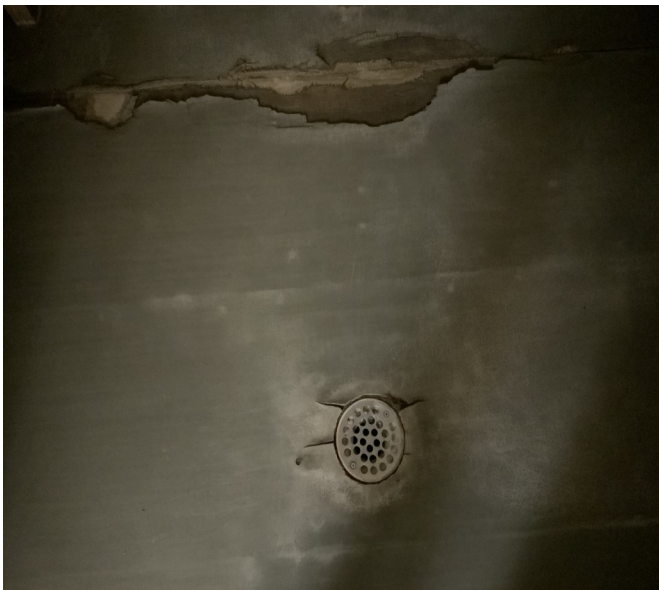
Compromised Floor in Men's Sauna: The last time the men's sauna floor was fixed it was not graded to drain properly leading to failure in the flooring seams. Once water began to get underneath it the floor began to peel.

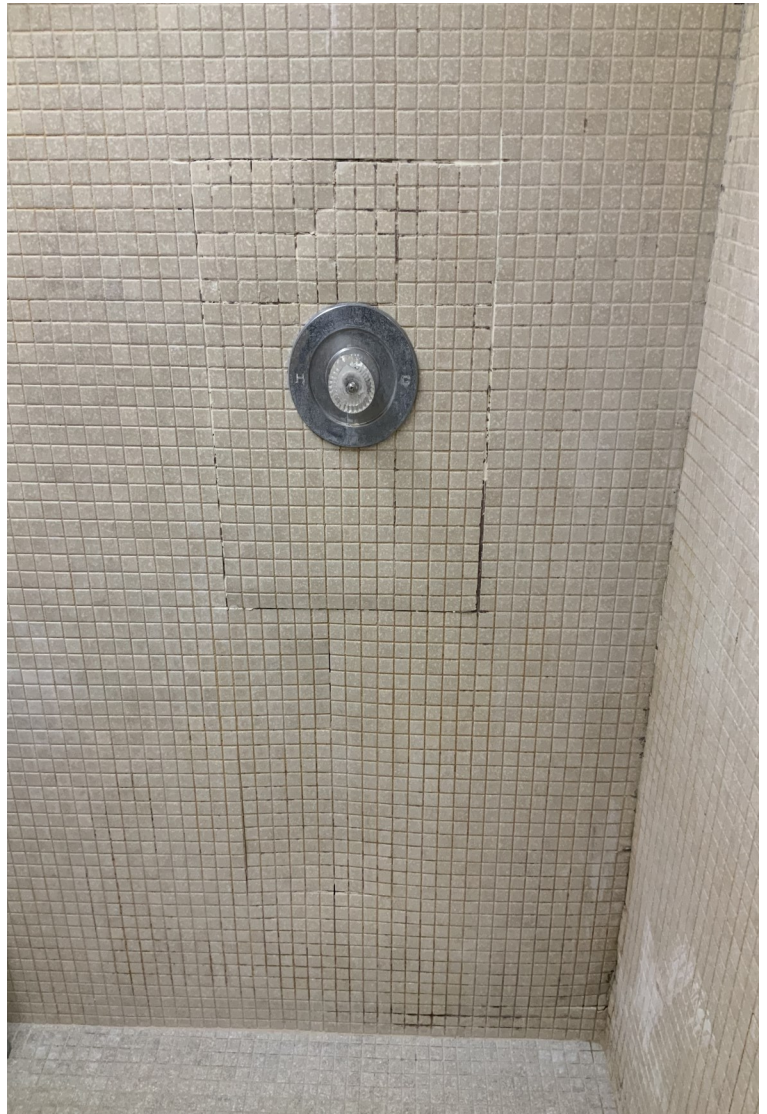
- **Deterioration of Grout/Tile:** In both group shower areas there has been significant degradation of the grout. In the corners most of grout has already been removed and water has penetrated into the walls and down into the subsurface material leading to soft and rotted areas. In the men's locker room some fiberglass reinforced plastic (FRP) has been placed in the corners to add some modicum of protection but we are now experiencing the same thing in the women's locker rooms except along the walls.

Needs Immediate Attention: Water has permeated the tile in the women's group shower so thoroughly that the walls are collapsing as evidenced by the wavy pattern visible above. In the lower right corner it is completely rotted.
