# LOWER IMHOFF CREEK HYDRAULIC & HYDROLOGIC STUDY PROJECT Norman, Oklahoma

**Prepared For:**  
City of Norman, Oklahoma

**Prepared By:**  
Meshek & Associates, PLC  
1437 S Boulder Ave, Suite 1550  
Tulsa, OK 74119  
&  
Amec Foster Wheeler  
245 N Waco Ave, Suite 110  
Wichita, KS 67202

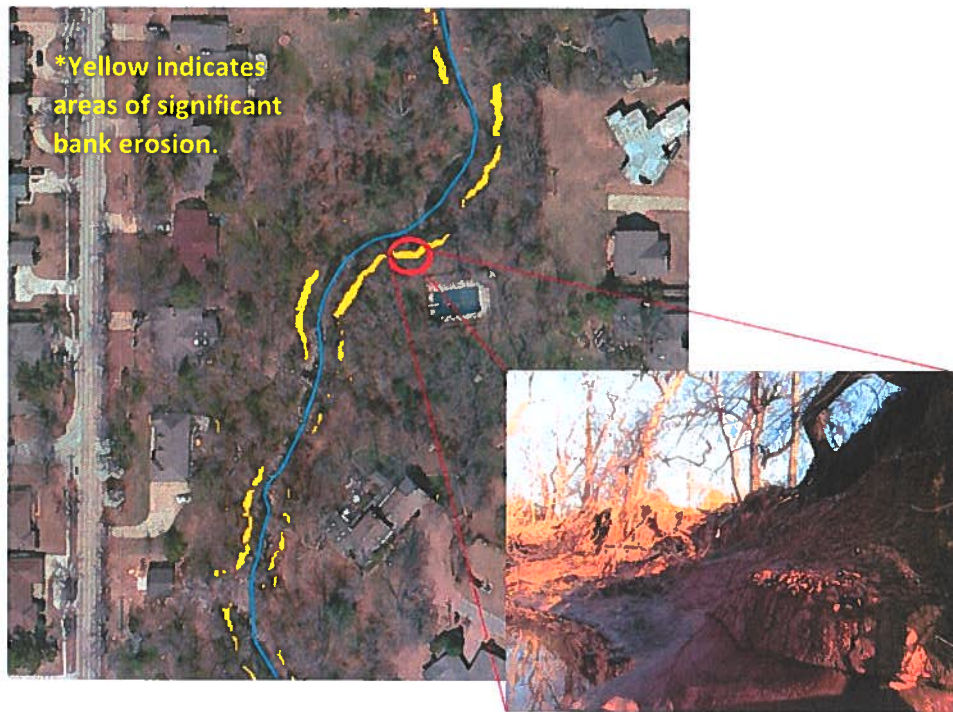
*Figure 3: Example of Site Problem Area*

In addition to the field investigation Amec Foster Wheeler also performed a review of the topographic information to highlight potential problem areas. These areas were identified by developing slope grids of the available topography using GIS processes. Areas identified during the field investigation were used as reference points during the analysis. Multiple areas were flagged in which unstable vertical streambanks were present. The conceptual solutions developed as part of this project were then selected to address these locations. Figure 3 below depicts in yellow an example of some of the locations that were identified as problem areas in the analyses. The areas highlighted in yellow indicate locations in which excessive bank erosion and instability exist.
