Clackamette Cove Water Quality and Habitat Improvement Feasibility Study

August 14, 2017

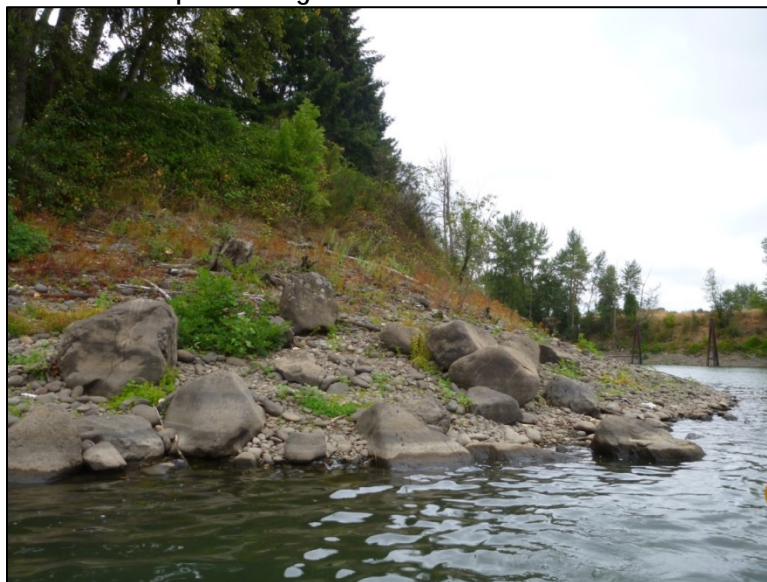
⁹ **Ash Creek Associates, Inc. 2011.** Geotechnical Assessment Clackamette Cove Development Oregon City, Oregon, Ash Creek Associates, Portland, OR.
https://www.orcity.org/sites/default/files/fileattachments/planning/project/6059/exhibit_g.2_geotechnical_assessment_0.pdf

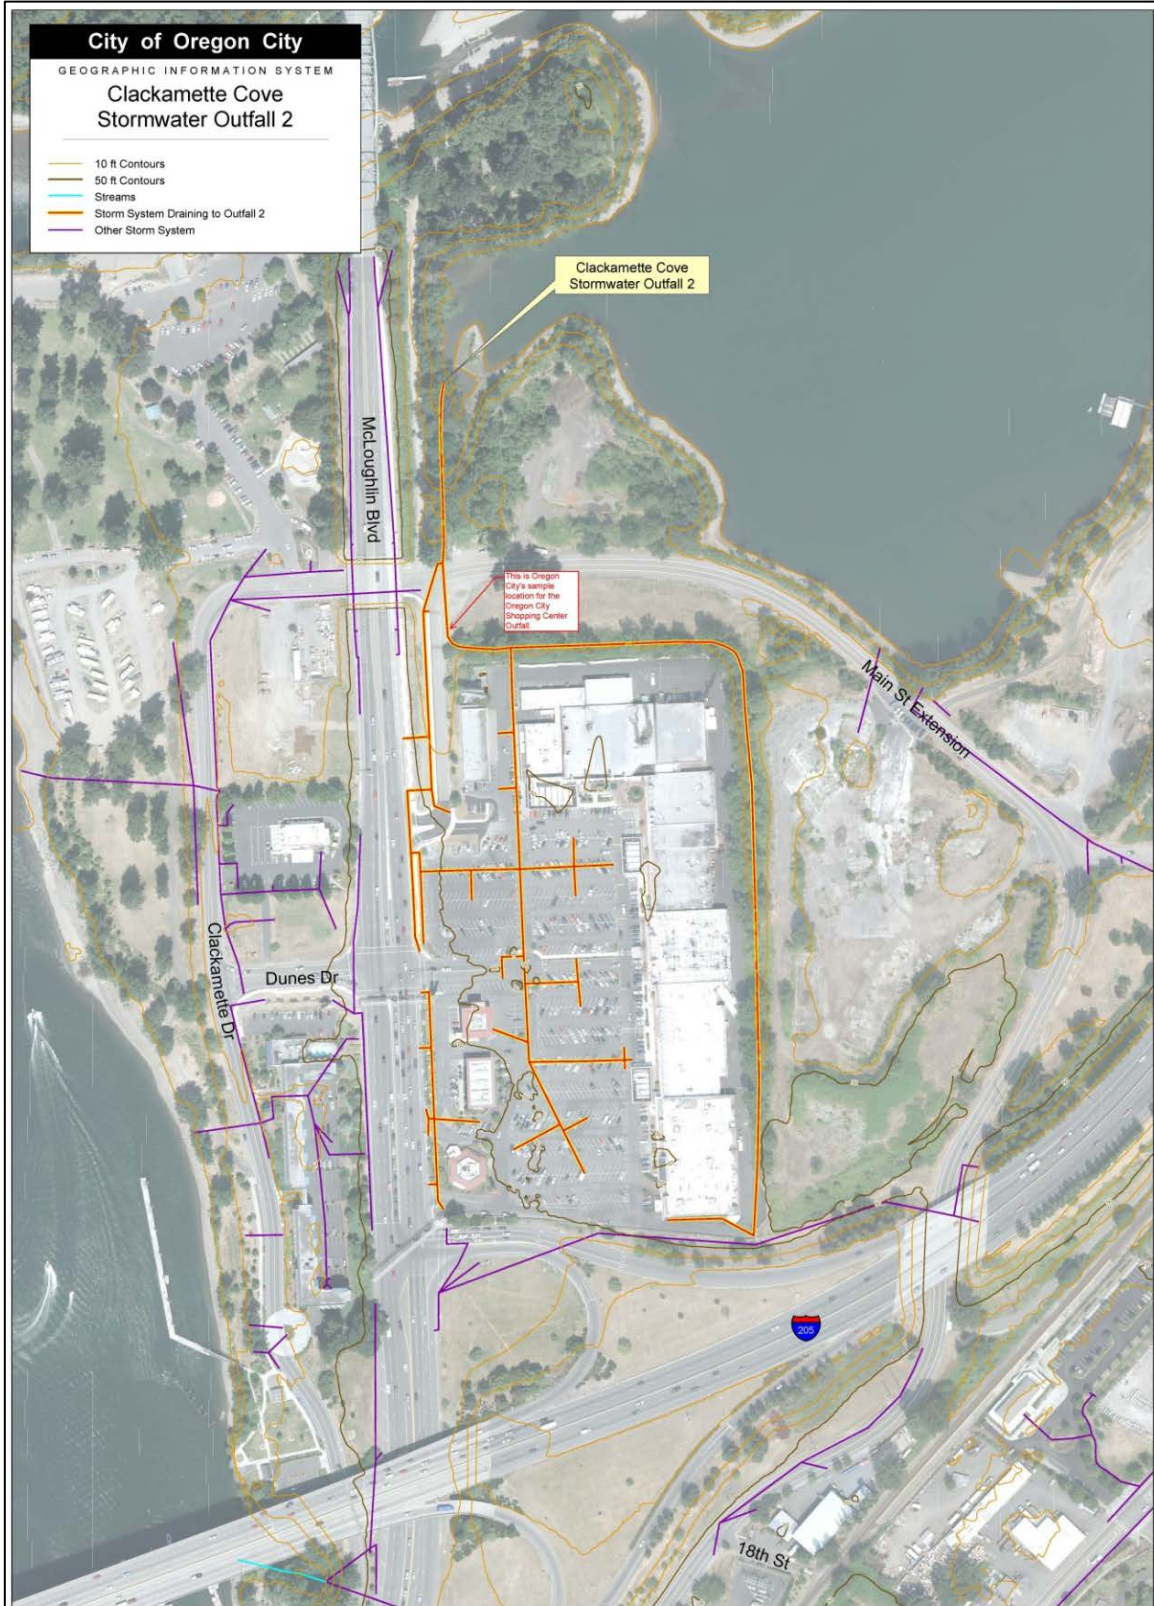
Groundwater Contamination

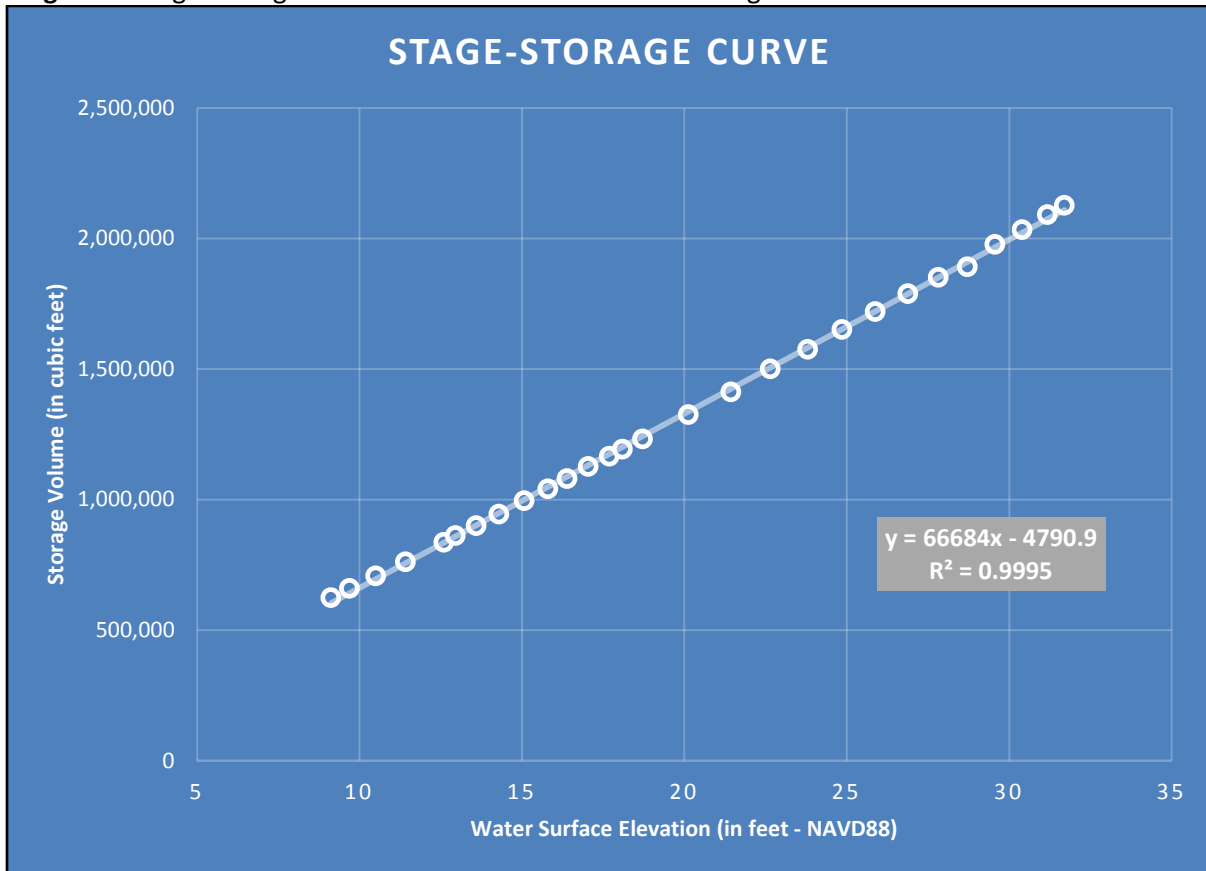
Table 3: Estimated residence time of water in Clackamette Cove under a range of water surface and inflow conditions.
