**SHEPPHARD ASSOCIATES**  
ARCHITECTS + ENGINEERS  
SHEPAE.COM

**Carnegie Center**  
912 3RD STREET,  
ORLAND, CA 95963

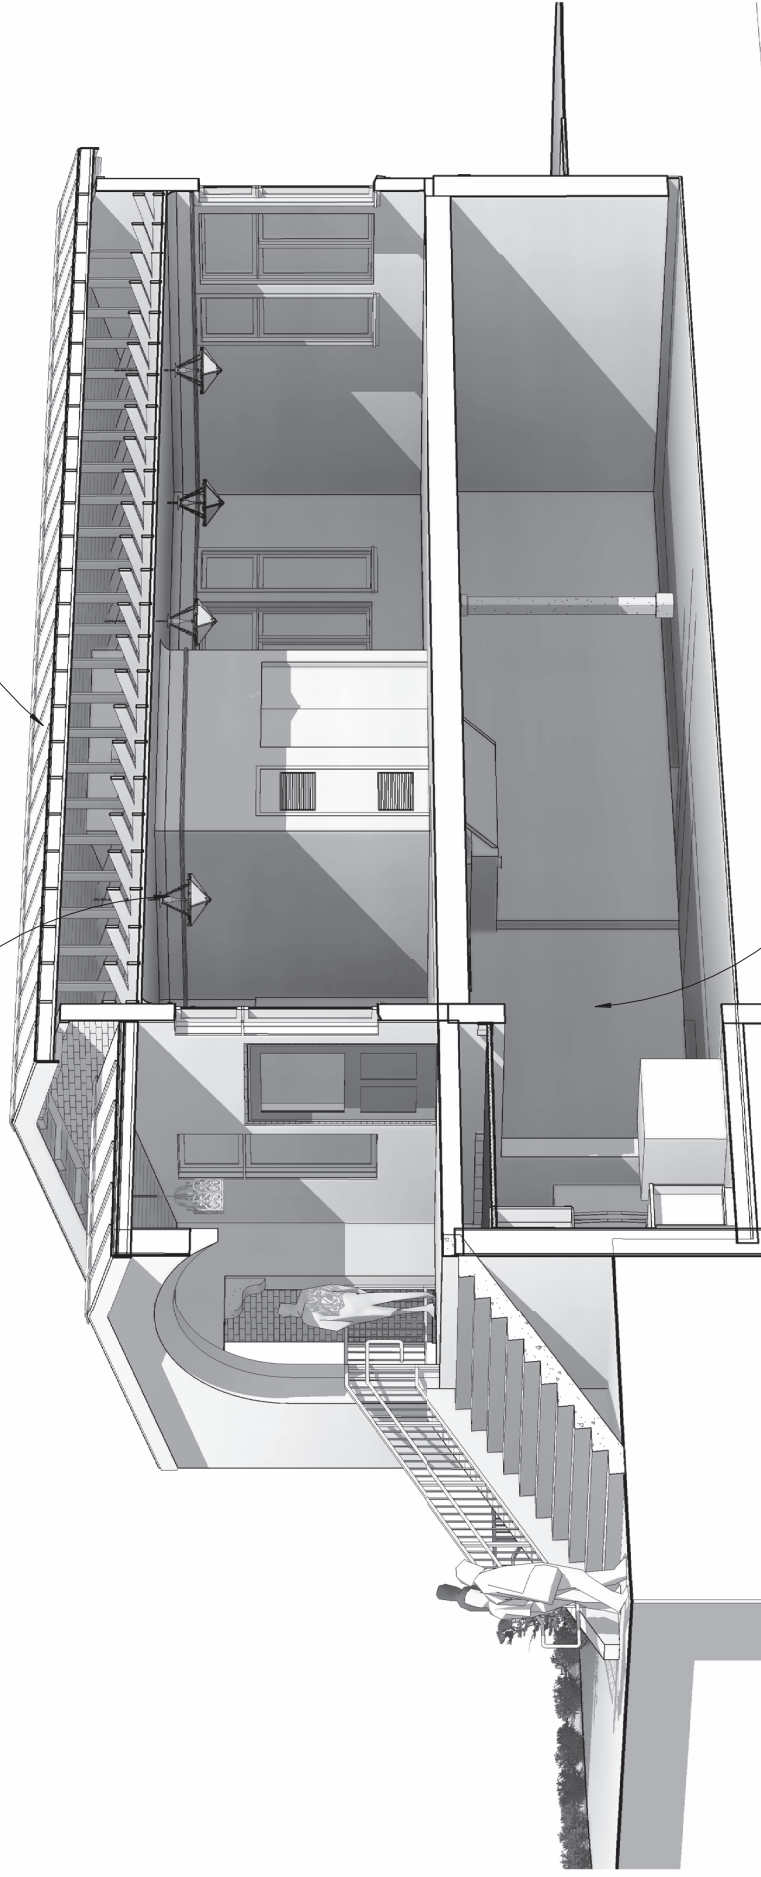
Section View  
1

new decorative  
pendant lighting

new standing seam metal roof over  
high temp underlayment over  
new plywood sheathing over  
original 1x sheathing over original  
wood trusses

new building systems and  
multiple tenant configurations
