# City of Port Lavaca

## Living Shoreline Project

*Revised Alternative Layout and 30% Design Update*

September 13, 2023

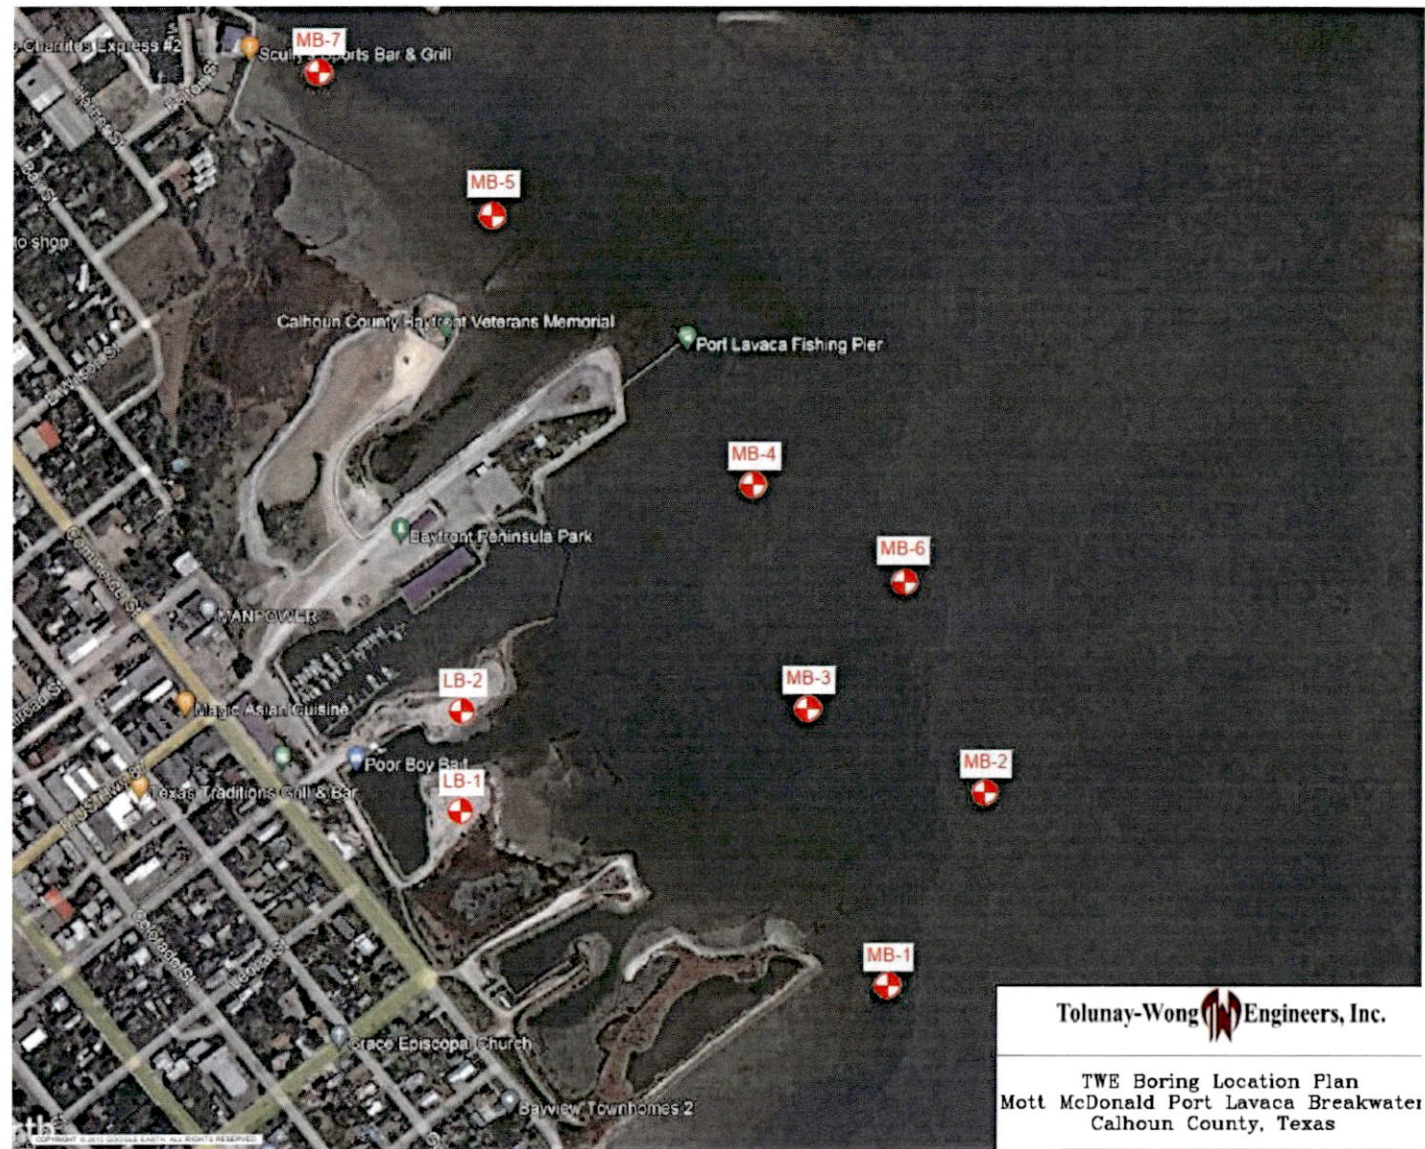
# Geotechnical Data

Data collected on week of June 27, 2023

Generally favorable soil conditions

Soil samples obtained largely consisted of soft to hard cohesive soils, LEAN CLAY (CL), SANDY LEAN CLAY (CL), FAT CLAY (CH), FAT CLAY w/ SAND (CH), and SANDY FAT CLAY (CH), and loose to very dense cohesionless/semi-cohesionless soil, CLAYEY SAND (SC).

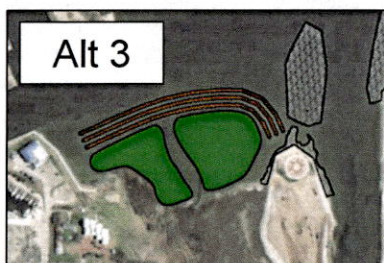
# Marsh Creation

Wave transmission and marsh vegetation tolerance for day-to-day conditions

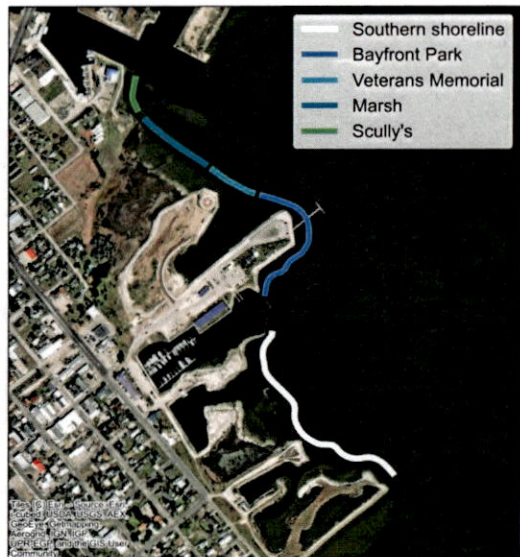
# 5yr Results

- Existing condition
- Alternative 1D
- Alternative 2A
- Alternative 3

Alternative 3 has gaps in shoreline protection in these areas due to the rubble mound breakwater being shortened and the oyster reef breakwaters being turned landward to avoid the existing live oyster reefs

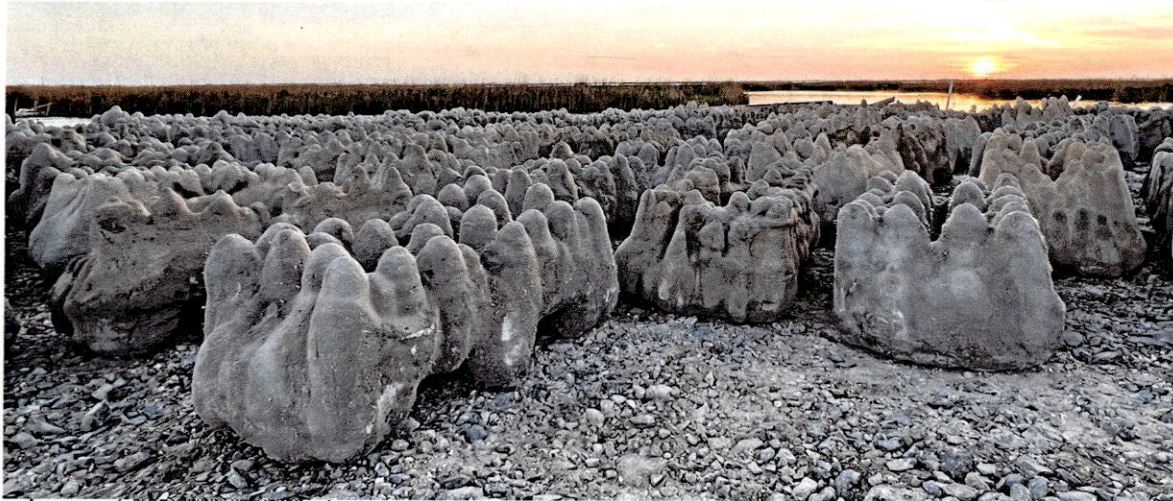
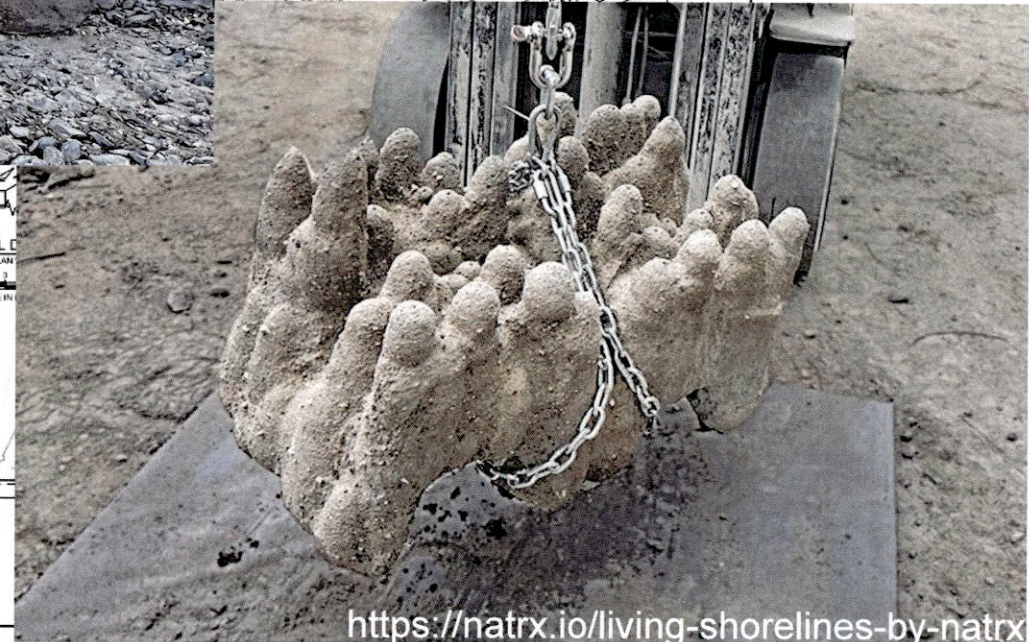
## 30% Design Plans

Future stages of design will include ability to use alternate products
