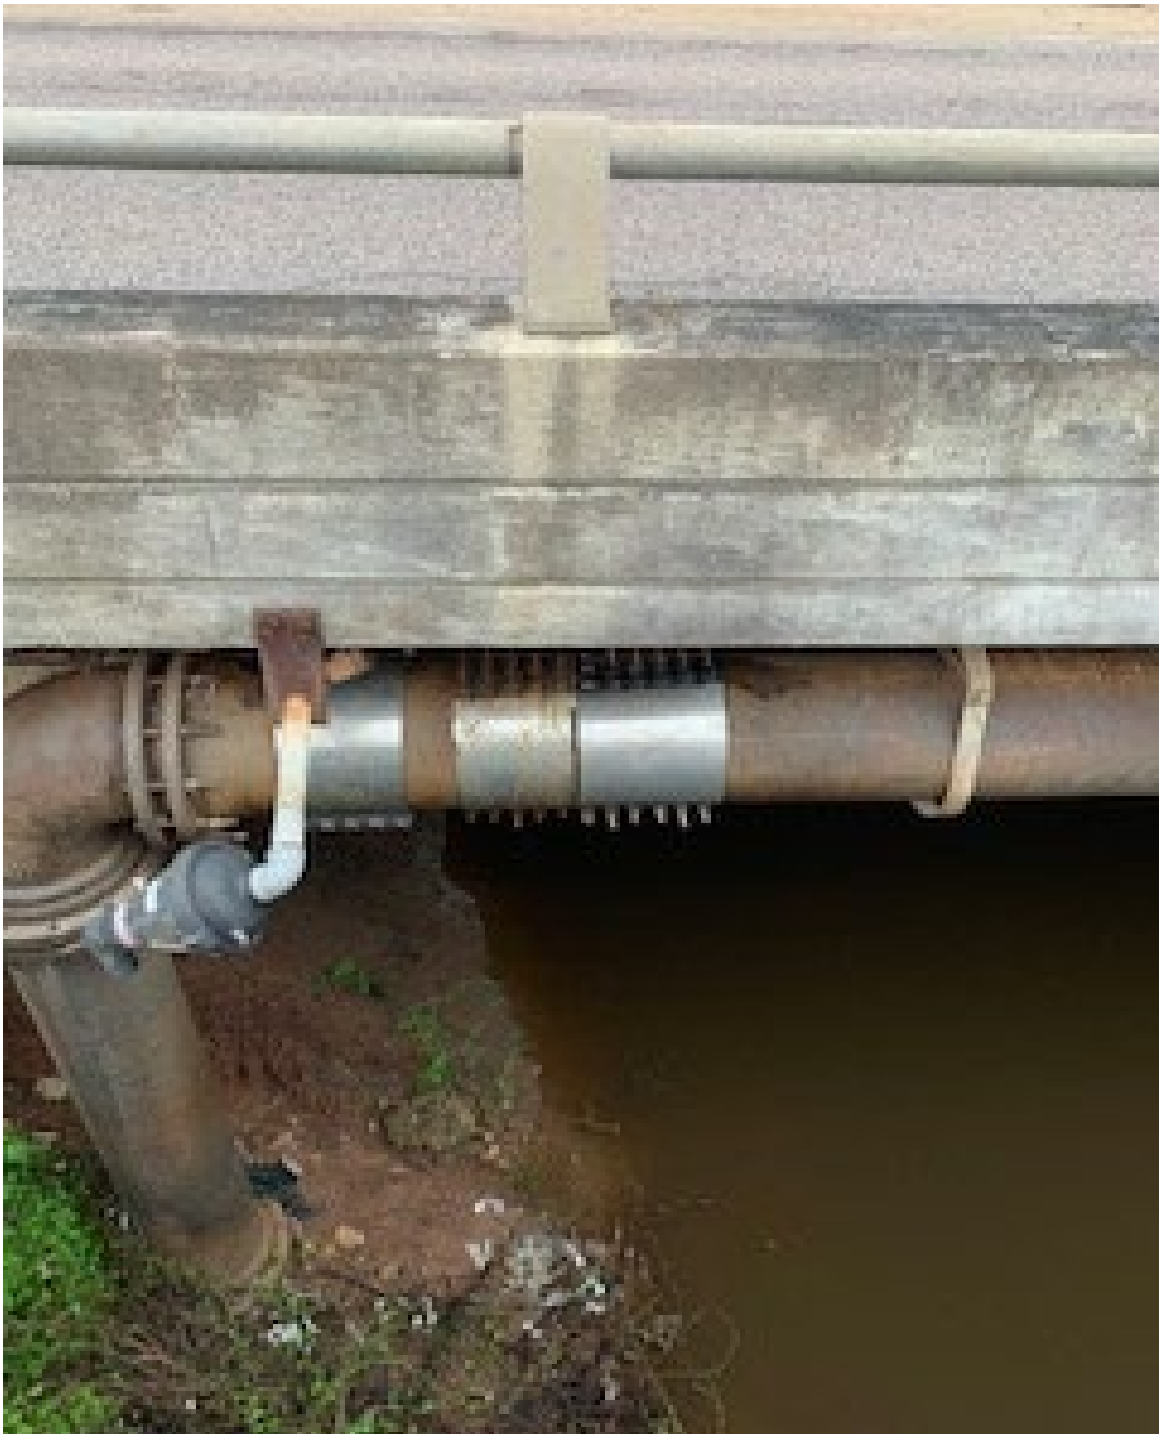
The current failing section of 170 feet of force main piping.

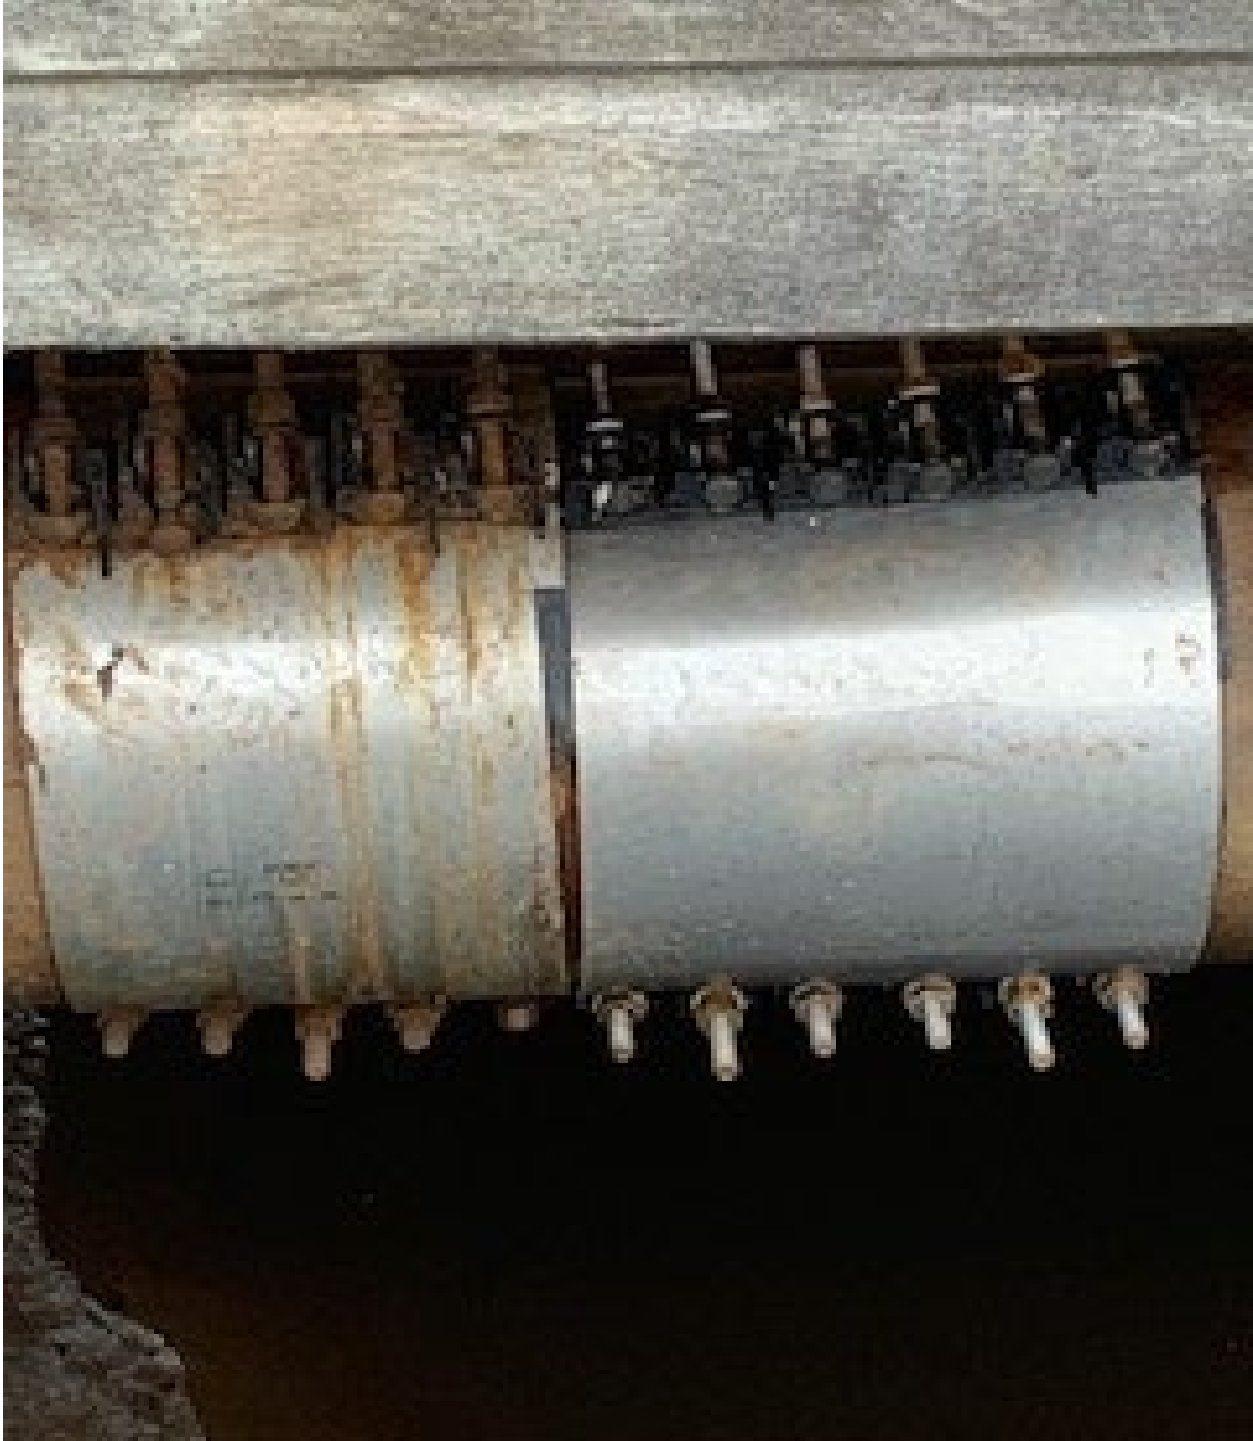
Deformed clamps around piping showing loss of structural integrity of piping which has been accelerated by the tightening of compression bolts on the clamp.
