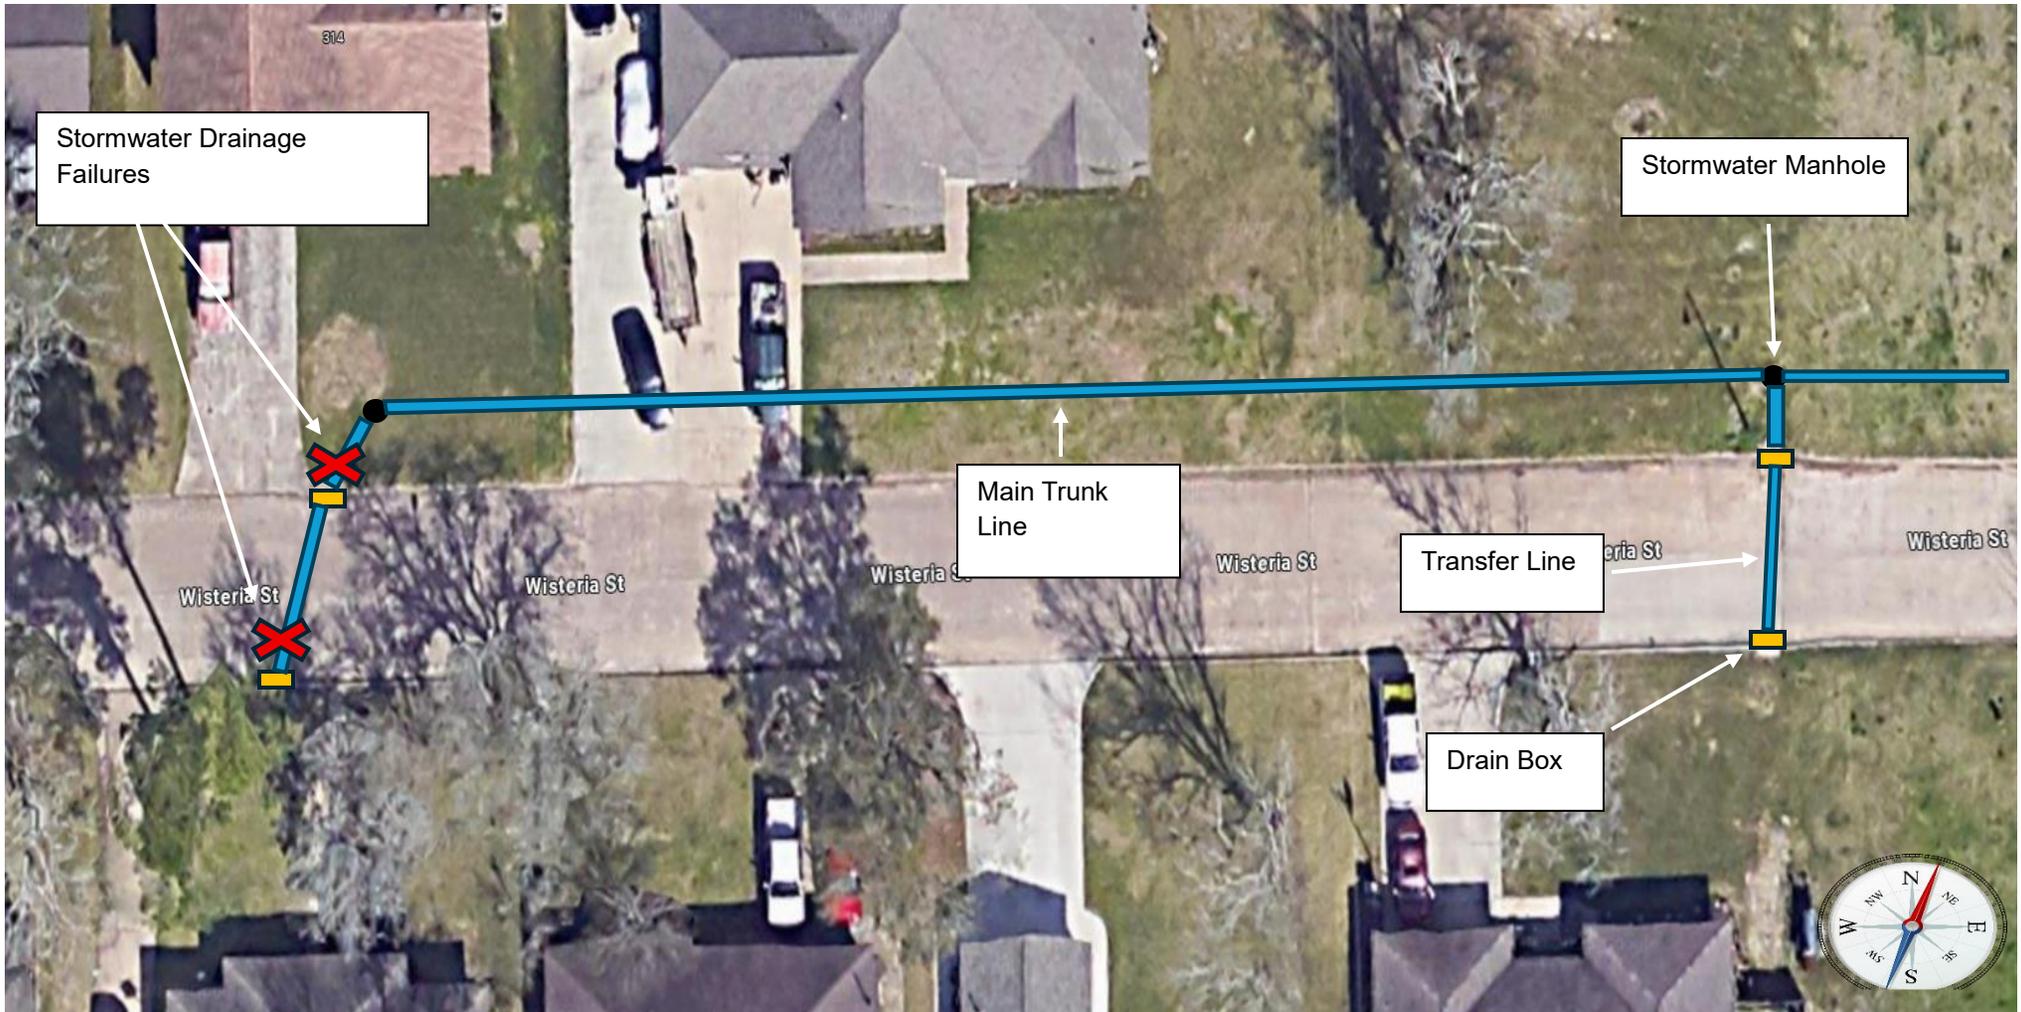
The south red X indicator represents the approximate location of the partial pipe collapse. The north X indicator represents an in-depth repair due to line and drain box failure that was made by PW earlier in the year.
