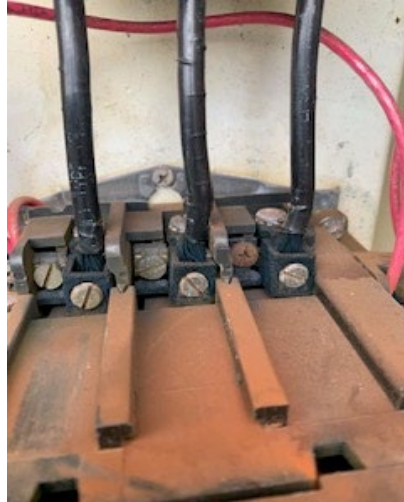
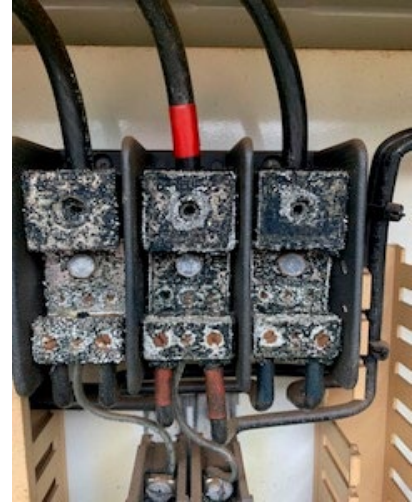
Corrosiveness of H2S requires more frequent service including the cleaning of points and contacts to keep the station operational.

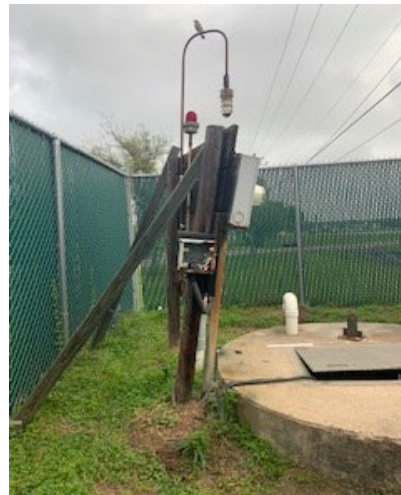
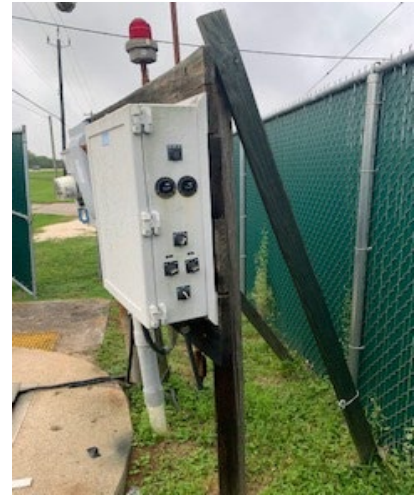
The compromised structural integrity of the electrical panel is causing it to lean under the weight of electrical components. Public Works is out of viable locations from which to brace the existing panel.

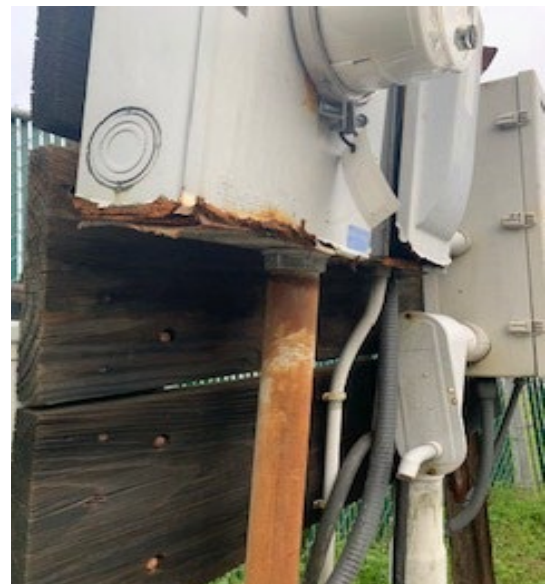
Further evidence of the corrosiveness H2S can be seen on the main disconnect and meter can that compromises a weather-tight seal crucial for safe operations.
