WATER PAYMENT APPEAL FORM

City of Rollingwood Water Payment Appeal Form Tushar and Julie Shah Account

The following is a summary report of Carrasquillo Associates' (CA) investigation conducted to date into the observed distress in the swimming pool of the residential pool (Project) located at 4824 Rollingwood Drive, West Lake Hills, TX 78746. Cracking distress in the pool shell was initially observed in the benches, tanning beach, and spa sections. The distress was reported to the pool contractor, Stag Pools, LLC (Stag) and subsequently, CA was retained by Stag's insurance carrier, Cincinnati Insurance (Cincinnati), on behalf of Stag. CA was tasked to determine the cause(s) of the observed distress and provide repair recommendations. Presented herein is the most relevant information regarding the findings and conclusions from CA's investigation into determining the cause(s) of the distress in the pool.

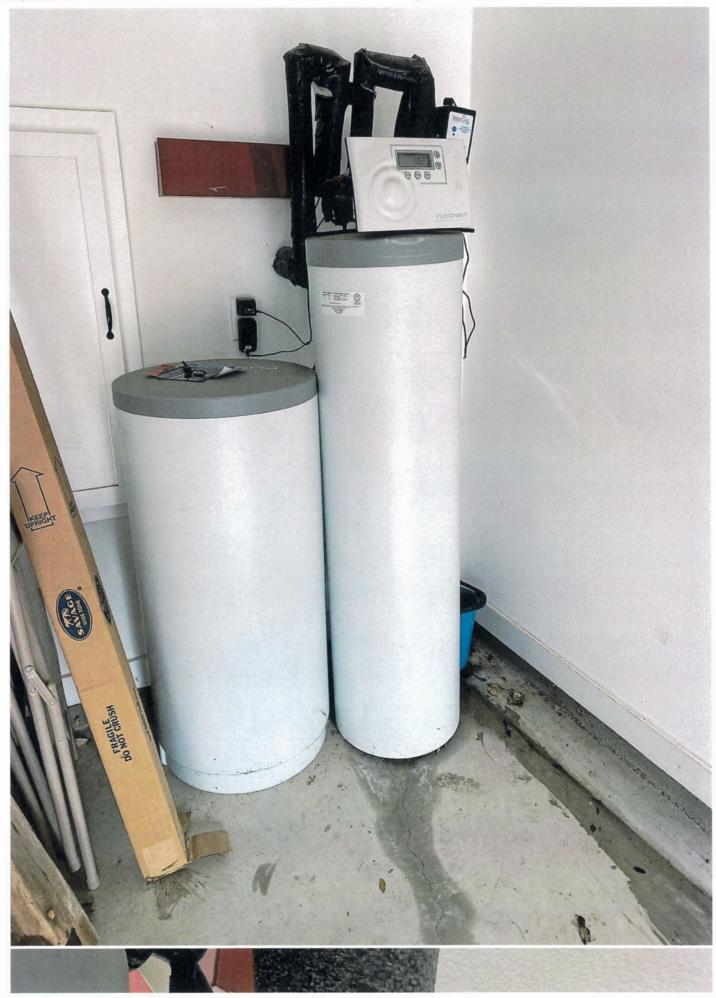
We have founded a leak at the plumbing connections at the water softener in the garage. We have also noticed cracks in the garage pavement where this leak has occurred.

I saw your warranty request, the water softener leak would not be covered under warranty. It's only a 1 year warranty. Also the cracks in the garage is a normal thing. The cracks would have to be 1/4 or more to be considered an issue. Let me know if you have any questions.

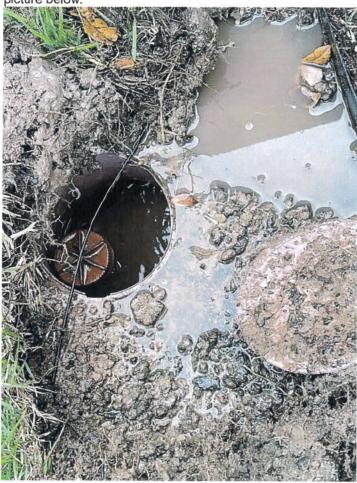
the service call was for a spring start-up and Alex fixed a leak at your relief valve on the drip line. Please see the picture below.

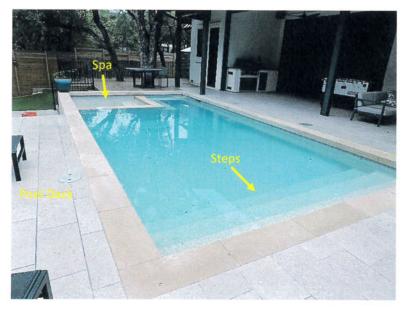
Figure 1: 4824 Rollingwood Drive swimming pool

The residence located at 4824 Rollingwood Drive is a custom-built home that includes a custom designed swimming pool. The pool, as shown in Figure 1, consists of a 12-inch-thick shotcrete shell with #4 steel reinforcement spaced at 10 inches on-center each way. The pool also contains several aesthetic features including steps, a spa, and a crawl space underneath the pool deck. The features described are identified in Figure 1.

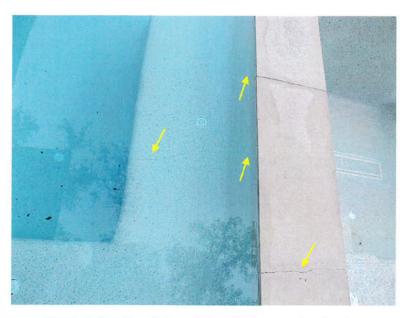
CA understands that the homeowner contacted Stag and notified them of the cracking distress and efflorescence observed at various locations in the pool shell and the perimeter wall. The cracking distress in the pool shell was not isolated to specific locations but was systemic as it was observed at the spa, steps, walls, and crawl space of the pool. Typical examples of this distress are shown in Figures 2 to 4.

Figure 2: Cracking distress in bench along pool perimeter

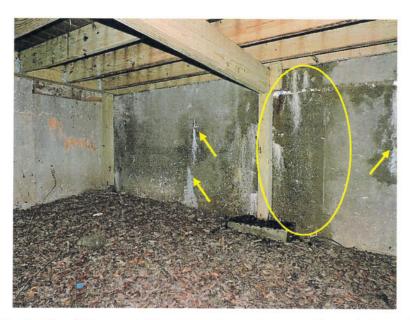
Figure 3: Cracking distress and efflorescence in crawl space underneath the pool deck

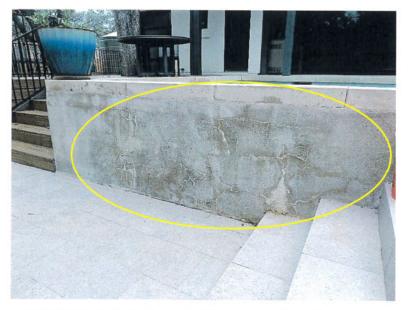
Figure 4: Cracking distress and efflorescence of exterior spa wall

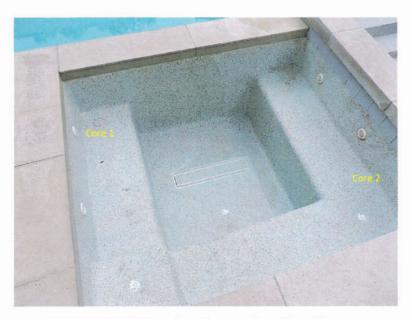
Figure 5: General overview of spa and location of the cores

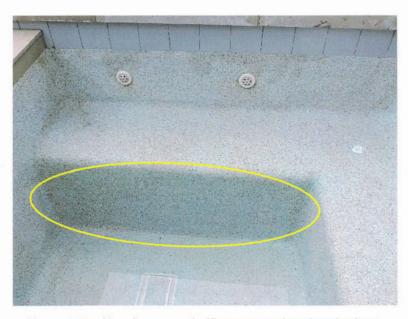
distress of the spa. The cracking distress shown in Figures 5 and 6 was systemic throughout the pool shell.

Figure 6: Cracking distress and efflorescence along bench of spa

distress observed in the pool shell and the external pool elements is an internal expansion

within the shotcrete caused by the ASR mechanism resulting in the observed cracking and

- 4. The shotcrete mixture did not contain fly ash or any other measures which could have mitigated the damage due to the ASR mechanism.
- 5. In this application, the ASR distress mechanism cannot be stopped given that the shotcrete contains the ASR reactive aggregate, and the shotcrete is not protected against the exposure and/or penetration of moisture.
- 6. It is CA's opinion that the only remediation alternative to restore the performance of the residential swimming pool at 4824 Rollingwood is the removal and replacement of the shotcrete and the reconstruction of the swimming pool.
